SSL EVALUATION

Area Lighting Yuma Sector Border Patrol Area, AZ

A unique GATEWAY evaluation on a stretch of border between the U.S. and Mexico looked at how high-flux LED lighting performed over nearly four years in a high-temperature environment.

DOE/EE-1780 · April 2018

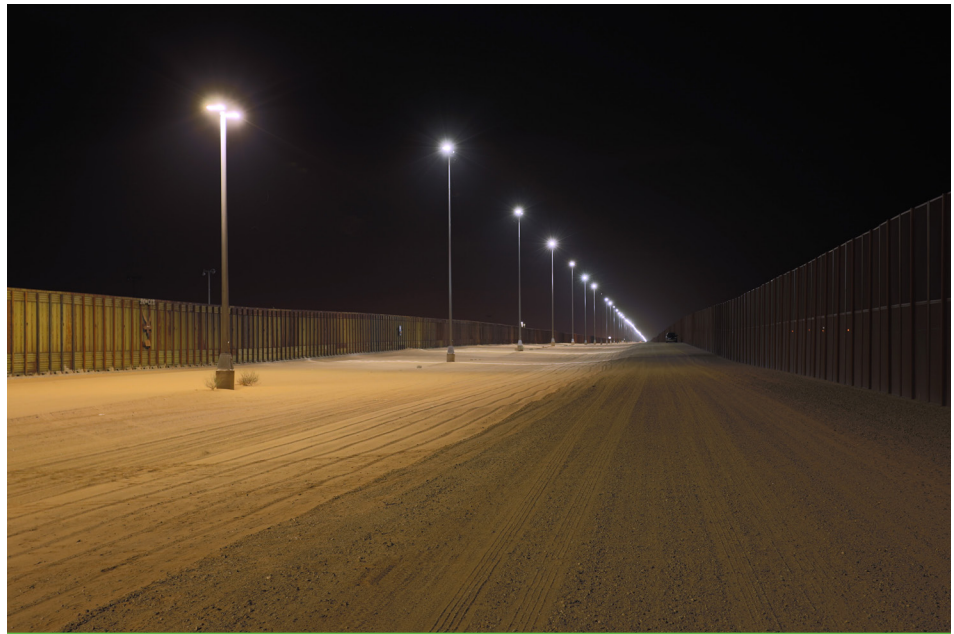
Yuma (AZ) Sector border lighting, showing the 40-foot pole height of the LED luminaires (on the first pole) and the 64-foot height of the incumbent QMH luminaires.
