Tribal Renewable Energy - Final Report

Project Title: Uk'e koley (*No Footprints*) Project

Through this award an Energy Audit and Renewable Energy Strategy Report for 14 Tribally-Owned Buildings of the Chickaloon Village Traditional Council was produced. This document included energy, heating and pollution audits; tips on how each location might be more energy efficient with the existing infrastructure; renewable energy assessment for the Tribal buildings; economic analysis of the costs of retrofitting Tribal buildings; and a conceptual design for retrofitting Tribal buildings. Also an Energy Efficiency Upgrade Cost Assessment was calculated including a cost benefit analysis of adding renewable energy systems to heat several Tribal buildings at one site. Finally, the third main result of this award was the Tribal capacity building and subsequent management of the Tribal alternative energy systems already in place, including securing a net metering agreement between the regional electric cooperative and the Tribe. This agreement required the electric cooperative to credit the Tribe for any power produced by one of the Tribe's existing solar arrays and used by the grid.

FINAL REPO

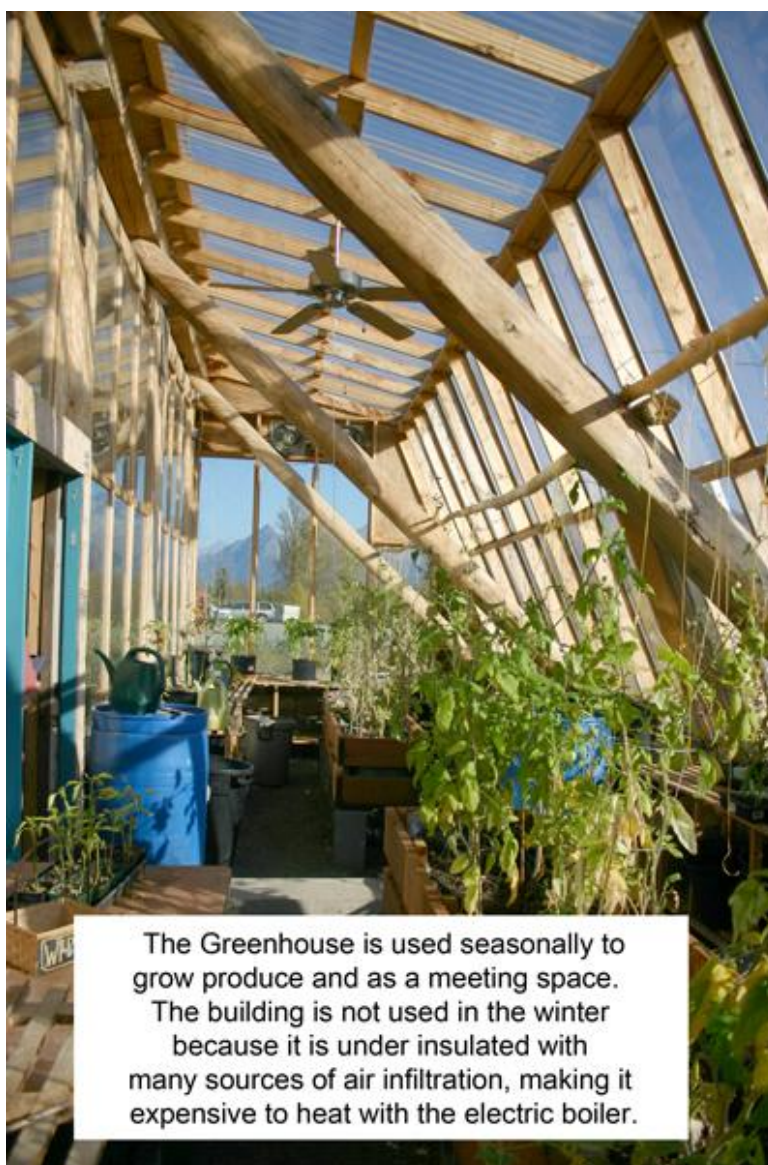
The large amount of air leakage is due to the large air gaps on the roof ridge between the meeting space and the sun space. Two exhaust fans exist in this area with no dampers and air is free to move into or out of the building.

Greenhouse Building - Blower Door Test and Air Leakage			
Building Area	Air Leakage @ - 50 Pa	Estimated Bldg Volume	Air Changes per Hour @ - 50 PA
Meeting Space	4,415 CFM	12,000 cu ft	22.1 ACH

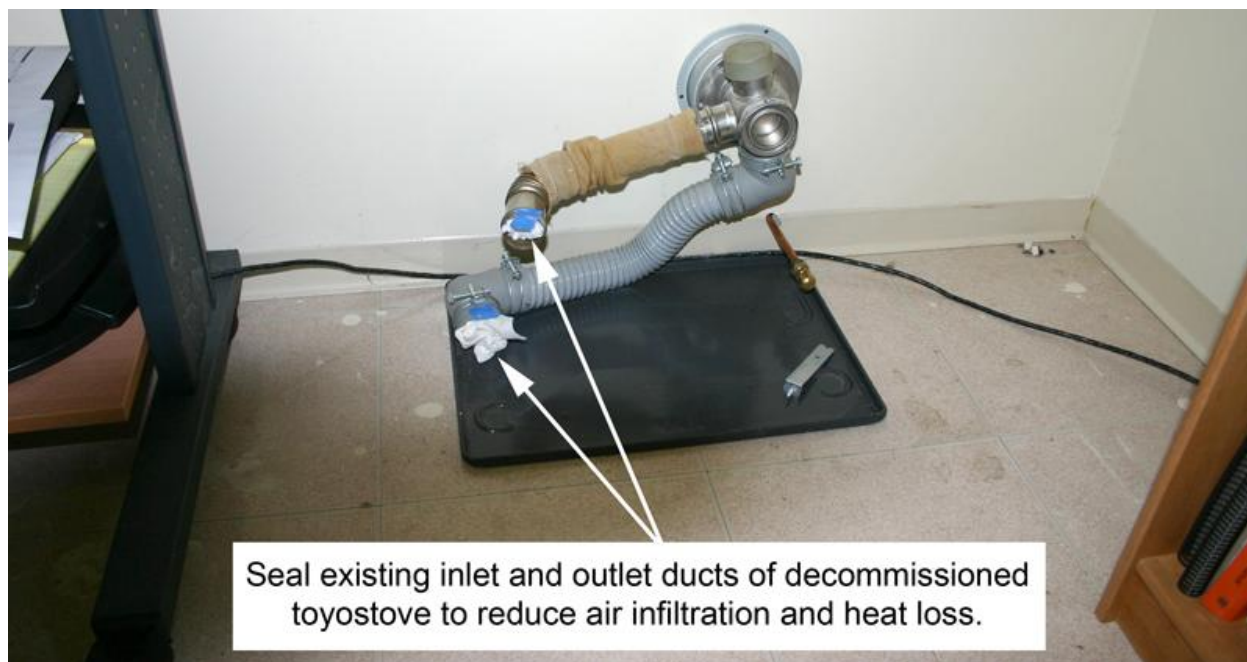
Air Leakage and Blower Door Test: The blower door test was completed using the only exterior door of the building. The entire building was tested at once. The building is leaky at 4.9 ACH50 and requires air sealing to improvements. A typical 5 Star building has 3 ACH50.

Transportation Building - Blower Door Test and Air Leakage			
Building Area	Air Leakage @ - 50 Pa	Estimated Bldg Volume	Air Changes per Hour @ - 50 PA
Transportation Bldg	396 CFM	4,864 cu ft	4.9 ACH

Building Envelope Recommendations: It is recommended that a new office complex be built to house the functions of the Transportation Bldg and the other out buildings on the site. In the interim, it is recommended that the Transportation Bldg be properly air sealed.

Recommendations for Building Envelope				
Description of Capital Investment	Improvement Number	Installed Cost	Annual Savings	Payback
Air seal the following:				
1) electrical outlets and Ethernet outlet,	Transportation Bldg 7.1.1	\$200	\$100	2 yrs
2) electrical panel, and				
3) old inlet and outlet to removed toyostove in the rear office addition.				
Items were marked with blue tape during blower door test.				
The weather-stripping on the existing exterior door is leaking air and in need of replacement. Replace weather-stripping on the door to ensure a proper air seal when door is closed.	Transportation Bldg 7.1.2	\$100	\$50	2 yrs

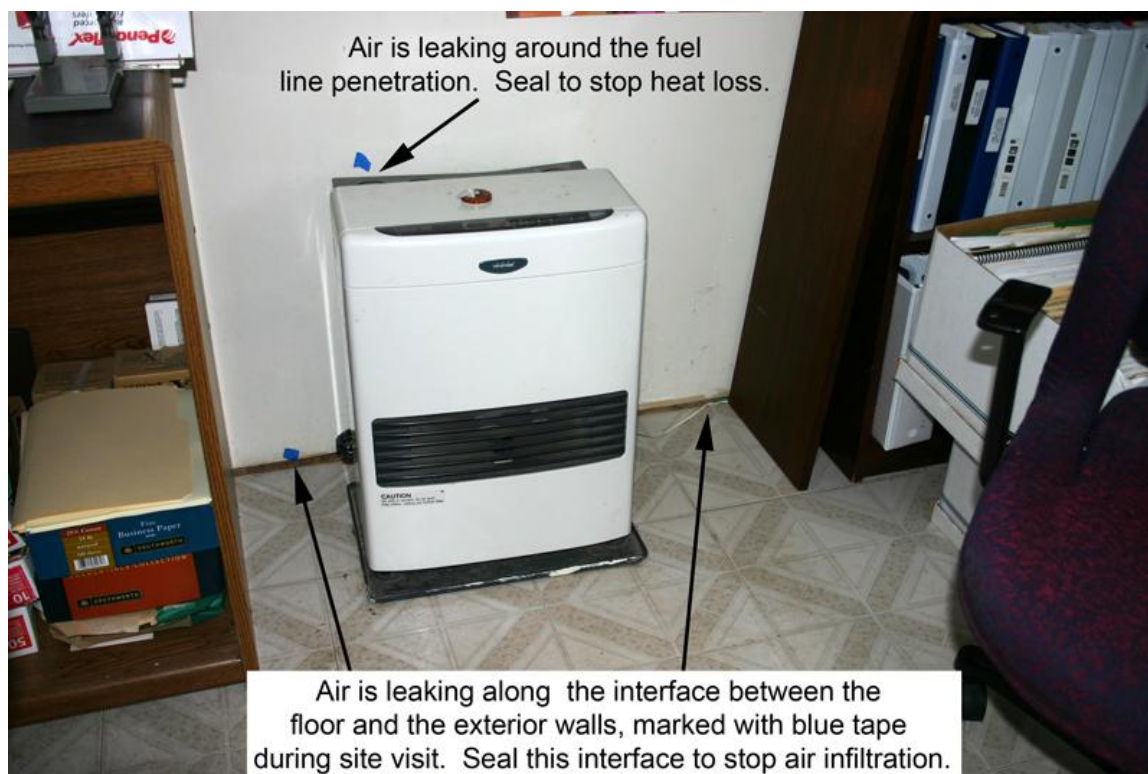
Air Leakage and Blower Door Test: The blower door test of the ICWAP Bldg shows that the bldg is quite leaky, which was unexpected based on the small size of the bldg. The test results show that the ICWAP bldg has more air leaks than the Transportation Bldg, even though the ICWAP Bldg is half the size. The blower door test was completed using the only exterior door of the building and the entire building was tested at once.

ICWAP Building - Blower Door Test and Air Leakage			
Building Area	Air Leakage @ - 50 Pa	Estimated Bldg Volume	Air Changes per Hour @ - 50 PA
H&SS Bldg	423 CFM	2,240 cu ft	11.3 ACH

Building Envelope Recommendations: It is recommended that a new office complex be built to house the functions of the ICWAP Bldg and the other out buildings on the site. In the interim, it is recommended that the ICWAP Bldg be properly air sealed.

Recommendations for Building Envelope				
Description of Capital Investment	Improvement Number	Installed Cost	Annual Savings	Payback
Air seal the following: 1) light fixtures in ceiling 2) window frame gaskets 3) electrical outlets and electrical breaker box, and 4) fuel line penetration Items were marked with blue tape during blower door test.	ICWAP Bldg 8.1.1	\$100	\$50	2 yrs
Air is leaking along the interface between the floor and the exterior walls, marked with blue tape during site visit. Seal this interface to stop air infiltration.	ICWAP Bldg 8.1.2	\$200	\$100	2 yrs
The weather-stripping on the existing exterior door is leaking air and in need of replacement. Replace weather-stripping on the door to ensure a proper air seal when door is closed.	ICWAP Bldg 8.1.3	\$100	\$50	2 yrs
Air seal window frames and add plastic membrane to interior side of window to reduce air leakage and heat loss.	ICWAP Bldg 8.1.4	\$100	\$50	2 yrs

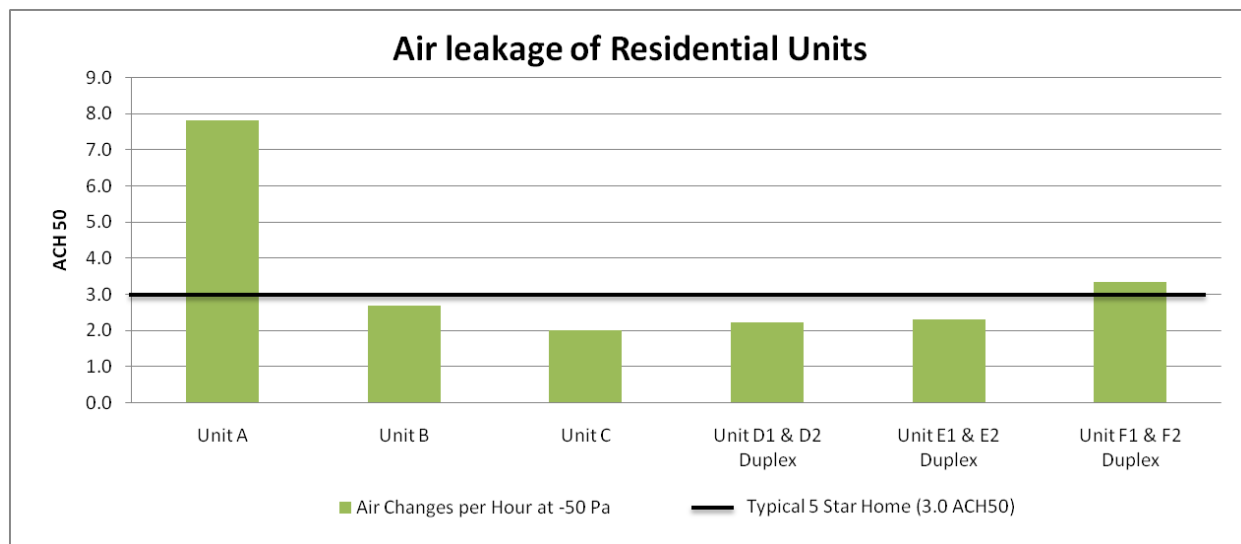
Air Leakage and Blower Door Test: Overall, the residential units built by CVTC (Units B, C, D, E & F) are very well sealed, as can be seen from the air leakage graph and table below. A typical 5 Star home has 3 ACH50, which all of the units are better than, except for Unit A and Unit F. Unit B and Unit C are the only two buildings that utilize a Heat Recovery Ventilator (HRV). Because Unit D, E and F have tight building envelopes, installing HRVs may be needed if tenants experience poor air quality or moisture problems.

As is expected, the air leakage in Unit A is significant and many air sealing improvements are necessary.

The blower door test for the single family buildings was completed on the front door of the unit. The blower door test for the duplexes required two blower door tests, with each side of the duplex being tested separately. In the table below, the test results for each side of the duplex are shown and are added together to obtain the total CFM50 for the entire duplex.

Residential Units - Blower Door Test and Air Leakage			
Residential Unit	Air Leakage @ - 50 Pa	Estimated Bldg Volume	Air Changes per Hour @ - 50 PA
Unit A	900 CFM	6,912 cu ft	7.8 ACH
Unit B	402 CFM	8,960 cu ft	2.7 ACH
Unit C	300 CFM	8,960 cu ft	2.0 ACH
Unit D1 & D2 Duplex	173 + 257 = 430 CFM	11,648 cu ft	2.2 ACH
Unit E1 & E2 Duplex	263 + 267 = 530 CFM	13,824 cu ft	2.3 ACH
Unit F1 & F2 Duplex	444 + 362 = 806 CFM	14,432 cu ft	3.4 ACH

Building Envelope Recommendations: Out of all the residential units, Unit A was determined to have the most need for building envelope improvements. The rest of the residential buildings do not require significant building envelope improvements at this time. The major improvements for Unit A involve adding additional insulation to the roof and crawlspace walls, along with air sealing.

Recommendations for Building Envelope				
Description of Capital Investment	Improvement Number	Installed Cost	Annual Savings	Payback
<p>The following sources of air leakage were found in Unit A:</p> <p>1) No outside air damper on bathroom fan,</p> <p>2) Attic hatch seal,</p> <p>3) Hole associated with clothes washer plumbing,</p> <p>4) Window frame in back room,</p> <p>5) Penetrations under the kitchen sink leading to the crawlspace.</p> <p>All items were marked with blue tape during the blower door test. Install a new damper to the bathroom fan and air seal the items above.</p>				
	Unit A 9.1.1	\$400	\$200	2 yrs
Install blown in cellulose insulation in the roof of Unit A to obtain R-38 minimum.	Unit A 9.1.2	\$2,160	\$472	4.6 yrs
Install 4" of XPS rigid insulation (R-20) to interior side of crawlspace wall of Unit A.	Unit A 9.1.3	\$2,400	\$366	6.6 yrs
