OES: 2020-01

February 2020

ORPS Data Indicates Work Process Deficiencies at Active Deactivation and Decommissioning Projects

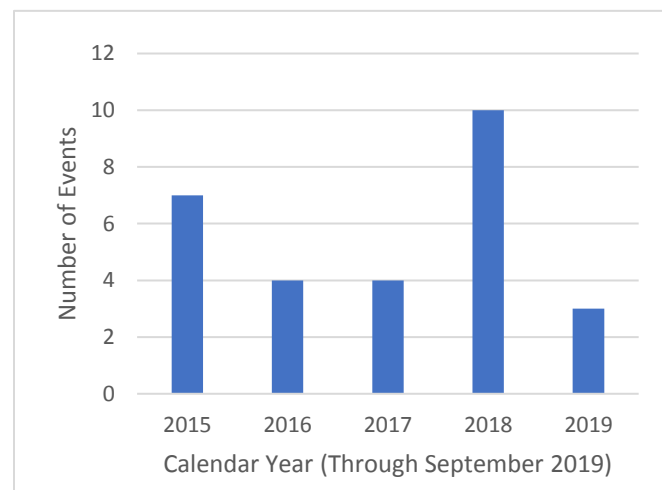
Figure 1 shows the number of radiological events with work process deficiencies at active D&D sites during the 2015 – 2019 time period.

Figure 1- Number of Radiological Events that Included Work Process Deficiencies at D&D Projects
