Joint Investigation Report

**Sealed Source Recovery at the University of Washington
Harborview Training and Research Facility Results in
Release of Cesium-137 on May 2, 2019**

March 30, 2020

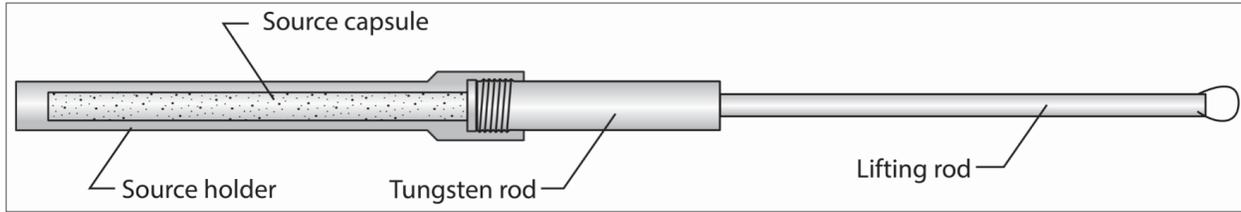
Figure 4: Notional Diagram of Source Holder

The Mark I irradiator utilizes a Model 6810 source capsule. The Model 6810 source capsules are designed to be used in irradiators, calibrators, and dry-well facilities. A Source Holder is machined to fit each category of source capsule. Sources containing large Ci quantities are normally in heavily shielded devices which bear a label that reveals the type, quantity of radioactive material, and source serial number. The sources vary in length (Figure 4).

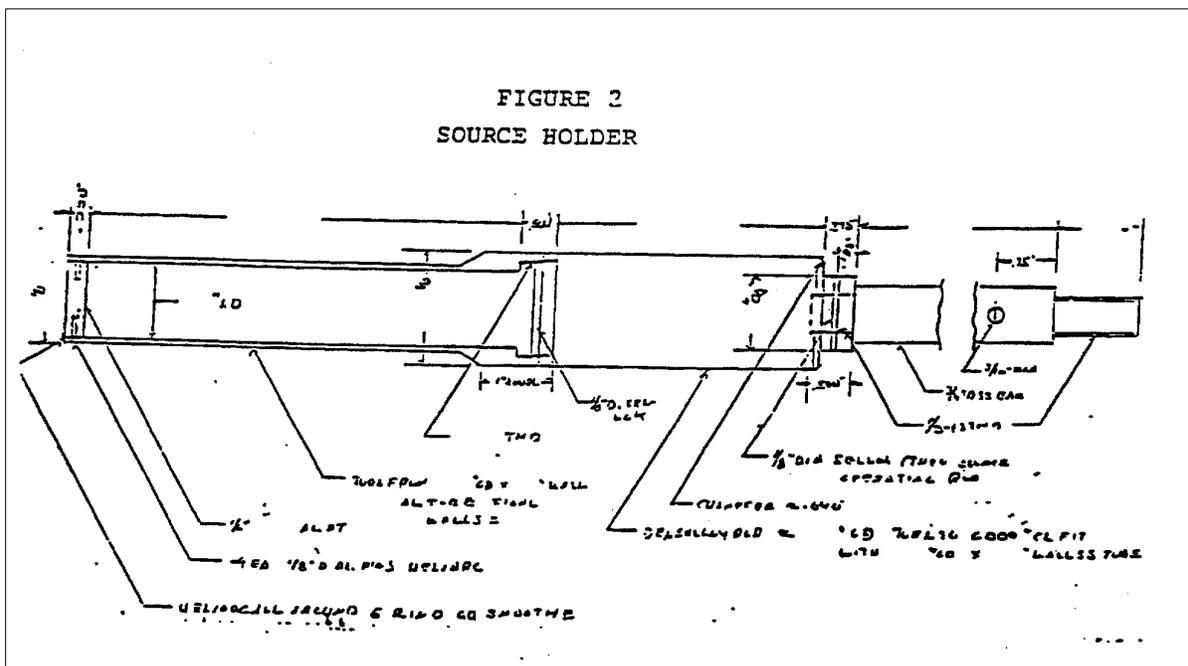
Figure 5: Source Holder Diagram (from the NRC Registry of Sealed Sources)

The NRC Registry of Radioactive Sealed Sources and Devices, Safety Evaluation of Sealed Source, CA-0598-S-119-S, dated April 2, 1990, identifies the configuration of a Source Holder (Figure 5). This figure was the only information publically available to support work planning for this operation.

INIS conducted the work without specific source holder configuration information for the Model 6810 sealed source. The INIS NRC license modification application to add the JLS Model 6810 sources to their license only included the grainy NRC source registry document (reference Figure 5 in Section 1.5.1.2), in which dimensions are illegible. INIS conducted the work based on only the previous Cleveland source recovery from a JLS Mark 1-68 irradiator, which was configured differently. Significantly, the source holder surrounding the JLS Model 6810 source at HRT was manufactured with only 0.5” of threading on the tungsten rod and a single 0.25” spacer, versus the configuration of approximately 1” of threading and two spacers for the Cleveland job. As INIS was cutting through the knurled aluminum portion of the source holder, they believed it was backed by the tungsten rod. In actuality, some of those cuts went through the aluminum and penetrated the stainless-steel-sealed source capsule, nearly creating a completed circular cut of the capsule, which would have resulted in an unconstrained release of cesium.

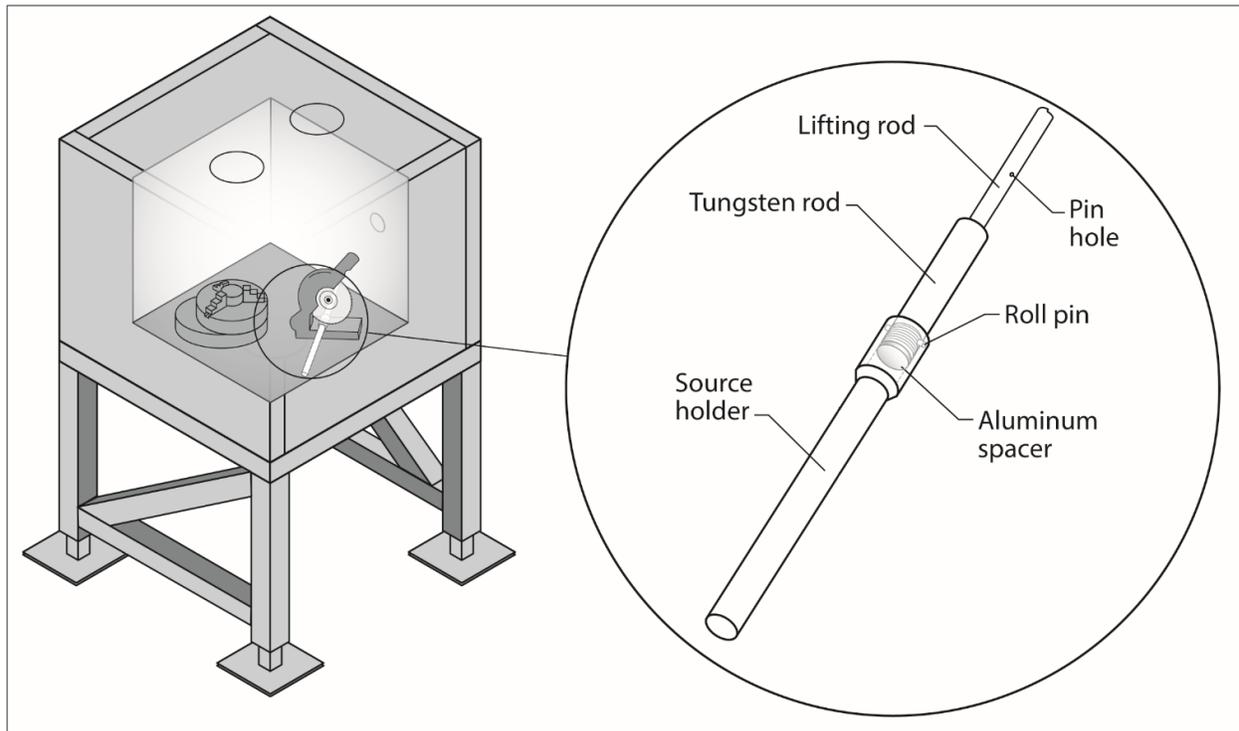
Figure 6: Mobile Hot Cell and Source Holder

The MHC is an INIS-designed carbon steel box 56” L x 56” W x 46” H (Figure 6). Unlike a traditional hot cell, the MHC is not configured with a viewing window. Rather, five digital cameras feed a monitor attached to the side of the MHC, to allow the operators to view activities inside the MHC. Four of the cameras are fixed and one is available to be handled with the

manipulators. The walls are 12” thick, and the top and bottom of the box are each 8” thick. The total weight is approximately 33,500 pounds. The volume inside the assembled box is approximately 32” L x 32” W x 30” H. The top of the box has two 8” openings, to accommodate manipulators used to remotely handle the sources. There are openings on the side and bottom to facilitate mating a cask and irradiator for source transfers. The MHC at the HRT was configured on top of a 56” stand. This allowed the irradiator to be mated to the bottom of cell through a 15” opening. An additional shield (donut shield) was available for this configuration. The donut shield is designed to reduce the amount of radiation shine from the bottom of the MHC. The MHC is open to the environment and has no containment capability for loose contamination.

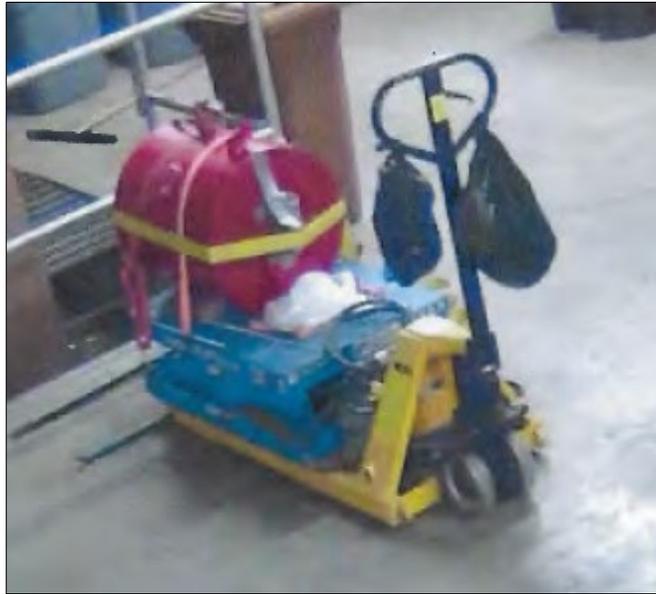
Figure 7: INIS Transfer Cask

The transfer cask is a steel-encased lead storage container designed to provide robust shielding for high-activity beta/gamma radiation sealed source(s) storage. The transfer cask mates to the transfer port of the MHC. It is used by INIS to hold sources for storage until the radioactive contents can be transferred into an appropriate transportation package, since the transfer cask cannot be used for over-the-road transportation of radiological material (Figure 7).

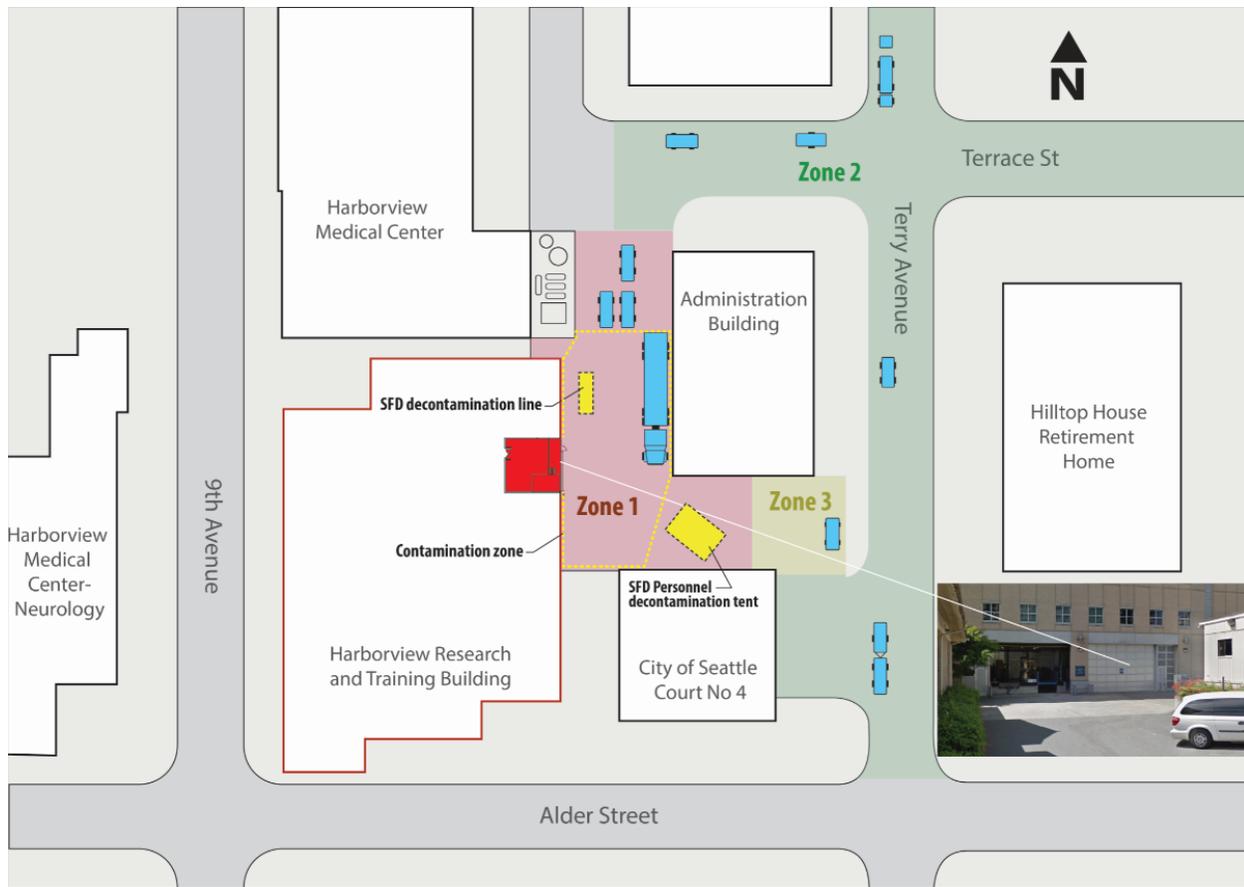
Figure 22: Notional Diagram of “Terry Command”

At 22:30 hrs., SFD HAZMAT response arrived outside the HRT and established Incident Command (IC) – designated “Terry Command” and started initial set-up (Figure 22). SFD HAZMAT had not received formal notification of source recovery activities. The initial HAZMAT response did not include mass radiological decontamination capability.

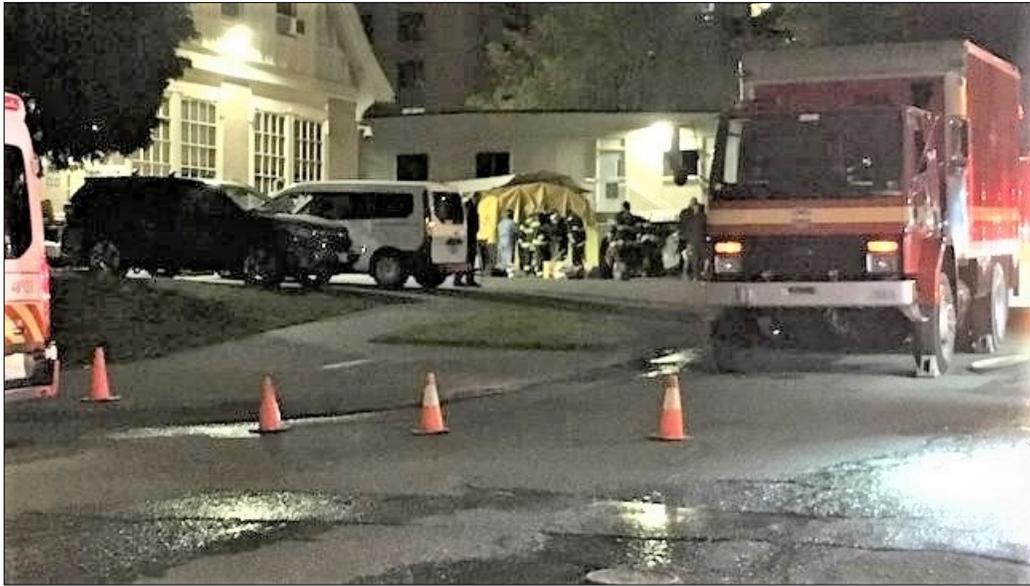
Figure 23: “Terry Command” Decontamination Tent

Around midnight on May 3, the SFD began to establish personnel decontamination protocol (Figure 23). The UW ARSO recommended to the SFD to decontaminate the highest-contaminated individuals first to mitigate their accumulating dose. However, the SFD

decontaminated individuals with the least contamination first, and the highest-contaminated individuals last, in order to limit the transfer of accumulated contamination in the decontamination pools.
