U.S. DEPARTMENT OF  
**ENERGY**

Legacy  
Management

## 2020 Annual Site Inspection and Monitoring Report for Uranium Mill Tailings Radiation Control Act Title II Disposal Sites

December 2020

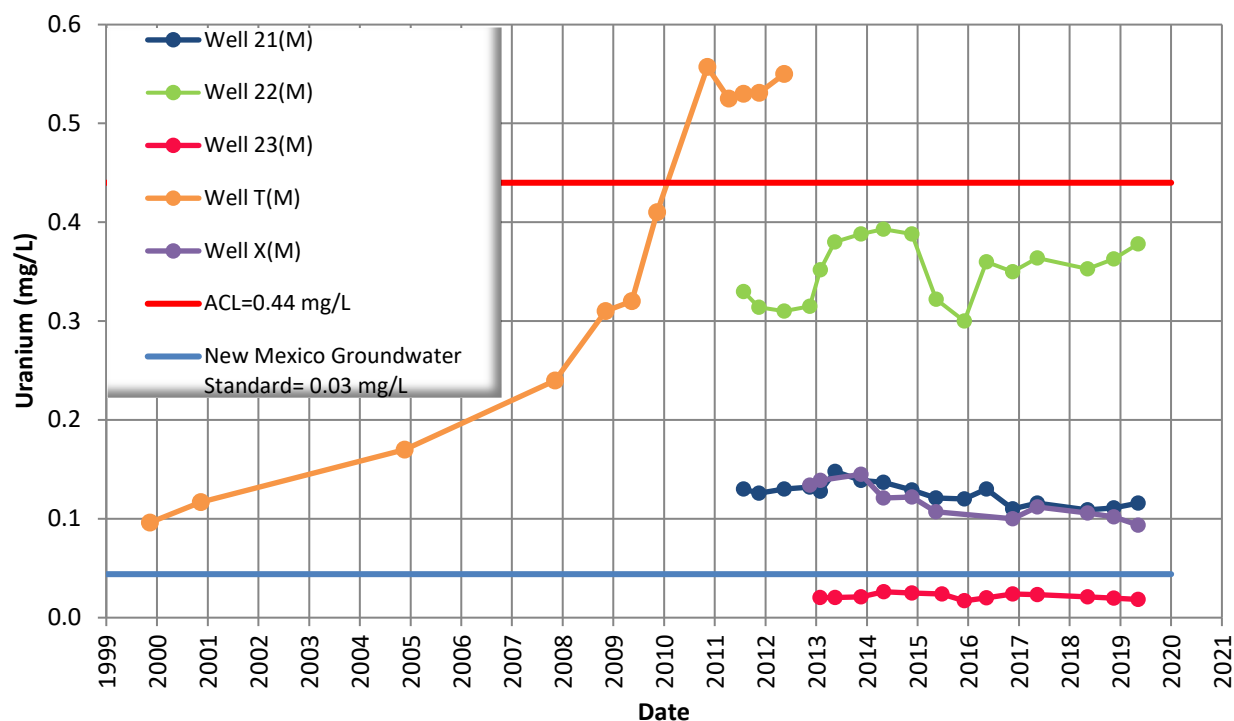
Figure 1-4. Uranium Concentrations in Alluvial Aquifer POC Well T(M) and Downgradient Wells at the Bluewater, New Mexico, Disposal Site

Figure 1-4 shows historical uranium concentrations measured at POC well T(M) and four additional wells screened in the alluvial aquifer. As this figure shows, the uranium concentration at well T(M) trended upward since LM began monitoring the well in 1999, and the November 2010 concentration of 0.557 mg/L was the first of five uranium concentrations that exceeded the ACL of 0.44 mg/L. LM notified NRC of the exceedance upon receiving the 2010 results from the laboratory. Well T(M) was sampled in May 2012 as declining water levels due to drought indicated it would soon go dry. Well T(M) has remained dry since 2012. Well 21(M) in the southeast corner of the site and POE well X(M) near the site's east boundary show a slightly decreasing trend in uranium concentration since 2013 (Figure 1-4). However, the elevated uranium concentrations at these two wells in recent years indicate that alluvial groundwater with uranium concentrations exceeding the New Mexico groundwater standard (0.03 mg/L) is discharging from the site toward the southeast. NRC requested that LM evaluate the performance of the main tailings disposal cell to assess whether seepage from the cell between 2005 and 2010 had increased to the extent it was responsible for the elevated uranium concentrations measured at POC well T(M) (see Figure 1-4) before it dried up. Based on an assessment of the disposal cell cover and an accompanying evaluation of the water balance for the main tailings disposal cell, the increase in uranium concentrations in well T(M) is not attributed to a compromise of the disposal cell's performance, and there was no surge of tailings-fluid seepage from the main tailings cell since it was closed (DOE 2014). It was further concluded that water levels in well T(M) decreased during the early 2000s below the contact between the alluvium and underlying Chinle Formation from 2008 to 2012. The simultaneous increase in uranium concentration was attributed to the declining water level and the influence of contaminated groundwater migrating through and interacting with weathered Chinle Formation materials, with the resulting fluids obscuring the water chemistry of groundwater in nearby portions of the alluvial aquifer that remained saturated (DOE 2014).

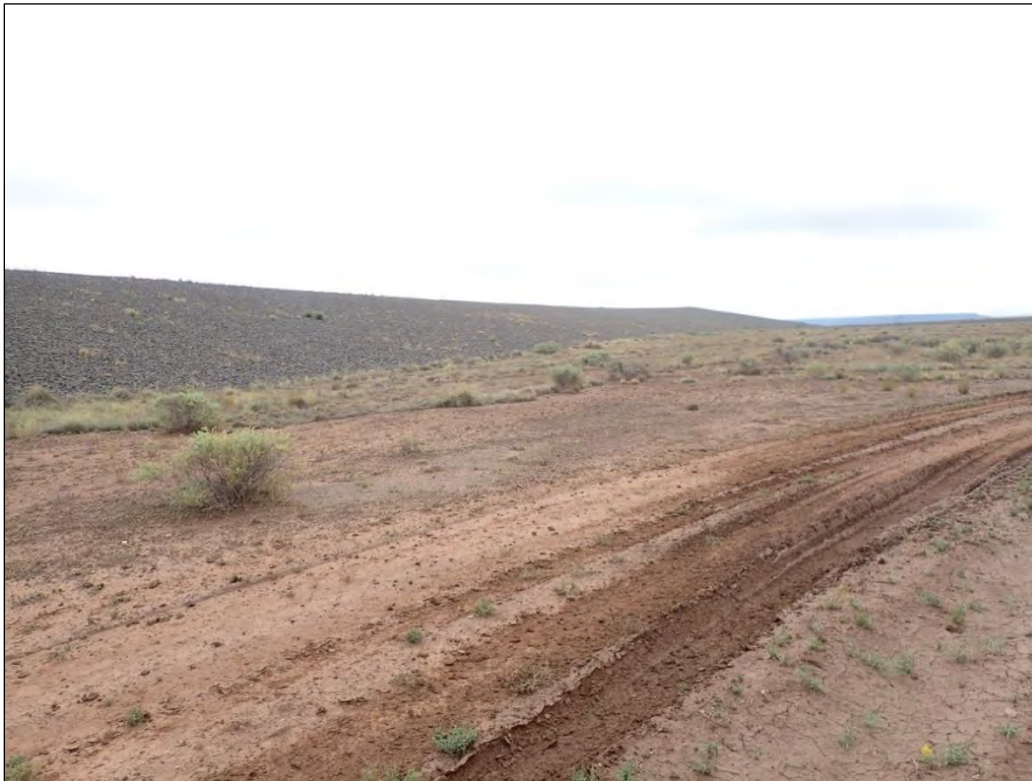
Interior roads used to access LM assets consist of a dirt track covered at places with crushed basalt (PL-1). The roads are susceptible to erosion and are repaired when they become impassable. Erosion on the road northwest of the main tailings disposal cell continues to be an issue. In 2017 riprap was added to repair a gully intersecting this section of the road. Additional erosion was noted along the road paralleling the northern perimeter of the site. LM is planning to repair the roads in 2021 through the interagency agreement with USACE. Vegetation was also overgrown along the road paralleling the north perimeter of the site, which LM cut back in a subsequent visit in September 2020. No other maintenance needs were identified.

*PL-1. Access Road and West Side Slope of the Main Tailings Disposal Cell*

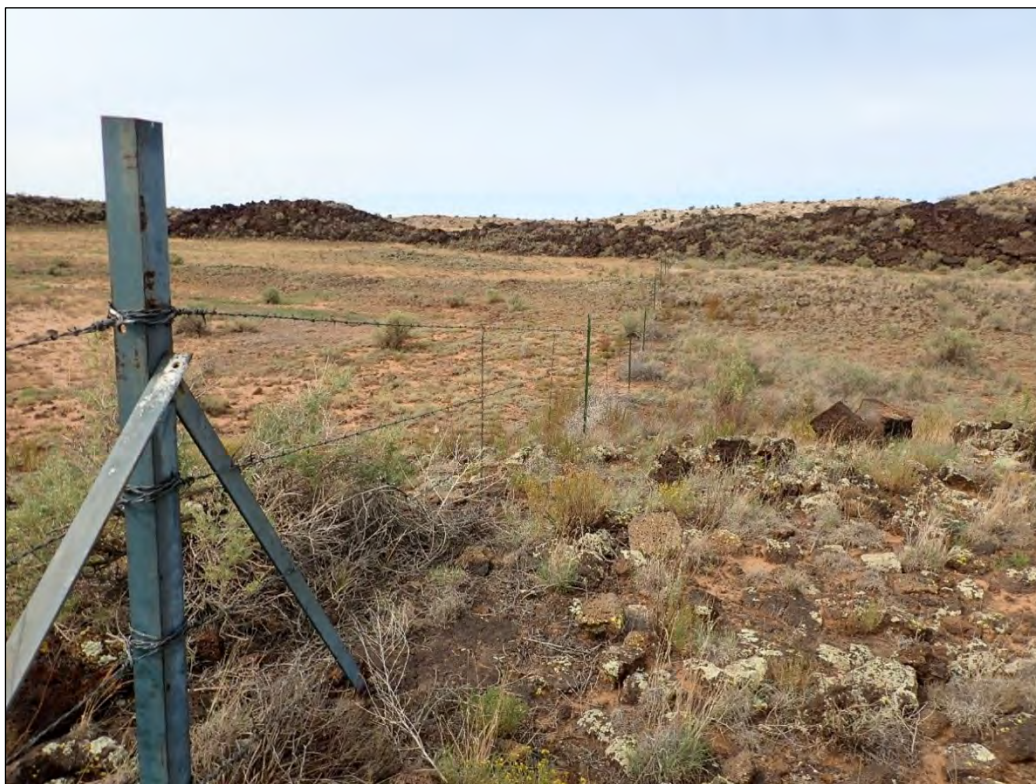
A four-strand barbed-wire fence encloses the site to facilitate land management by LM, which retains a local subcontractor to periodically check the site perimeter fence and remove trespassing cattle (PL-2). Minor fence repairs are conducted as needed. Numerous sections of the fence are in remote areas of the site and cannot be observed from site access roads. Inspectors observed the gullies paralleling the perimeter fence northwest of the main tailings disposal cell, which were identified in the 2019 inspection. No significant changes were observed. Inspectors will continue to monitor this area for damage to the perimeter fence.

*PL-2. Fence Line Near Boundary Monument BM-4*

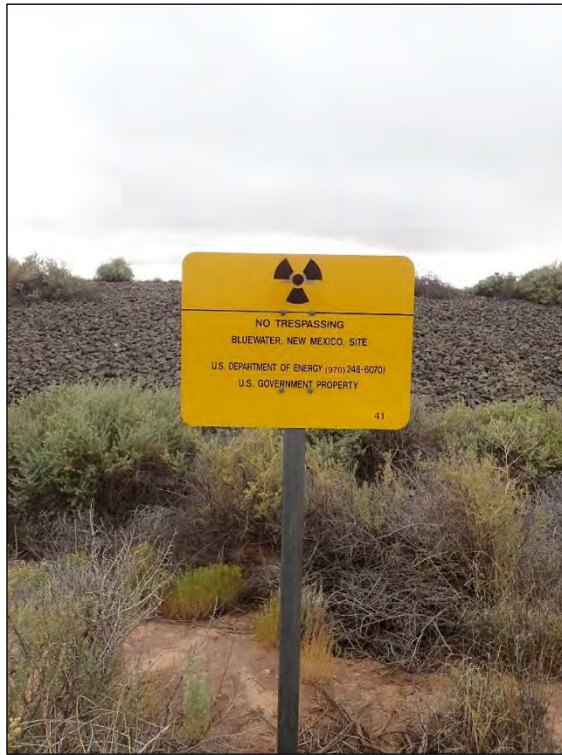
Fifty-five perimeter signs (warning and no-trespassing signs) are mounted on steel posts along the site boundary and around the main and carbonate tailings disposal cells (PL-3). Perimeter signs P3 and P10 have bullet hole damage but are legible. The base of perimeter sign P16 was loose, though immediate maintenance is not required. Inspectors will continue to monitor the condition of the sign. No other maintenance needs were identified.

*PL-3. Perimeter Sign P41*

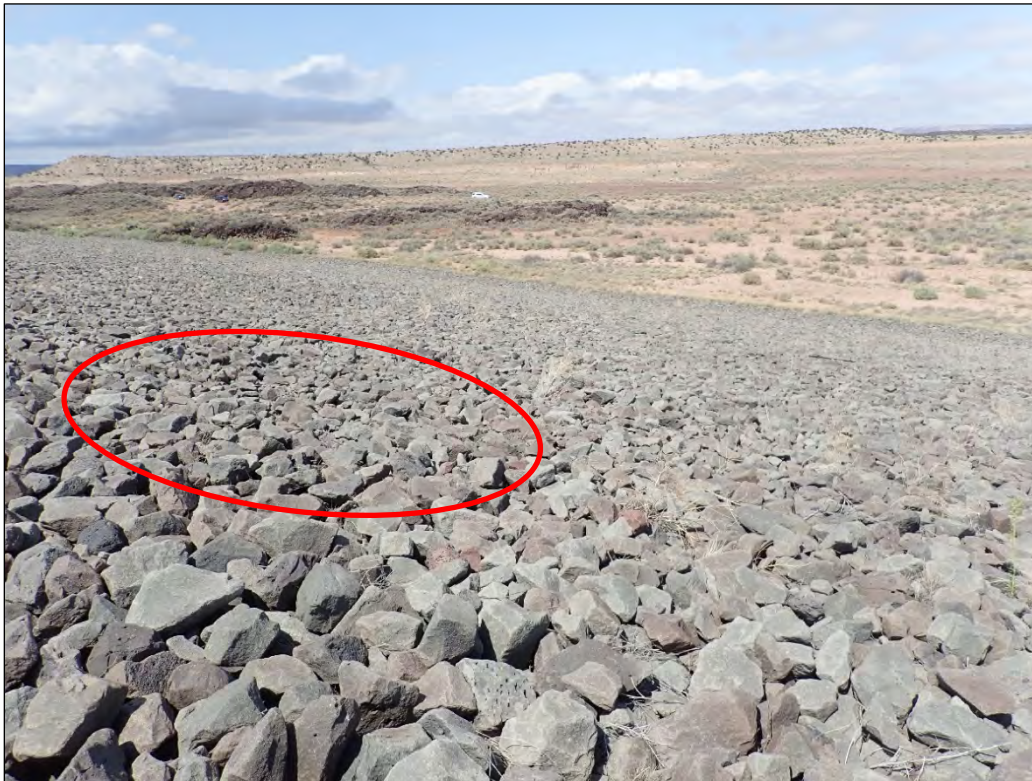
| Site | Chapter | Page | Issues and Actions |
|---|---|---|--|
| | | 1-7 | An additional area of potential settlement was observed on the north side slope of the disposal cell. |

*PL-11. Potential Settlement on the North Side Slope of the Main Tailings Disposal Cell*

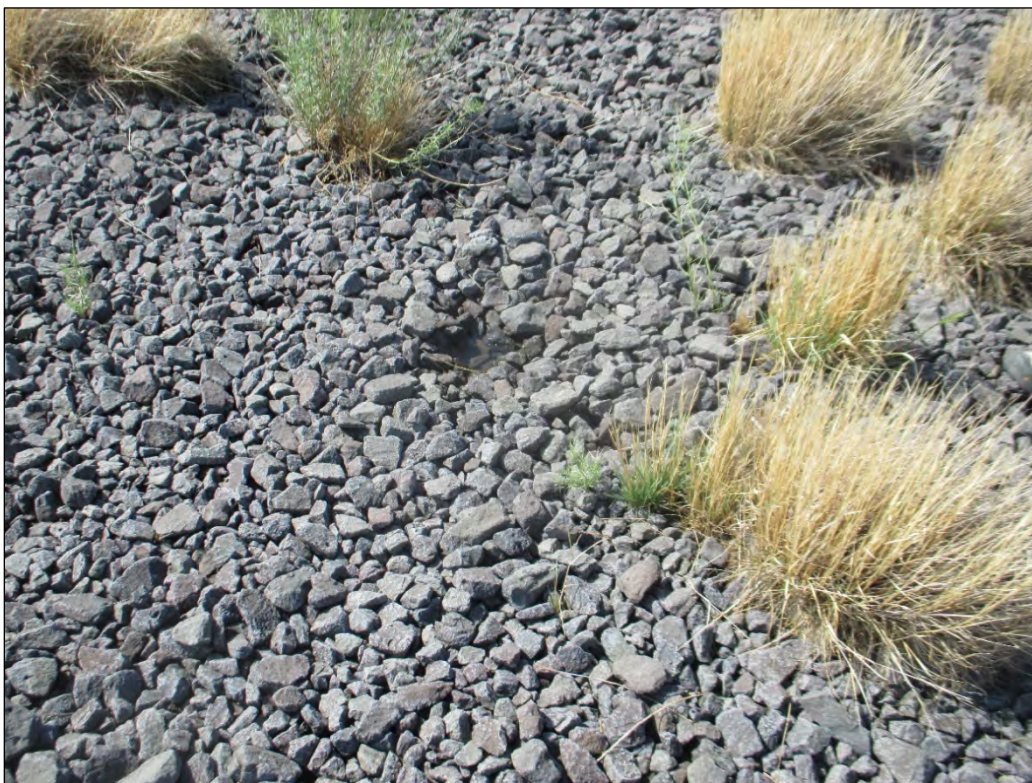
*PL-13. Ponded Water Near Shallow Depression on the Northwest Extension of the Carbonate Tailings Disposal Cell*

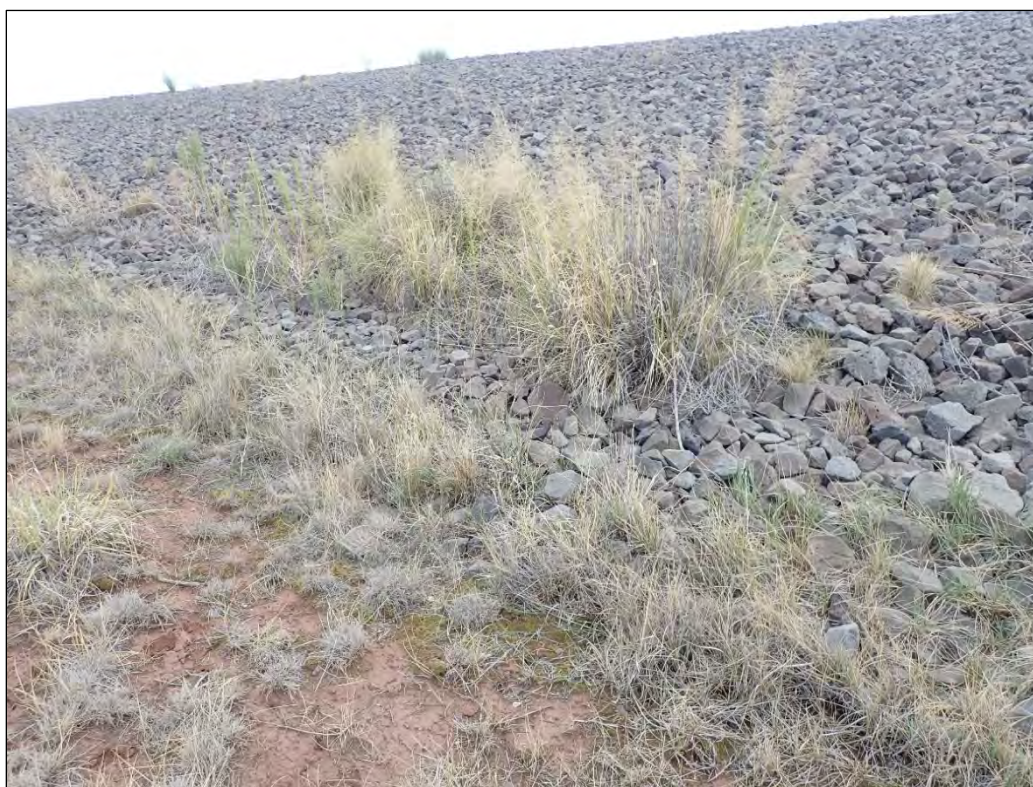
*PL-14. Wet Area Near North Toe Slope of the Carbonate Tailings Disposal Cell*

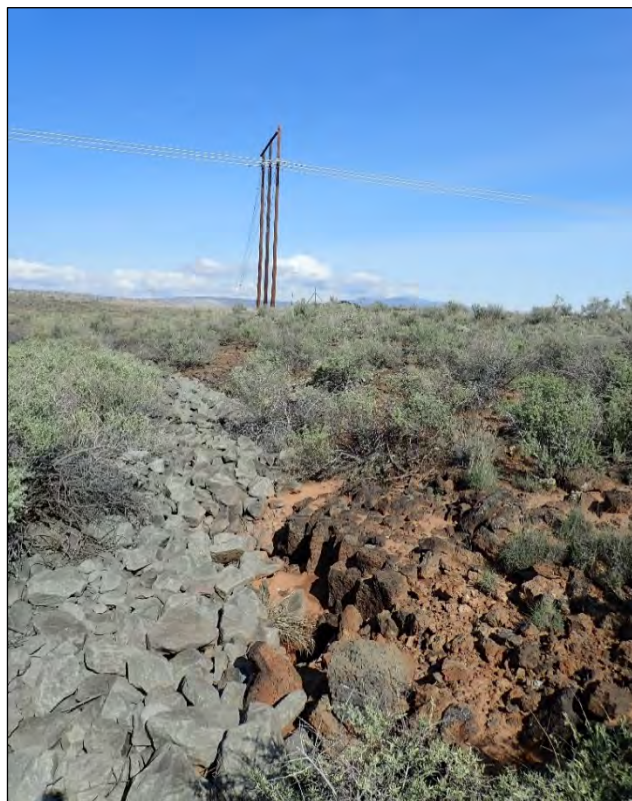
*PL-18. Settlement in Fill Covering Basalt at the Interface of the East Dump Cover*

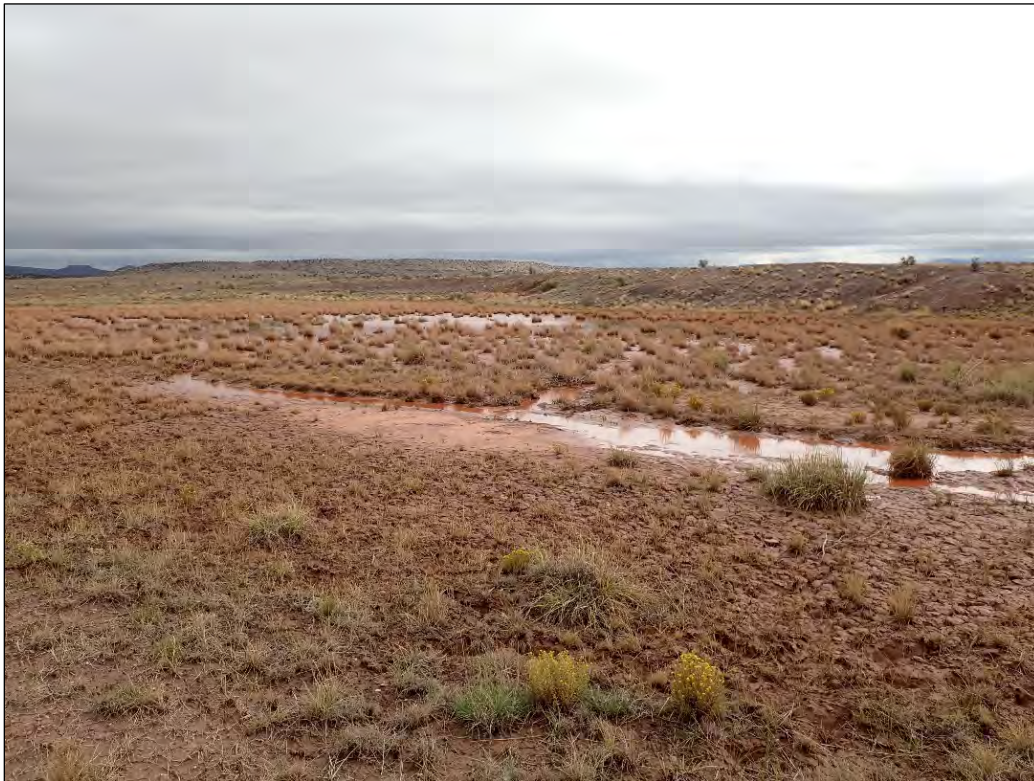
*PL-19. Wet Ephemeral Ponds*

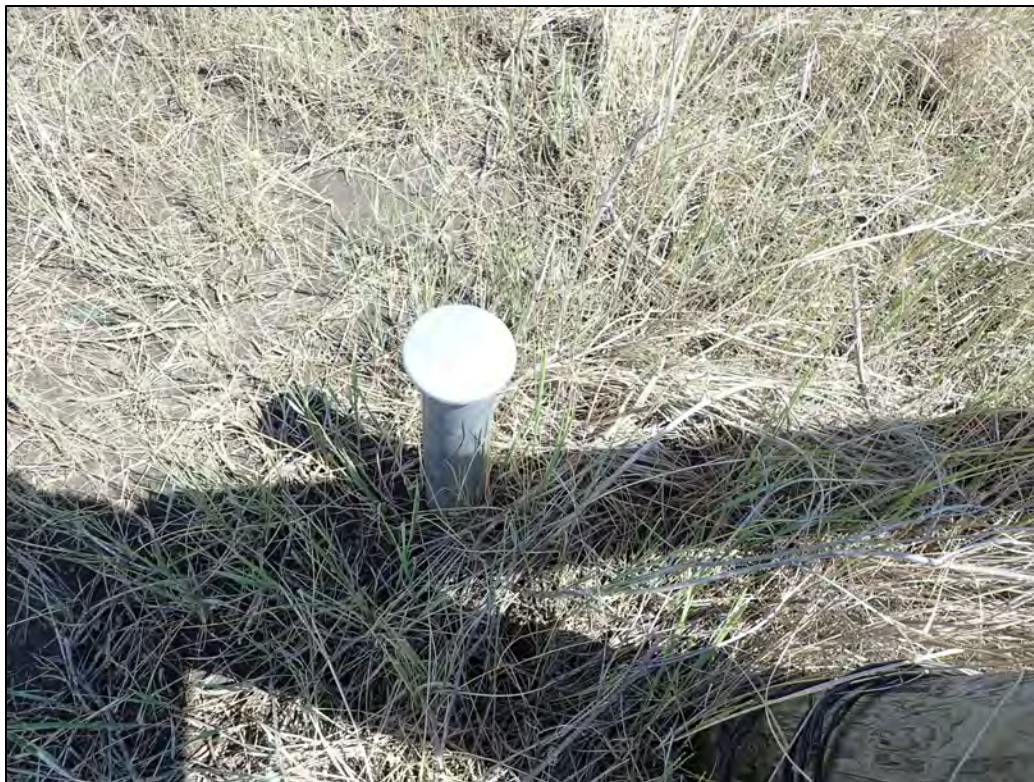
Boundary monuments are present at each of the property's four corners (PL-2). All boundary monuments were inspected, and no maintenance needs were identified.

*PL-2. Boundary Monument BM-1*

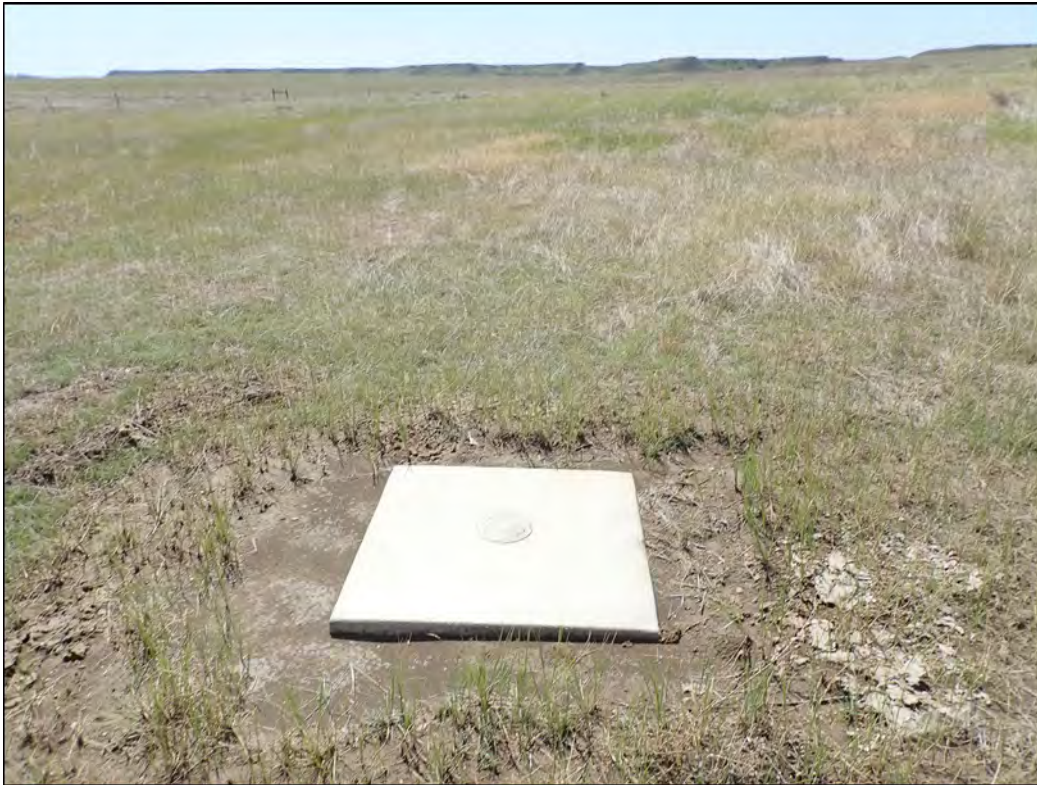
Seven aerial survey quality control monuments, installed in 2019, were inspected during the 2020 annual inspection (Figure 2-1, PL-3). No maintenance needs were identified.

*PL-3. Quality Control Monument QC4*

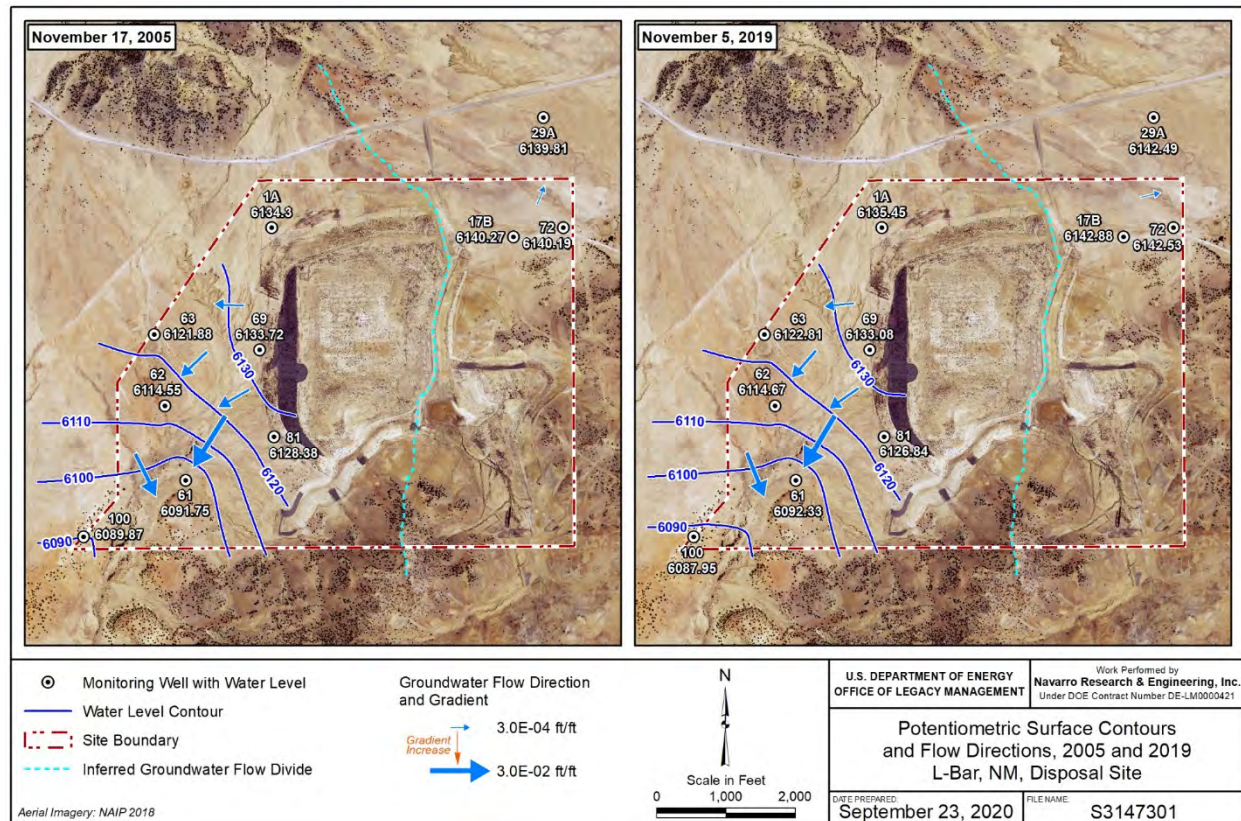
Figure 3-11. Potentiometric Contours and Groundwater Flow Directions in the FTH Sandstone in 2005 and 2019

Measured depth-to-groundwater levels for all of monitoring wells at the L-Bar site in November 2005 and November 2019 are shown in Figure 3-11. A north-northwest-trending topographic drainage divide northeast of the tailings impoundment was interpreted to bifurcate groundwater the flow directions to (1) southwest beneath the impoundment and (2) east away from the northeastern corner of the site. Location of the groundwater divide line is estimated based on available water level and digital elevation model data, under the assumption that the water table is a subdued expression of surface topography.

Previous groundwater data for the L-Bar site (Kennecott 1996) showed a general horizontal flow gradient toward the southwest for the wells west of the tailings impoundment. The data in both 2005 and 2019 also reflect this trend. Only three wells are available to calculate flow direction northeast of the site. The gradient at this location is relatively small ( $3.0\text{E-}4$  ft/ft) relative to up to 0.03 ft/ft southwest of the site, indicating this location is near the groundwater flow divide. The calculated flow direction seemed to have changed significantly from north-northeast in 2005, to

east-northeast in 2019, but this was most likely resultant from having only one calculation with a very small gradient magnitude, rather than a significant shift in regional flow direction.

Water levels in the three wells northeast of the site have increased an average of 2.54 ft between 2005 and 2019. Wells 69 and 81 are nearest to the tailings impoundment to the west and each had an overall decrease in water elevation by about 0.5 and 1.3 ft, respectively. It is unknown whether the steady change in groundwater level is resulting from recharge from surface water diversions to the northeast, or water levels are continuing to equilibrate from mounding below the tailings impoundment. Water level trends southwest of the tailings impoundment do not suggest the latter.

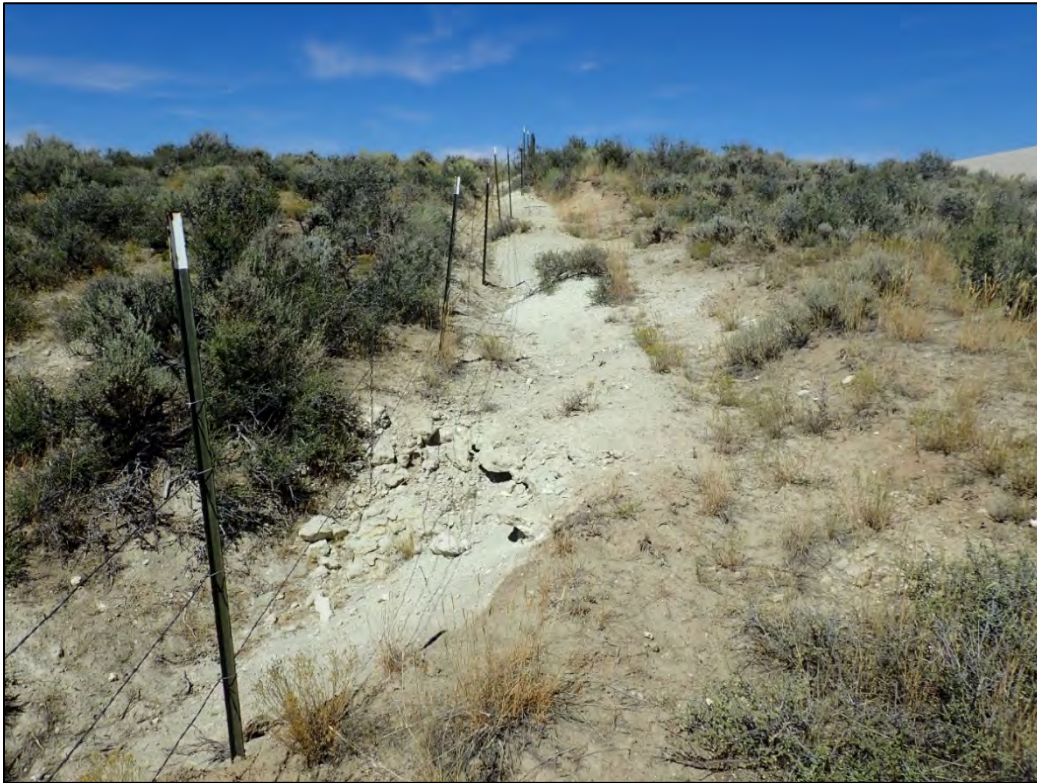
Gullies were observed west of Diversion Channel No. 2, and slight rilling under the northern and southwestern perimeter fence was also observed. None of this erosion currently threatens the integrity of the main disposal cell, ancillary cell, or associated surface water diversion structures; monitoring of this erosion will continue. Minor maintenance needs associated with the perimeter fence, a boundary monument, and perimeter signs were identified. Inspectors identified no cause for a follow-up inspection. Groundwater monitoring is not required at the site.

*PL-1. Erosion Along Western Perimeter Fence South of Perimeter Sign P7*

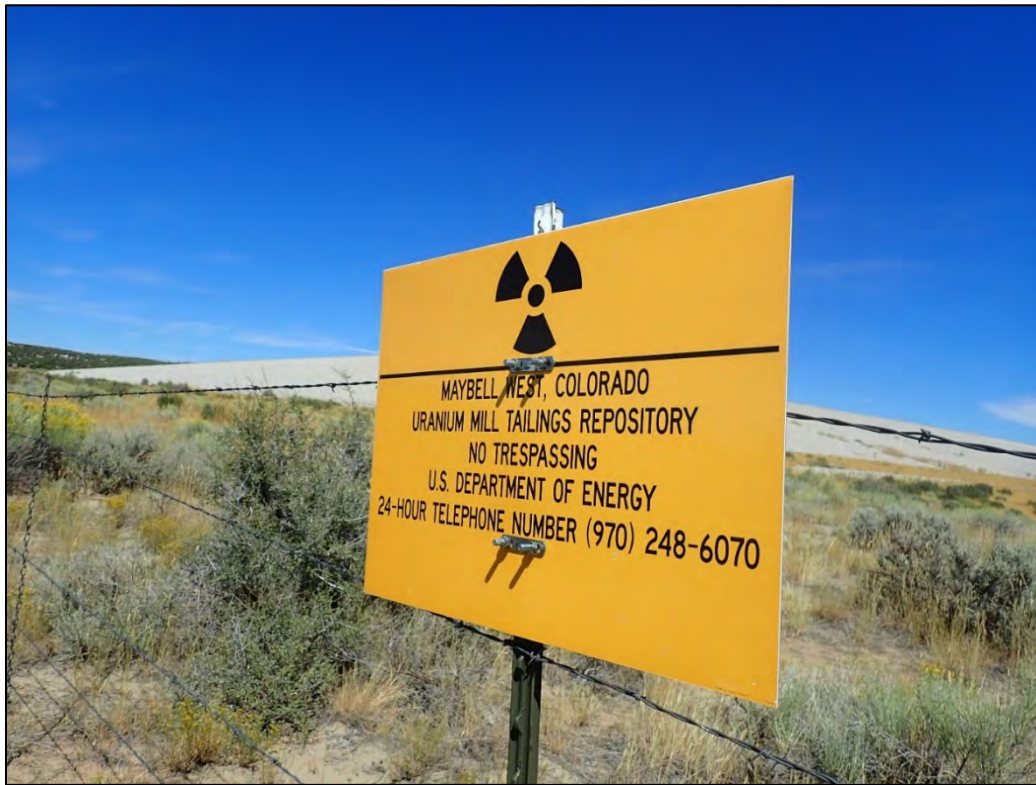
The entrance sign is mounted on a metal T-post directly south of the entrance gate (PL-2). Ten warning or perimeter signs are mounted on metal T-posts around the site (PL-3). Perimeter sign P2 was found to be missing at the time of the inspection and was replaced during a routine maintenance trip on September 23, 2020. No other maintenance needs were identified.

*PL-3. Perimeter Sign P7*

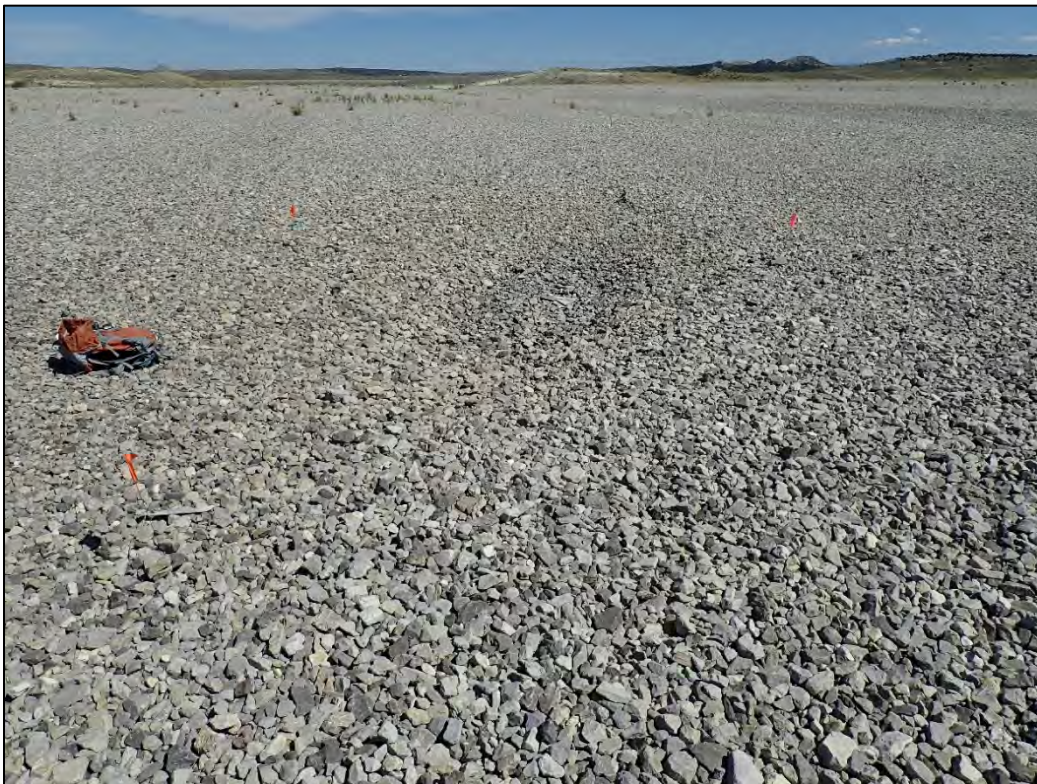
No standing water was observed in any of the depressions during the inspection. These depressions currently do not threaten the integrity or performance of the disposal cell. No maintenance needs were identified.

*PL-8. Shallow Depression No. 1 on Disposal Cell Top Slope*

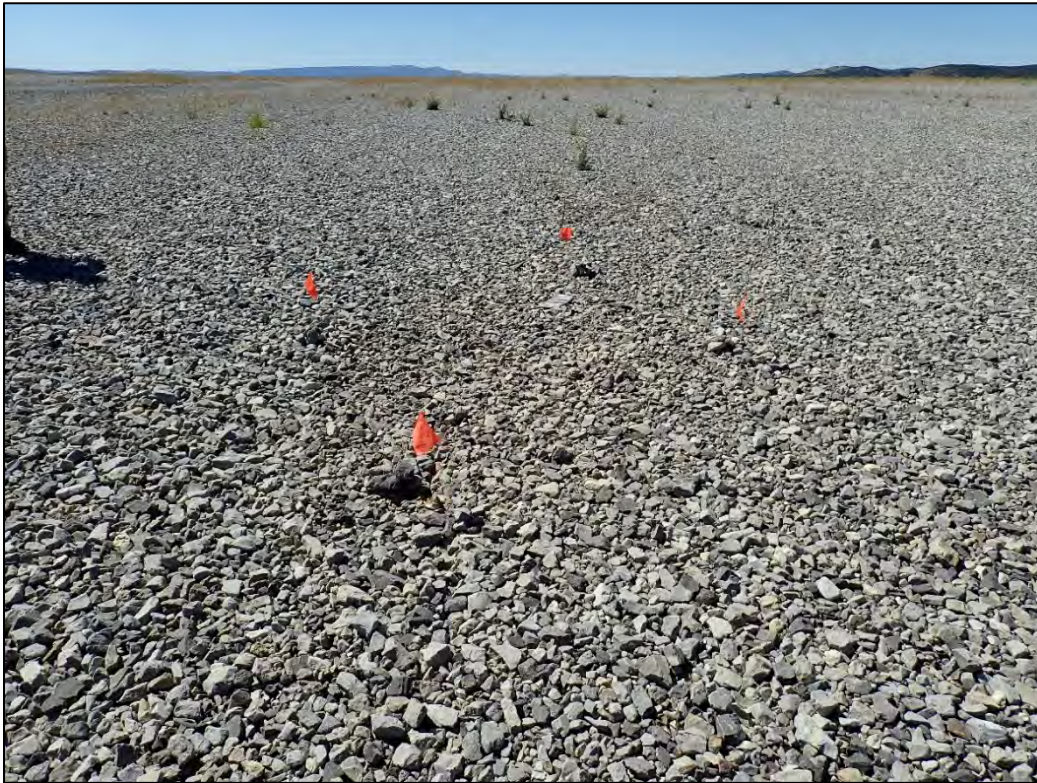
*PL-9. Shallow Depression No. 2 on Disposal Cell Top Slope*

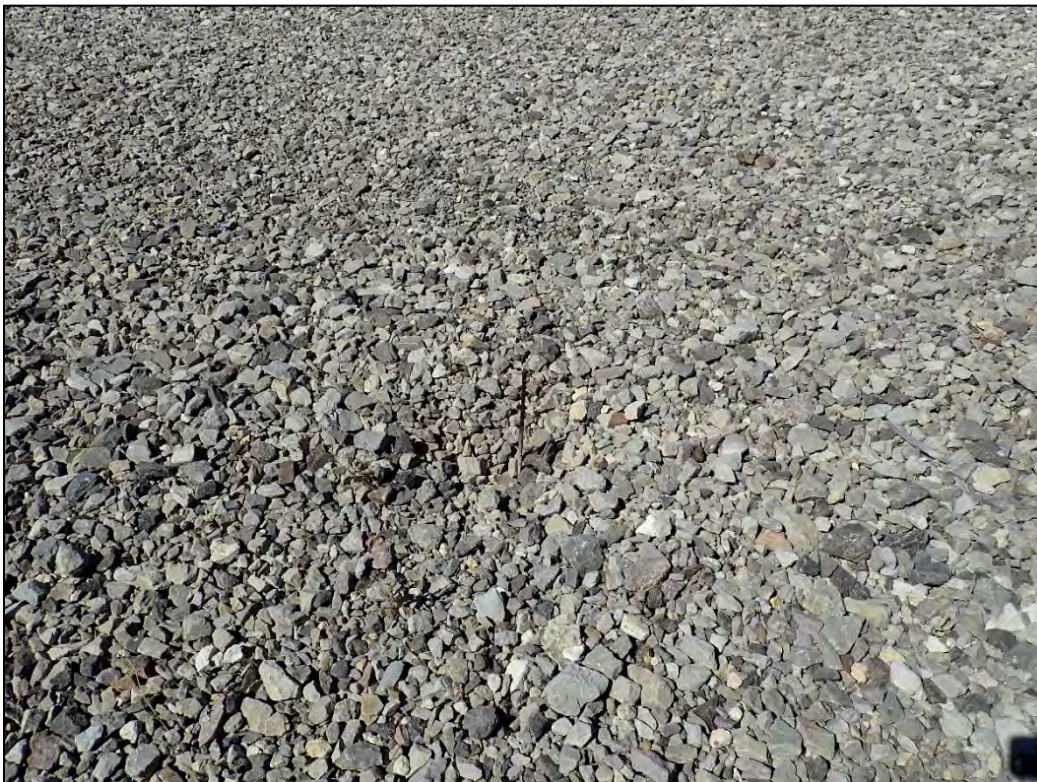
*PL-10. Shallow Depression No. 3 on Disposal Cell Top Slope*

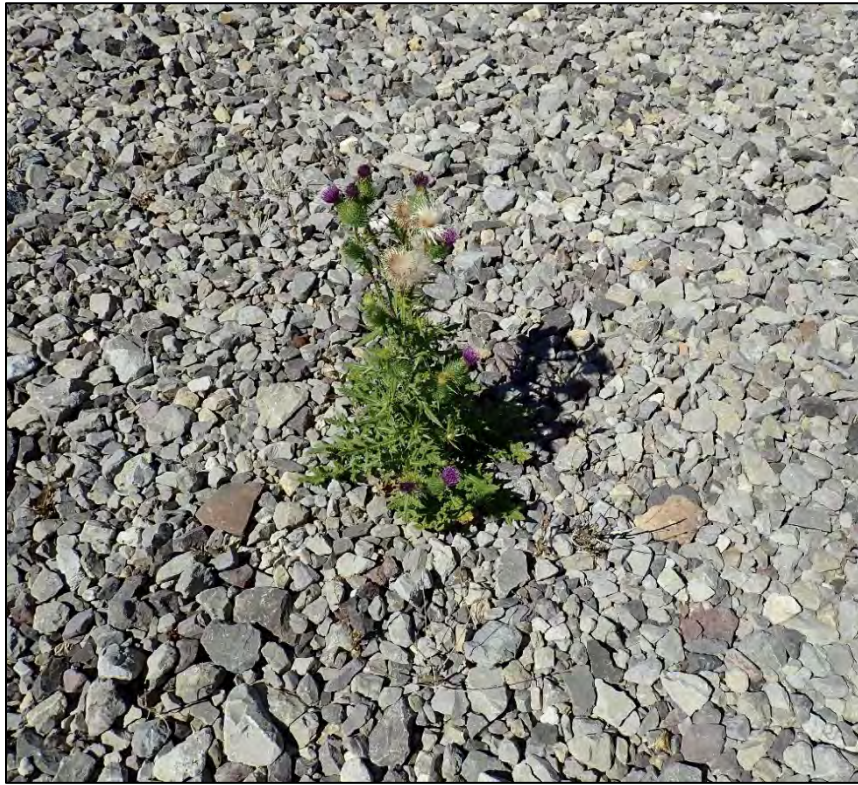
*PL-11. Noxious Weed Growth on the Disposal Cell Surface*

While various species of plants were present on the top slope of the disposal cell, no deep-rooted vegetation was observed. If encroachment of deep-rooted vegetation is observed, an evaluation will be conducted as required by the LTSP to determine if any action is necessary. Noxious weeds (PL-11) were identified and controlled (treated with herbicide) on the disposal cell top slope in accordance with the LTSP.

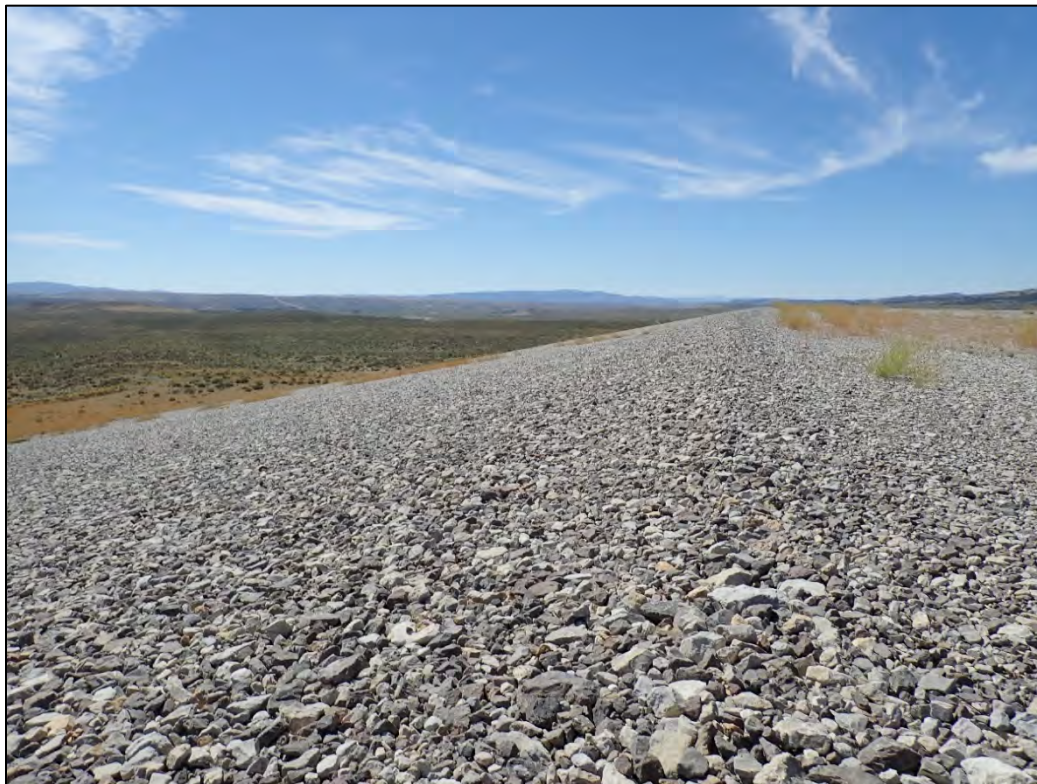
The disposal cell was designed to control surface water runoff resulting from a probable maximum flood event. The side slopes of the disposal cell were constructed with a 20% slope and are covered with a 1-foot-thick layer of riprap (PL-12). Minor sediment accumulation observed in the toe drain apron below the northwest side slope appears to be windblown (PL-13), and there was no evidence of side slope instability, erosion, or settlement. This area of sediment accumulation will continue to be monitored to ensure the toe drain and side slope are functioning properly.

*PL-12. Disposal Cell South Side Slope*

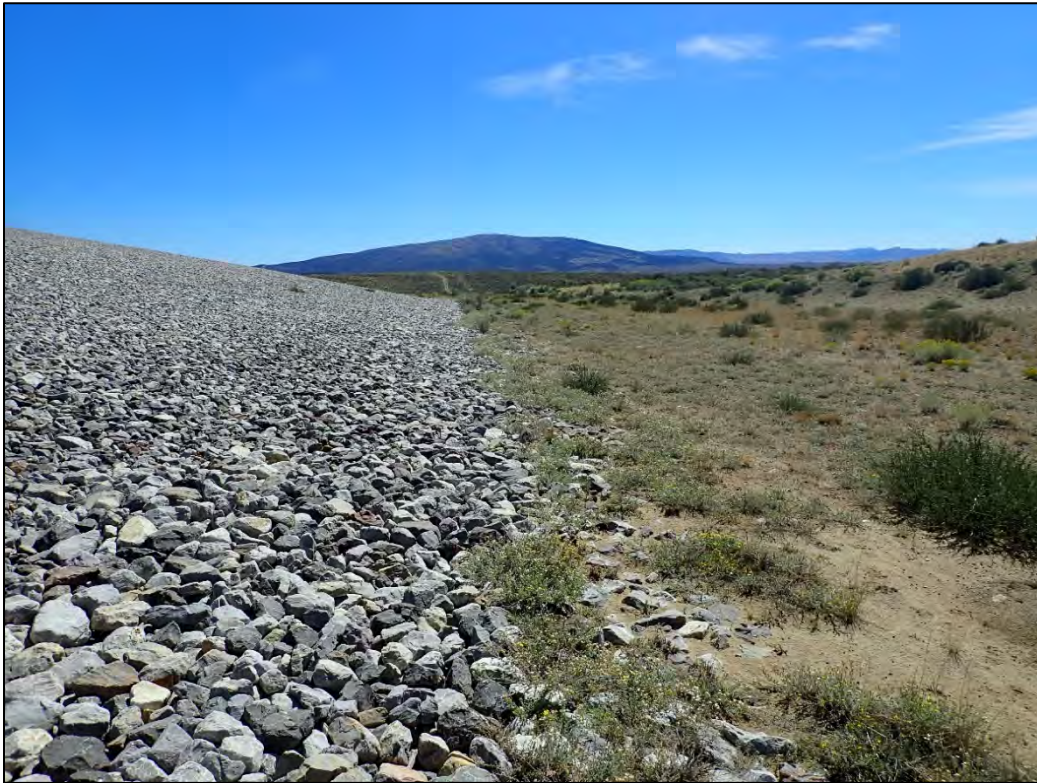
*PL-13. Windblown Sediment Accumulating at Toe of Disposal Cell West Side Slope*

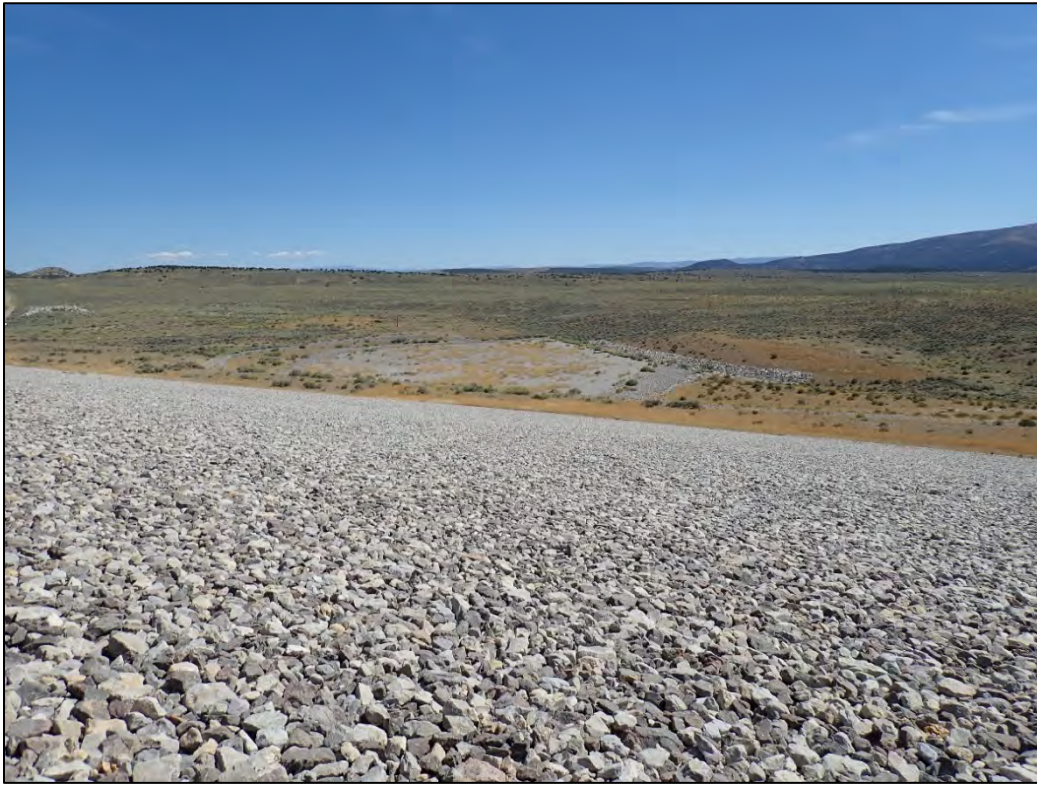
The ancillary cell (PL-15) was constructed to contain waste materials associated with the reclaimed evaporation pond area. It slopes gently toward the southwest. A rock berm wraps around its eastern and northern sides to protect it from surface water runoff. A small depression observed on the west end of the ancillary cell top scope is not impacting the performance of the cell, but it will continue to be monitored (PL-16). Various species of plants were present on the top slope of the ancillary cell. Noxious weeds were also observed on the ancillary cell at the time of the inspection and were treated during the September 23, 2020, routine maintenance trip.

*PL-15. Disposal Cell South Side Slope with the Ancillary Cell in the Background*

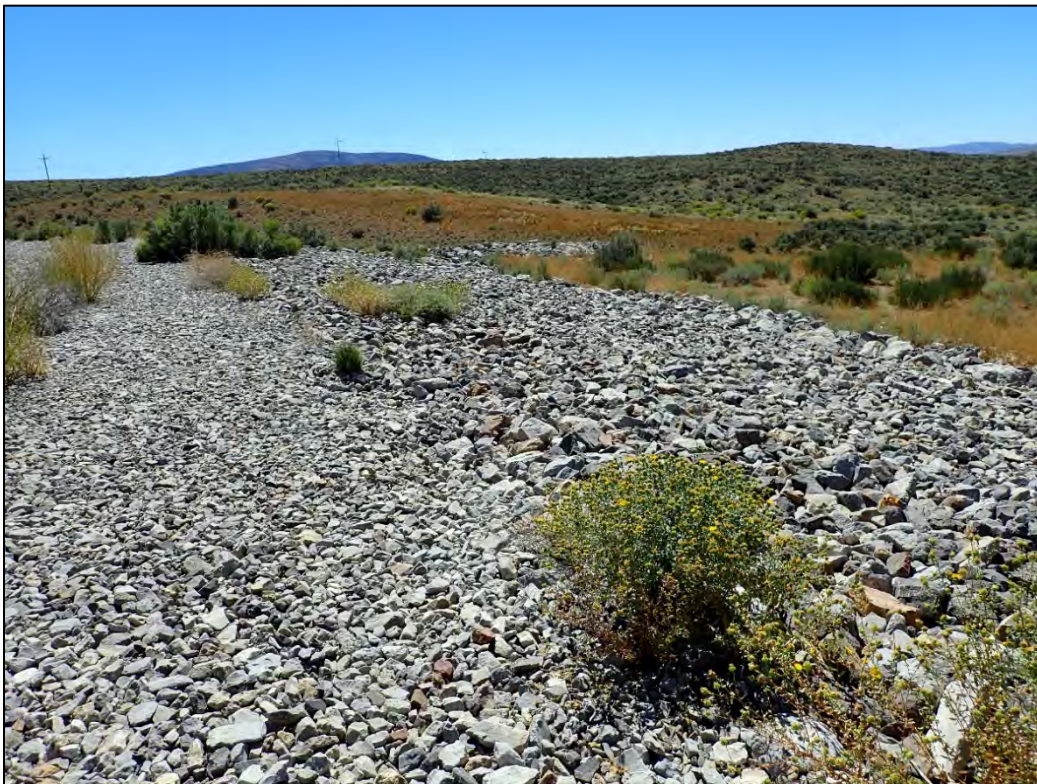
*PL-16. Ancillary Cell West Side Slope with Small Depression on Cell Top Slope in Foreground*

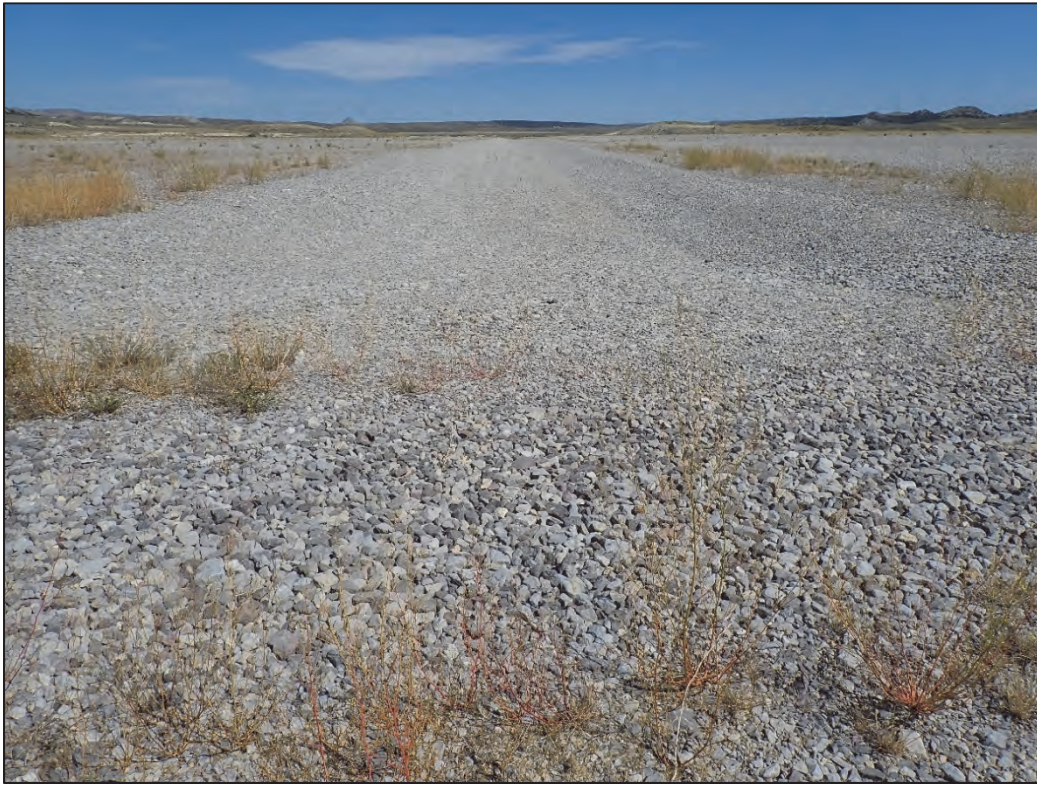
*PL-17. Diversion Channel No. 1*

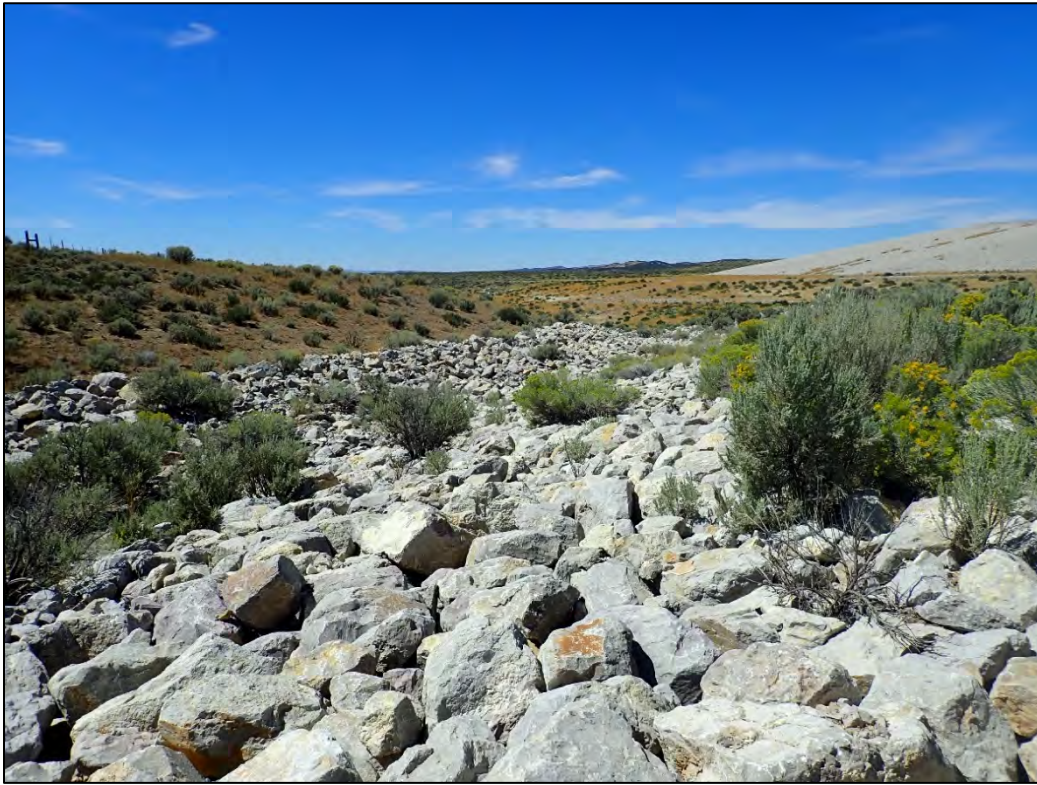
*PL-19. Diversion Channel No. 2*

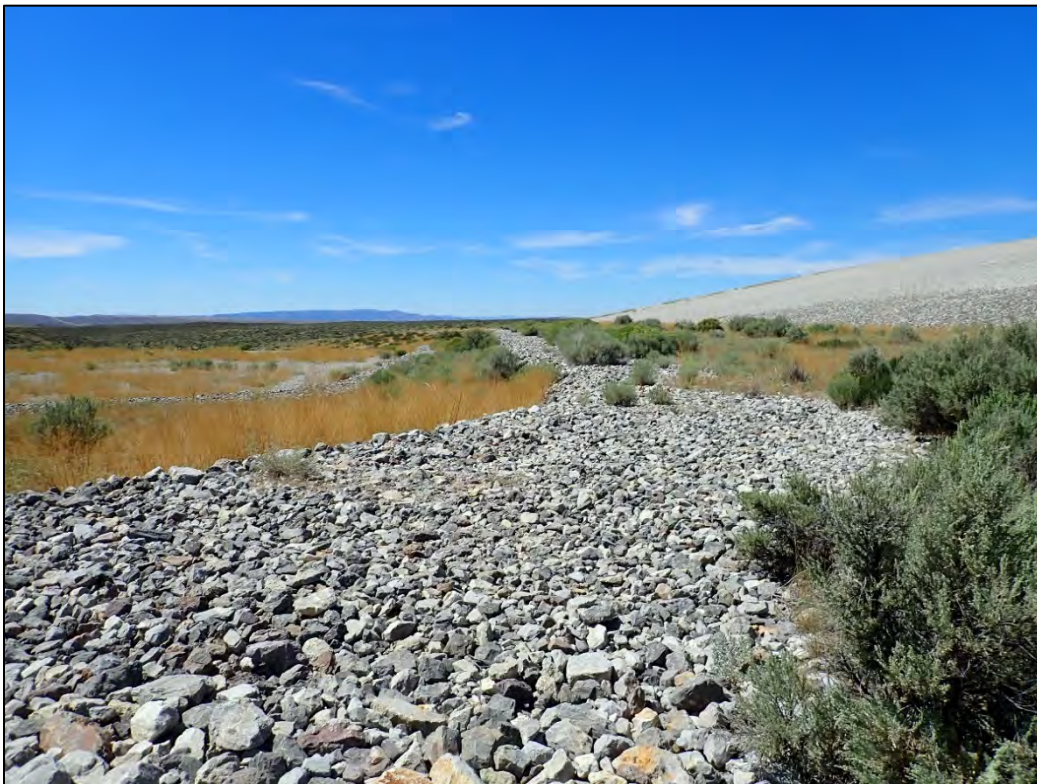
*PL-20. Rock Berm North of Ancillary Cell*
