U.S. DEPARTMENT OF  
**ENERGY**

Legacy  
Management

## 2020 Annual Site Inspection and Monitoring Report for Uranium Mill Tailings Radiation Control Act Title II Disposal Sites

December 2020

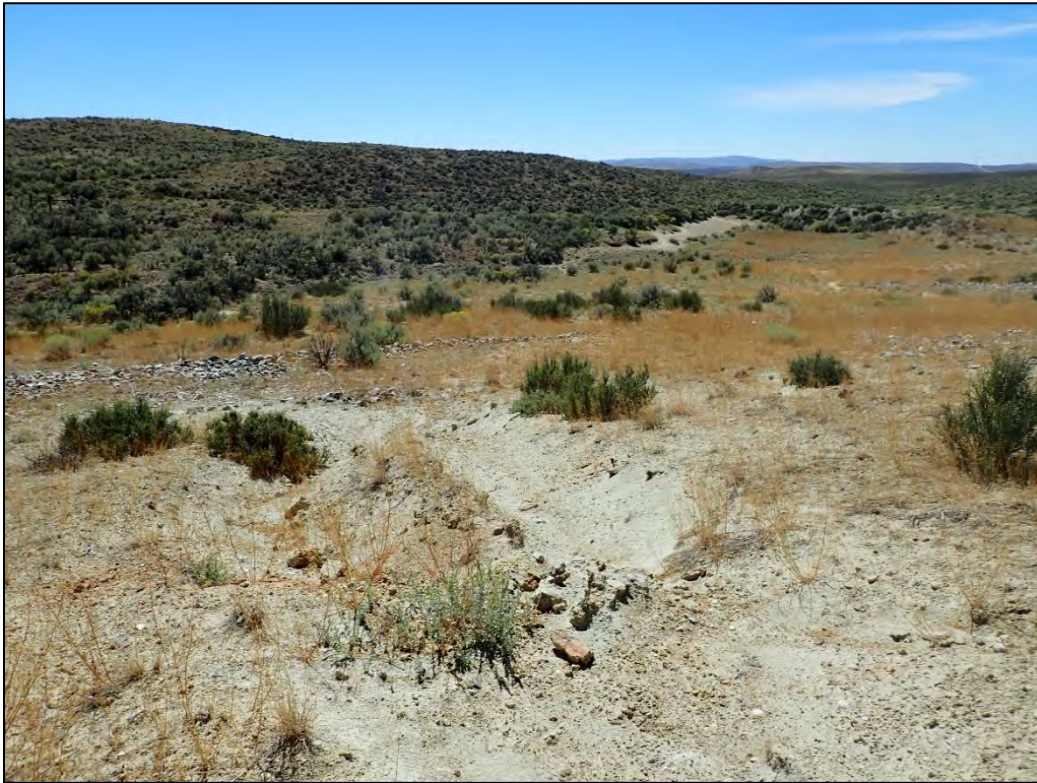
*PL-21. Erosion Between Rock Berms West of Ancillary Cell*

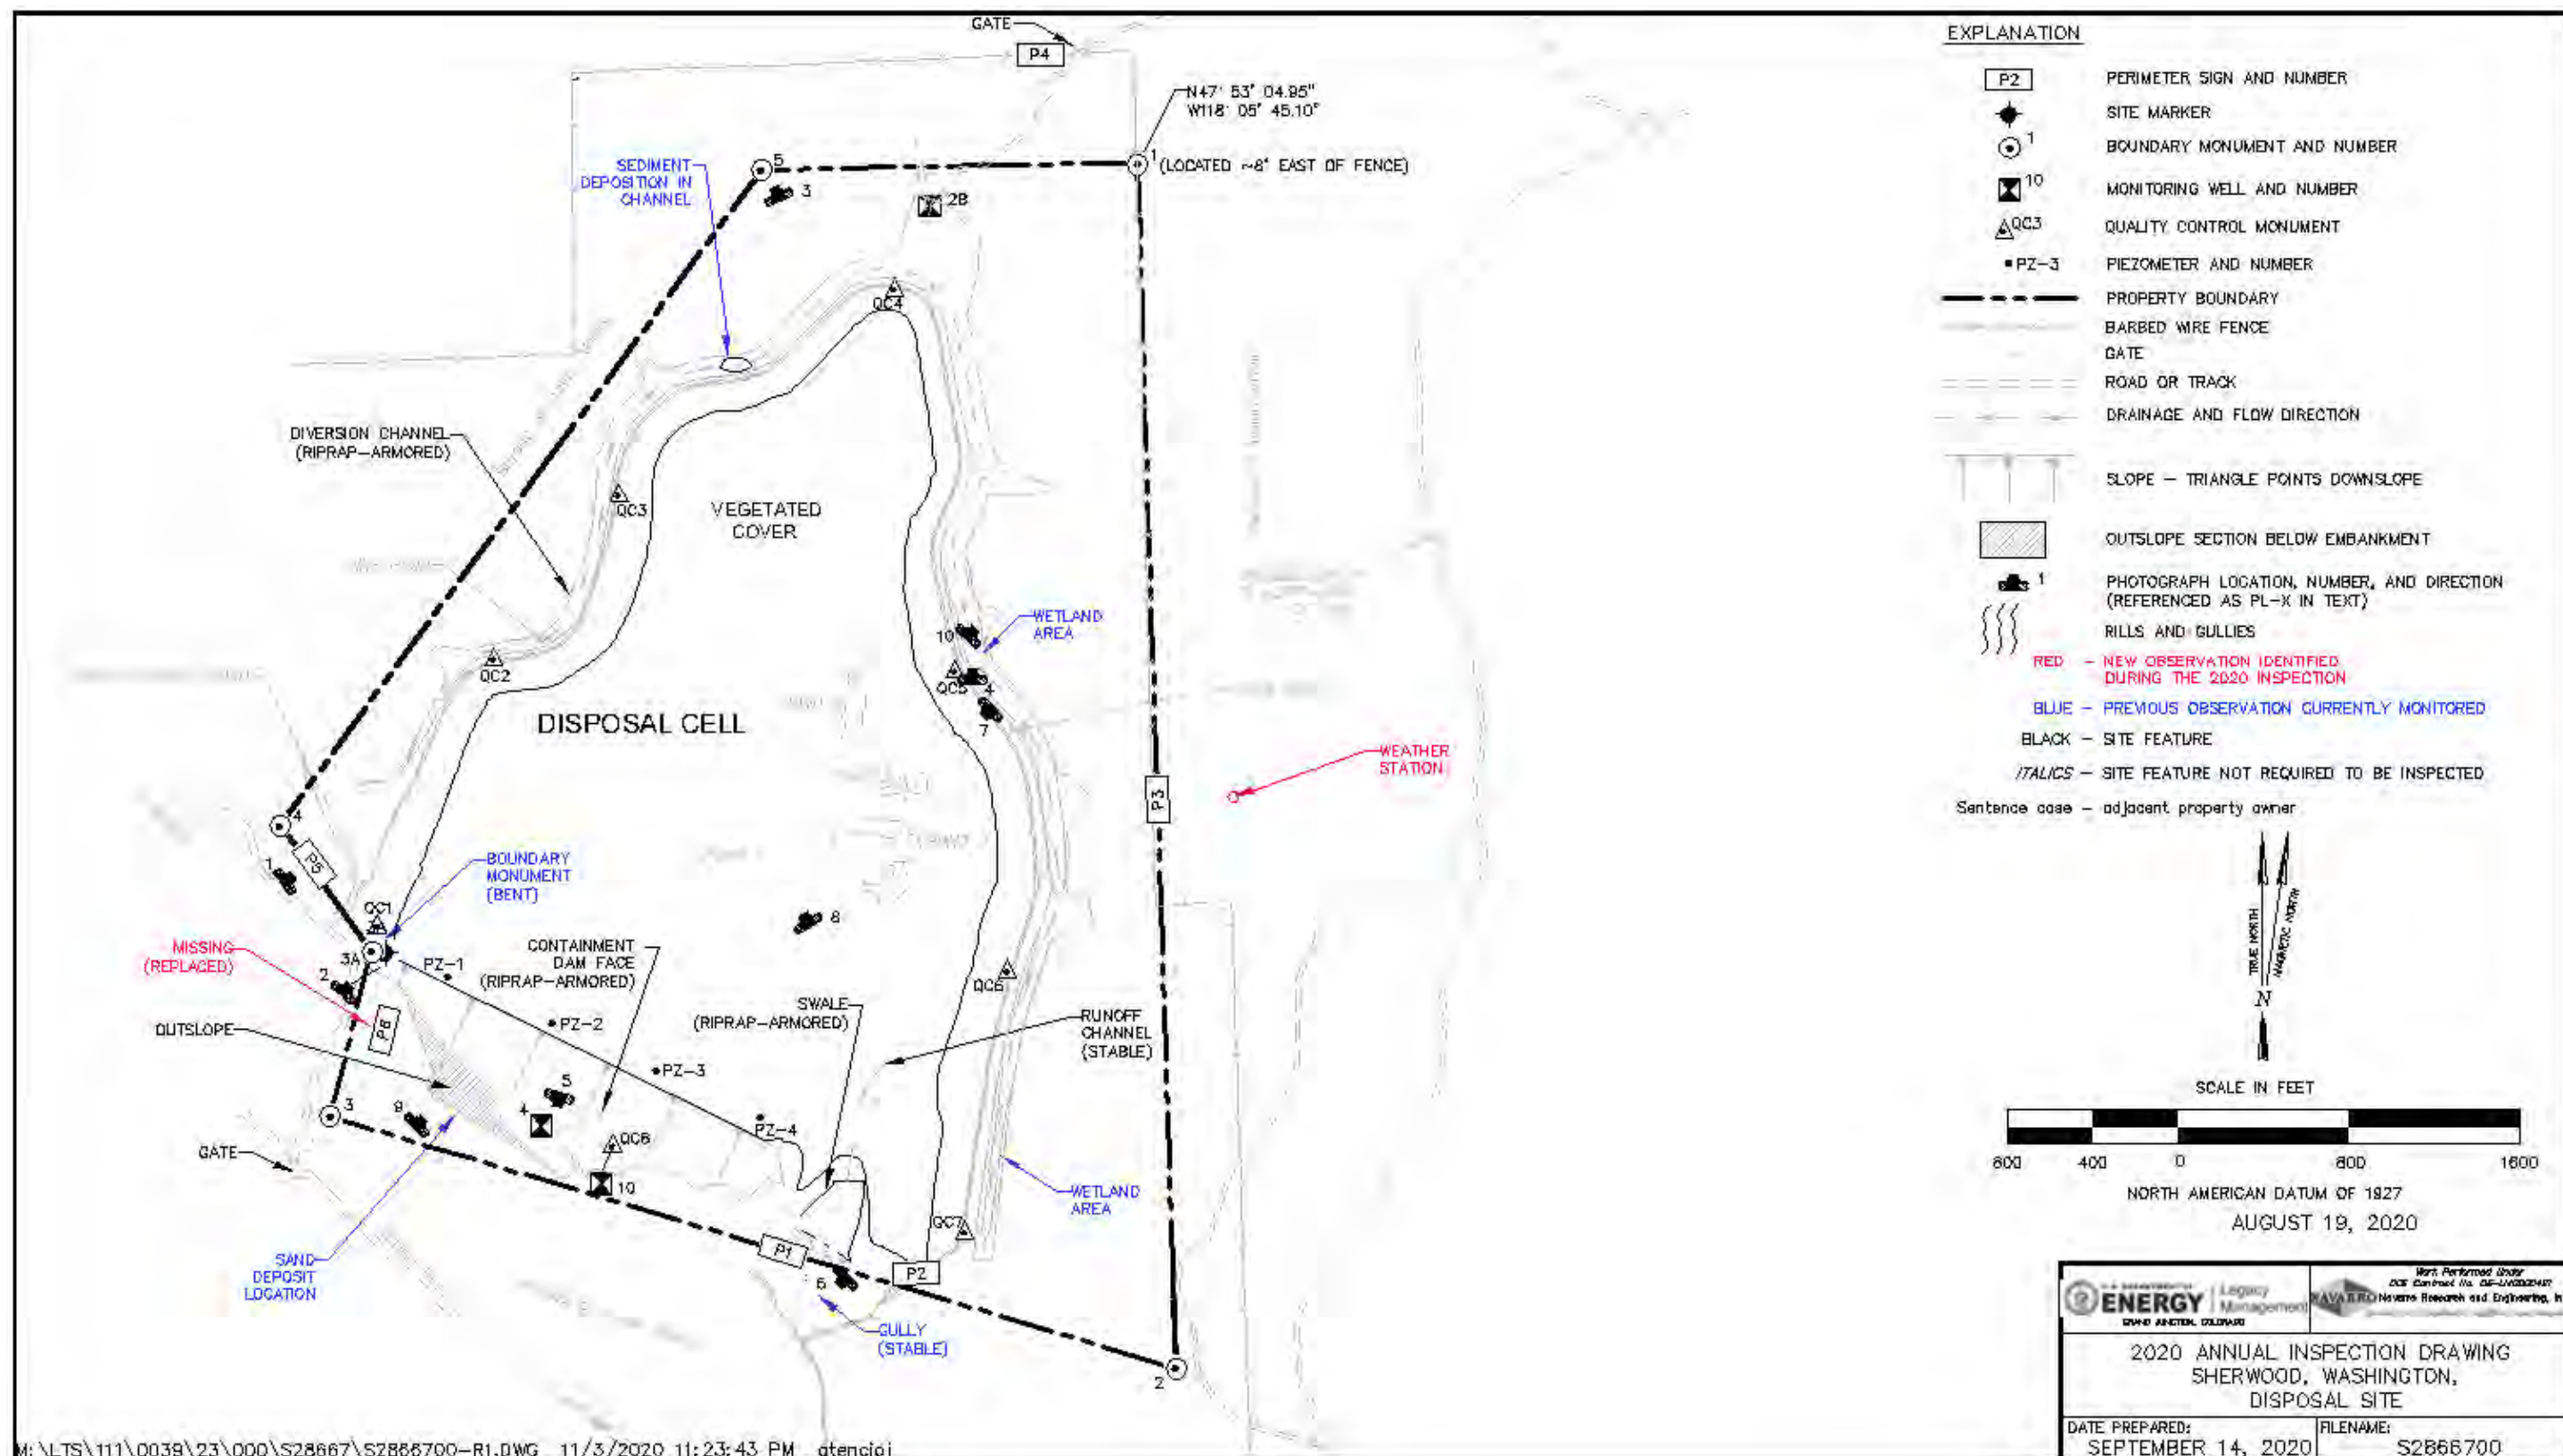
Figure 5-1. 2020 Annual Inspection Drawing for the Sherwood, Washington, Disposal Site

Figure 5-1 shows the locations of site features in black and gray font, including site surveillance features and inspection areas. Site features that are present but not required to be inspected are shown in italic font. Observations from previous inspections that are currently monitored are shown in blue text, and new observations identified in the 2020 annual inspection are shown in red. Inspection results and recommended maintenance activities associated with site surveillance features are included in the following subsections. Photographs to support specific observations are identified in the text and in Figure 5-1 by photograph location (PL) numbers. The photographs and photograph log are presented in Section 5.9.

During the 2016 annual inspection, one location at the base of the rock-covered containment dam face was found to have a deposit of sand that had washed out from underneath the rock cover, as evidenced by a shallow rock-filled erosion feature upgradient of the deposit (Figure 5-1). A subsequent follow-up inspection and evaluation identified that the sandy material was the same as natural undisturbed material nearby. During reclamation, this area of the site was used as a source for fill material used to contour the area below the toe of the containment dam. Review of

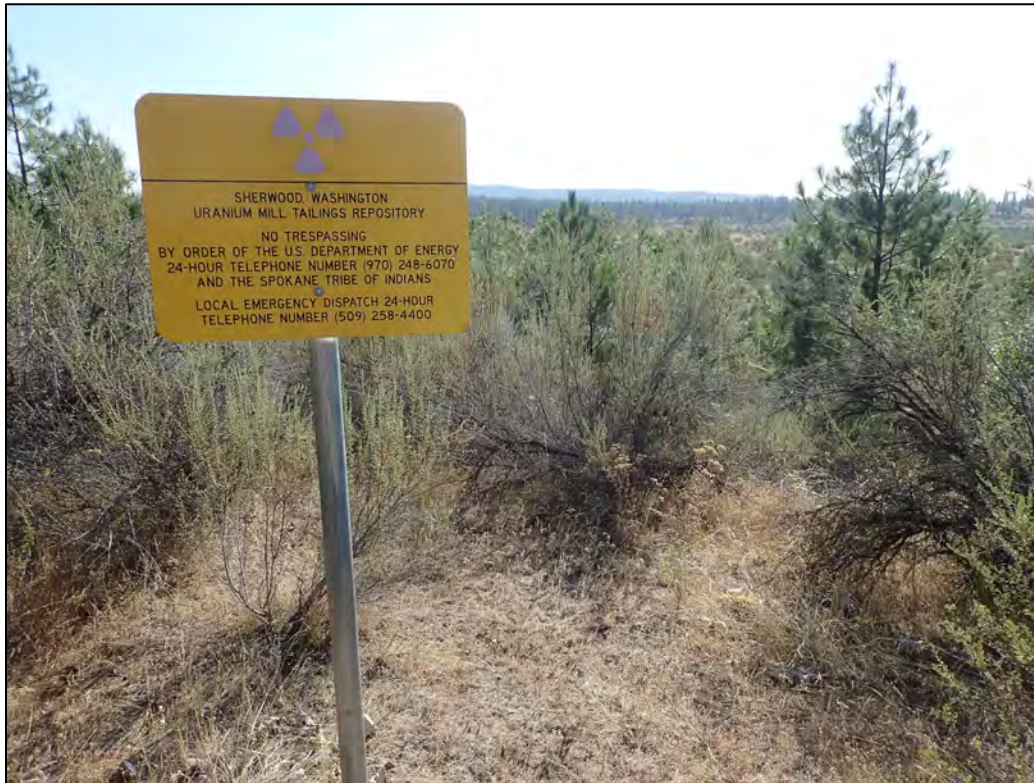
There are six warning or perimeter signs, attached to steel posts set in concrete, positioned along the site boundary at likely access points around the site (PL-1). Perimeter sign P6 was missing and was replaced during the inspection. No additional maintenance needs were identified.

*PL-1. Perimeter Sign P5*

Perimeter sign P6 was identified as missing and was replaced during the inspection. No additional routine maintenance needs were identified.

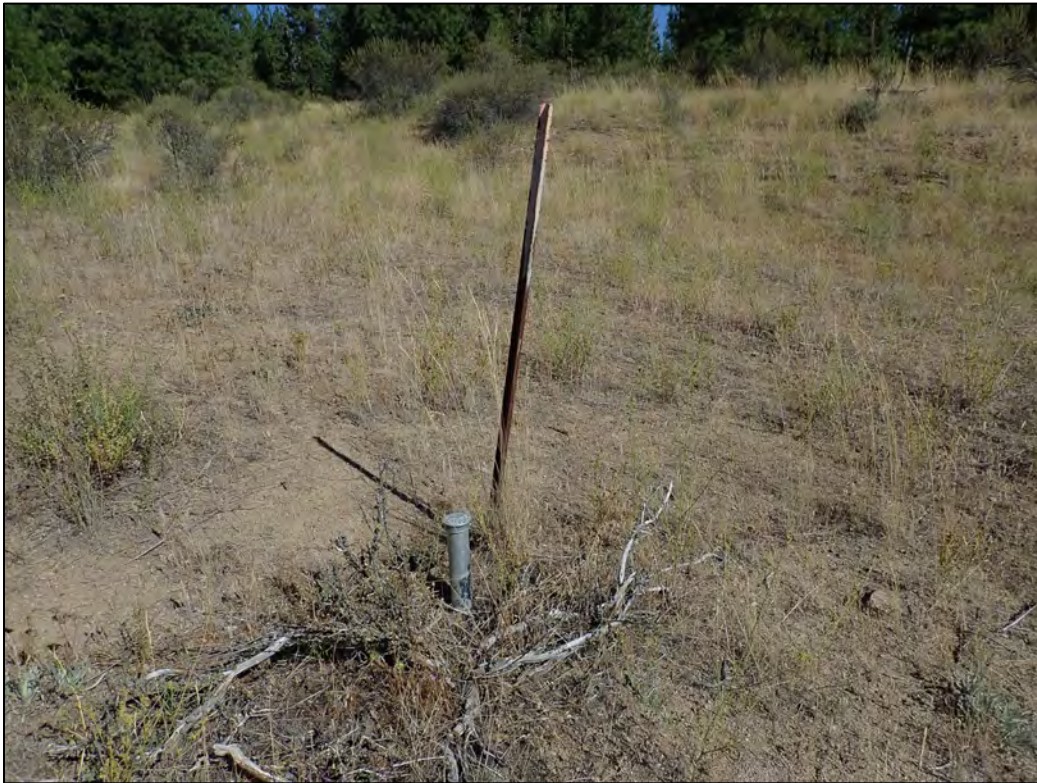
Six boundary monuments set in concrete define the site boundary. Because surrounding vegetation has made it difficult to locate some of the monuments, metal T-posts were installed at each monument location (PL-3). All boundary monuments were inspected. No maintenance needs were identified.

*PL-3. Boundary Monument BM-5*

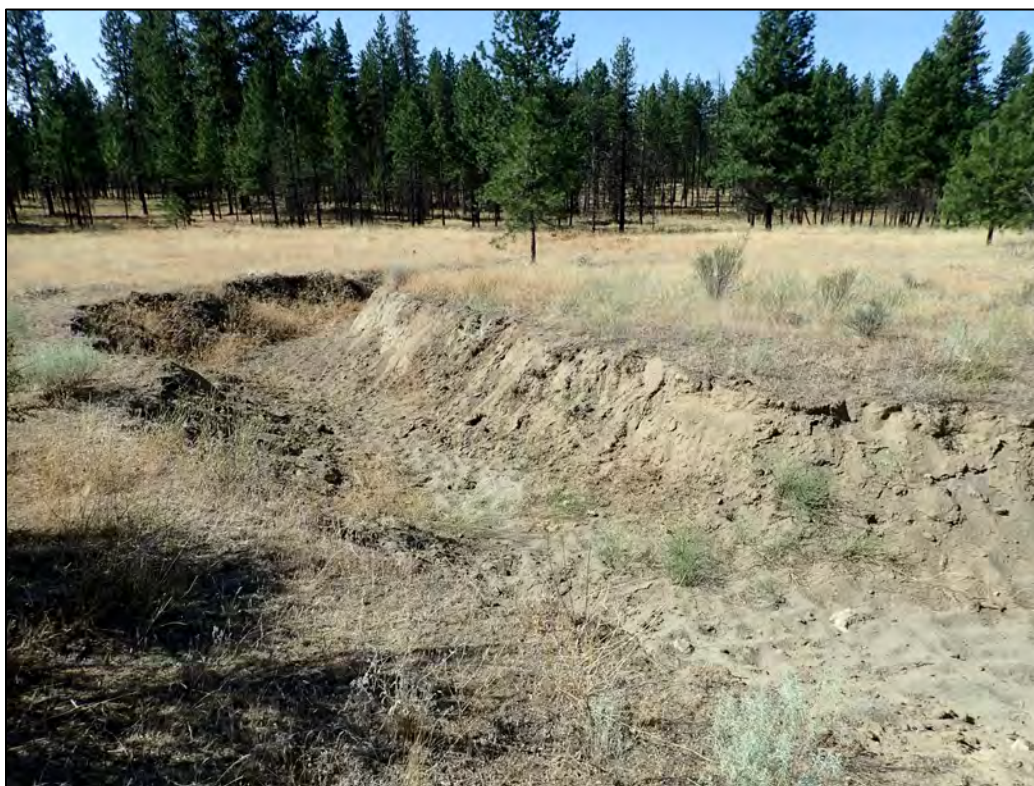
A gully offsite, downgradient of the riprap-armored swale near perimeter sign P1, was first observed in 2009. The gully is photographed periodically to monitor its development (PL-6). Although erosion continues to occur because of site drainage effects, the gully appears to be stabilizing as its grade reaches equilibrium with the surrounding topography. The gully is not impacting site features or access but will continue to be monitored. No maintenance needs were identified.

*PL-6. Gully Downgradient of Riprap-Armored Swale (Near Perimeter Sign P1)*

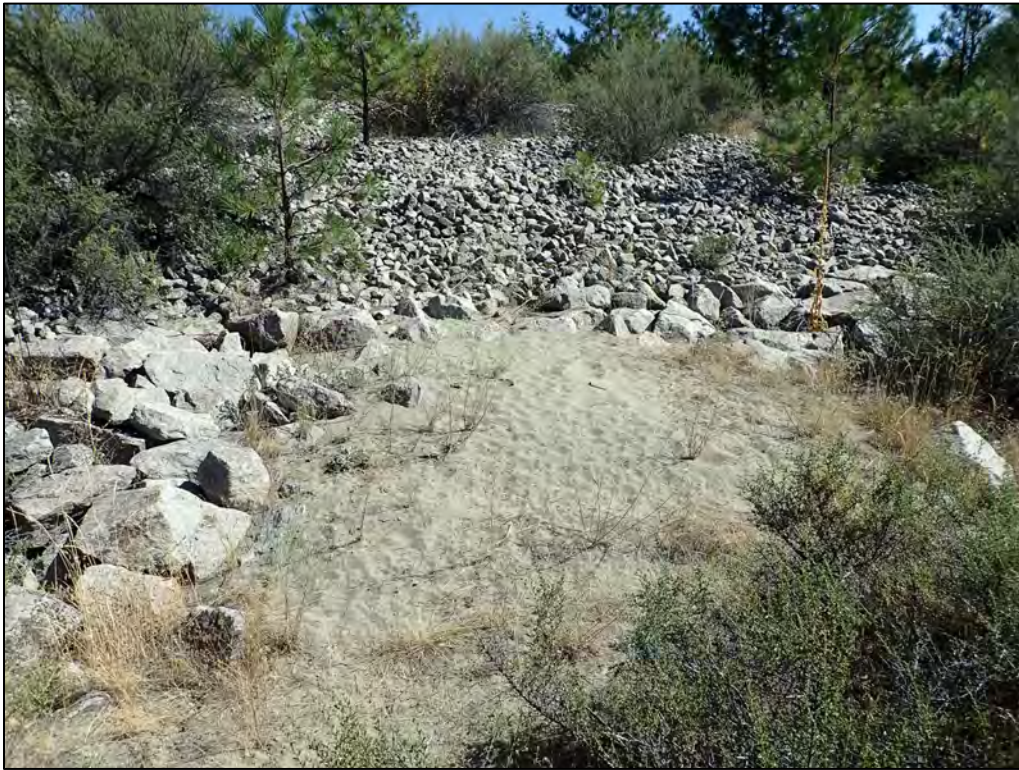
The sand deposit location was examined during the inspection, and there was no apparent change in the deposit or the upgradient erosion feature (PL-9). The area will be visually monitored during future inspections and by periodic aerial remote sensing surveys. Repair options will be evaluated and implemented, in consultation with NRC, if the erosion area increases such that the containment dam could be affected.

*PL-9. Sand Deposit at Toe of Containment Dam Outslope*

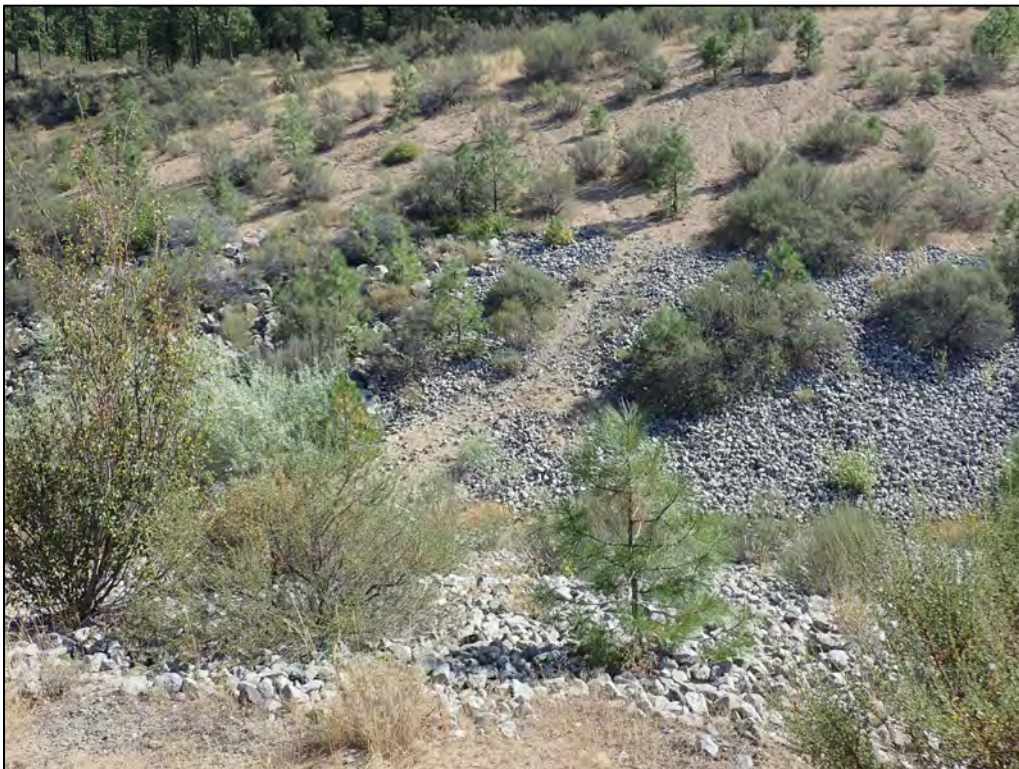
A riprap-armored diversion channel surrounds the disposal cell and diverts runoff away from the disposal cell surface. The diversion channel was designed to allow trees to grow and stabilize the surfaces, and the presence of trees in the diversion channel is not expected to hinder the diversion channel's ability to convey design flows. The establishment of volunteer plants, including trees, is evident in most areas of the diversion channel. Sediment deposition is found in places on the west leg of the diversion channel but does not interfere with the diversion channel's design function. Upslope areas that have contributed to the sedimentation have stabilized with vegetation. Wildlife trails cross the diversion channel at numerous locations and have displaced the diversion channel riprap in several places (PL-10). These disturbances will be visually monitored for erosion but are not in areas that would impact the disposal cell. No evidence of erosion was observed downgradient of the diversion channel outlet. No maintenance needs were identified.

*PL-10. Diversion Channel with Wildlife Trail*

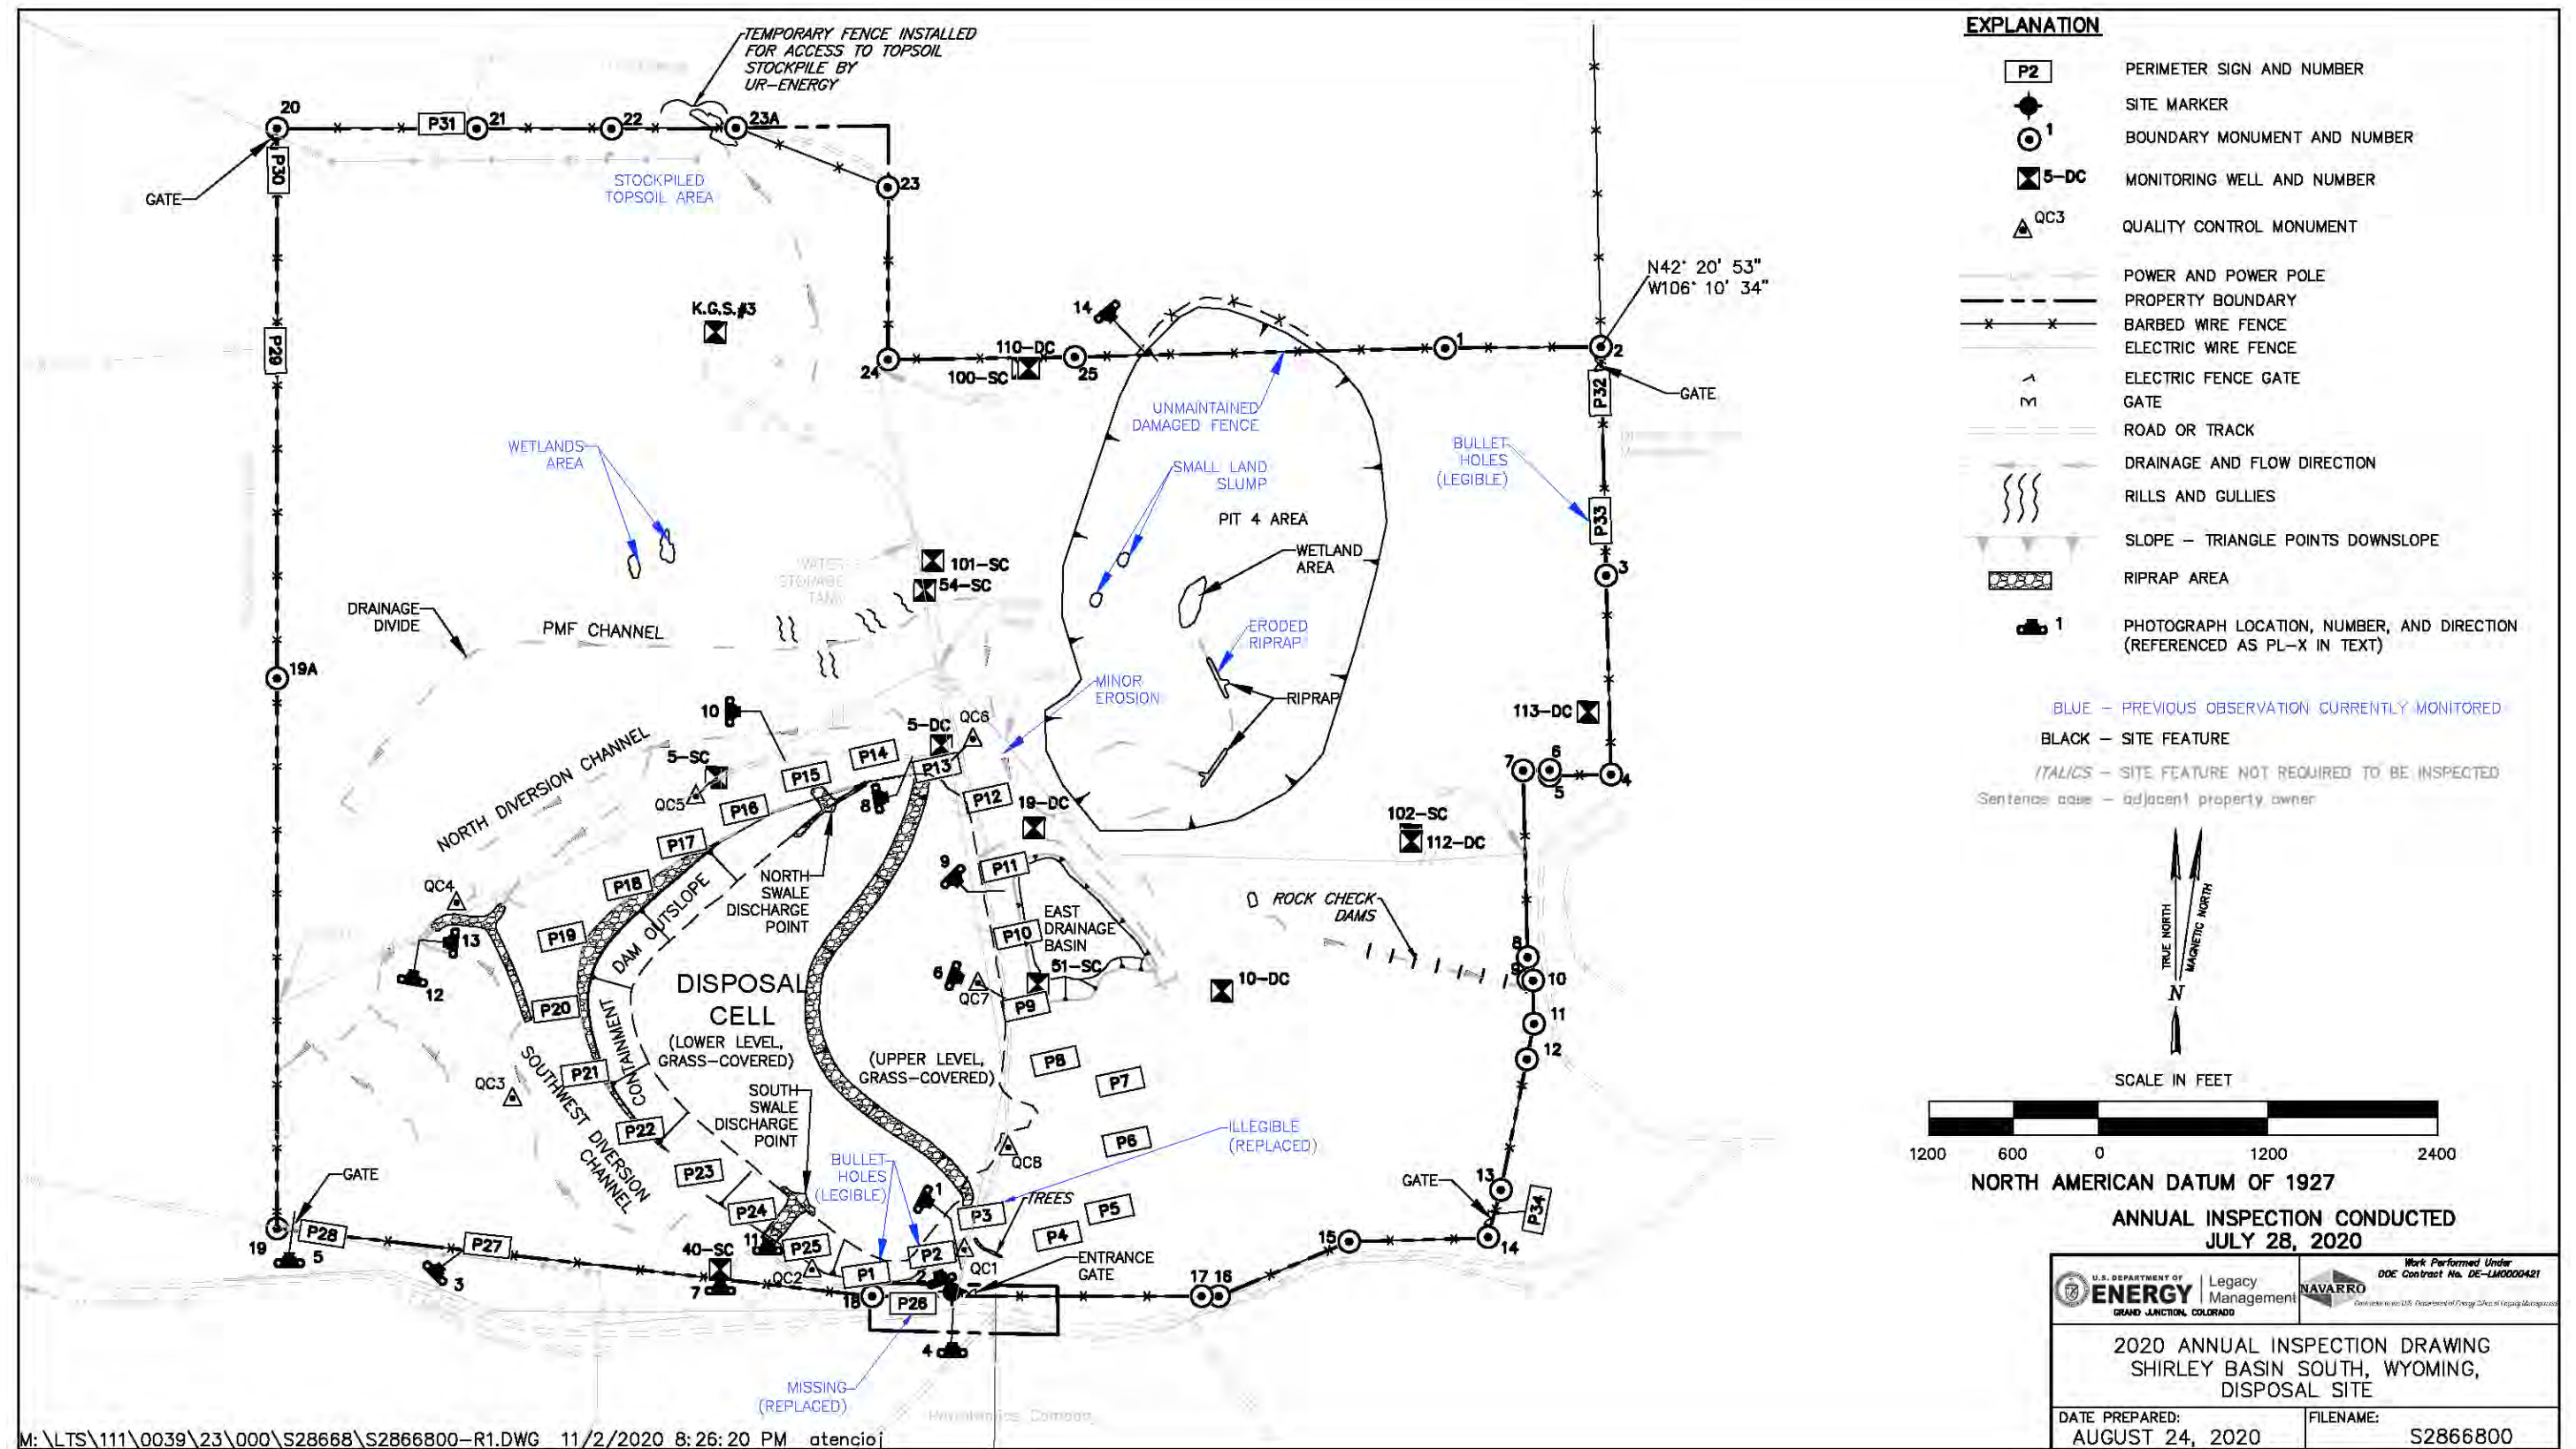
Figure 6-1. 2020 Annual Inspection Drawing for the Shirley Basin South, Wyoming, Disposal Site

Figure 6-1 shows the locations of site features in black and gray font, including site surveillance features and inspection areas. Site features that are present but not required to be inspected are shown in italic font. Observations from previous inspections that are currently monitored are shown in blue text. There were no new observations in 2020. Inspection results and recommended maintenance activities associated with site surveillance features are included in the following subsections. Photographs to support specific observations are identified in the text and in Figure 6-1 by photograph location (PL) numbers. The photographs and photograph log are presented in Section 6.9.

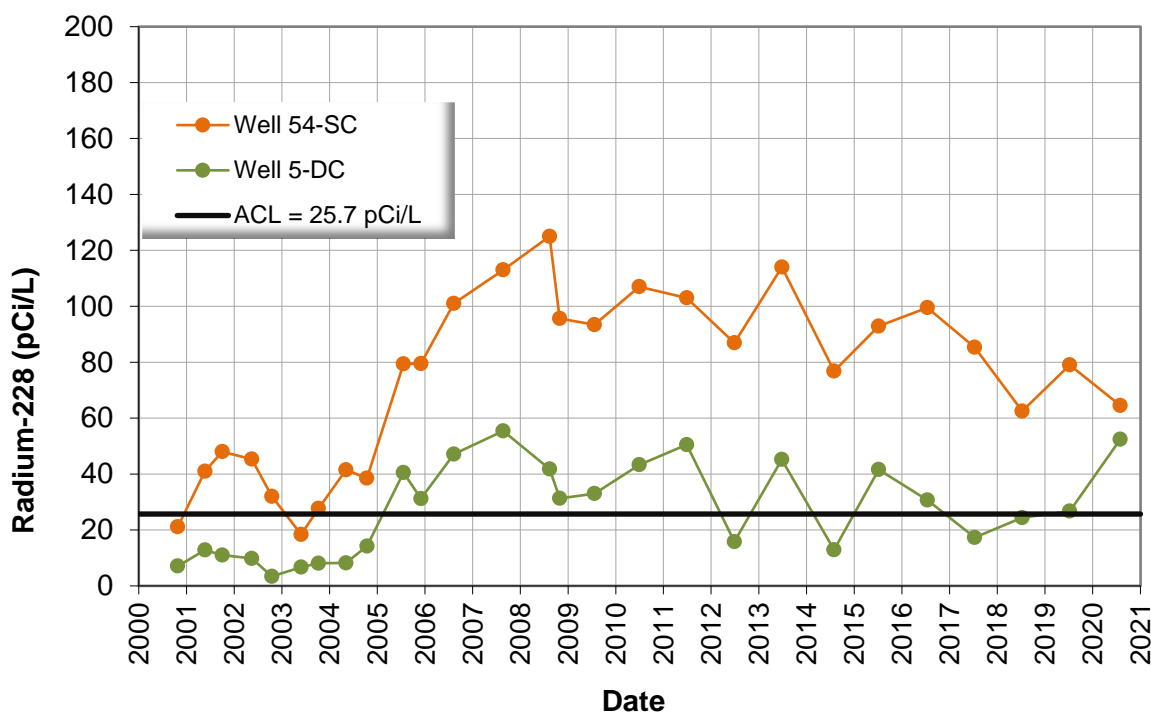
Time-concentration plots of  $^{228}\text{Ra}$  are shown for wells 5-DC and 54-SC in Figure 6-7. Well 5-DC first exceeded the ACL for  $^{228}\text{Ra}$  in 2005, after which concentrations have fluctuated above and below the ACL since 2012. As stipulated by the LTSP, NRC and WDEQ were notified of any exceedances in constituent ACLs. Although the  $^{228}\text{Ra}$  concentration was elevated in well 54-SC, it is lower than the highest concentration measured in this well in the early 1990s (greater than 180 pCi/L) during site groundwater remediation activities (Petrotonics 1996). Radium-228 is a decay product of thorium-232 ( $^{232}\text{Th}$ ), which is highly immobile. Because the half-life of  $^{228}\text{Ra}$  is relatively short,  $^{232}\text{Th}$  sources must be near monitoring wells 5-DC and 54-SC. Additionally,  $^{226}\text{Ra}$  concentrations over time have been consistently above the ACL in well 110-DC since 2009 (Figure 6-8). Both elevated  $^{226}\text{Ra}$  and  $^{228}\text{Ra}$  in these site wells indicate continuous sources nearby.

*Figure 6-7. Radium-228 Concentrations in Wells 5-DC and 54-SC Since Completion of the Disposal Cell at the Shirley Basin South, Wyoming, Disposal Site*

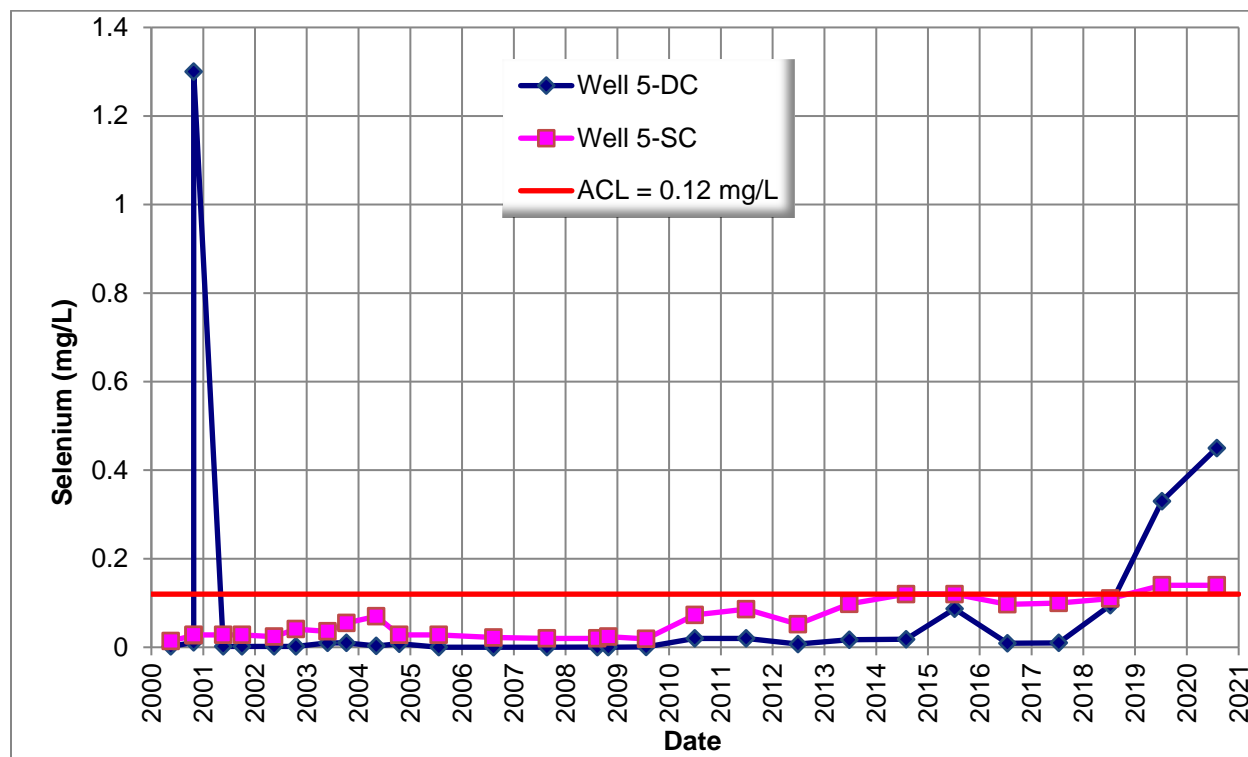
In 2020, the ACL for selenium was exceeded in POC and Upper Sand Aquifer well 5-SC and Main Sand Aquifer well 5-DC (Table 6-5 and Figure 6-9). Selenium concentrations were measured at the ACL of 0.12 milligrams per liter (mg/L) in well 5-SC in 2014 and 2015, and then they increased to exceed the ACL in 2019. Aside from an anomalously high selenium concentration of 1.3 mg/L in 2000, well 5-DC did not exceed the ACL until 2019 and further increased to 0.45 mg/L in 2020. Although the water levels in wells screened in the Main Sand Aquifer suggest the regional flow direction within the aquifer is oriented toward the south-southeast, it is unknown whether groundwater high in selenium from beneath the disposal cell is flowing in the direction of well 5-DC in the Main Sand Aquifer.

*Figure 6-9. Selenium Concentrations at the Shirley Basin South, Wyoming, Disposal Site*

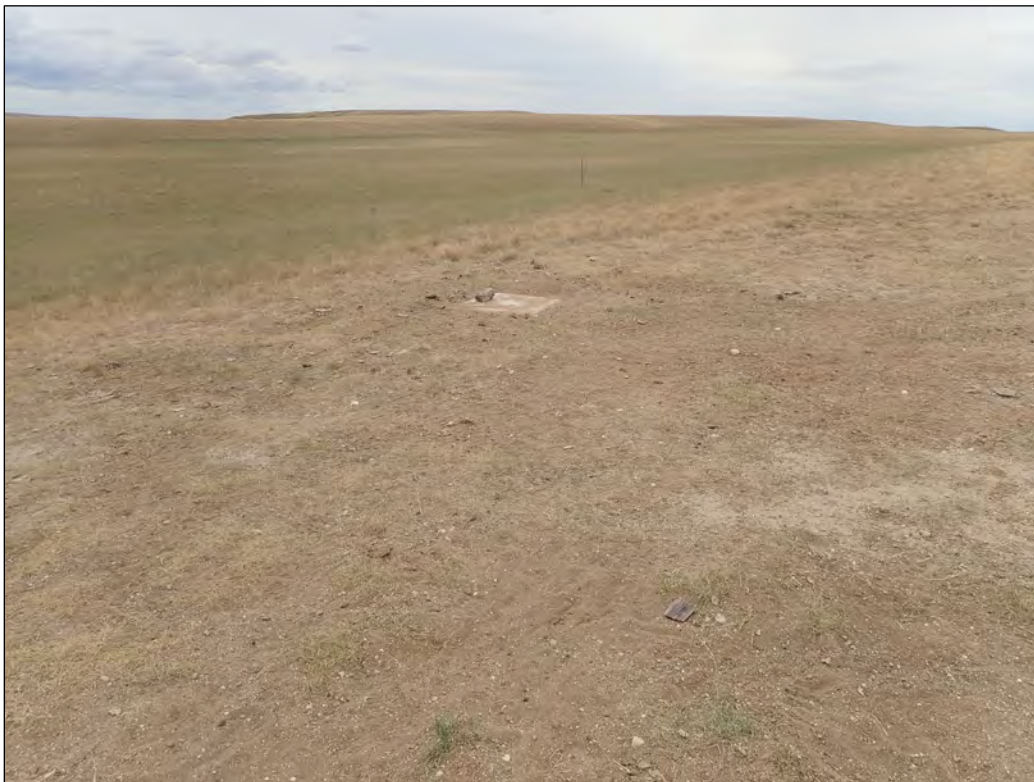
In July 2019, eight permanent quality control (QC) monuments were installed at the site in preparation for a baseline aerial survey of the disposal cell. The QC monument locations are shown in Figure 6-1. QC monument QC7 was unearthed for inspection (PL-6). No maintenance needs were identified.

*PL-6. Quality Control Monument QC7*

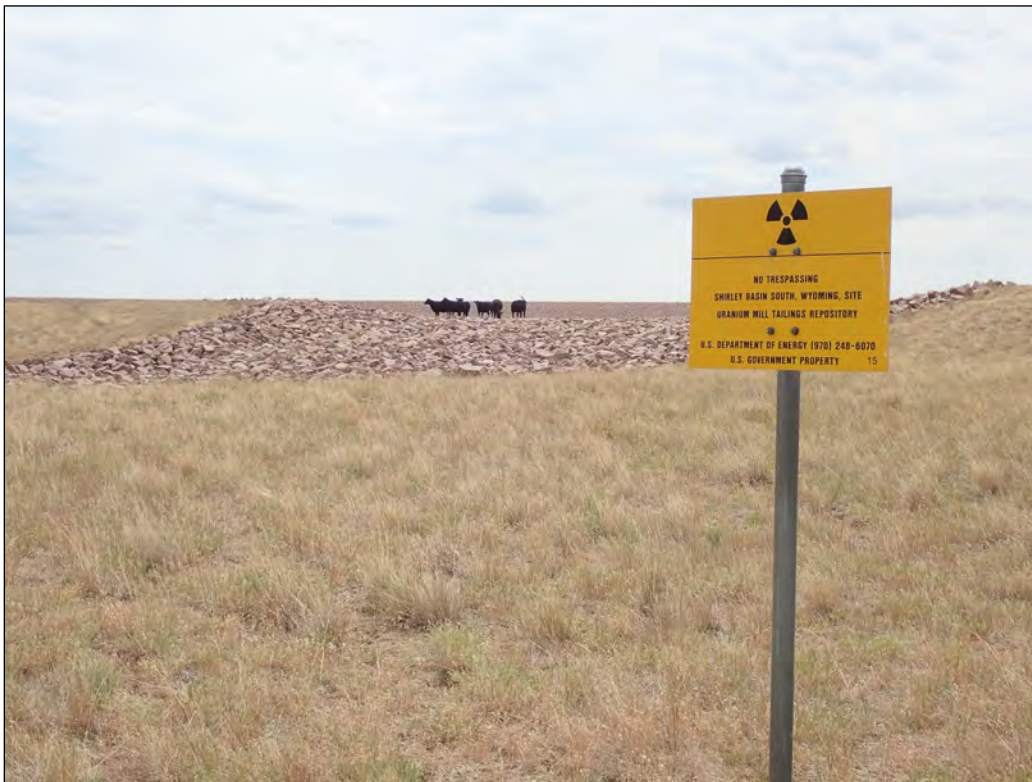
*PL-10. North Swale Discharge Point and Perimeter Sign P15*

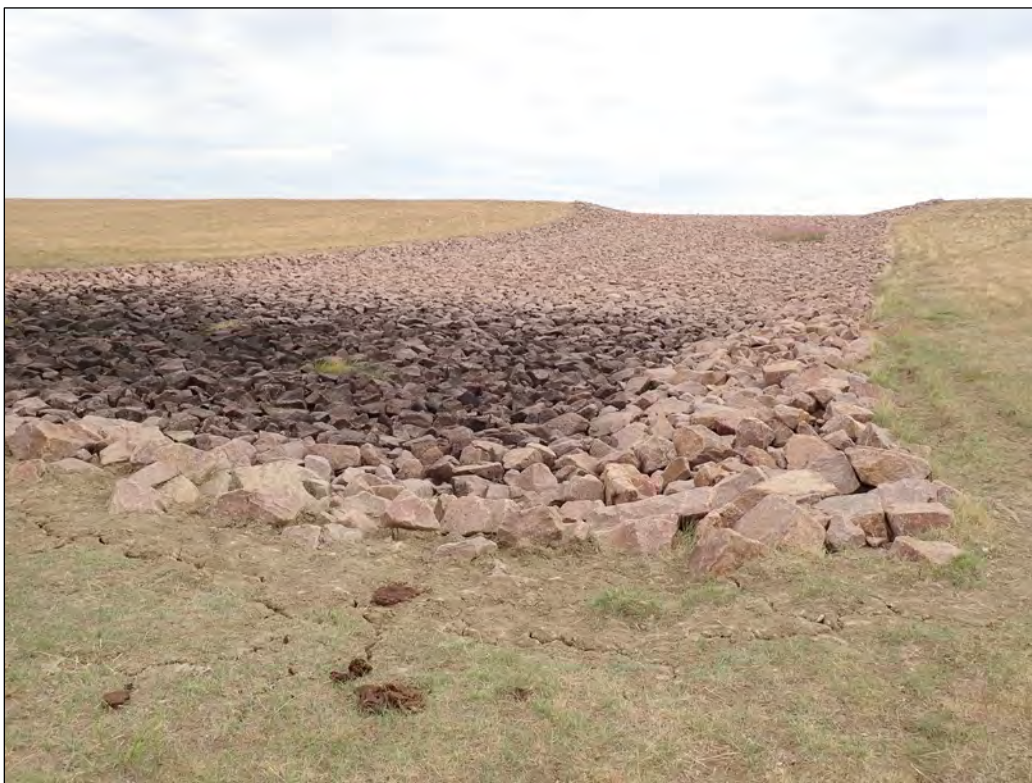
*PL-11. South Swale Discharge Point Riprap*

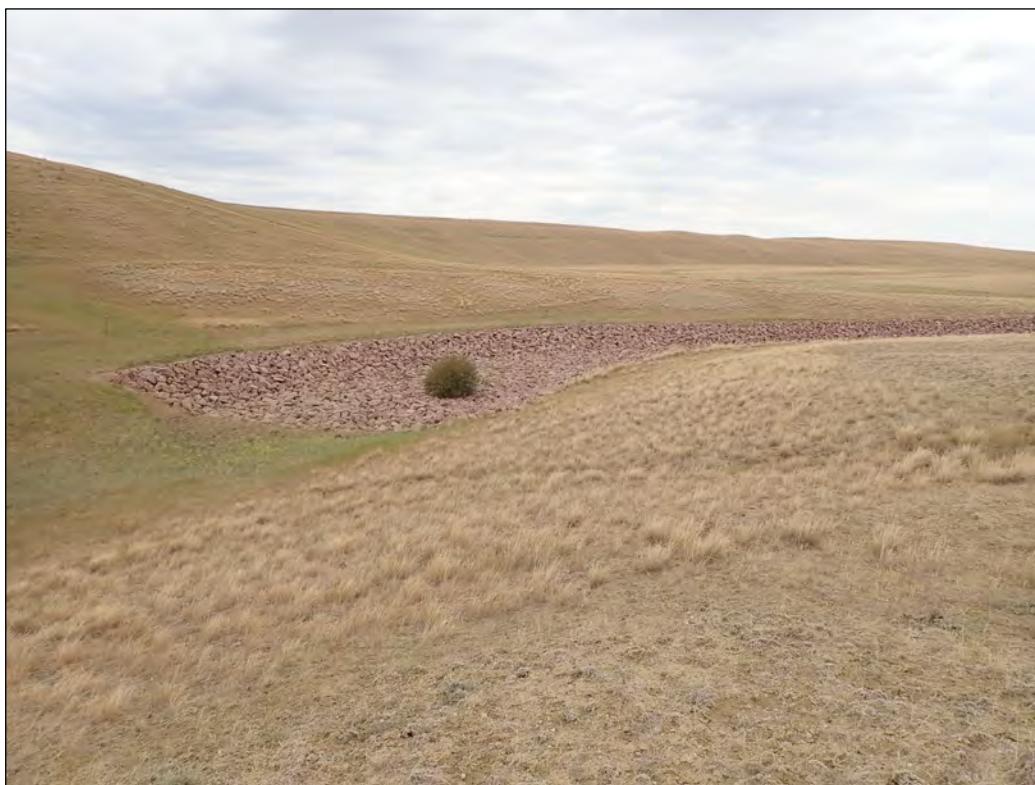
*PL-12. Southwest Diversion Channel Riprap*

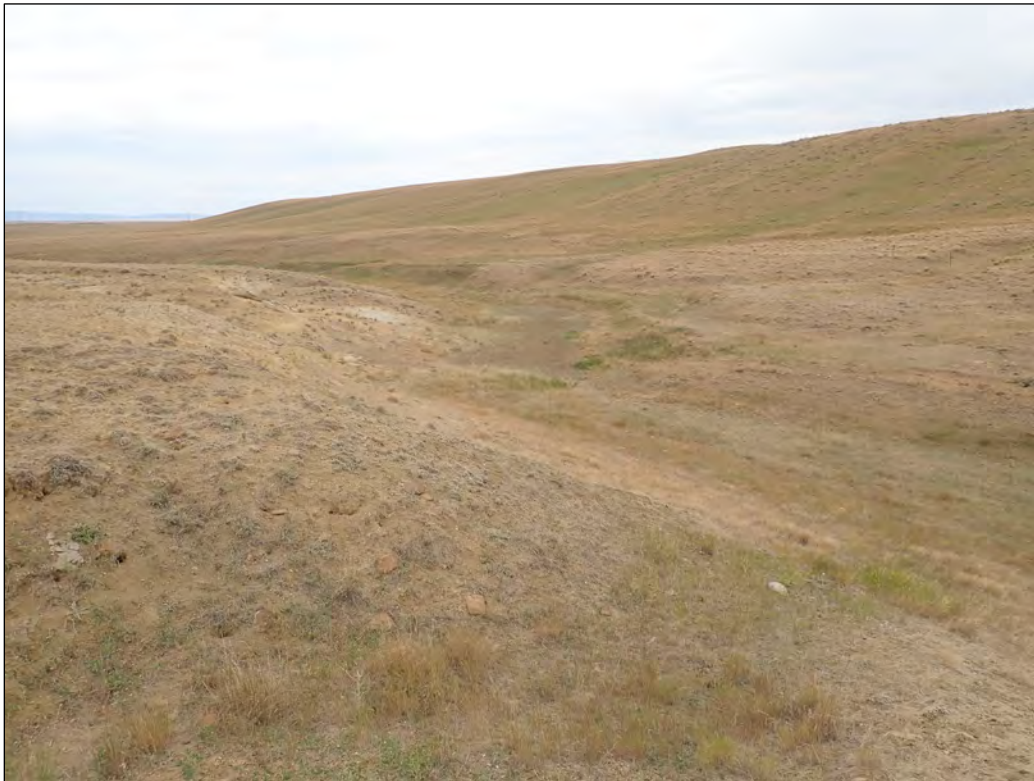
*PL-13. Southwest Diversion Channel*

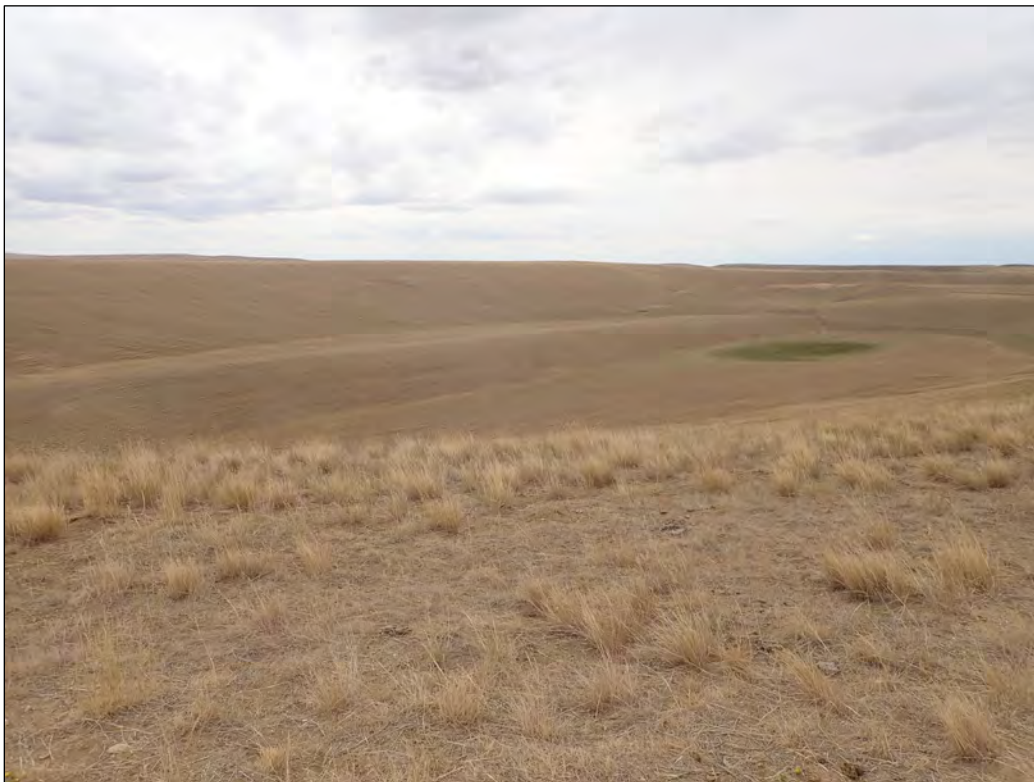
*PL-14. Pit 4 and Wetland Area*
