# **Overview of the First Quarter 2021 Surveillance and Maintenance Report for the Rocky Flats Site, Colorado**

January – March 2021

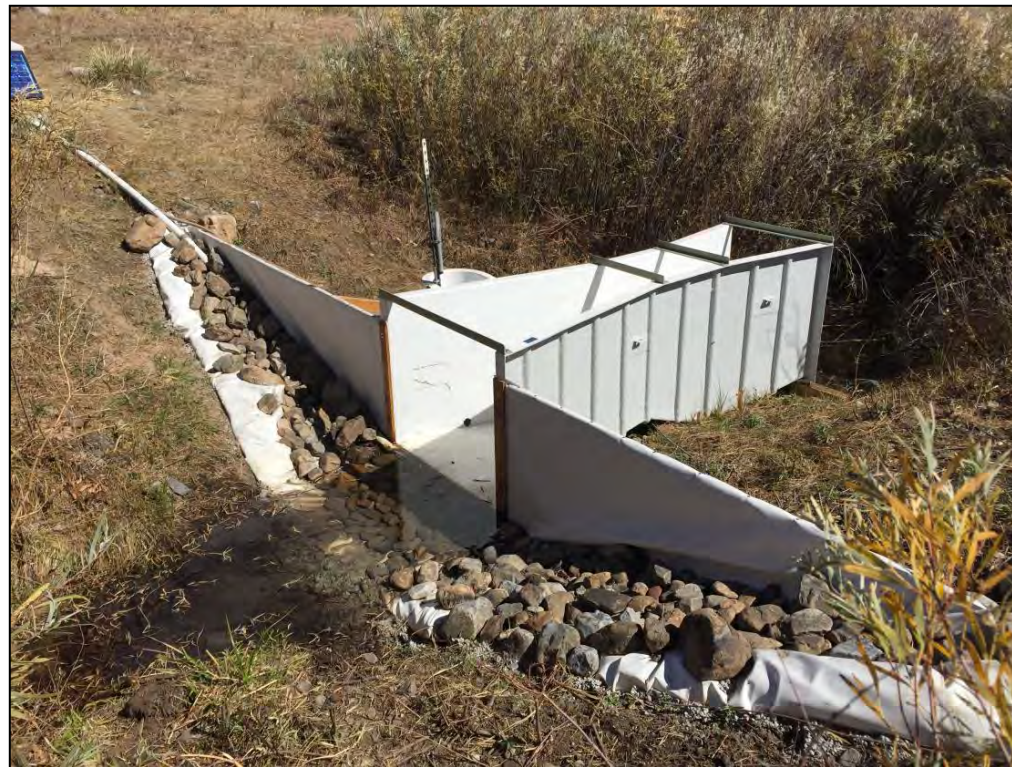
- Original Landfill (OLF) – location GS59
  - Routine surface water sampling in Woman Creek, downstream of the OLF (GS59), during the first quarter of 2021 showed mean concentrations for all analytes below applicable RFLMA water quality standards

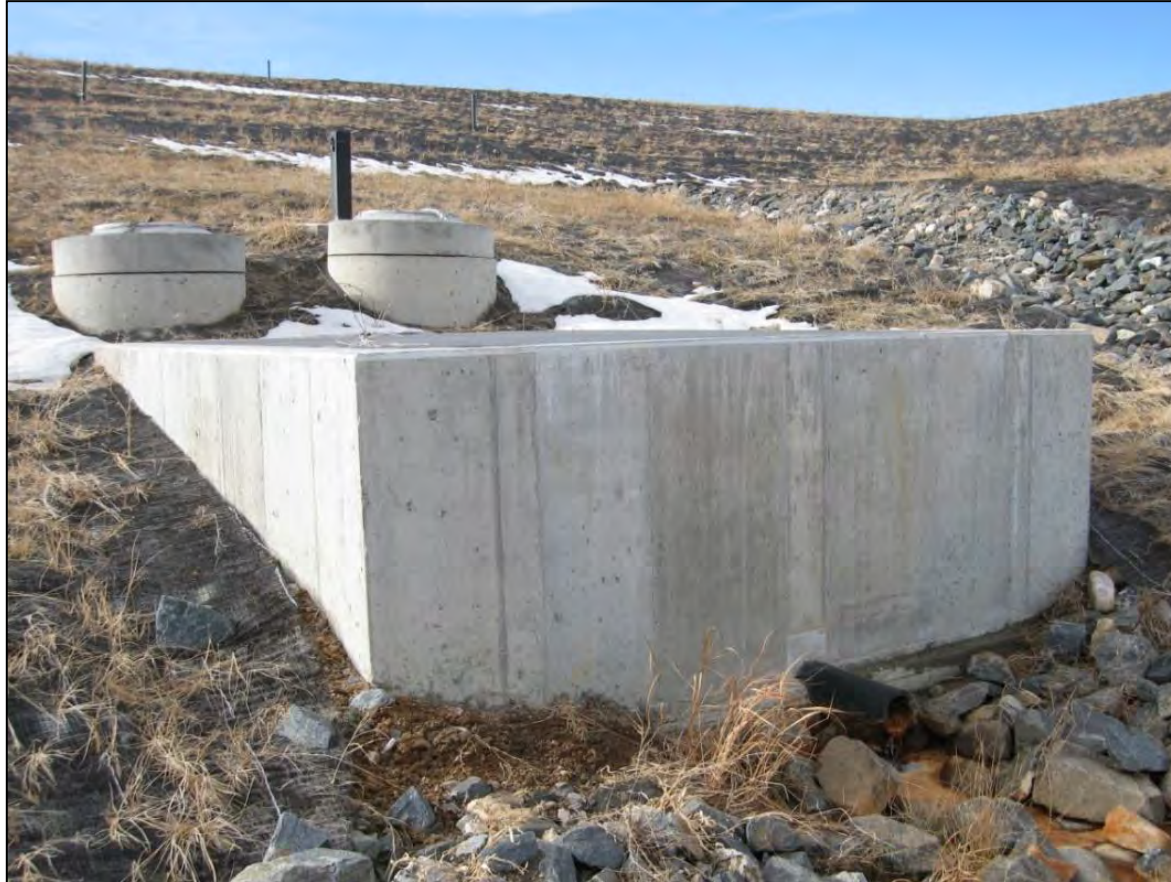
- Present Landfill Treatment System (PLFTS) — location PLFSYSEFF
  - During the first quarter of 2021 at the system effluent, concentrations for all analytes were below applicable RFLMA standards
