Unalakleet Microgrid Optimization & Typhoon Merbok Impacts

US Department of Energy –
Office of Indian Energy
Annual Program Review
Denver, CO
November 16, 2022

Effects on Airport

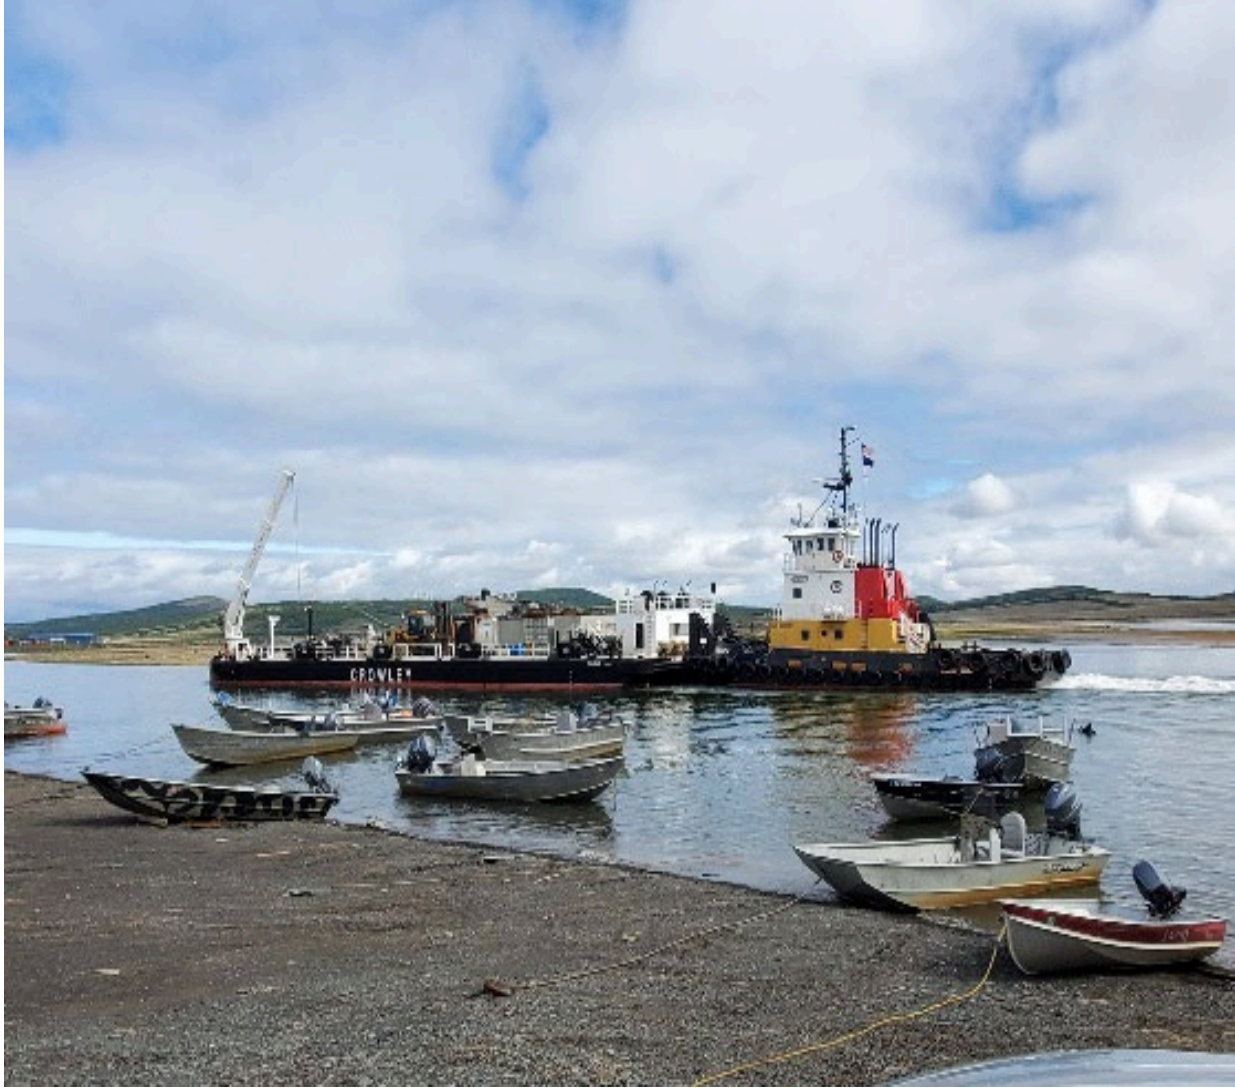
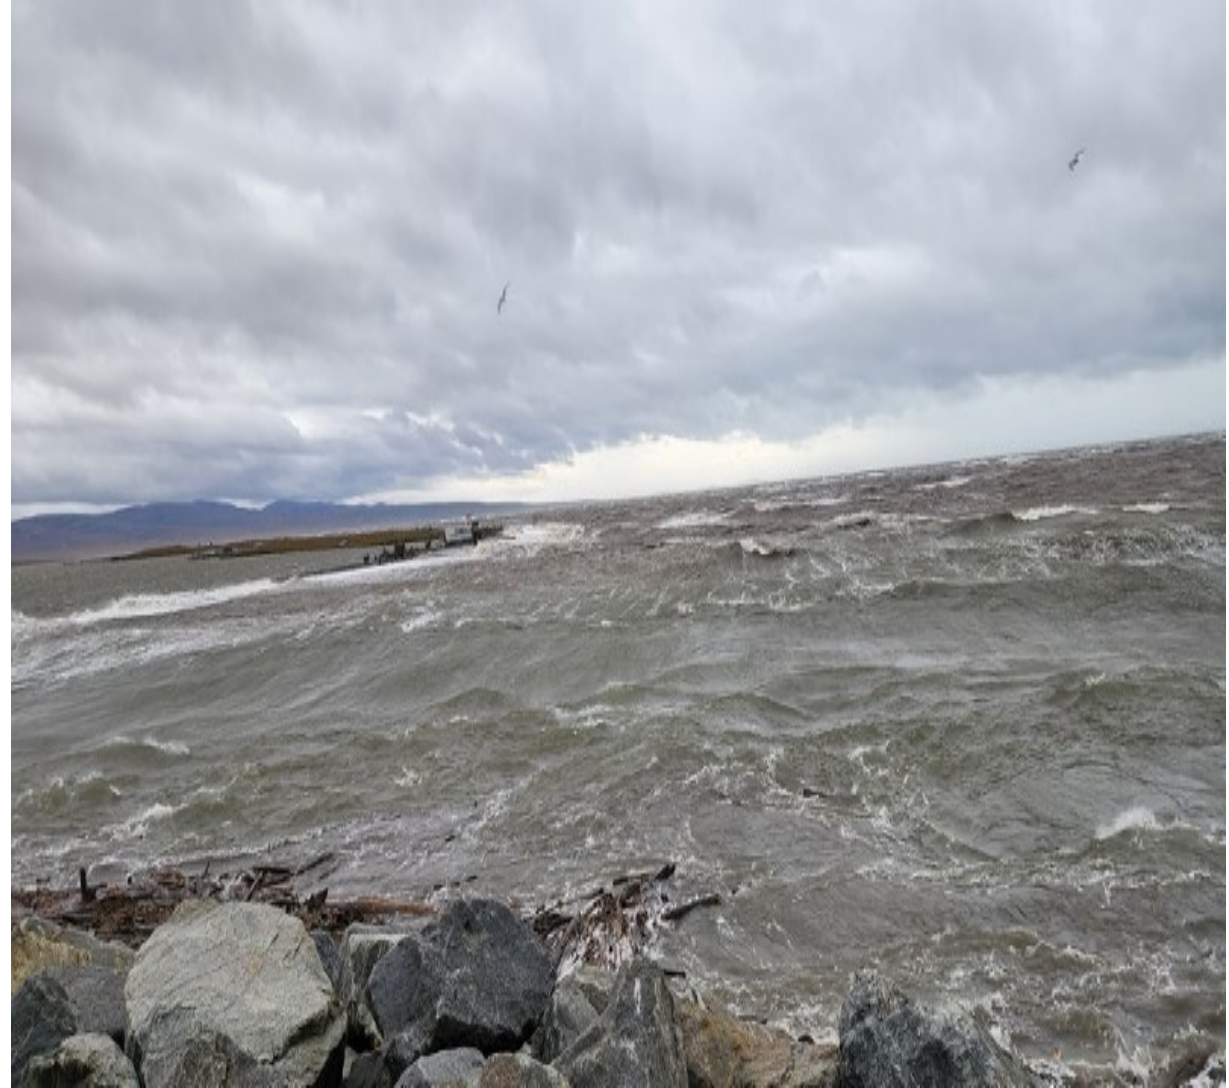
River Mouth – Normal & Typhoon

Recent Impacts from Typhoon Merbok were significant and costly: inundation of airport infrastructure, power and water outages, and accelerated coastal erosion.

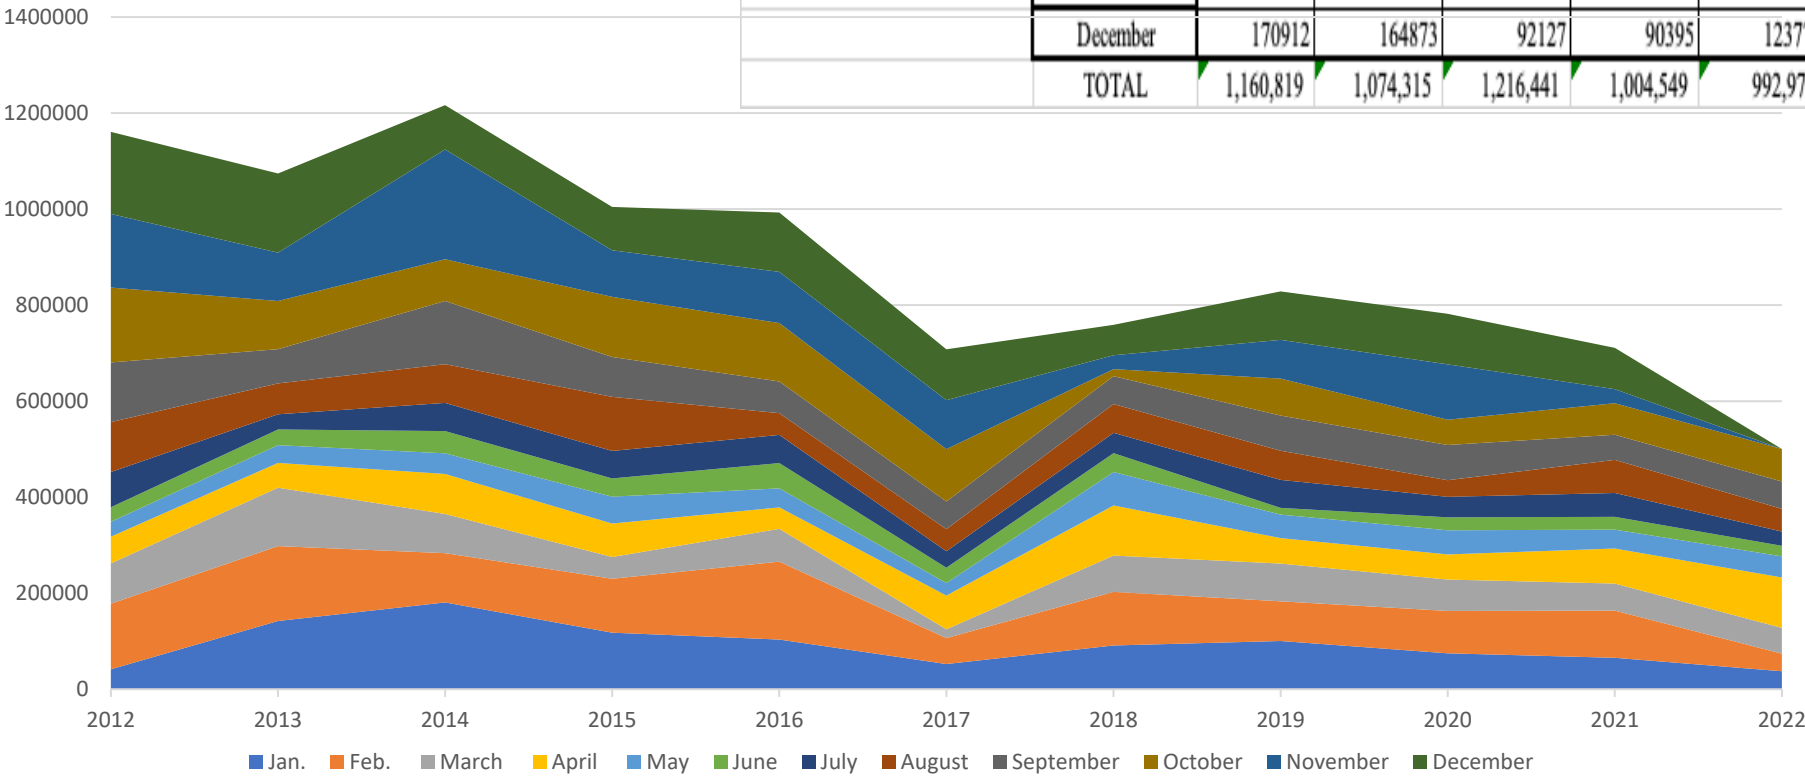
Wind Generation Over Time (2012-2022)

The Trend is Clear: More Curtailment, Less Wind Energy Production

**Actual wind production is ~40% LESS than Predicted, AND
High winds require UVEC to turn on a second generator for grid stability.**

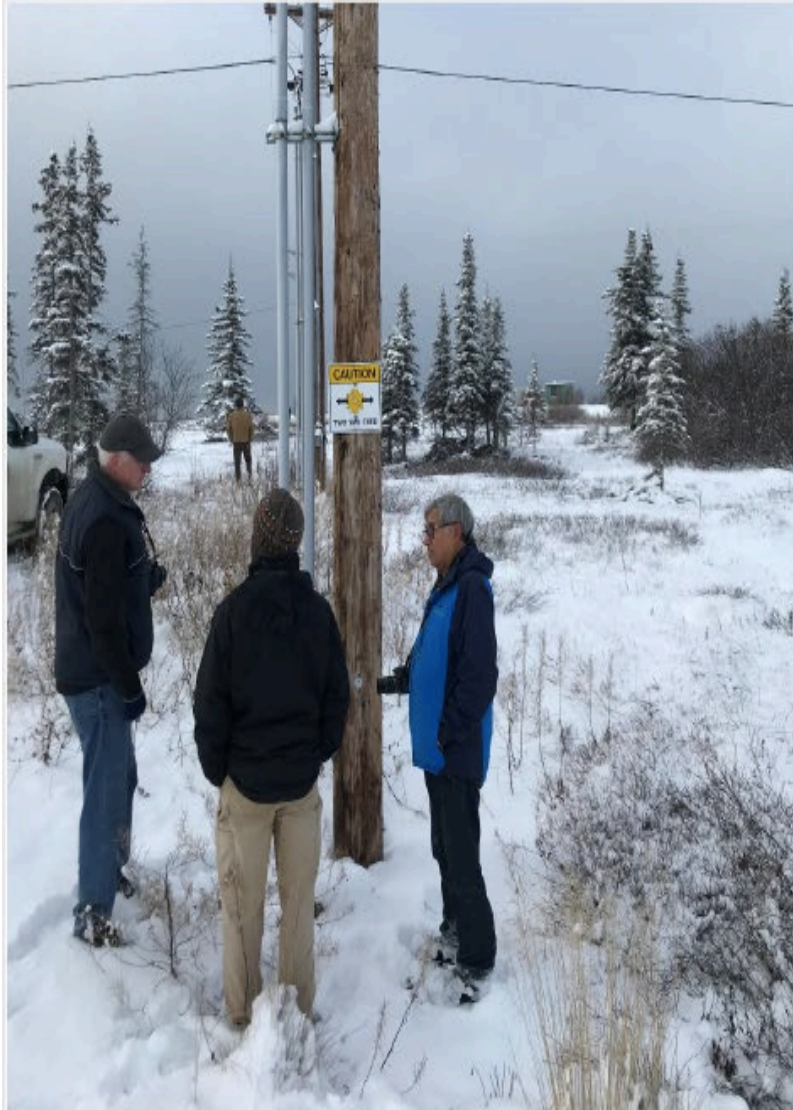
Power Line Capacity

Transmission line capacity constraints have led to a demand for reactive power at the wind farm. Higher turbine production often requires a second genset come online.

At a typical level of wind production (300 kW),

- Paladin analysis indicates transmission line loss > 12%.
- Voltage drop at plant > 10%.
- Power loss over time = annual power output of an entire 100 kW turbine.

1. Upgrade power line & increase voltage, starting with transformer replacement, then conductor and structural improvements as long-term solution to mitigate reactive power issues.
