# TA-53 Arc-Flash Accident Joint Accident Investigation Team (JAIT) Report

Prepared by a joint team representing both NNSA and Los Alamos National Laboratory

An interdisciplinary, learning-focused, and joint Federal and Laboratory team investigated the causes of an electrical accident at Technical Area (TA) 53 at Los Alamos National Laboratory. This event affected nine Los Alamos employees, two of whom required hospitalization. The Joint Accident Investigation Team (JAIT) determined the direct cause of the accident to be cleaning fluid sprayed into the air gap between an energized switchgear bus and the grounded enclosure. The aerosolized fluid created a path to ground, resulting in an arc-flash. The root cause was less-than-adequate management of control implementation. This report identifies relevant facts; determines direct, contributing, and root causes; provides detailed analysis; and establishes conclusions and judgments of need to prevent recurrence.

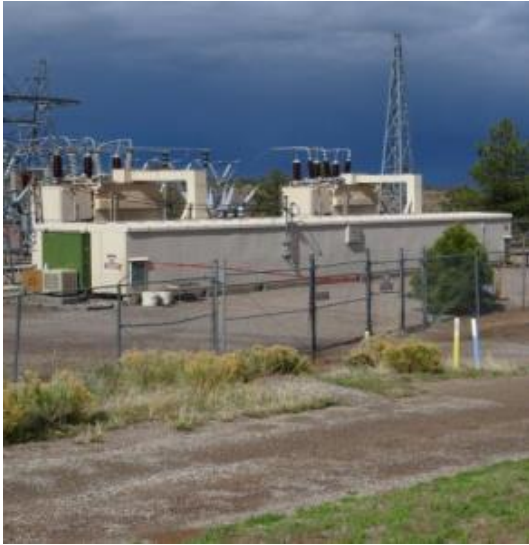
*Figure 1-1. The 13.8-kV substation was the site of the electric-arc accident on May 3, 2015.*

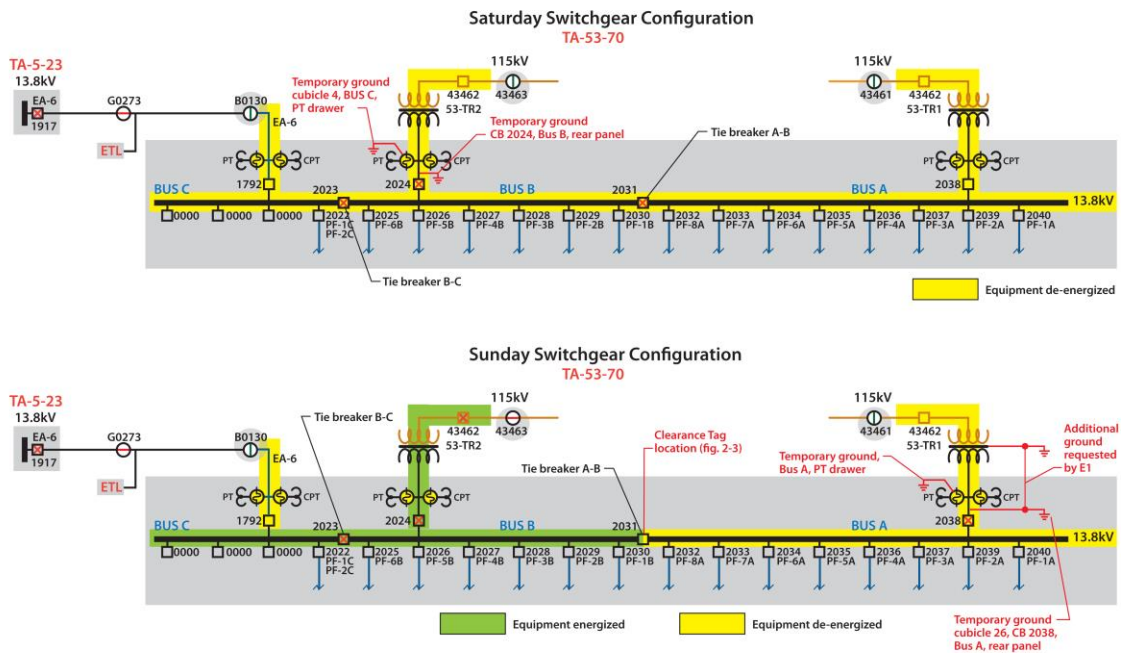
On May 2, 2015, all three buses were de-energized so that workers could perform maintenance tasks (Figure 2-2). Breaker maintenance and cleaning operations for Bus B and Bus C were completed, and both were re-energized by linemen, using the approved switching procedure, at the end of shift (1904 MDT), so that electrical service could be restored to some facilities within TA-53 to minimize outage impacts. Personnel attached a clearance tag (Figure 2-3) to the cubicle-18 tiebreaker. This tag indicated a demarcation between energized and de-energized cubicles. A lineman was available for zero-energy checks.

Figure. 2-2. Substation TA-53-0070 clearance configuration on Saturday, May 2, 2015 (top) and on Sunday, May 3, 2015. On Saturday, energy isolation breakers of disconnect blades (yellow) were opened to achieve the desired boundary. TA-53-0070 buses A, B, and C were all de-energized.

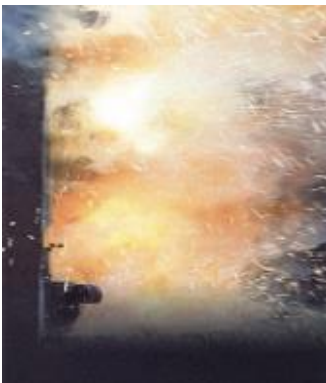
**The rapid release of thermal energy from the flash event resulted in serious burns to E1's hands, forearms, chest, face, head, and left rear upper torso. The subsequent pressure wave forced him backward and downward onto the floor, where his head struck a micro-ohm testing instrument.**

*Figure 2-7. This photo shows the energy released from thermal, pressure, sound, and light modes during a typical arc-flash event.*
