Steve Laxplane to record
NAA-SR-4488 (suppl)
COPY 56A

**SRE FUEL ELEMENT DAMAGE
FINAL REPORT**

**OF
THE ATOMICS INTERNATIONAL AD HOC COMMITTEE**

(1961)

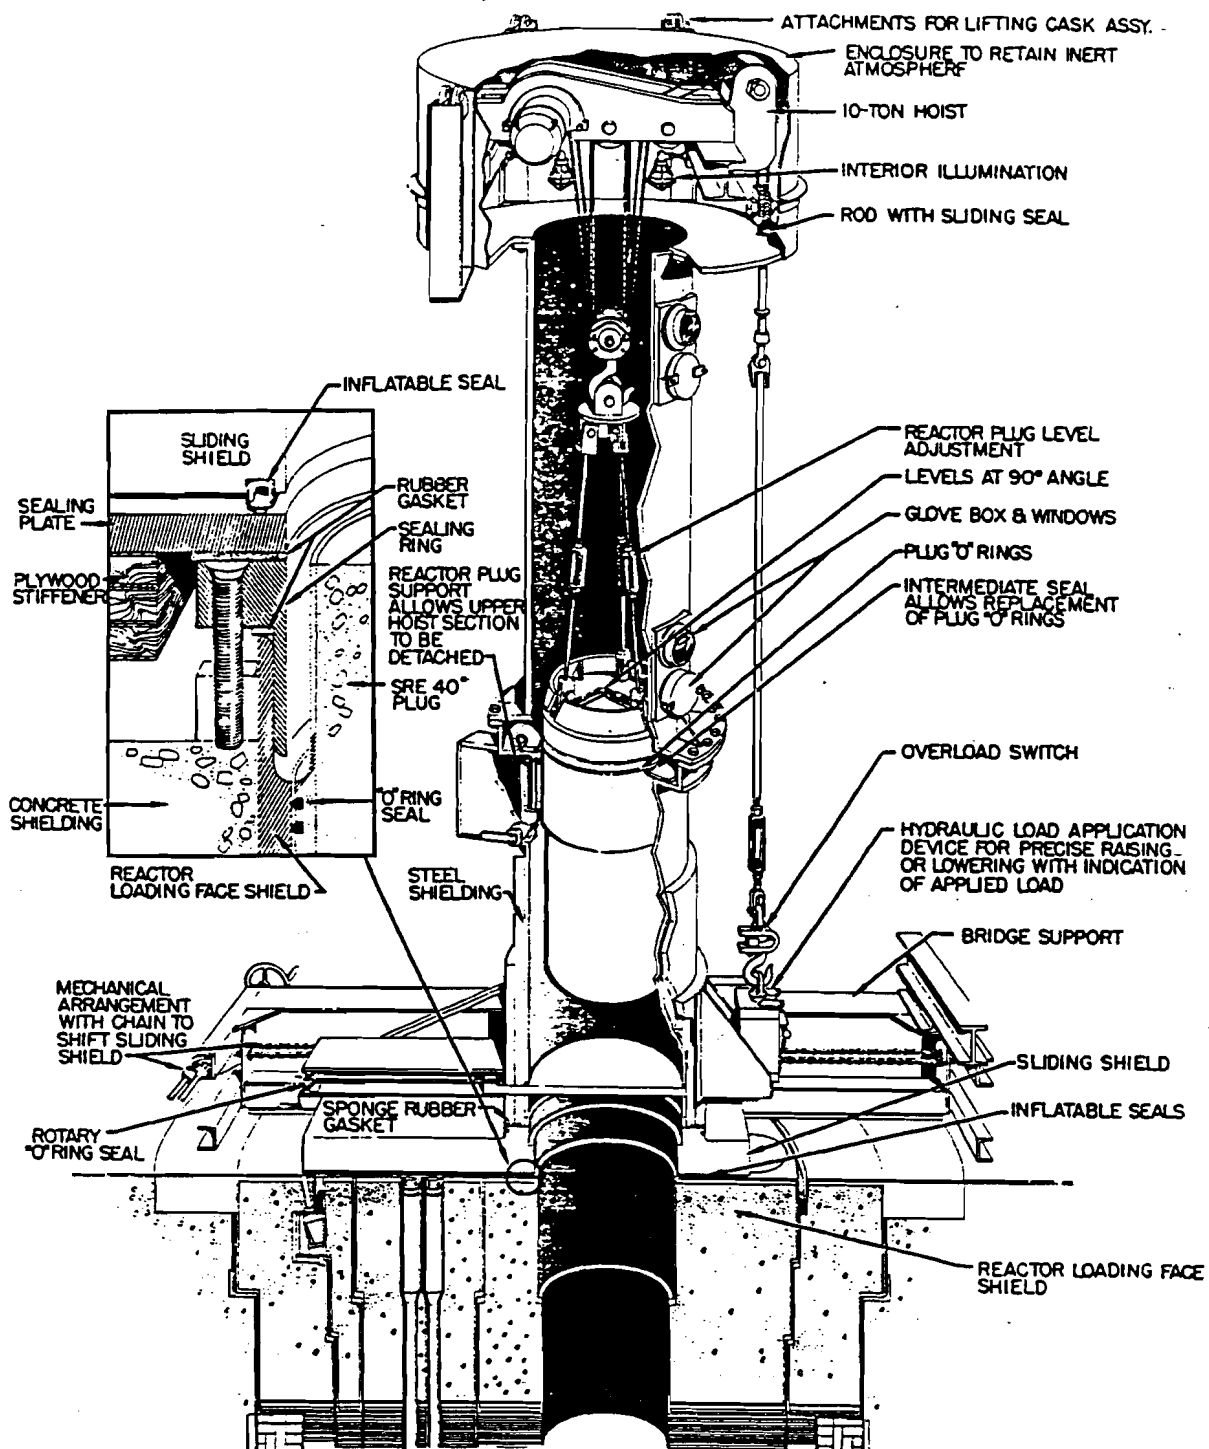
Figure II-3. Equipment for Removing Moderator Cans

During the moderator-can-removal operation all of the cans were inspected for carbon deposit. None was observed on the sides of the removed cans or on the six adjacent can panels. A light carbonaceous deposit was noted on the bottom of some cans. Observations of the top of the grid plate through the void created by the removed can disclosed a very thin and somewhat mottled dark coating. The amount observed did not warrant the additional manipulative and exposure hazard which would have been necessary for its removal.

After establishing that the system was reasonably clean, it was refilled with sodium, heated to 600°F, and sodium circulated for seven days to check for any additional leaky cans. Three were found, R-32, R-44, and R-45; these were replaced. It was subsequently established that two of the three cans (R-32 and R-44) failed because of mechanical damage to the short unprotected zirconium pumpout tubes during fuel slug grappling operations. The third can (R-45) was

not examined in sufficient detail to establish the point of sodium entry. This made a total of 16 cans replaced. A second sodium circulation test and height probe showed that all the cans were sound. The critical loading was conducted, the cans were again tested, and found to be intact, thus validating critical loading measurements. Any future can failures can be detected by changes in reactivity.
