**United States
Department of Energy
Office of Science**

Accident Investigation Report

**Ironworker Injured from Fall at the
Fermi National Accelerator Laboratory
Proton Improvement Plan – II Construction Project**

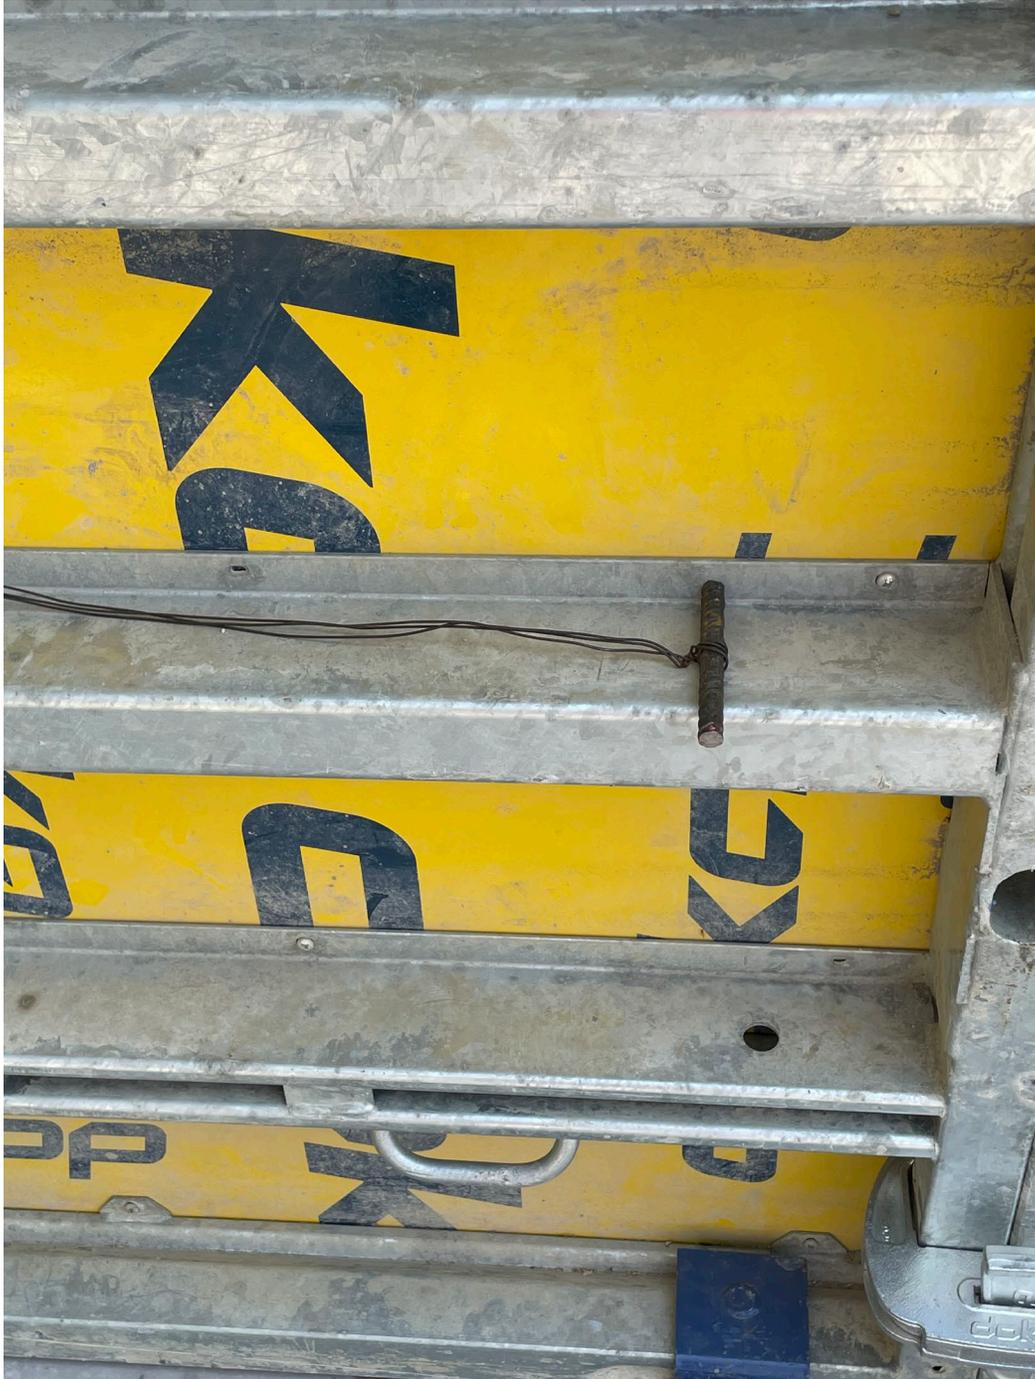
Figure 2-4. Example of Rebar Tie

On the morning of May 25, 2023, the ironworkers used a crane to install a rebar column on the northwest corner of the forms. Subsequently, they installed a rebar template bar on the north side of the installed Doka form wall (Figure 2-3). IW1, a journeyman Harris ironworker, was assigned the task of passing wires attached to a piece of rebar through holes in the formwork at various points. Rebar ties are short sections of rebar with connecting wires which are used to secure the template bar to the formwork (Figure 2-4).

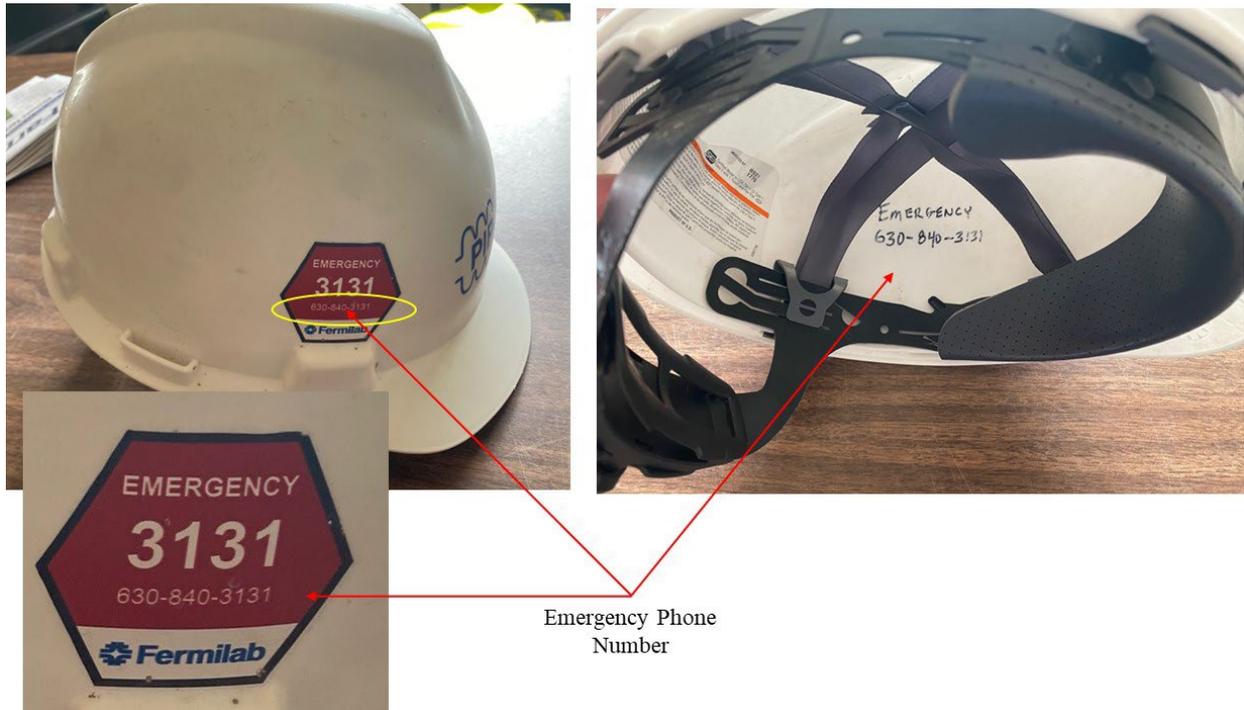
**Figure 2-12. Emergency Phone Number Handwritten Written
Inside Workers' Hard Hat**

The phone number to emergency dispatch was readily available and enabled the WCEI Superintendent to place the call for help within seconds of the accident. The workers had been given a sticker for their hard hats with the emergency numbers printed on it. The WCEI Superintendent stated that the numbers on the original sticker were so small that some workers wrote the numbers inside their hard hats (Figure 2-12).

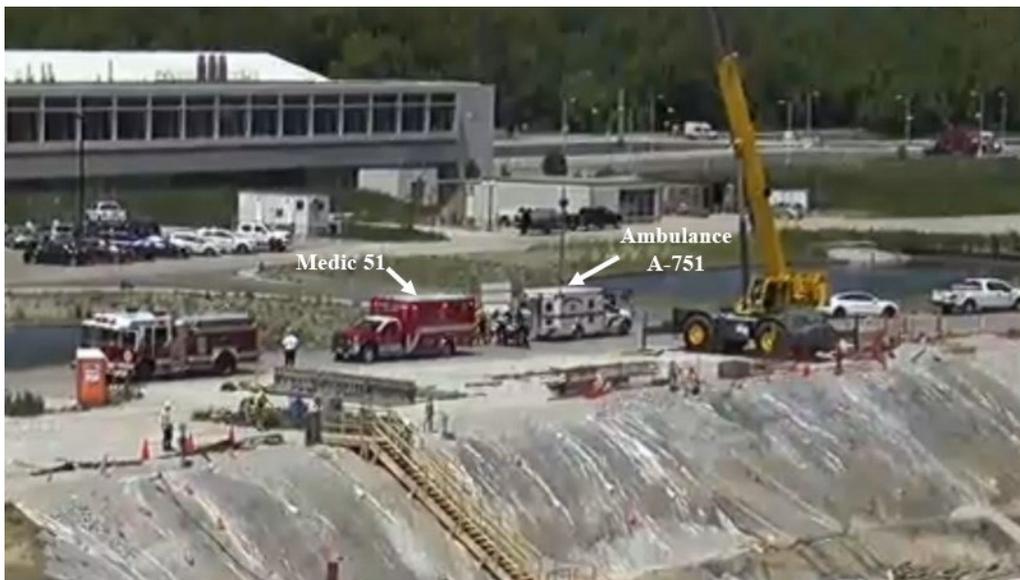
Figure 2-13. Transfer from Ambulance A-751 to Medic M-51

The Incident Commander staged A-751 at the edge of the construction area and loaded IW1 into A-751, before proceeding 150 yards to transfer IW1 to M-51 at 1329 (Figure 2-13). The location where A-751 received IW1 was on the hard gravel, and the drive to M-51 took less than 32 seconds. During the interview with the Board, the Incident Commander made this decision based upon the available information, familiarity with equipment, and anticipated terrain at the time. This transfer added an extra three minutes to transporting IW1 to Landing Zone 3.

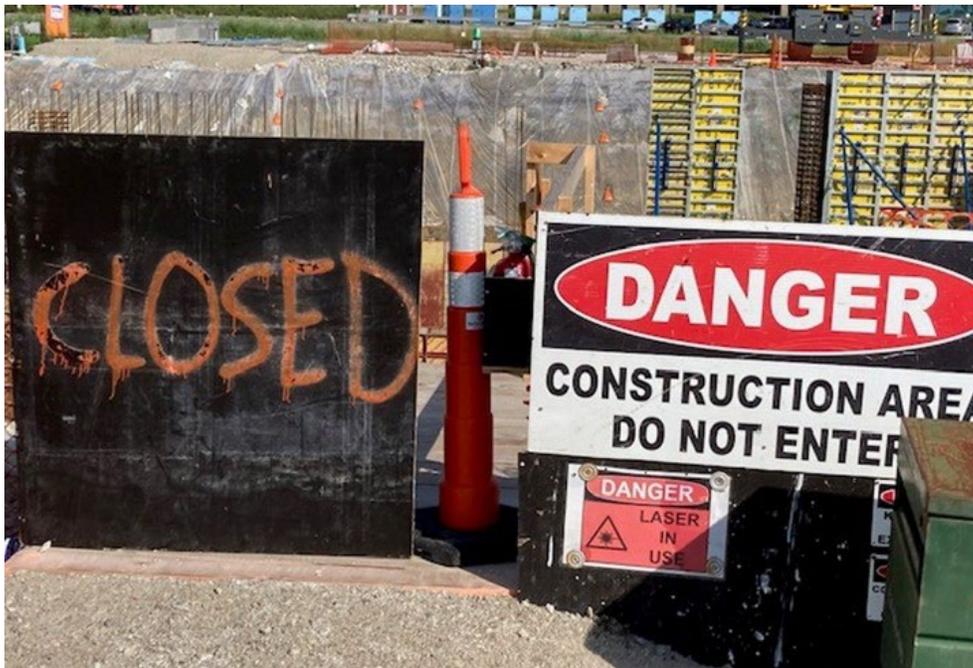
Figure 2-14. Barricades to Stairway Access in Place

On May 25, 2023, at approximately 1430, the PIP-II construction site was turned over to FRA security personnel and controlled from further access. The stairs on the east and west sides of the construction site, routinely used for site access, were blocked by a sign and wooden board, and site monitoring for unscheduled access conducted by security cameras (Figure 2-14). Public access to the PIP-II project video feed utilized to monitor project progress was discontinued shortly after the accident.

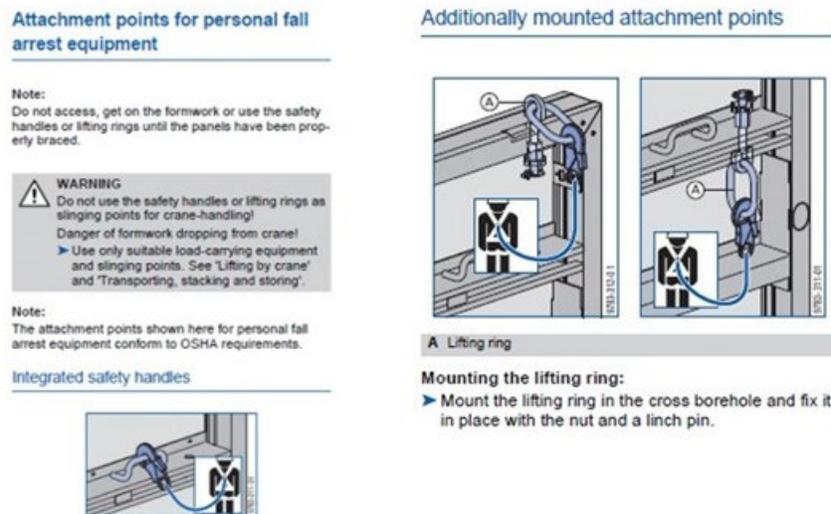
Figure 3-3. Anchor Point Information from Doka Website

WCEI is responsible for the selection of the form wall systems, and their carpenters are responsible for the associated installation; therefore, WCEI should be in possession of all necessary specifications and user instructions, including climbing form walls and the use of compliant fall protection anchor points for each form wall system. WCEI submitted to FRA a proposal on form wall systems to be used on the project on February 3, 2023. That submission was accepted by FRA, and it included information on both types of form wall systems the Board identified in use at the PIP-II project. Upon closer review of that submittal, it did not include information on compliant fall protection anchor points associated with the Doka system.

Some, if not all, of the Doka user instructions for their form wall products can be obtained through internet searches (Figure 3-3). Additionally, Doka includes a Quick Response (QR) code on their form wall sections to facilitate convenient access to information on the Framax Xlife system from a mobile phone. As the installer of the form walls, WCEI has a direct and immediate need to understand the specifications on those systems, as well as a responsibility in conveying information to their sub-tier subcontractors when form wall assemblies are adequately braced for climbing. During an interview with the Board, the WCEI Safety Representative stated they had no prior familiarity with the Doka system. This should have compelled WCEI to fully investigate the user instructions associated with this product to become sufficiently knowledgeable to share that information with the workforce and fulfill their oversight responsibility on the associated fall protection practices at the site.

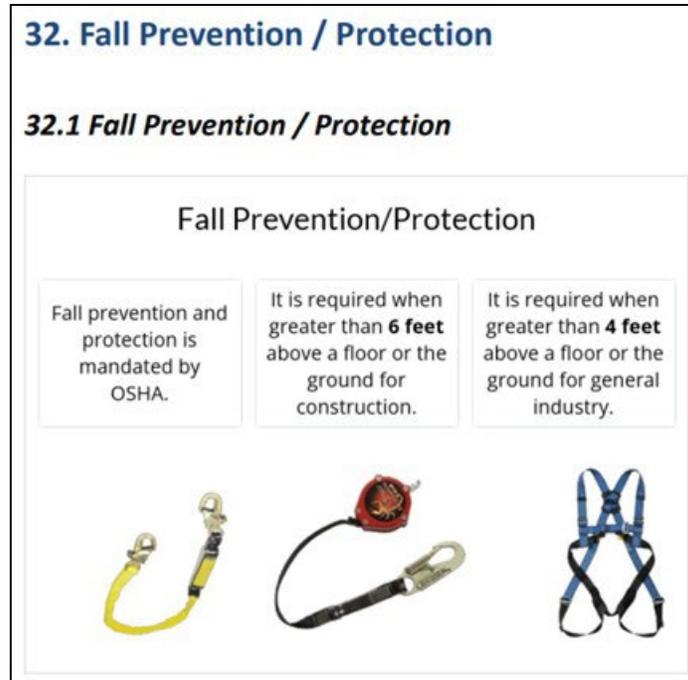
**Figure 3-9. FRA Subcontractor
Orientation Training Slide - Fall Prevention / Protection**

FRA's Subcontractor Orientation training content on fall protection and personal fall arrest systems is depicted in the slide in Figure 3-9 below.

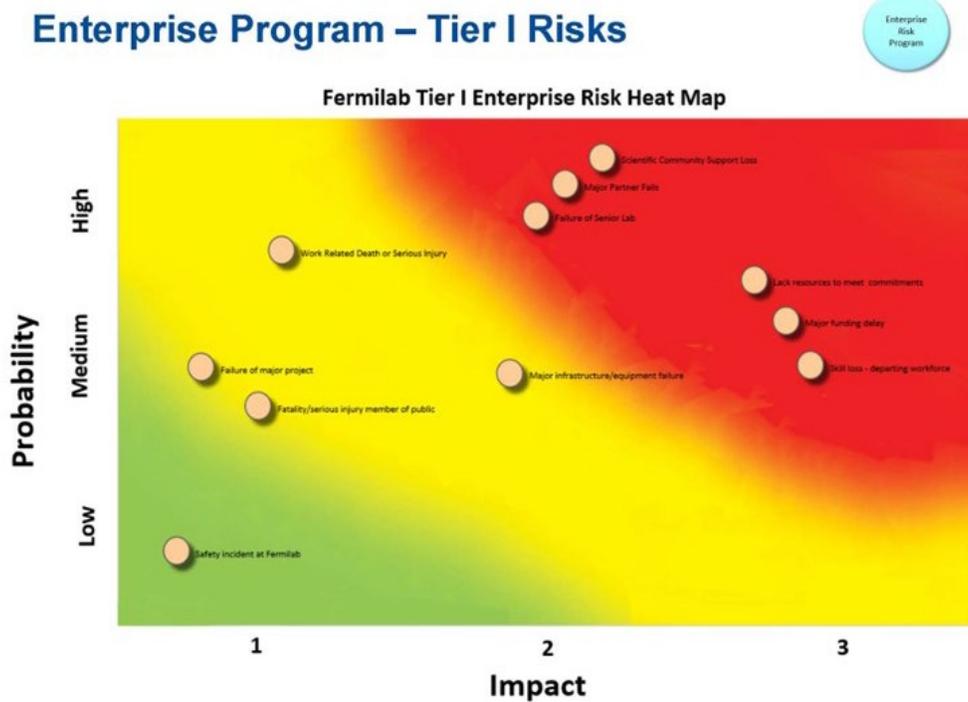
Figure 3-10. FRA Tier I Enterprise Risk Heat Map Corrective Action Status and Adequacy from Prior Construction Incidents

The FRA Risk Matrix is used to evaluate the overall characterization of an identified risk by determining each risk's probability and severity, which develops an overall risk level. The risk level then serves as the basis for prioritization and mitigation decisions. FRA's highest level (Tier I) risks are mapped based on the probability and impact to identify levels of management attention (Figure 3-10).

According to the Program criteria, the Risk associated with this accident would be classified as “Work Related Death or Serious Injury.” Impact is the component of the risk that describes its actual or potential impact and FRA rated this type of incident as Medium (Impact Level 2). Probability is the risk component that characterizes the likelihood of occurrence and was considered High, with a greater than 20% probability of occurring.

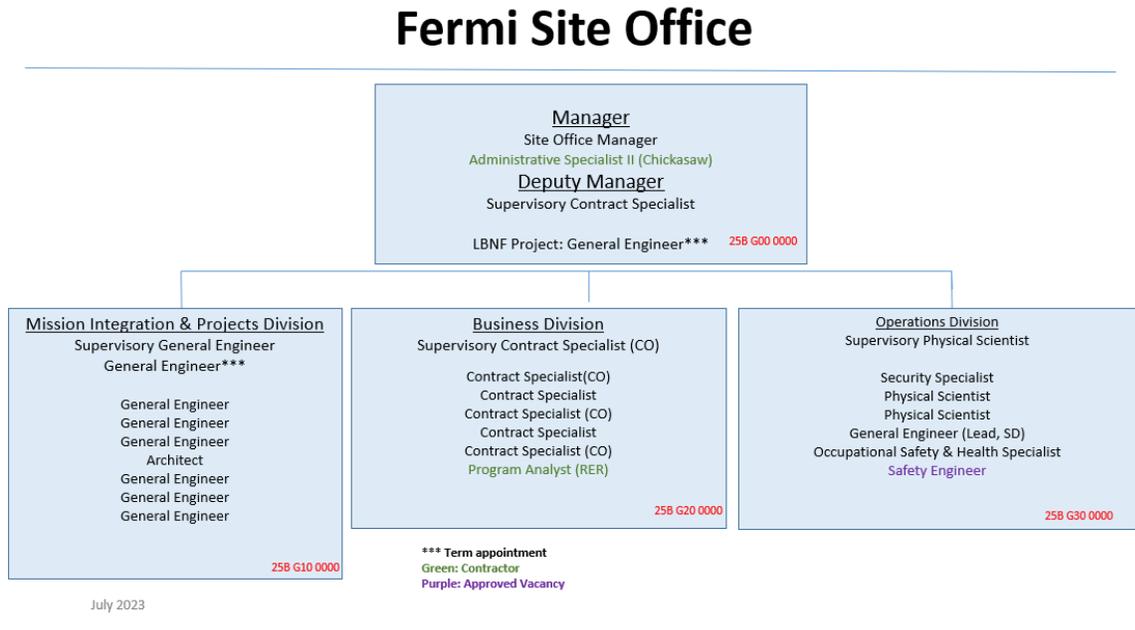
Figure 3-11. FSO Organizational Chart

FSO's general organization structure (Figure 3-11) includes three major divisions that report to the FSO Site Office Manager and Deputy Manager, and a special direct report position:

There are no current vacancies within FSO’s organizational structure/approved staffing plan. The FSO Manager has been concurrently serving as the Acting Argonne Site Office Manager for approximately one year. FSO has a suite of internal procedures to facilitate their delivery of SC’s mission objectives and responsibilities. Upon the Board’s review of FSO procedures, many are beyond the scheduled date for reissue.

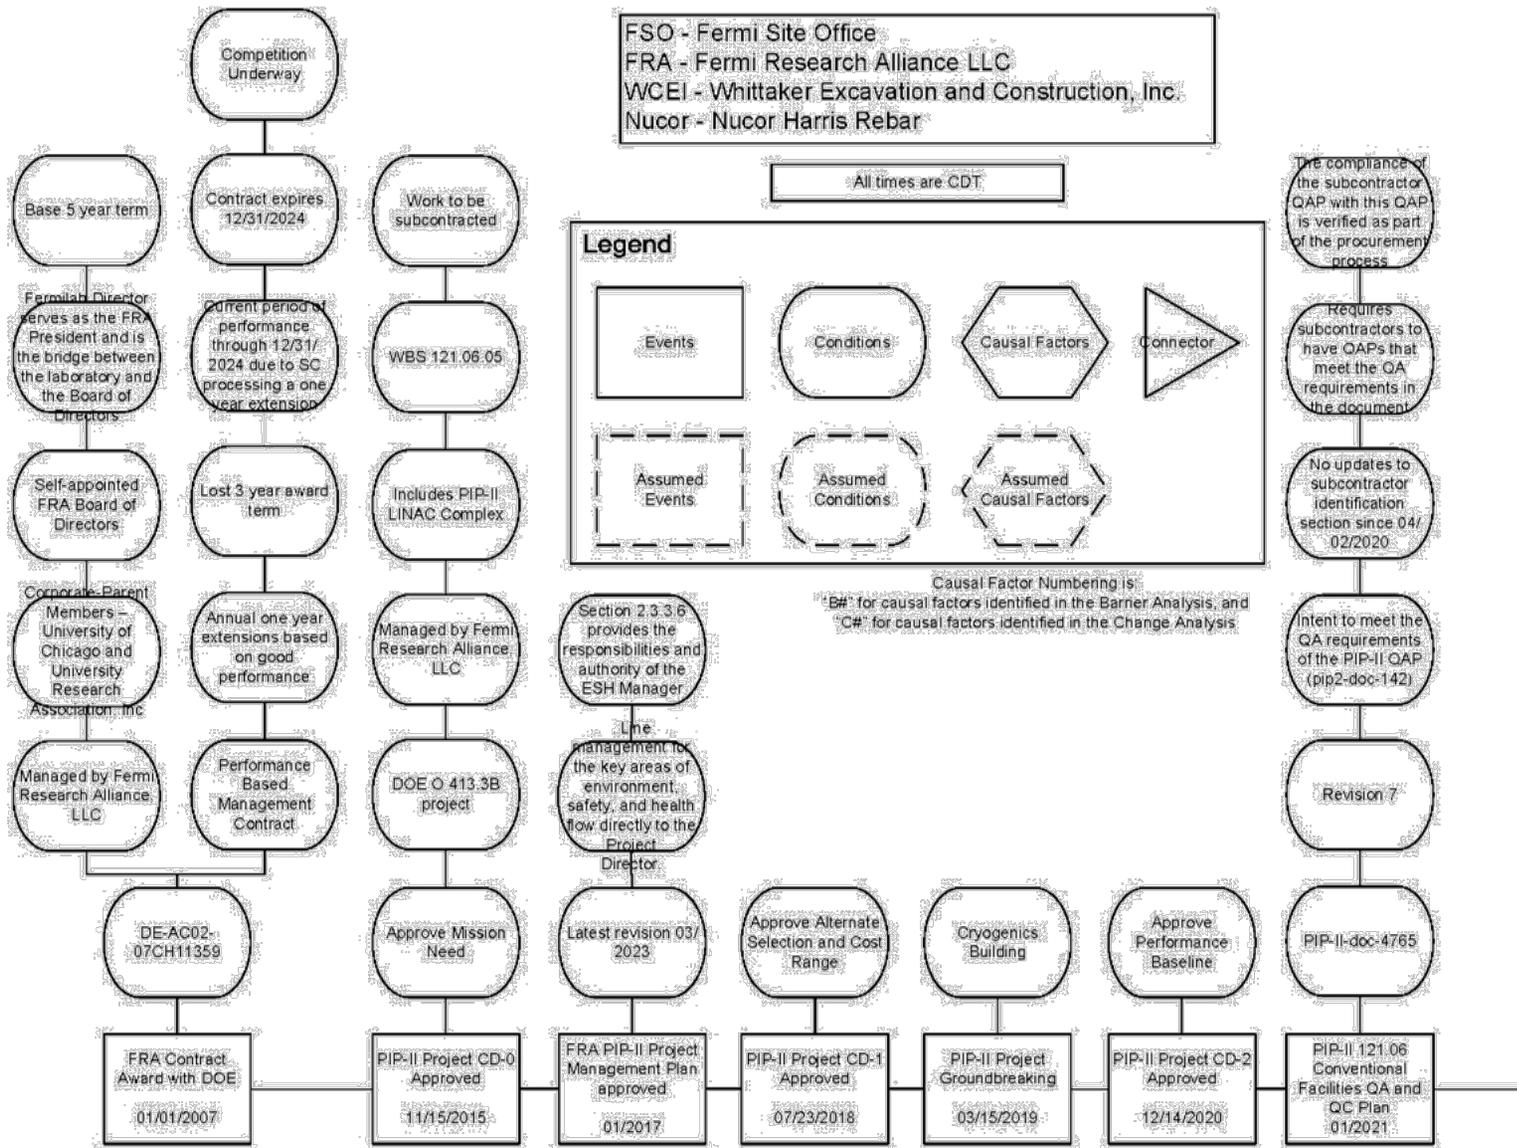
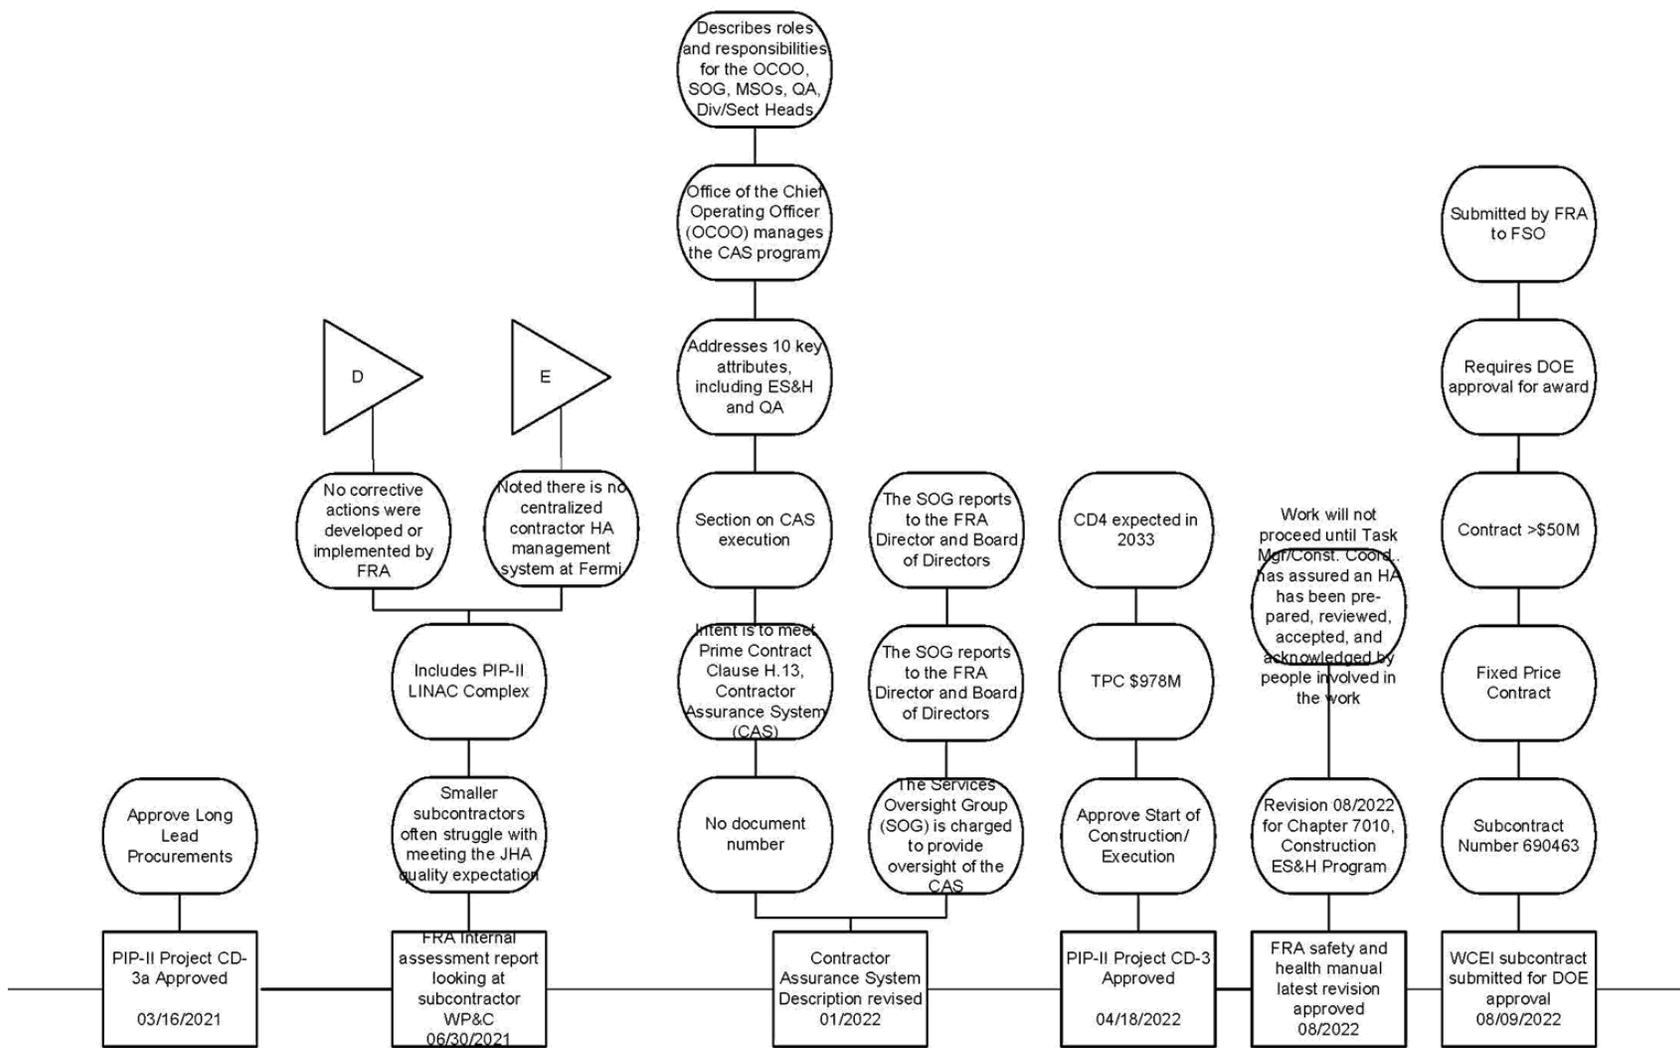
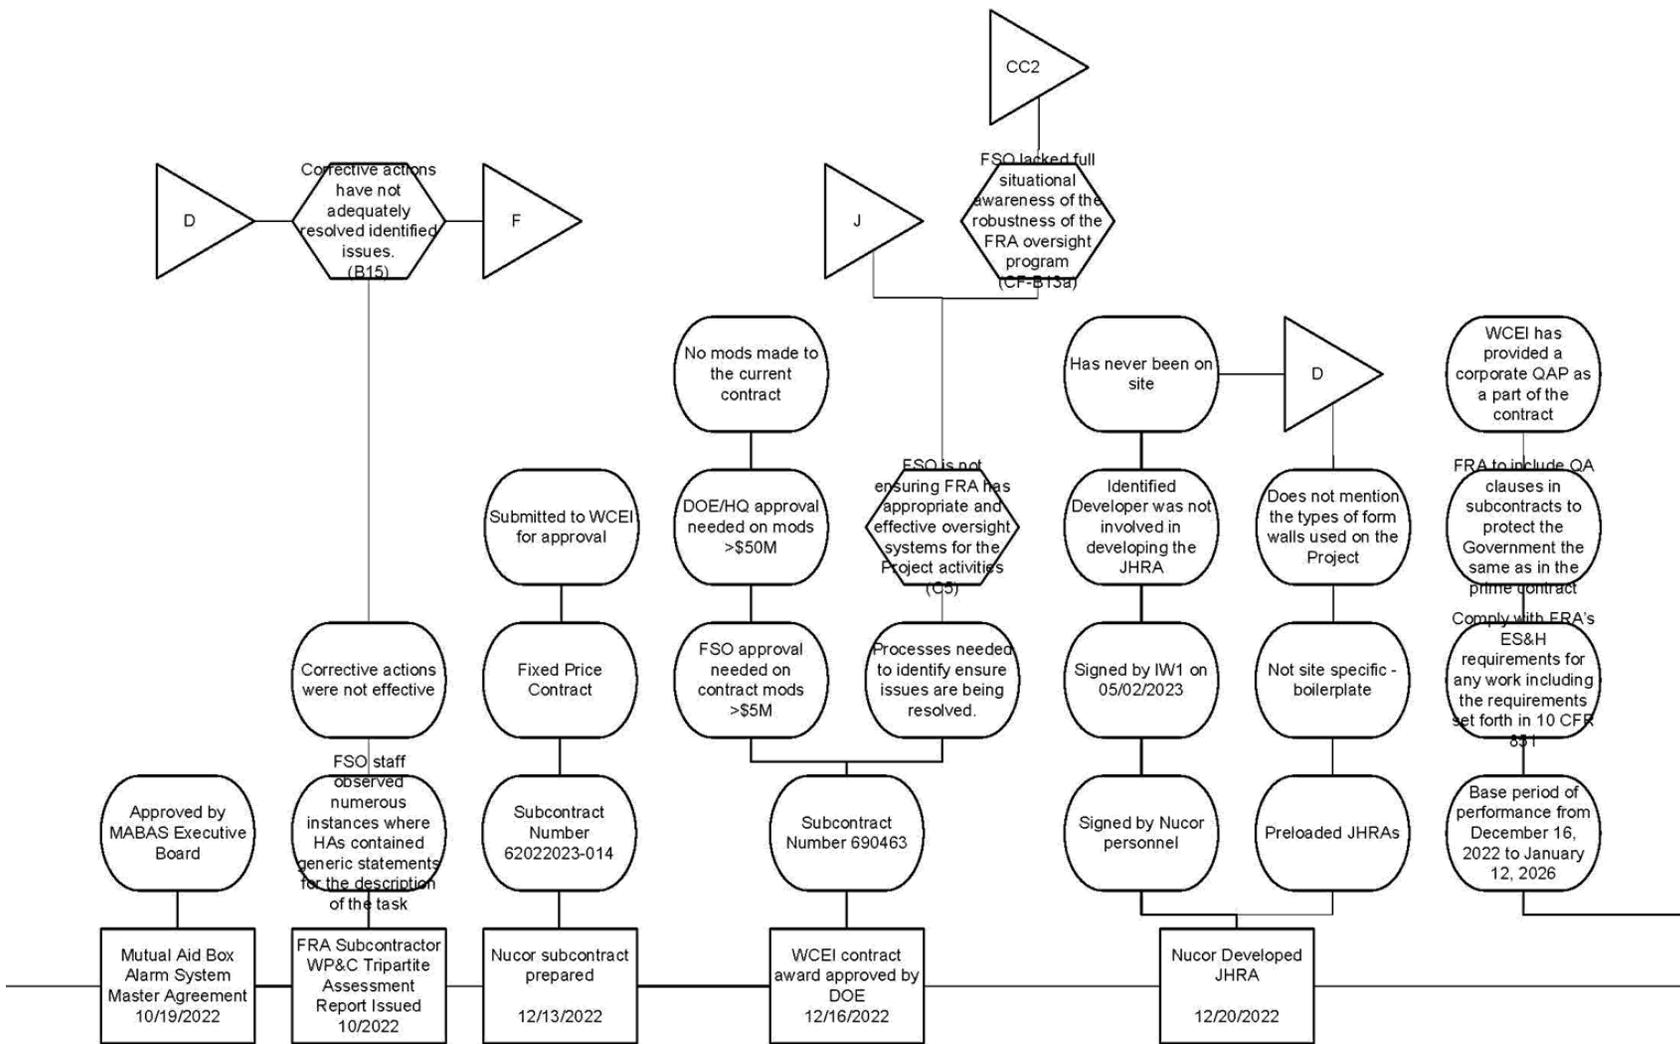
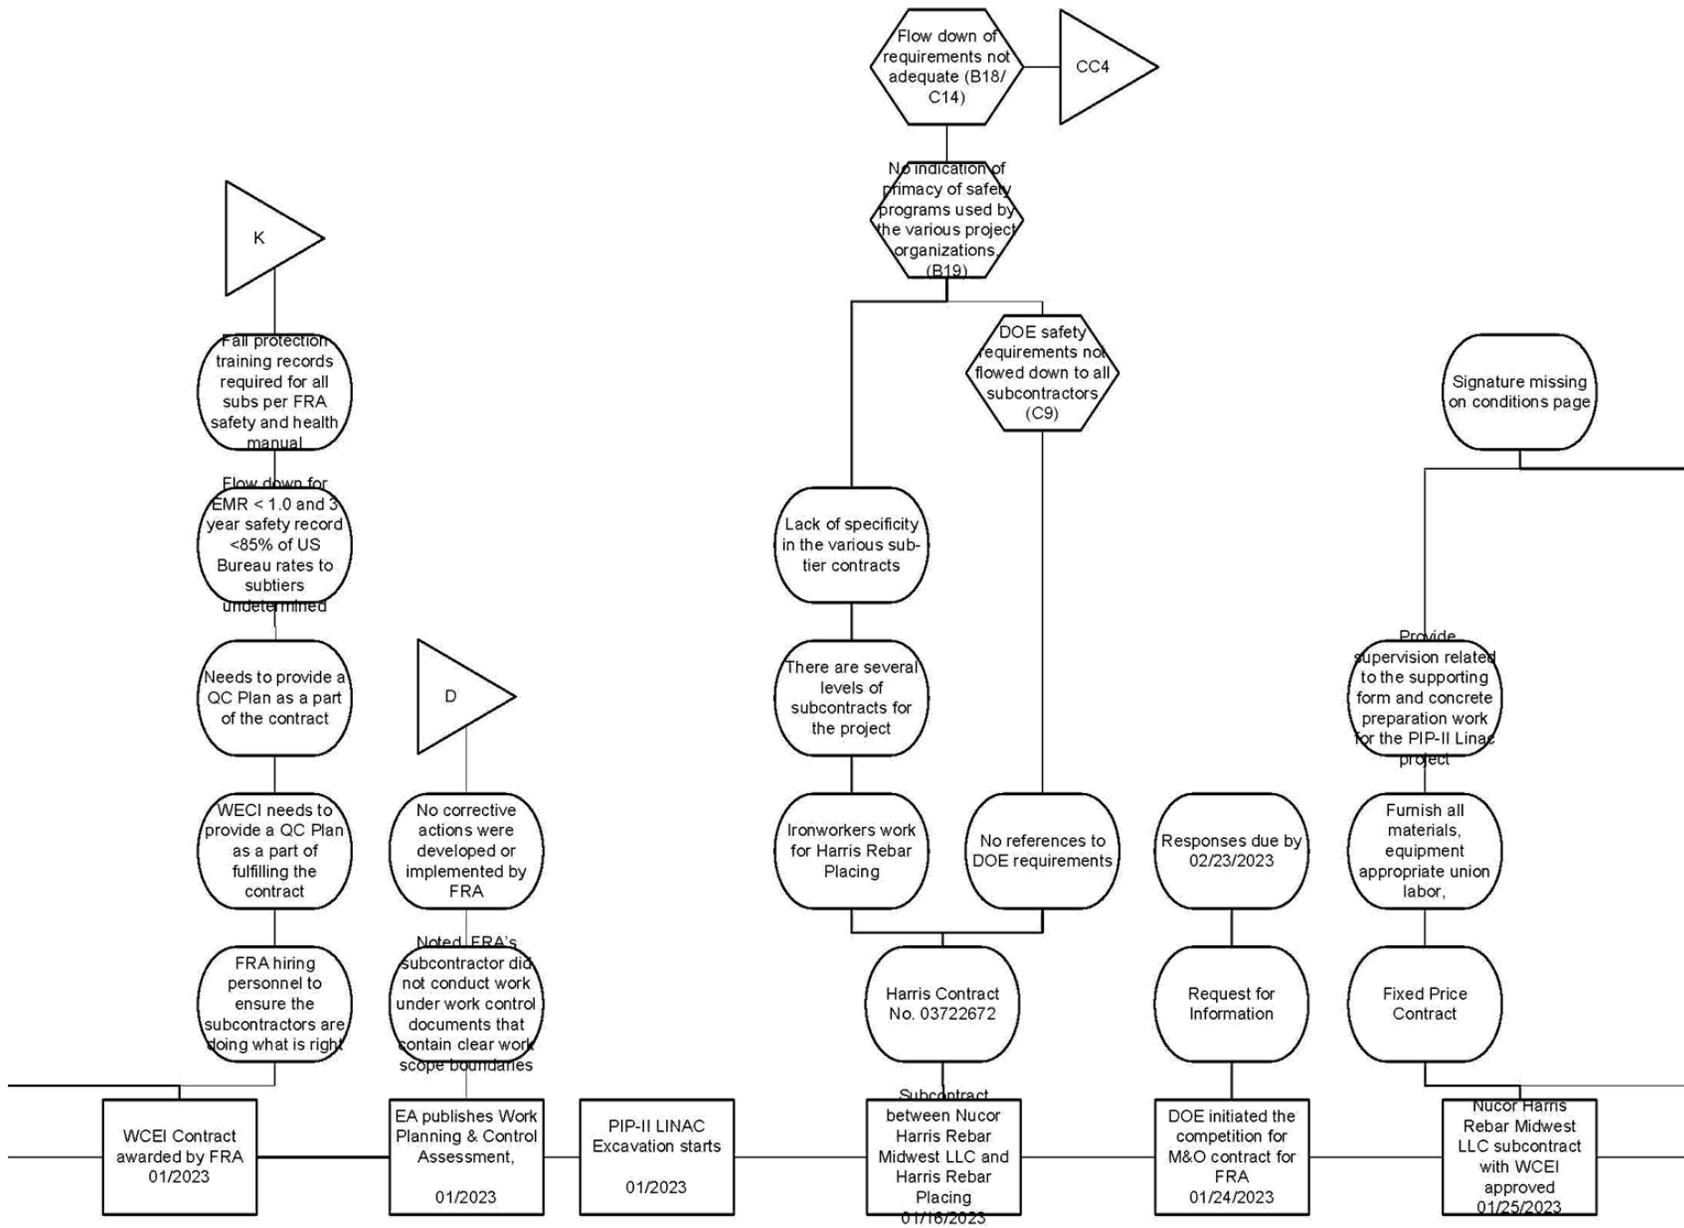
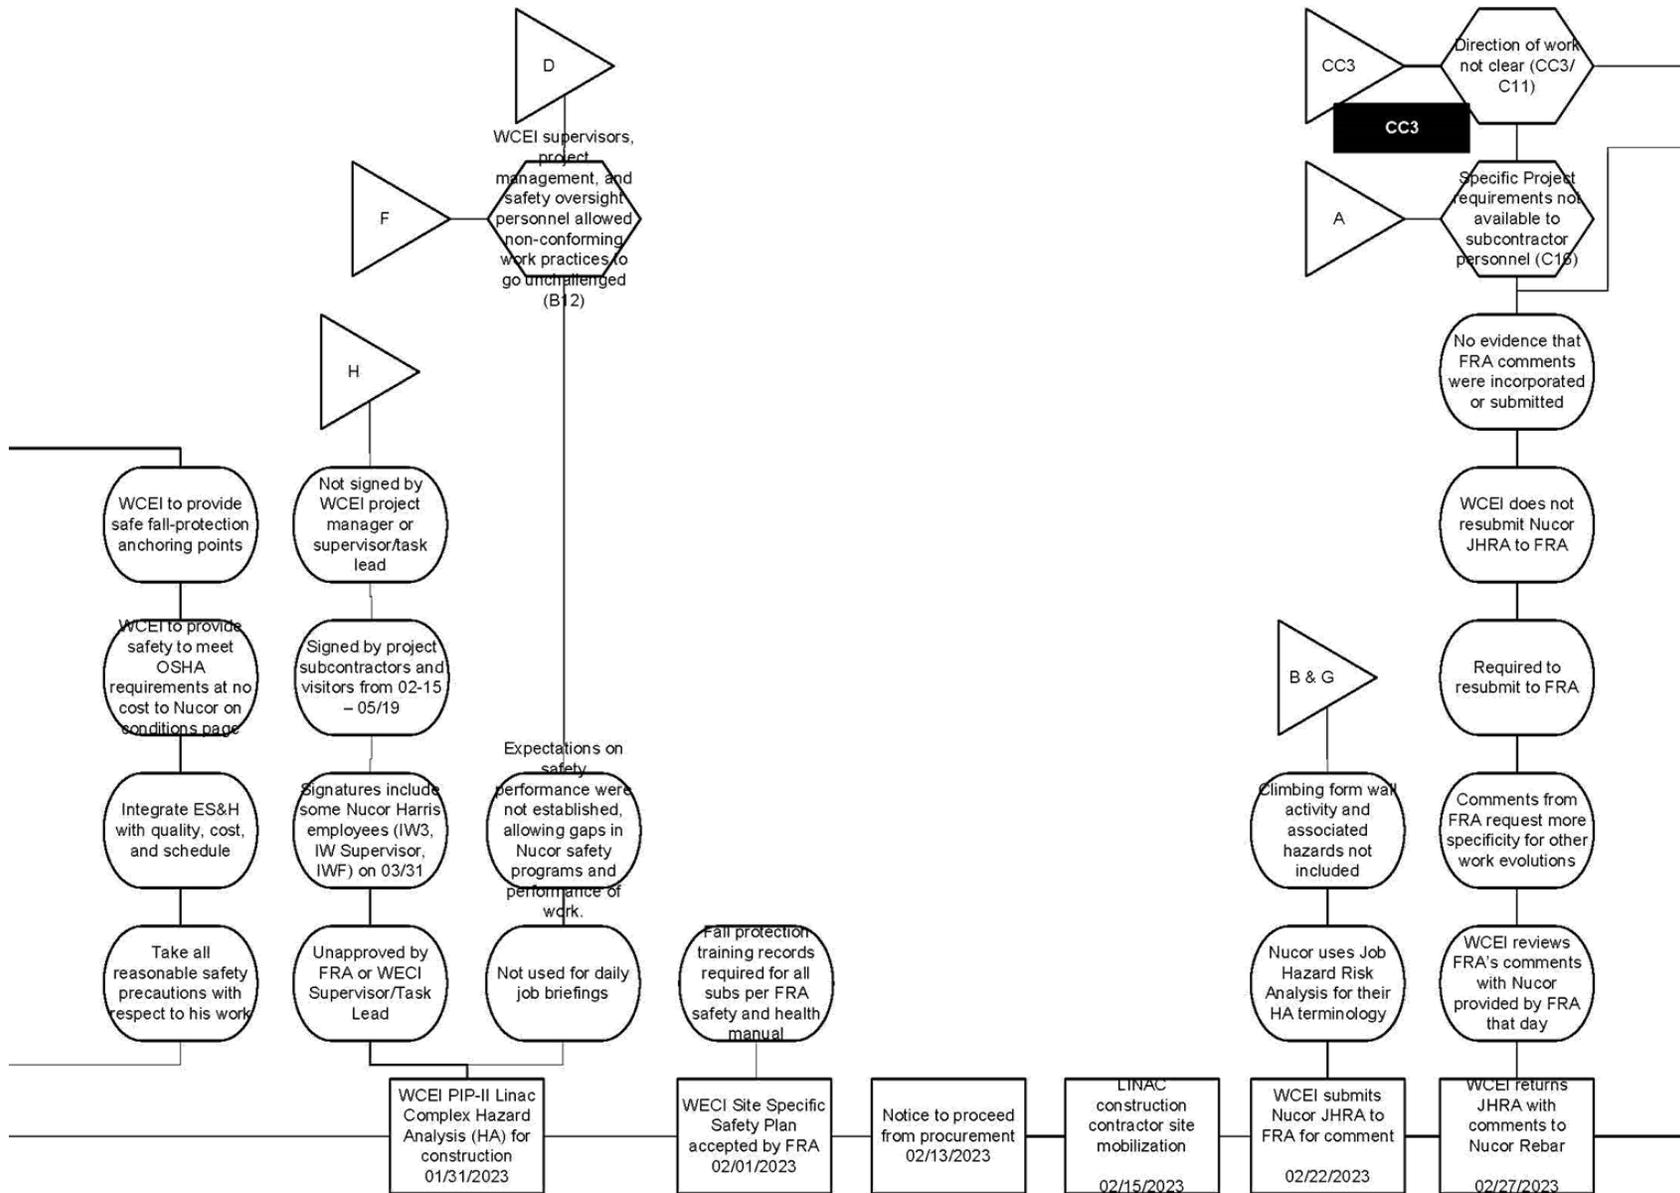
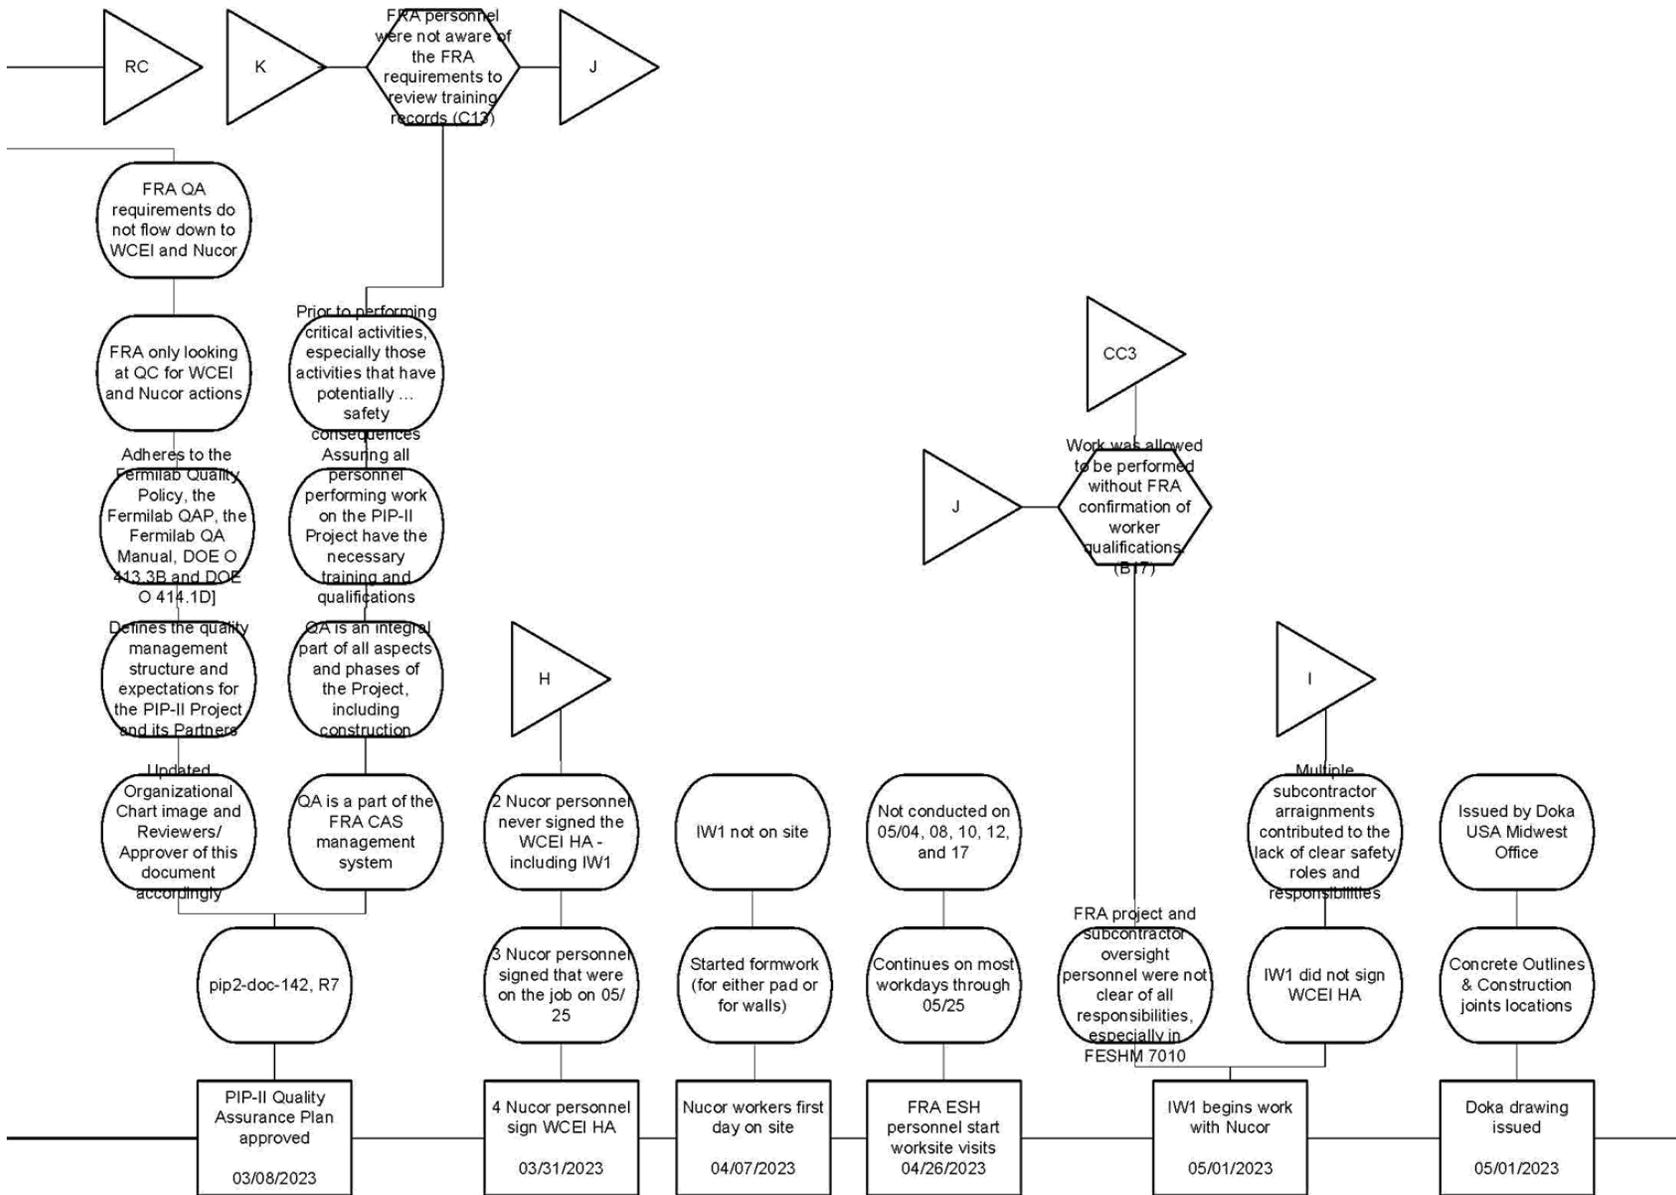
Events and Causal Factors Chart

identified in the analyses are placed in the appropriate portions of the E&CF chart and tied to the supporting facts; and the direct, contributing, and root causes are identified on the chart. As a result, the reviewer can identify in a graphical way the chain from facts to causal factors, up to and including the root causes.
