U.S. DEPARTMENT OF
ENERGY

Legacy
Management

2022 Annual Site Inspection and Monitoring Report for Uranium Mill Tailings Radiation Control Act Title I Disposal Sites

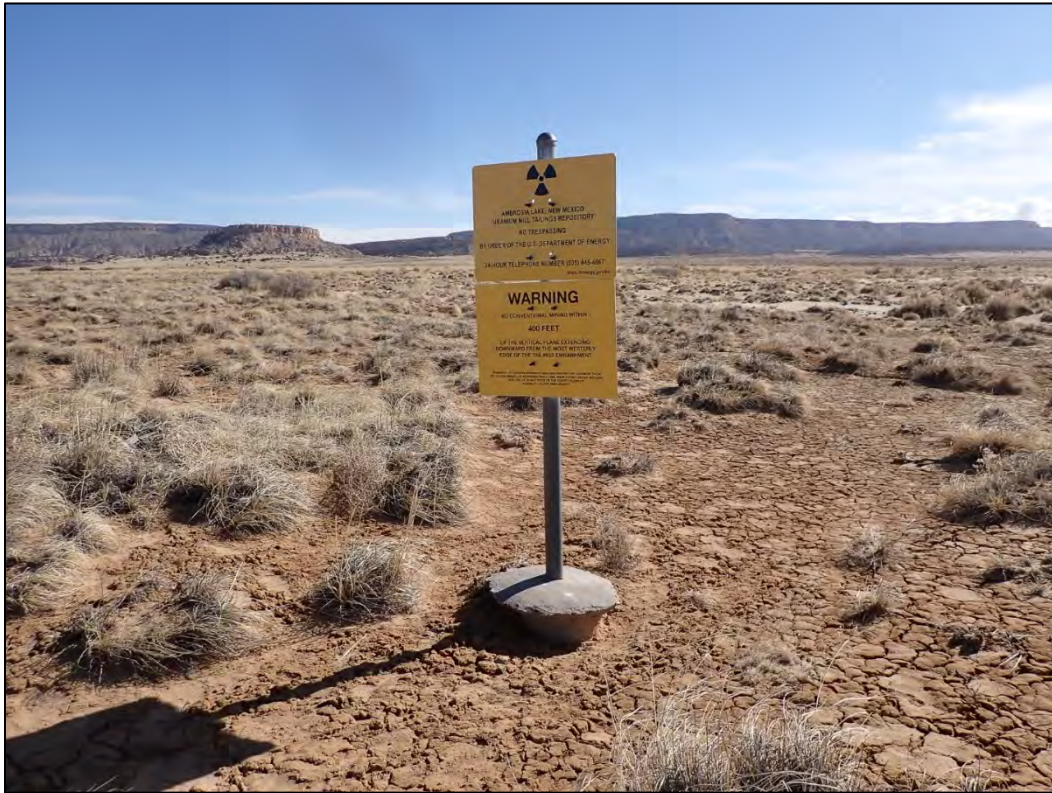
PL-3. Wind Erosion at Base of Perimeter Sign P12

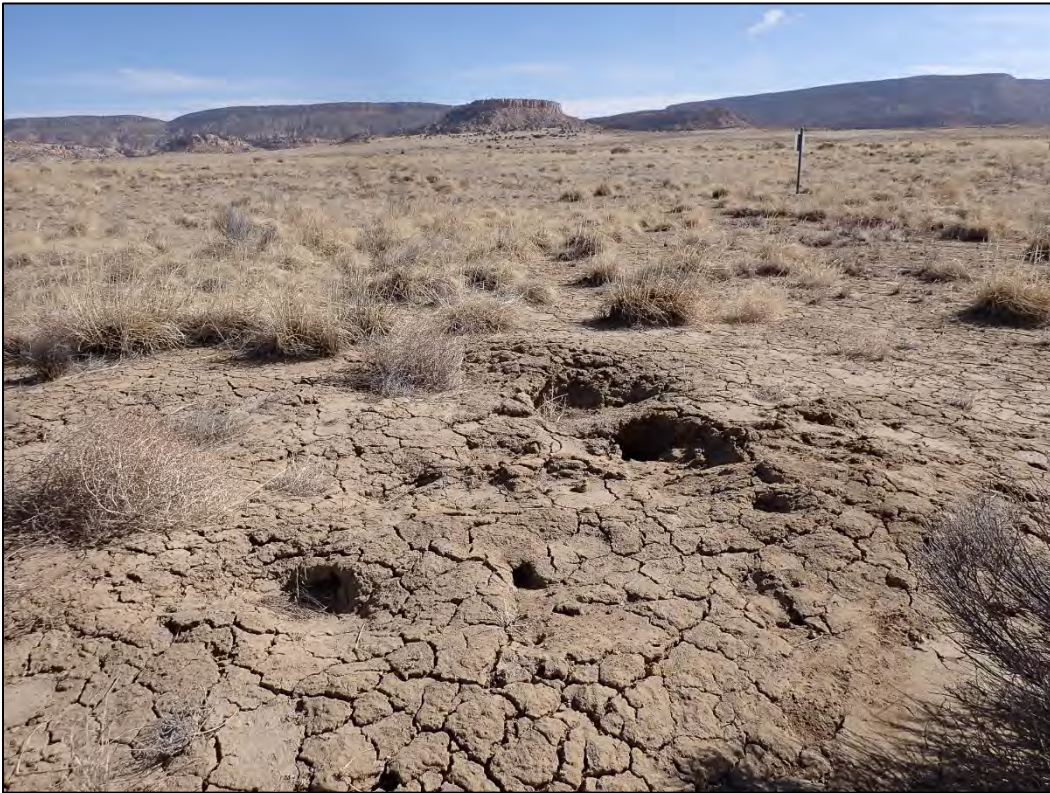
PL-7. Prairie Dog Colony near Boundary Monument BM-4 and Perimeter Sign P15

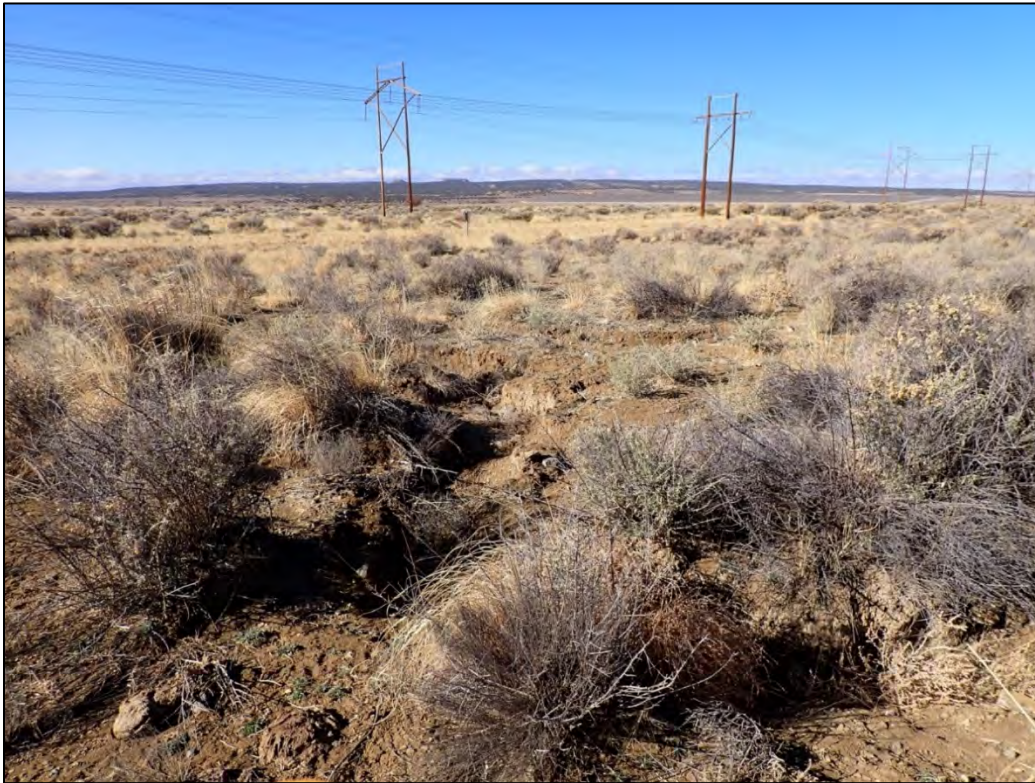
PL-11. Rills near Aerial Survey Quality Control Monument QC-5

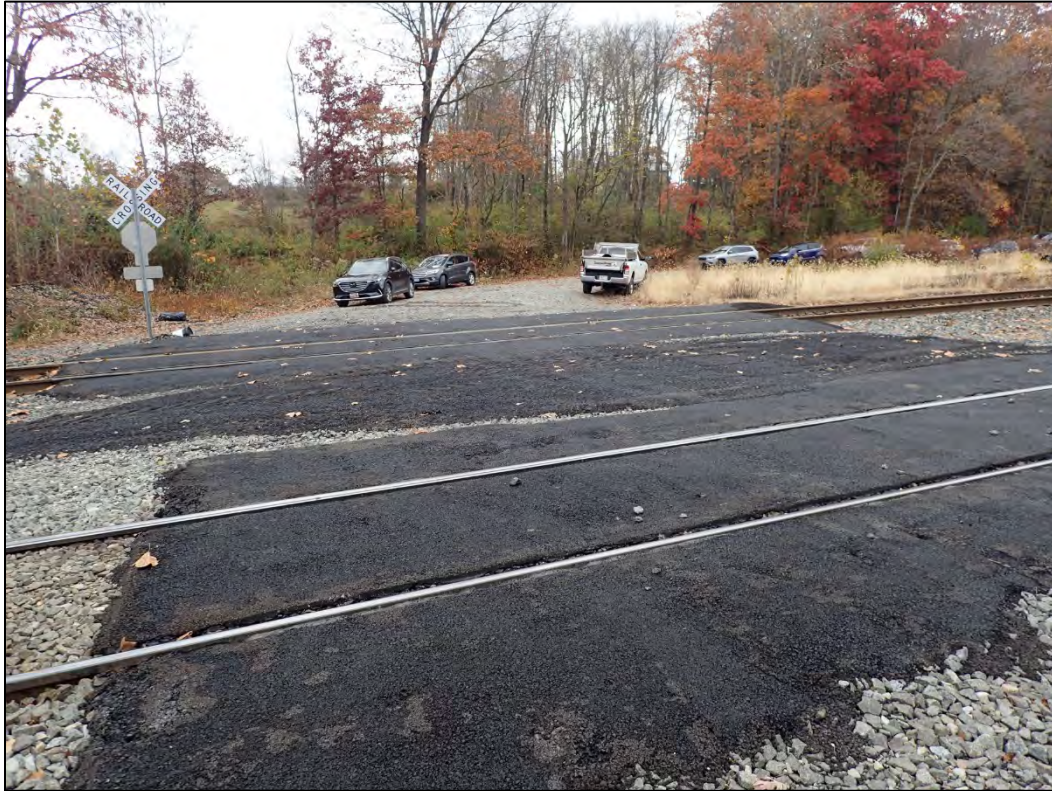
Access to the site is from a road leading from Strangford Road, along a DOE right-of-way through a parcel of private property (Tract 201-E), and across DOE's leased crossing over Norfolk Southern Railroad tracks. Entrance to the site is through a locked gate on the east end of the security fence. Local residents have historically used the area along the DOE right-of-way for unpermitted dumping, hunting, target shooting, and all-terrain vehicle use. Personnel associated with commercial interests use the road for access to the railroad tracks and several nearby natural gas wells. Because the DOE right-of-way cannot be controlled, NRC concurred that the entrance gate in the site security fence is the IC for site access rather than the gate across the access road. The entrance gate was locked and functional. Locks on all access gates were replaced during the inspection. Entrance signage on the main vehicle entrance gate was current. The railroad crossing was improved in 2022 with the installation of an asphalt crossing (PL-1). No maintenance needs were identified.

PL-1. New Blacktop Crossing to Site Entrance

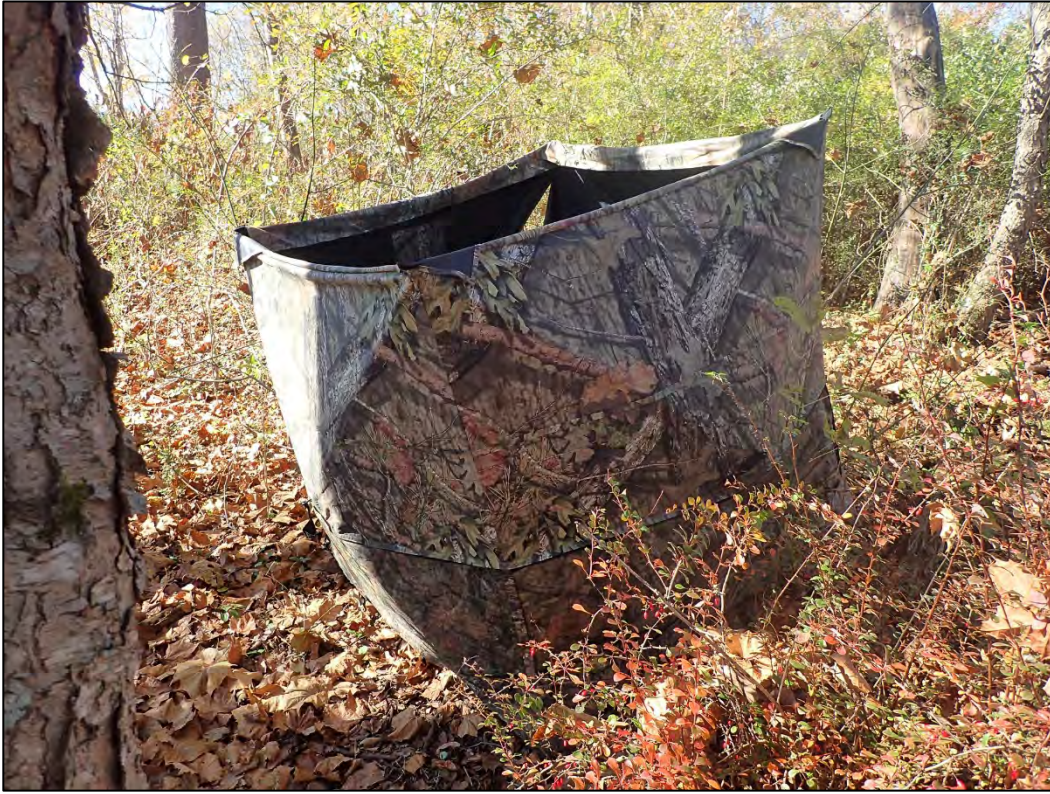
PL-9. Unauthorized Hunting Blind to Be Removed

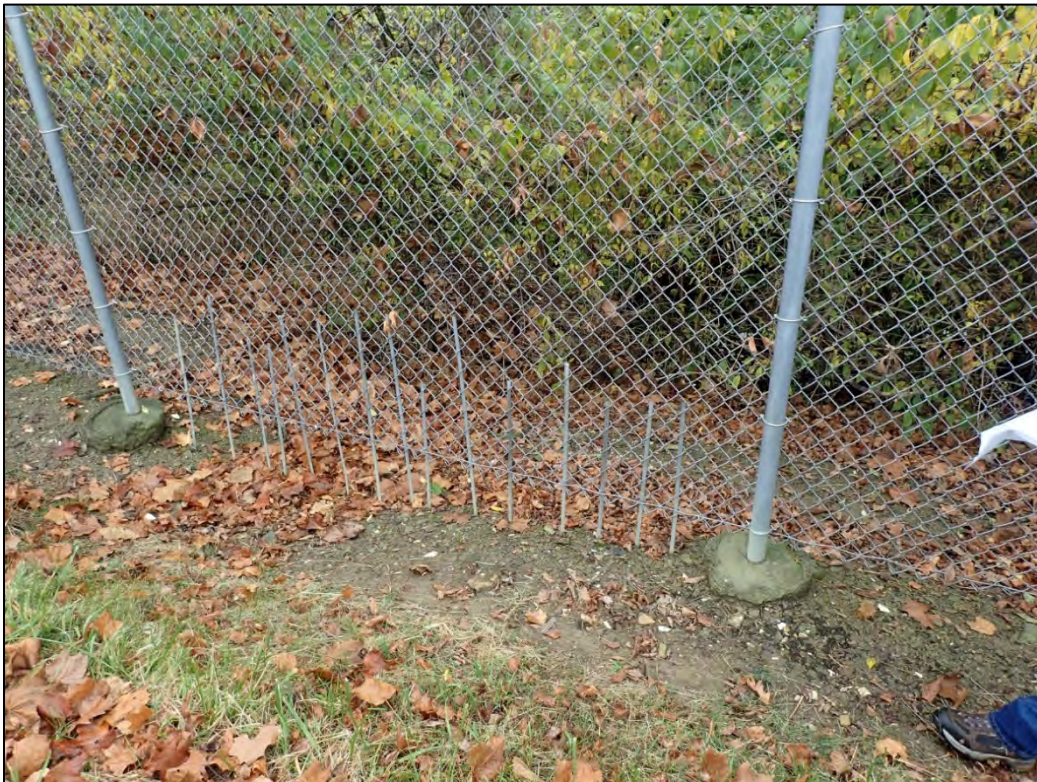
PL-2. Slats in Fence at Erosion Area

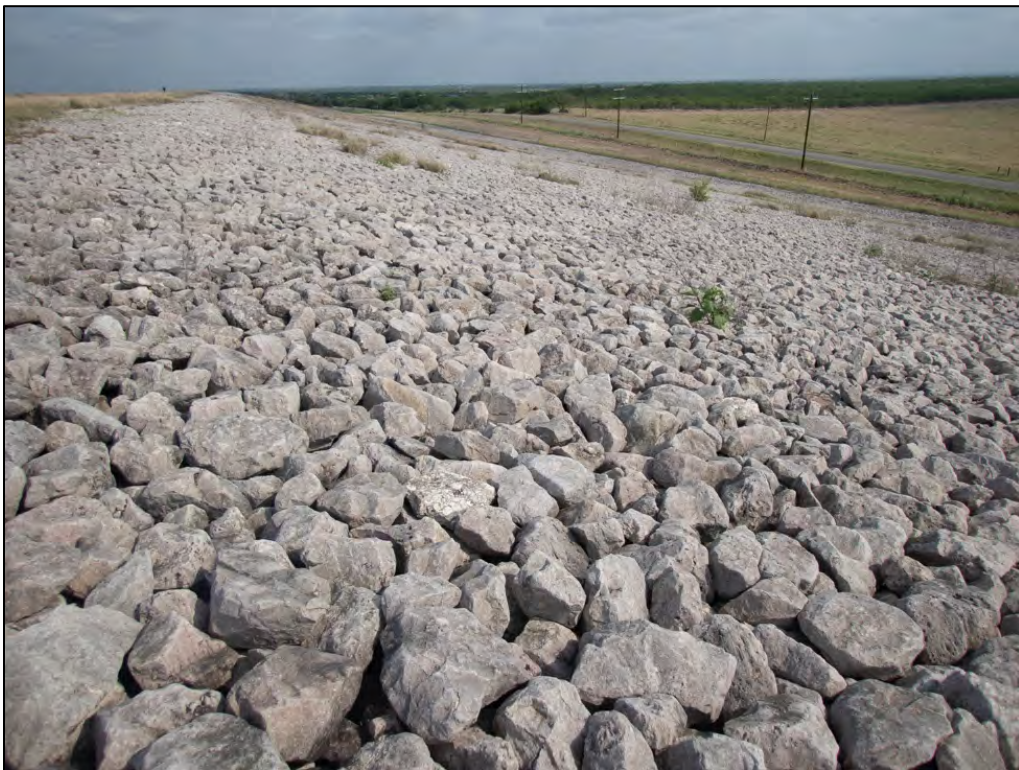
PL-8. Northeast Side Slope

Riprap armors the disposal cell side slopes and a transition zone where the top slope meets the side slopes (PL-8). LM has monitored several small depressions on the northwest side slope of the disposal cell since 2010. These depressions do not compromise the protectiveness of the riprap side slope, and no changes have been observed since 2010. Inspectors will continue to monitor these areas.

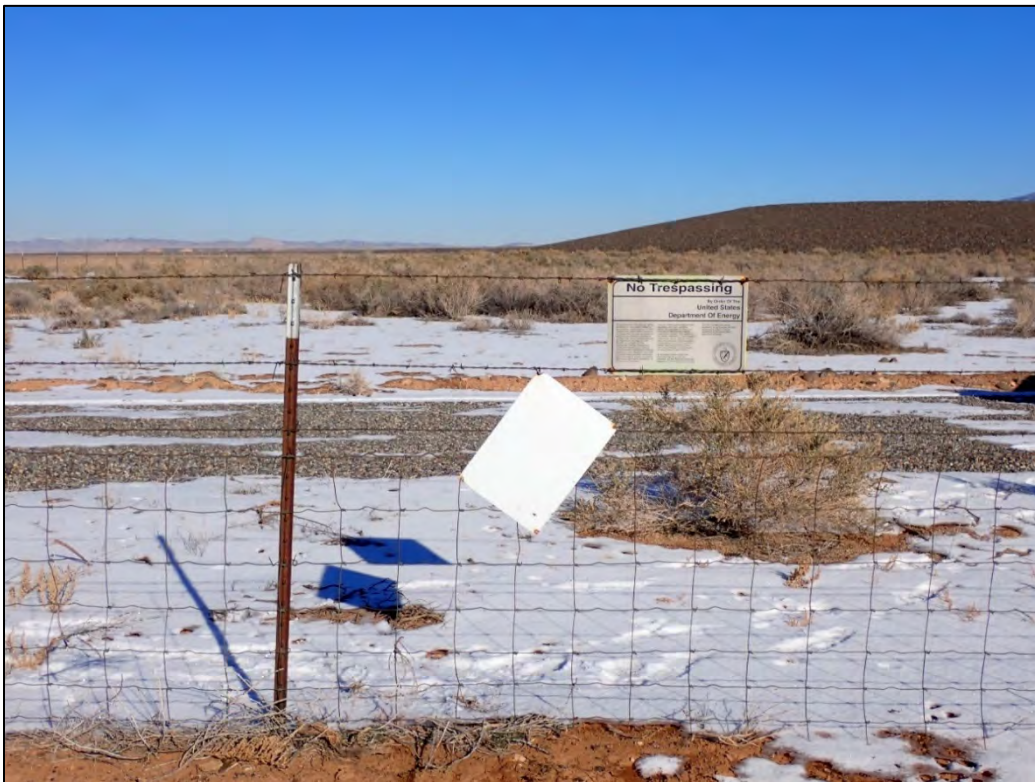
PL-4. Partially Detached Perimeter Fence Sign

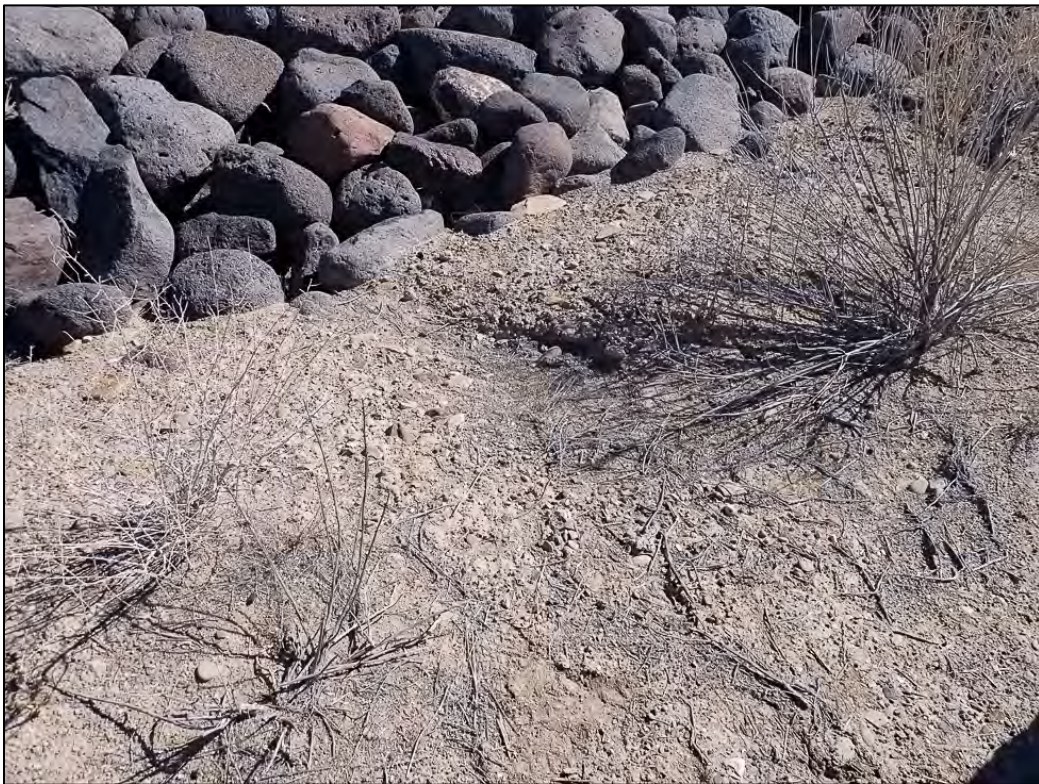
PL-10. Soil Erosion Along Southwest Side Apron (Onsite)

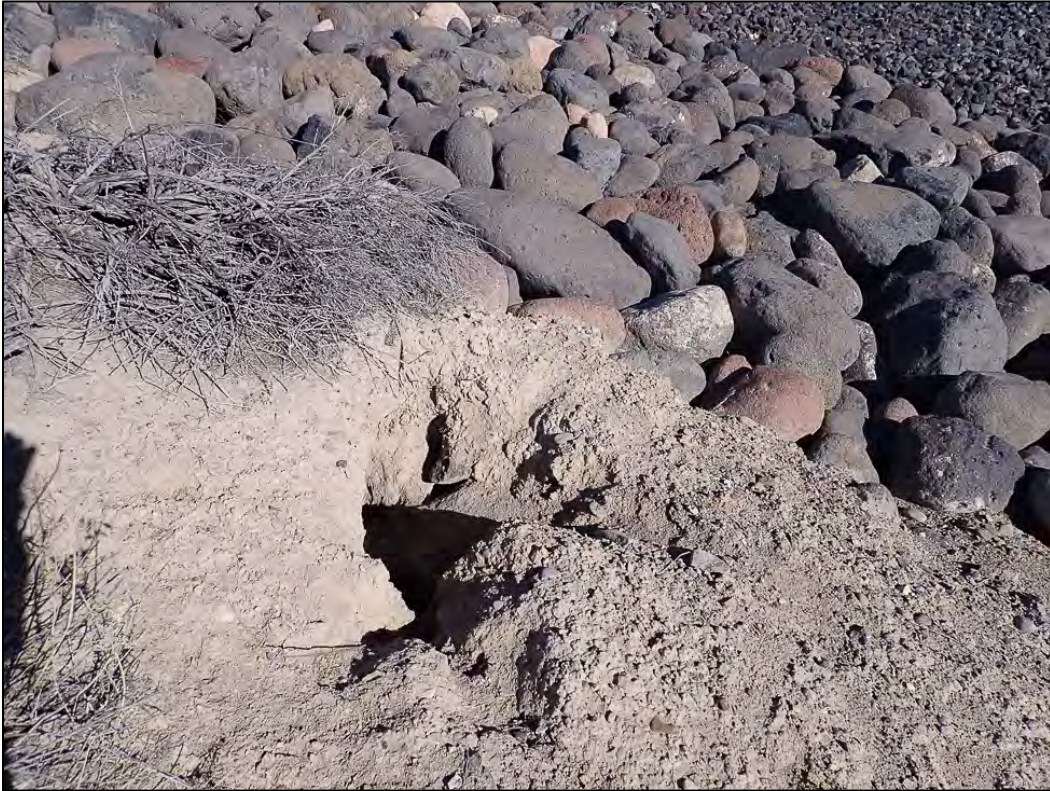
PL-11. Possible Soil Piping near South Corner of Disposal Cell

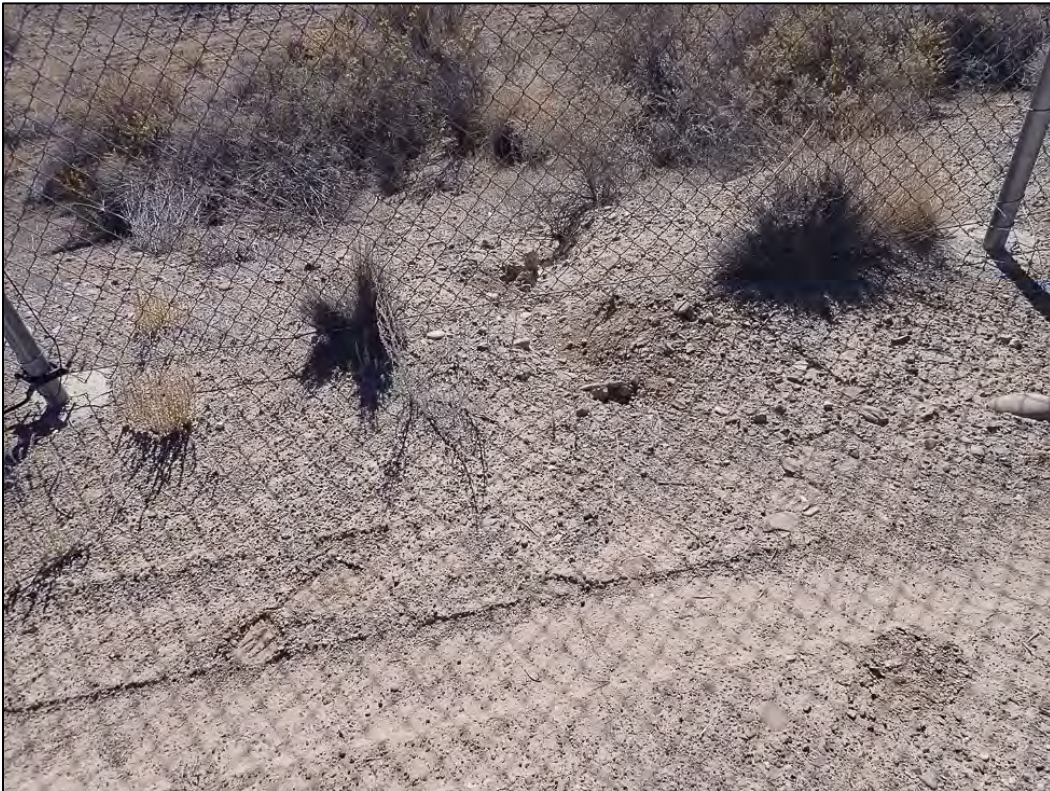
PL-12. Soil Erosion Along Southeast Side Chainlink Security Fence

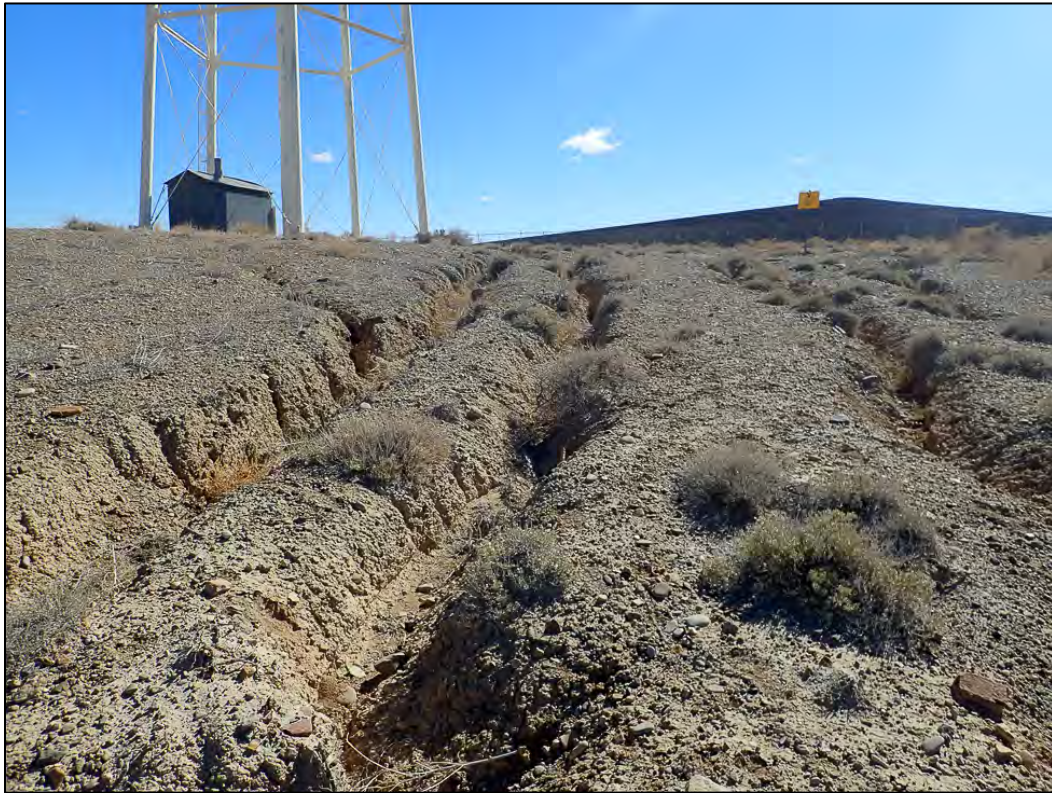
PL-13. Soil Erosion near Perimeter Sign P7

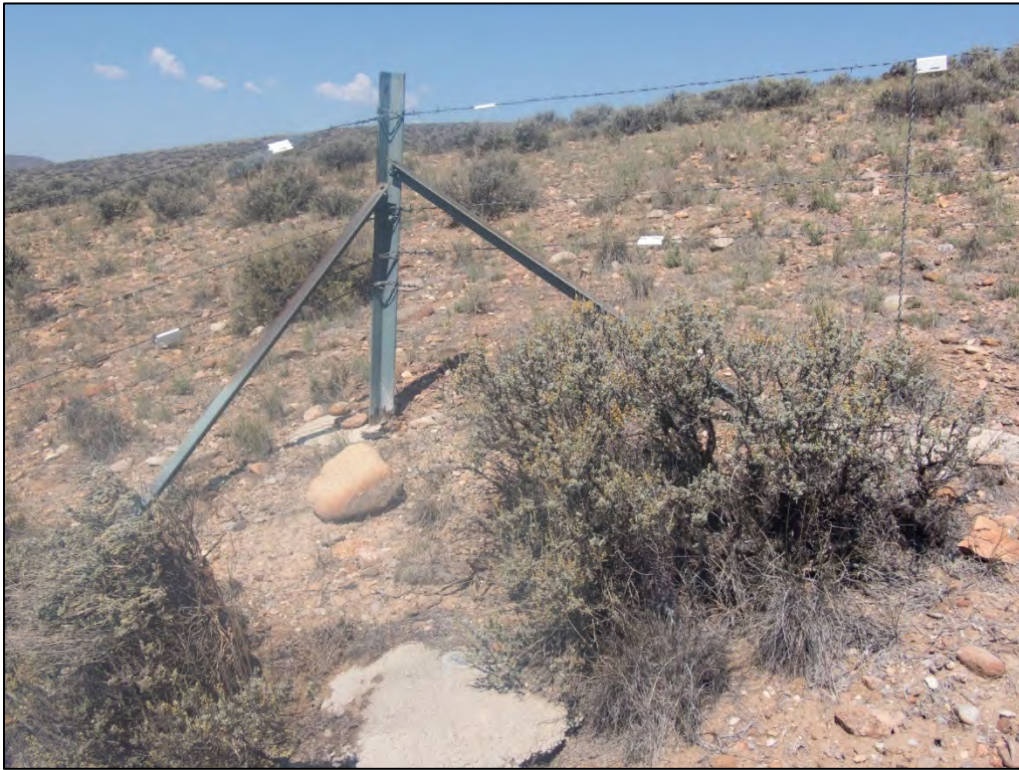
Three combined survey and boundary monuments and eight additional boundary monuments delineate the property boundary (PL-3). Inspectors noted that boundary monument BM-4 is slightly undercut but remains stable. No maintenance needs were identified.

PL-3. Boundary Monument BM-4 with Corner Posts in Background

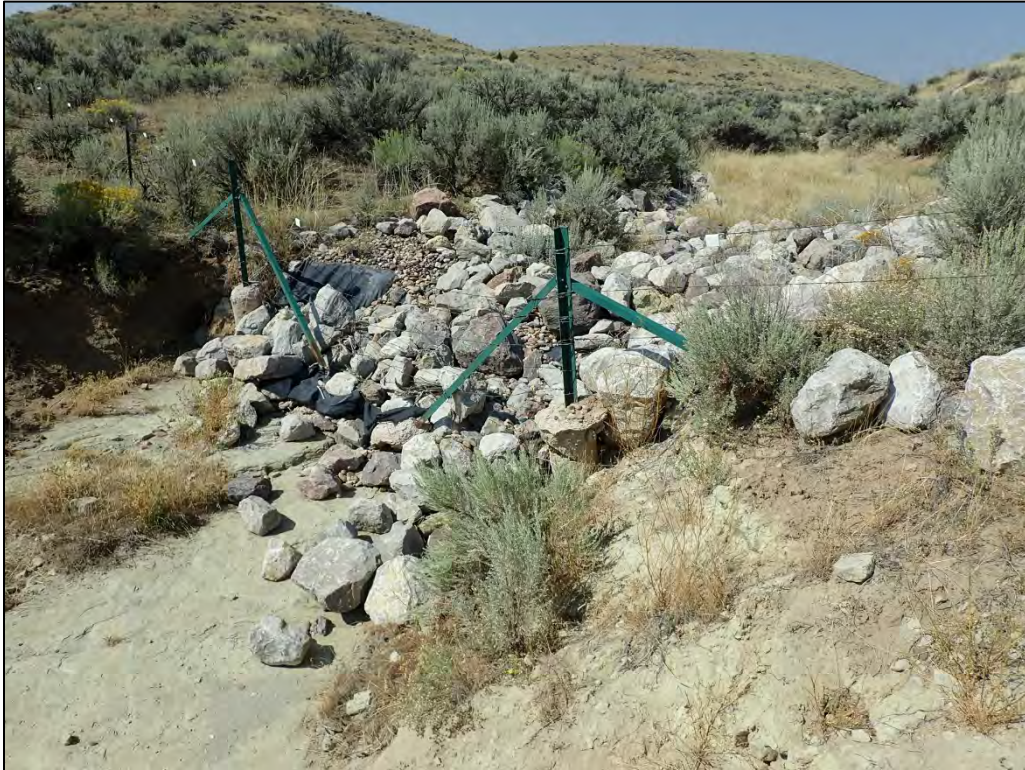
Surface conditions at the site are a combination of rock-armored drainage and diversion channels, along with contouring of soil surfaces to achieve the necessary surface water drainage control to protect the disposal cell from erosion. The rock-armored diversion channels (PL-10), swales, and gullies are performing as designed. Noxious weeds were observed growing in the diversion and drainage channels and were treated after the inspection.

PL-11. Exposed Geofabric in Diversion Channel No. 1

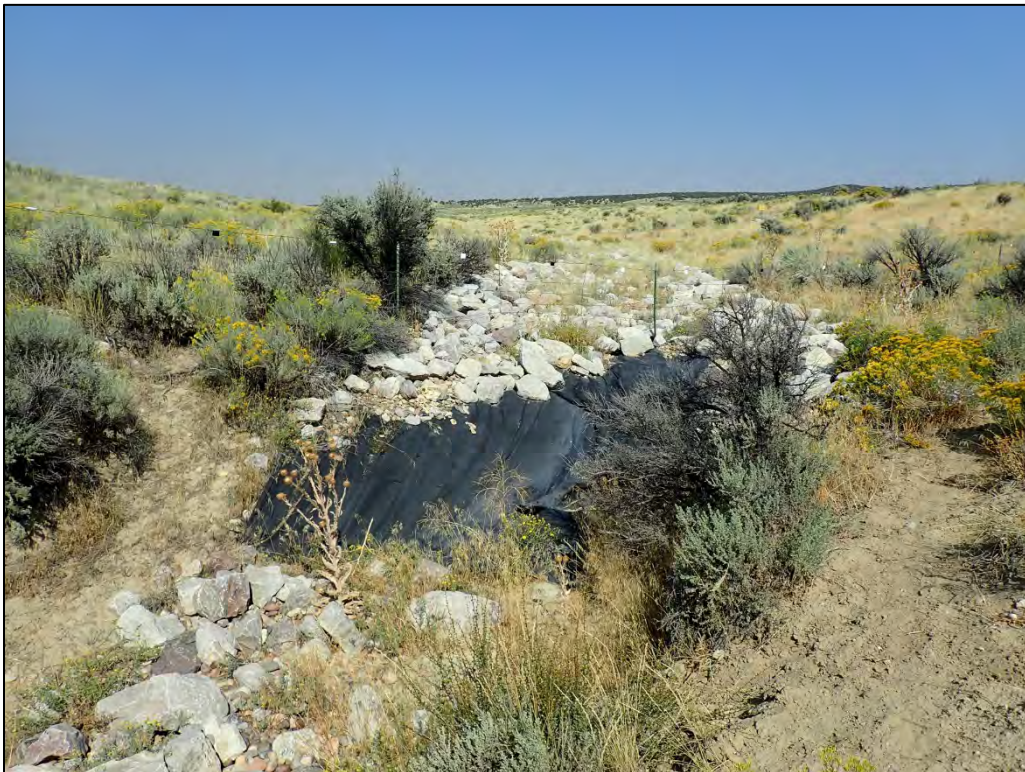
PL-12. Exposed Geofabric in Swale No. 1

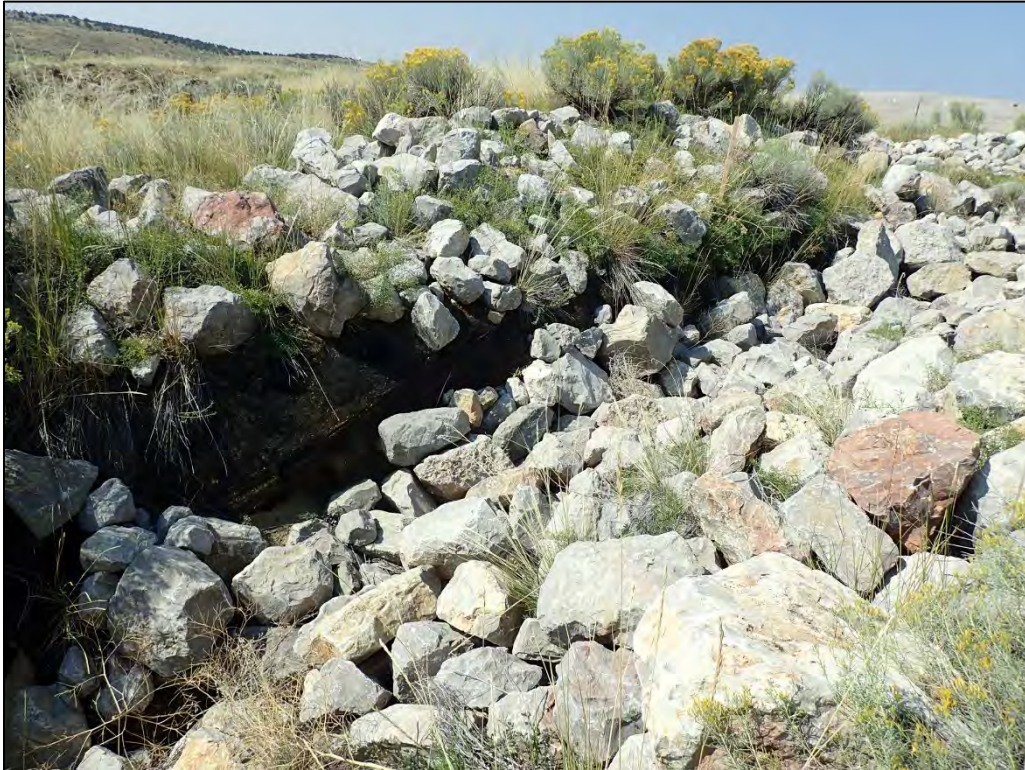
PL-13. Exposed Geofabric in Swale No. 2

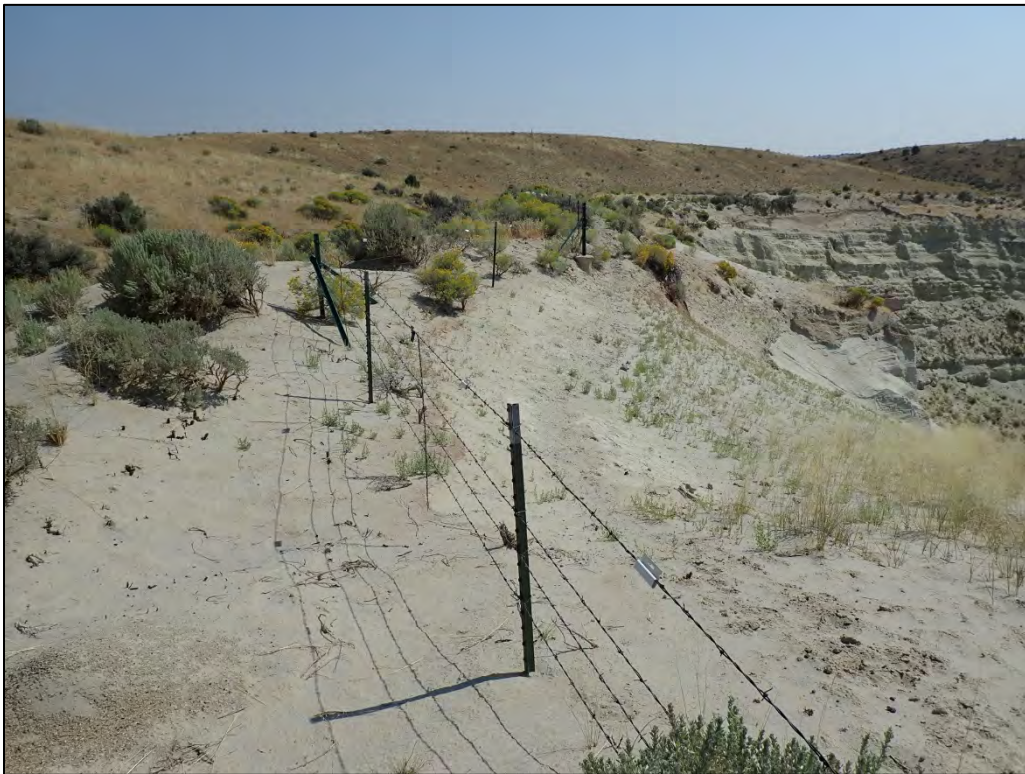
Directly south of the site is a former open-pit uranium mine known as the Johnson Pit. Over time, slumping of the pit wall caused the pit to encroach several feet onto property now owned by DOE (PL-14). This encroachment presents no threat to the integrity of the disposal cell at this time. This encroachment is visually monitored annually; it is periodically documented with photographs to assess whether the pit wall has slumped further and to verify the integrity and functionality of the perimeter fence. At the time of the inspection, there was no evidence of any additional encroachment of the pit onto the site. However, windblown sand continues to accumulate along the northern crest of the pit wall along the perimeter fence line (PL-15). The perimeter fence remains functional, but continued accumulation of sand will require vertically extending the fence or removing the sand. Inspectors will continue to monitor this area. No immediate maintenance needs were identified.

PL-14. Encroachment of Johnson Pit

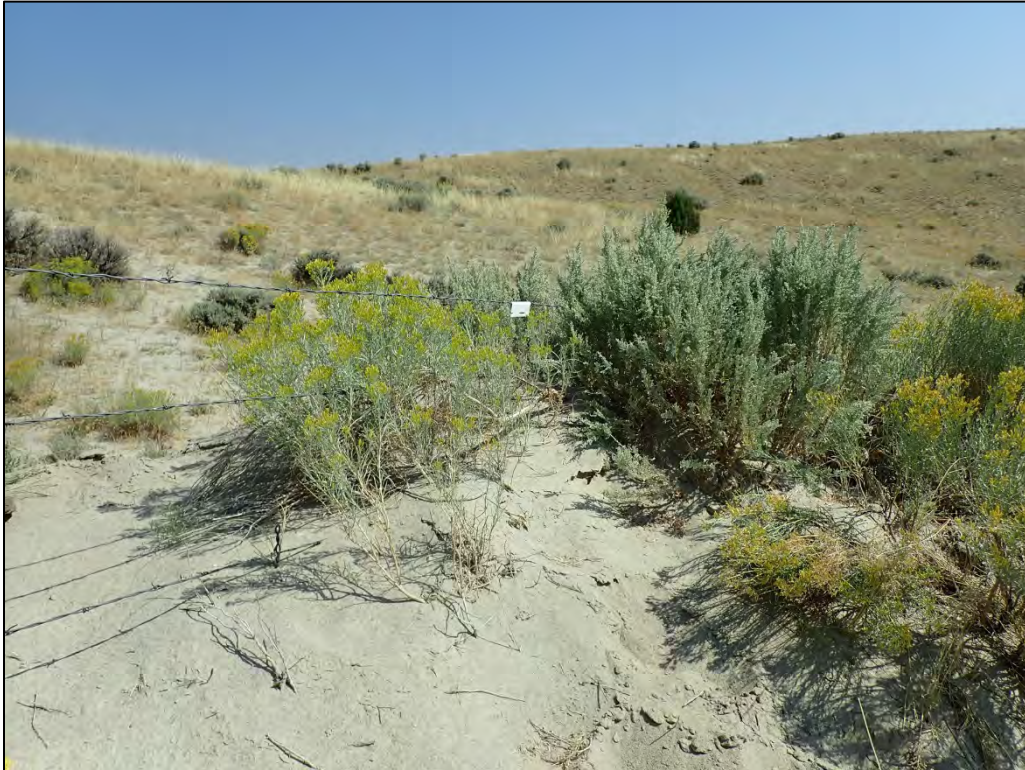
PL-15. Sand Buildup Along Fence near Johnson Pit

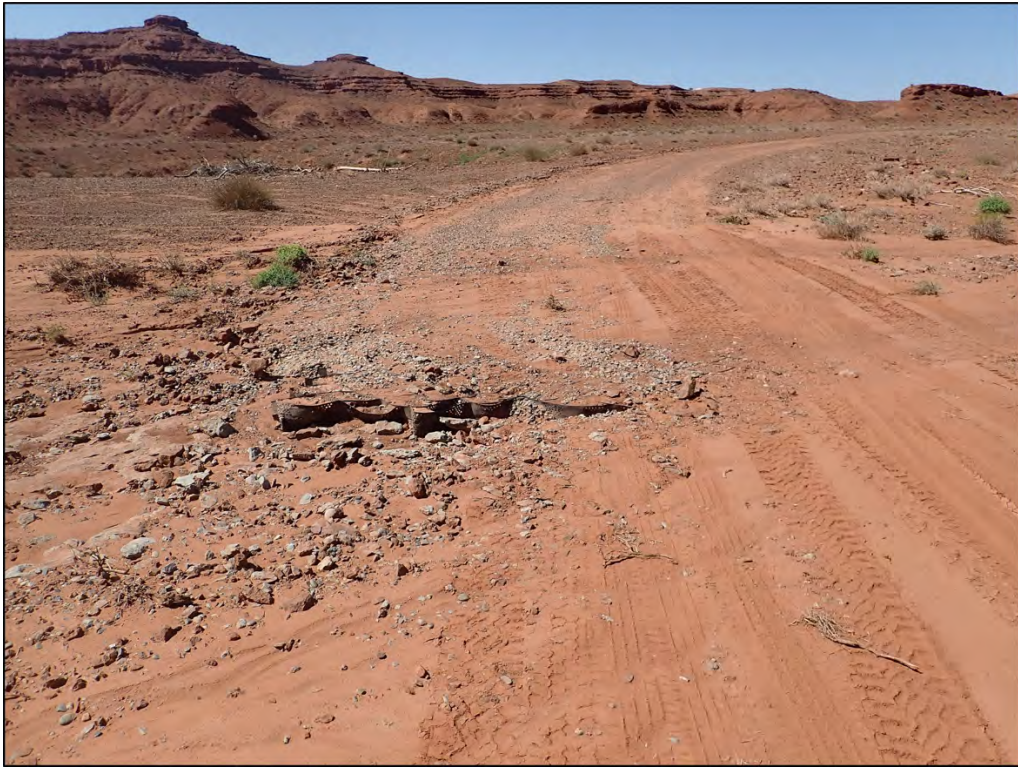
Access to the site is from a short, unmarked dirt road off U.S. Highway 163 that ends at a graded parking area. Minor erosion continues along the dirt access road, but the site remains accessible (PL-1). The steel entrance gate at the northwest corner of the site was locked and functional. The entrance sign is affixed to a steel post immediately behind the entrance gate. No maintenance needs were identified.

PL-1. Access Road with Minor Erosion

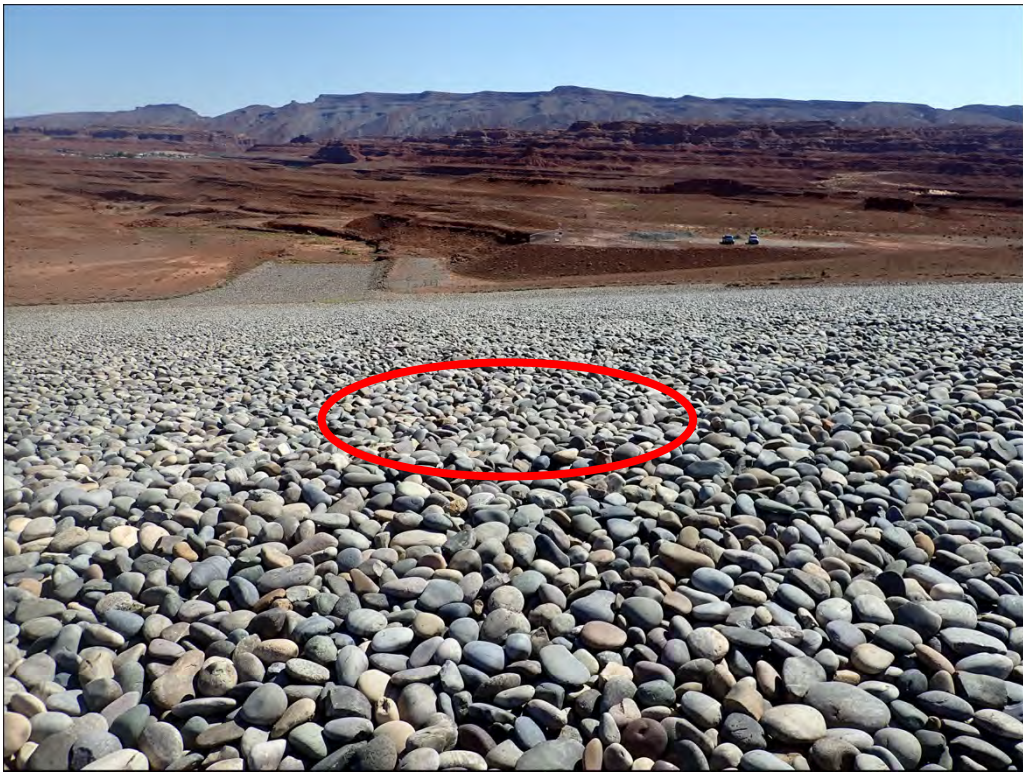
PL-6. Depression Feature on the Northeast Side Slope

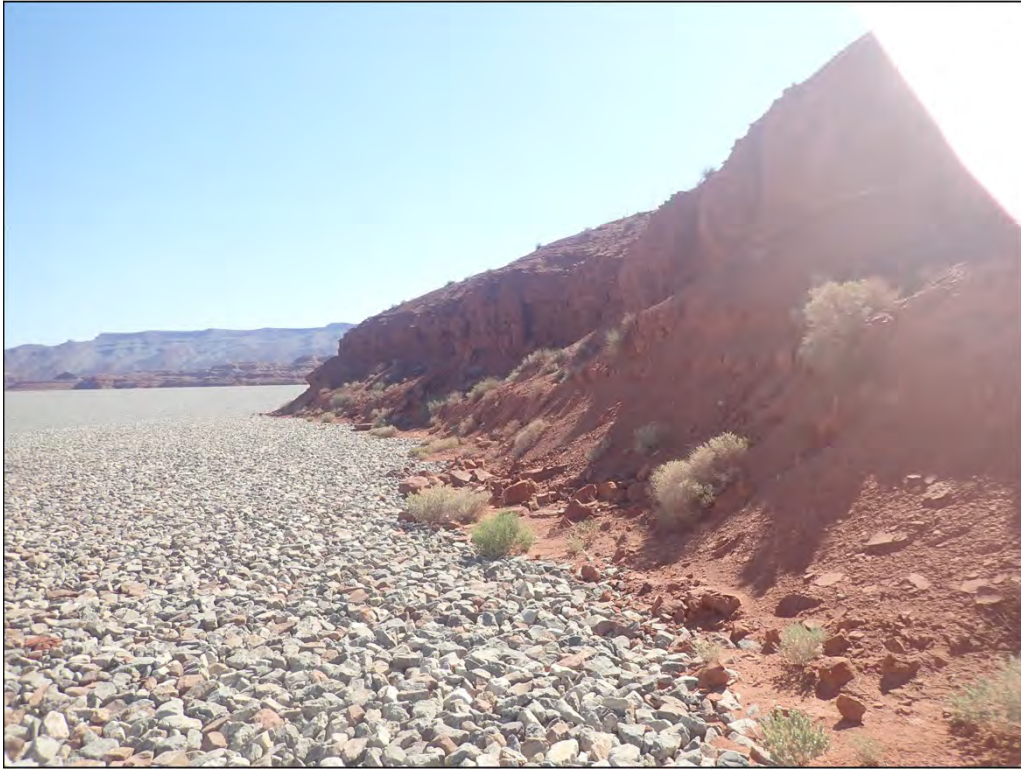
PL-7. Sloughing Rock Along the South Apron

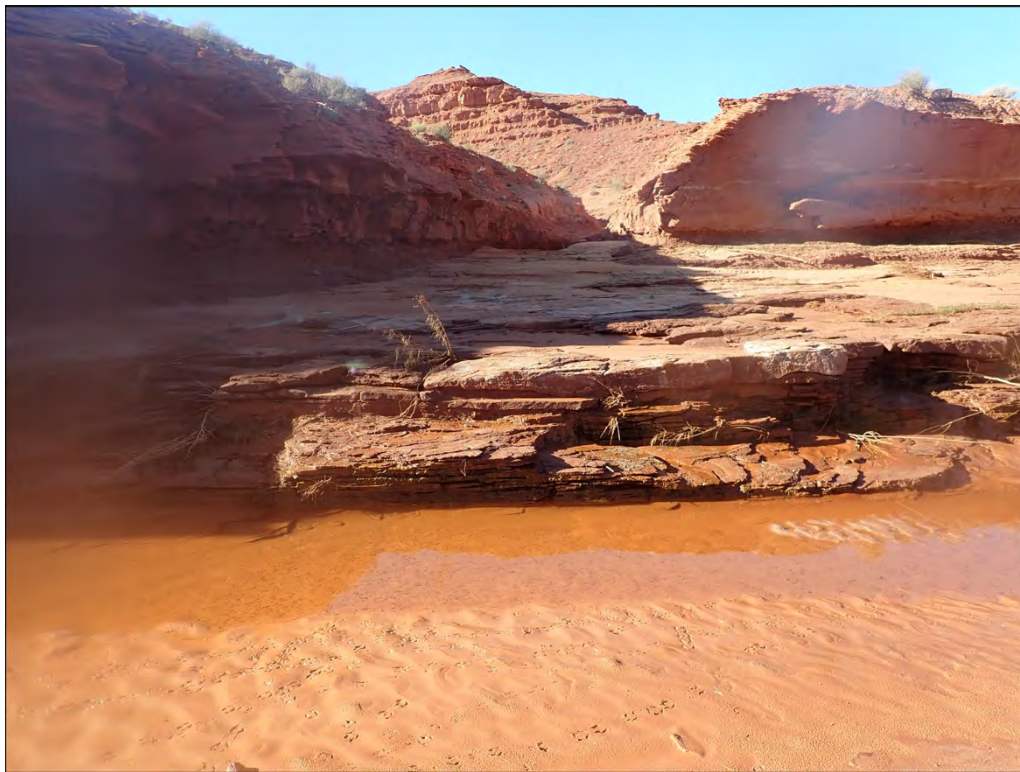
PL-14. Seep 0261 (Dripping)

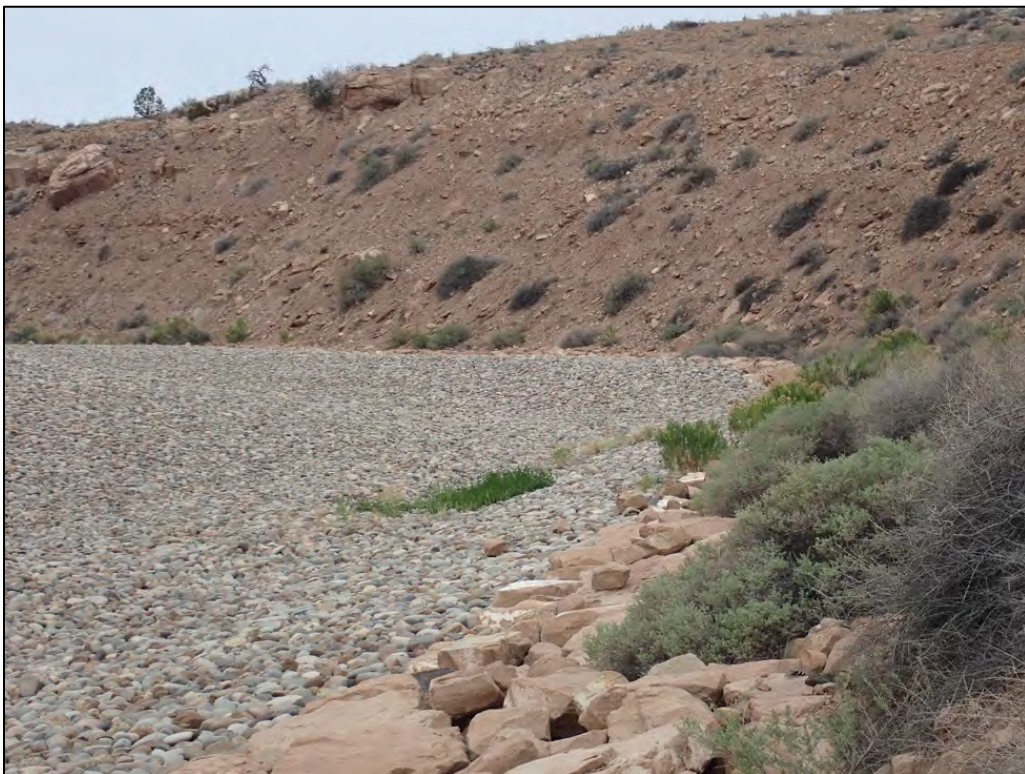
PL-6. Vegetation Growing in Accumulated Sediment Downslope from Culvert Break

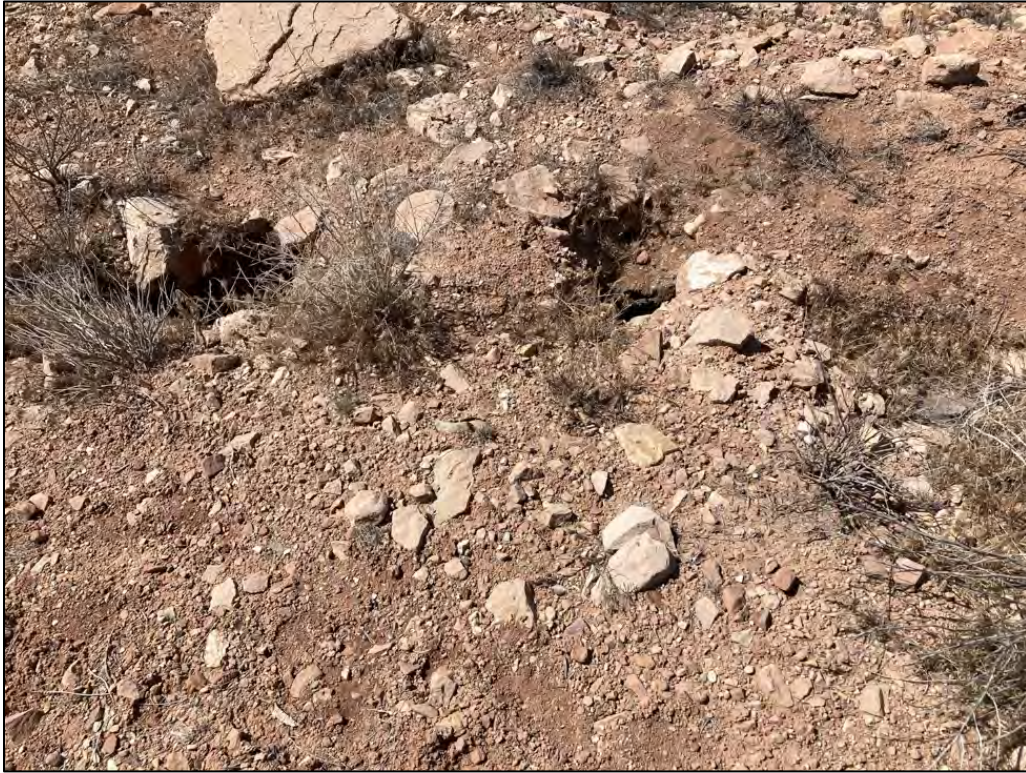
PL-7. Erosional Channeling on Slope North of Disposal Cell

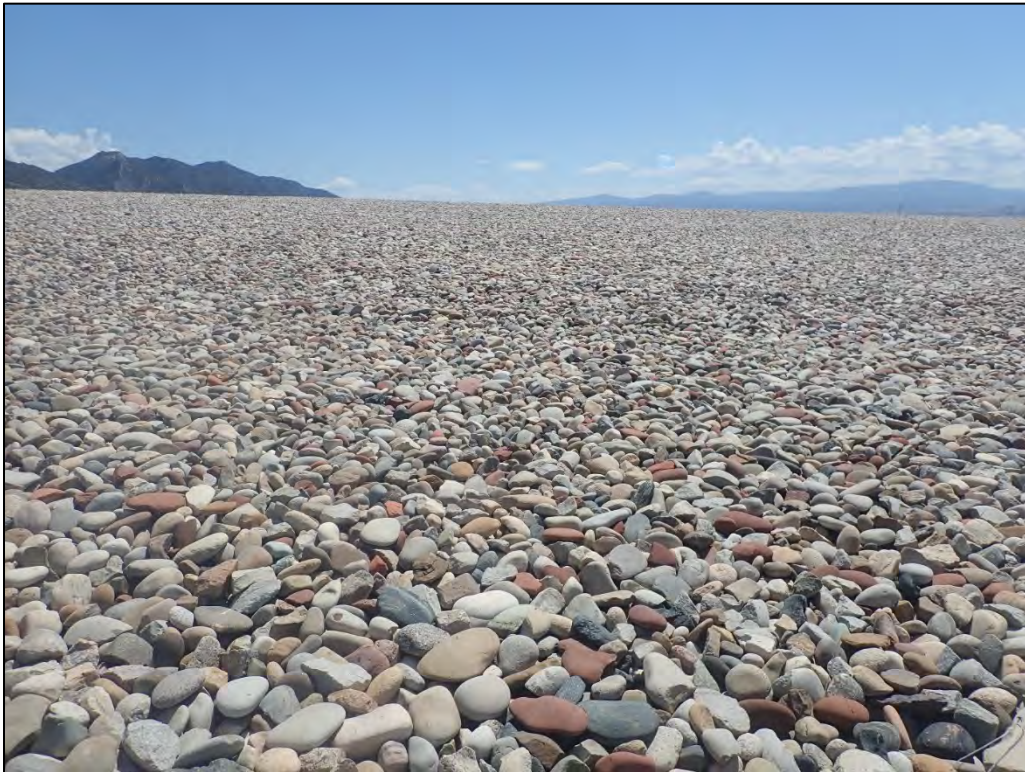
PL-8. Potential Depression on Edge of Disposal Cell

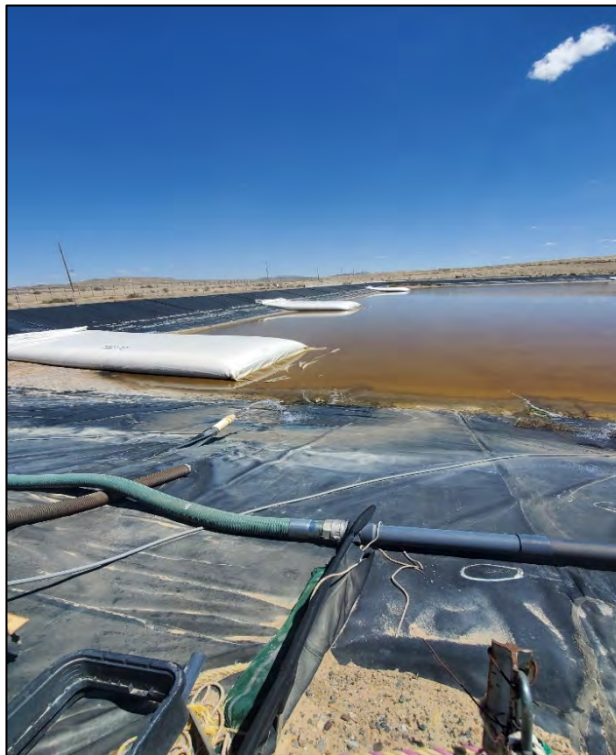
PL-10. Evaporation Pond with hydrologic barriers deployed to mitigate seepage

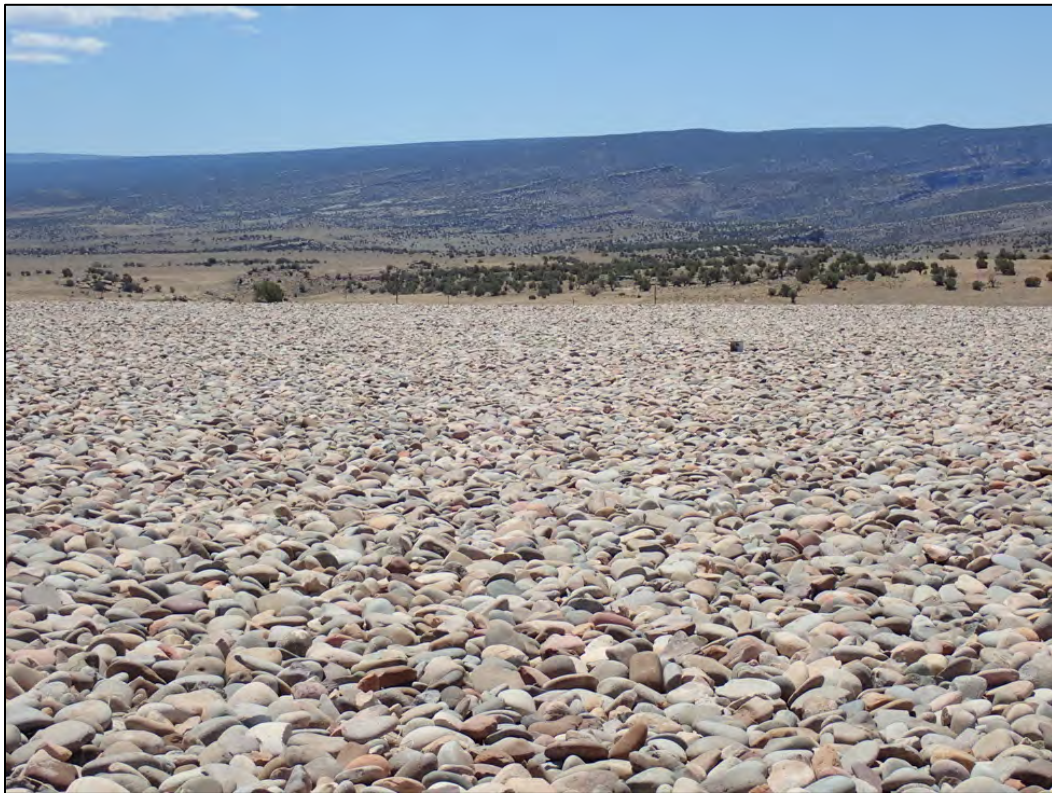
PL-4. Disposal Cell Top Slope
