U.S. DEPARTMENT OF
ENERGY

Legacy
Management

2022 Annual Site Inspection and Monitoring Report for Uranium Mill Tailings Radiation Control Act Title I Disposal Sites

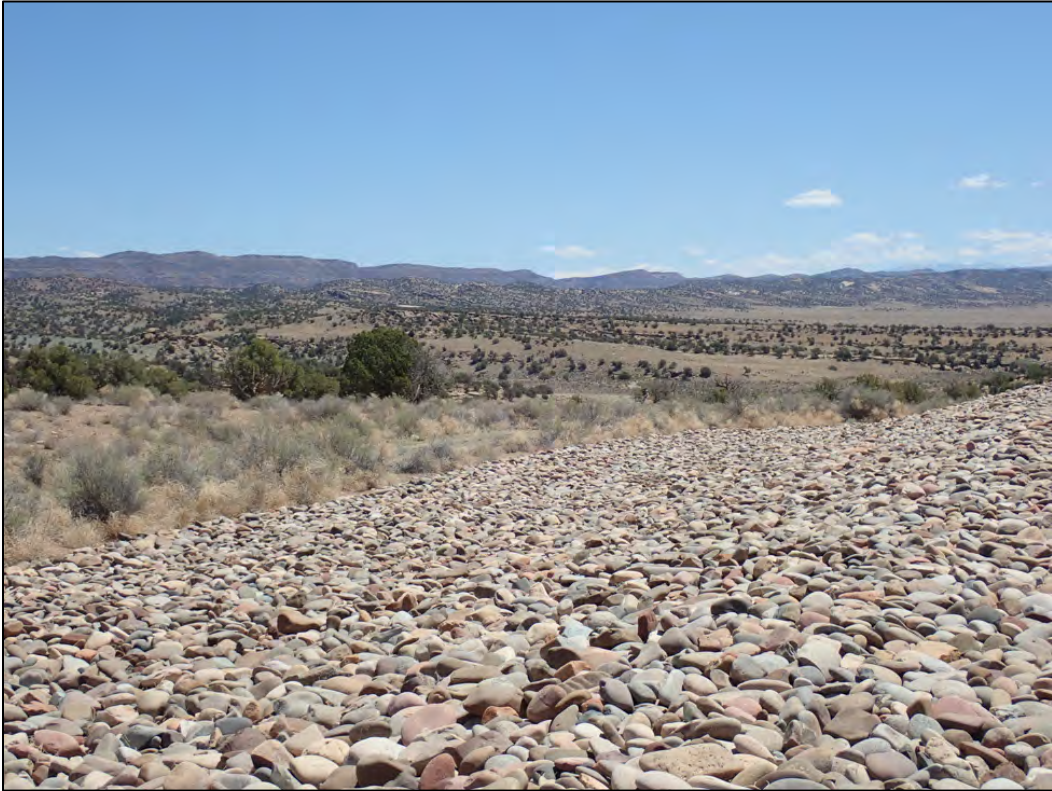
PL-5. Key Trench on East Side Slope

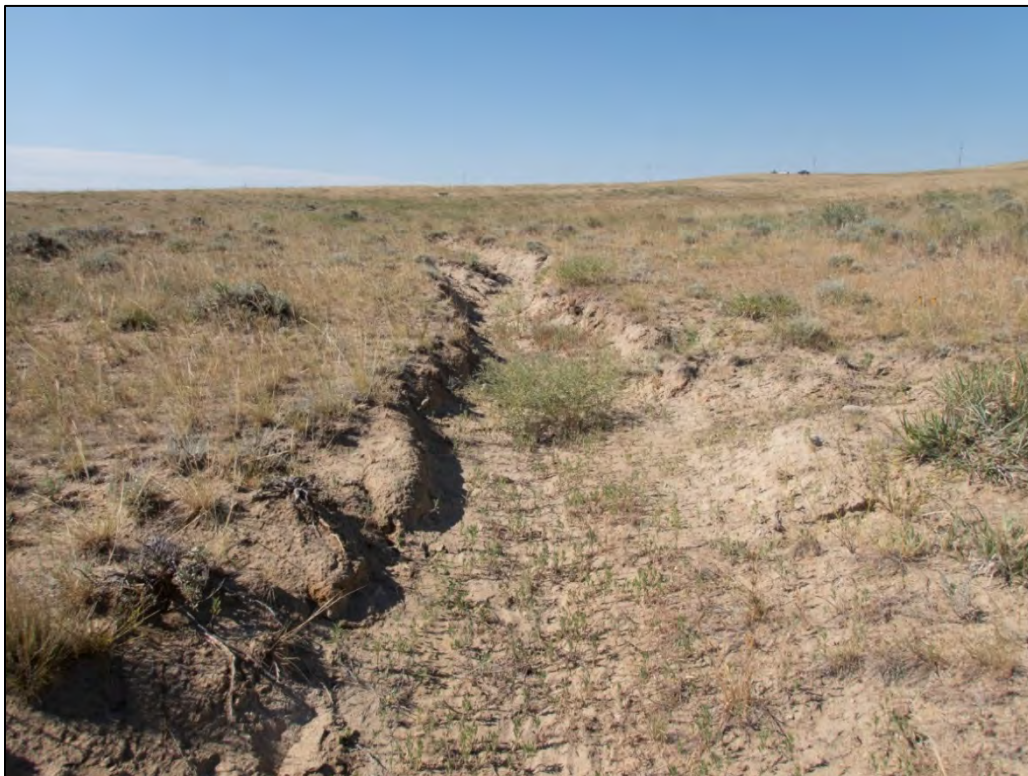
The area beyond the site boundary for a distance of 0.25 mile was visually observed for erosion, changes in land use, or other phenomena that might affect the long-term integrity of the site. No such impacts were observed. Several minor rills and gullies are near the site and appear to be stable. One minor gully was noted north of the disposal site, which was not identified in previous inspections (PL-6). This gully appeared to be stable and had established vegetation. None of the erosion areas are harming the function of the disposal cell cover or other site features and are not a concern at this time. Inspectors will continue to monitor these erosion areas.

PL-6. Erosional Gully, Previously Unreported

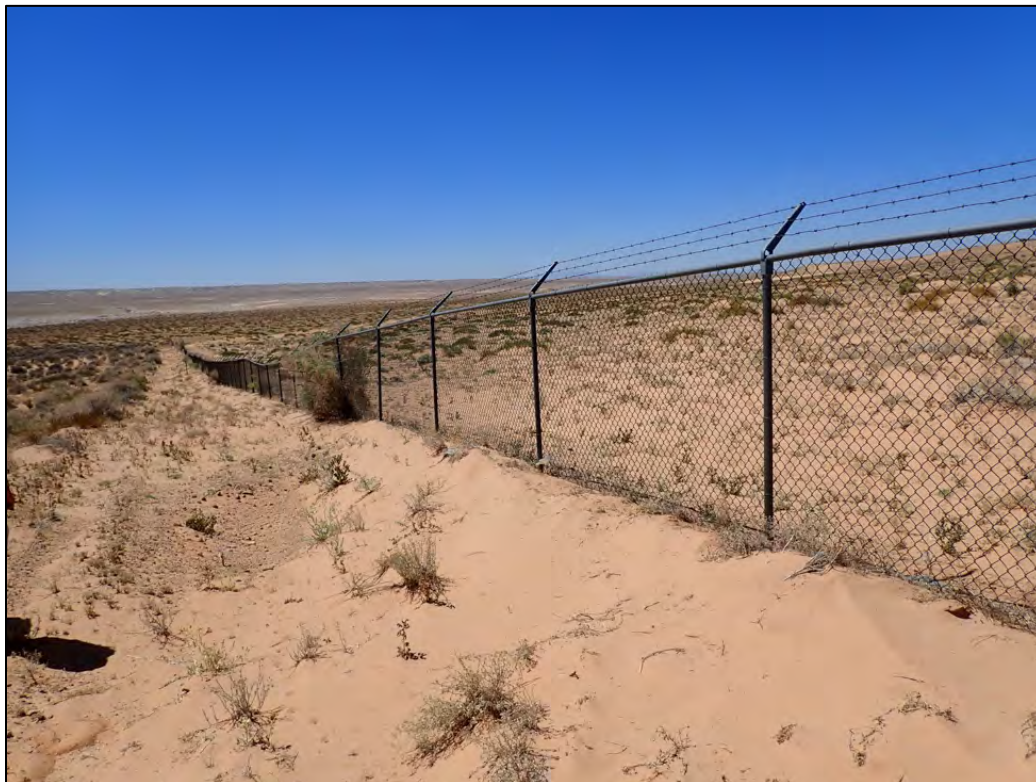
PL-2. West Perimeter Fence with Sand Deposition

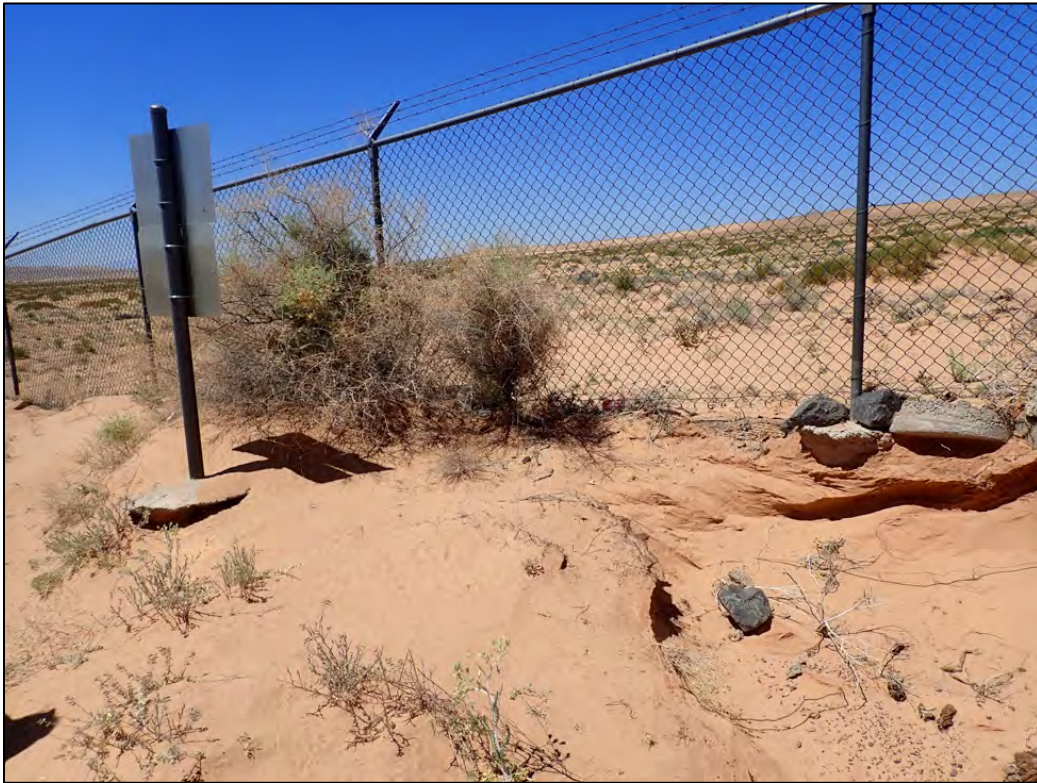
PL-3. Vegetation and Debris on Fence near Perimeter Sign P9

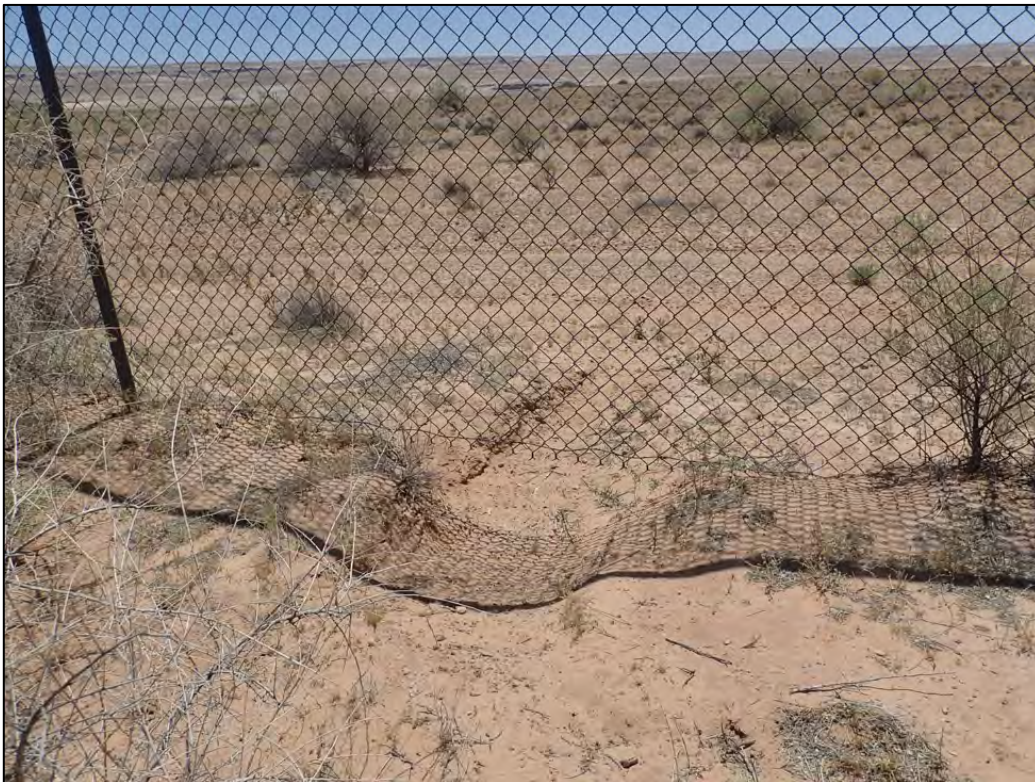
PL-4. Gap Under Perimeter Fence near Perimeter Sign P9

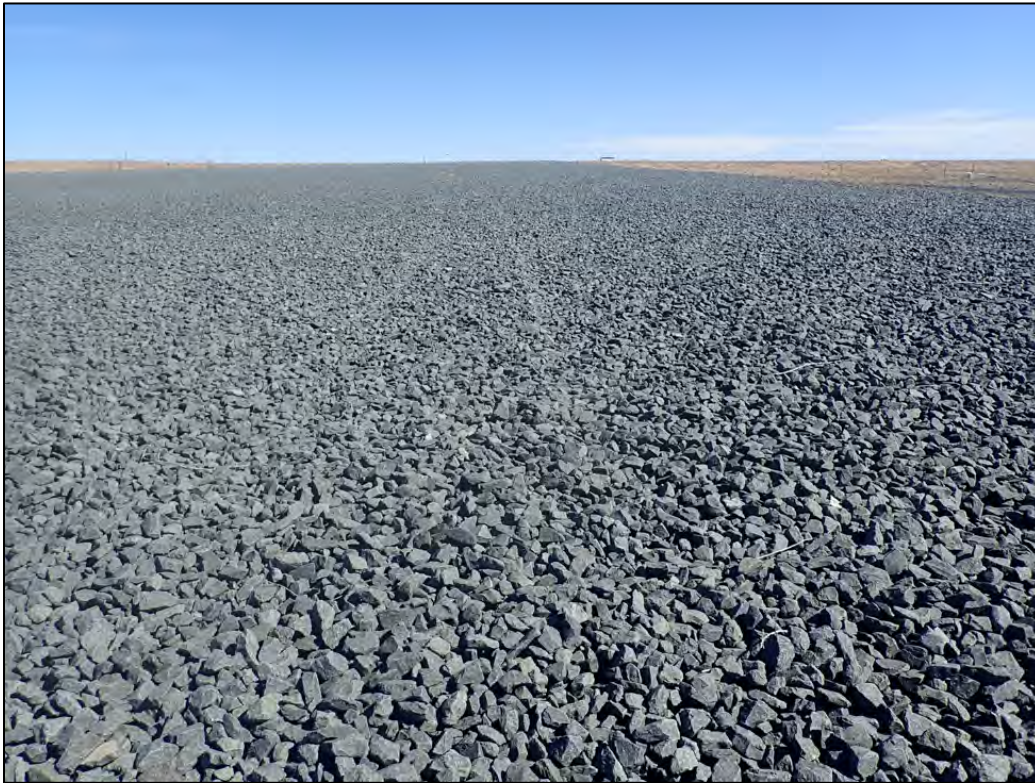
PL-7. Parallel Tracks Visible on Top of Disposal Cell

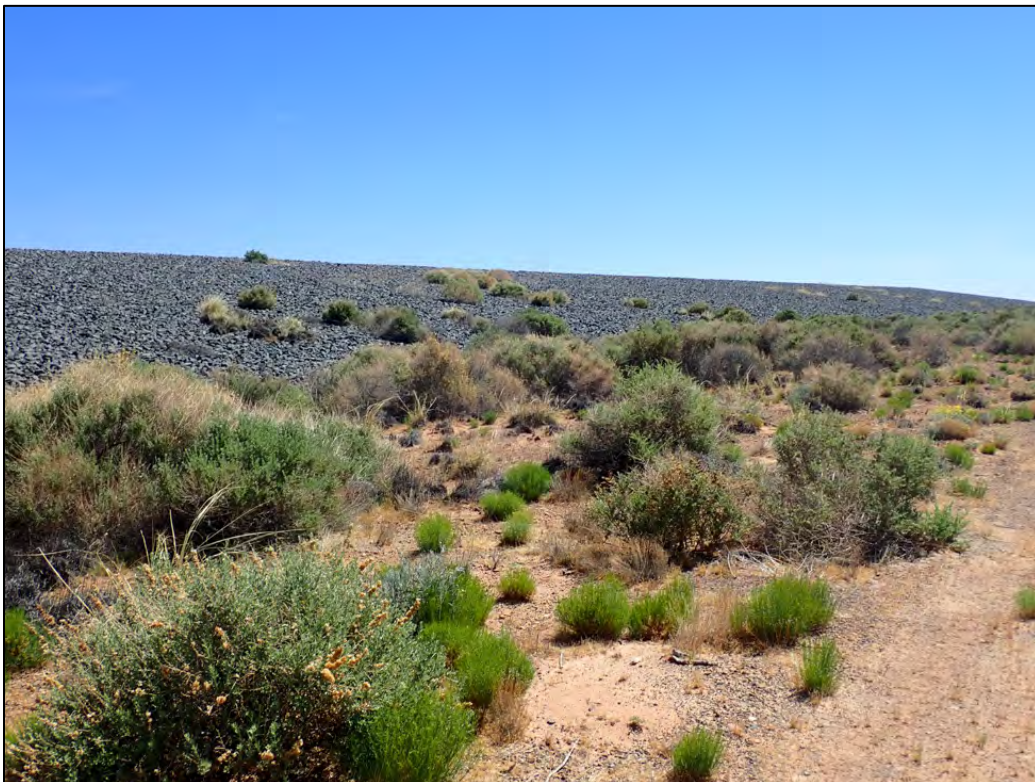
PL-8. Vegetation on South Slope of Disposal Cell

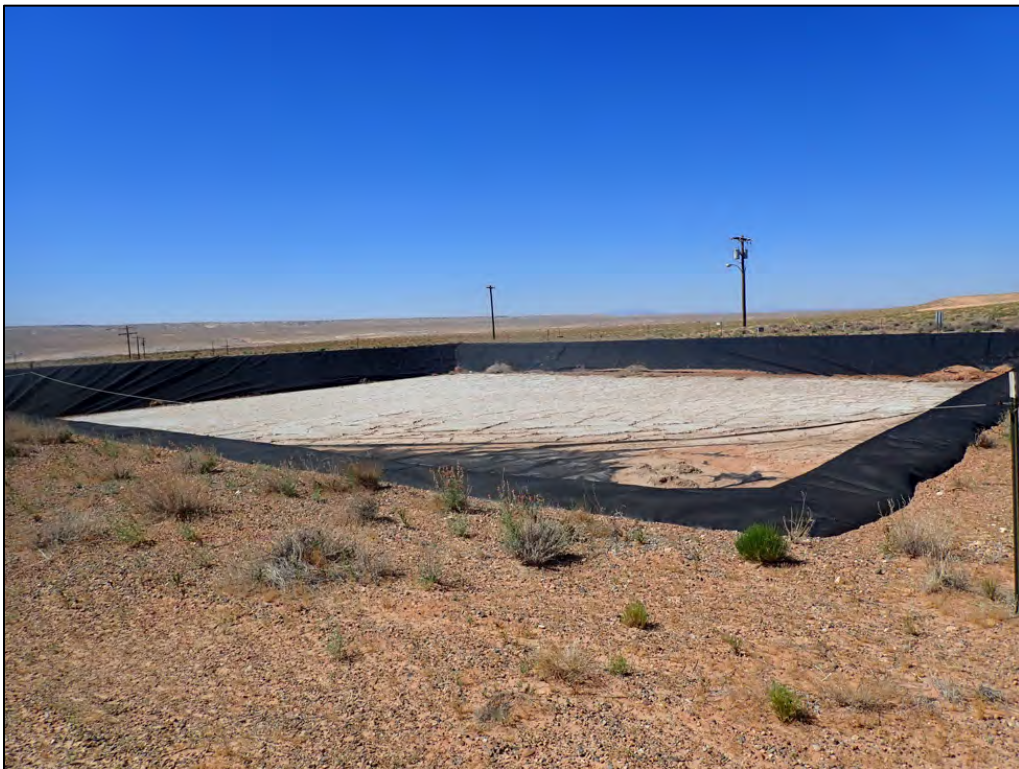
PL-10. Inactive Evaporation Pond
