ESG-DOE-13403

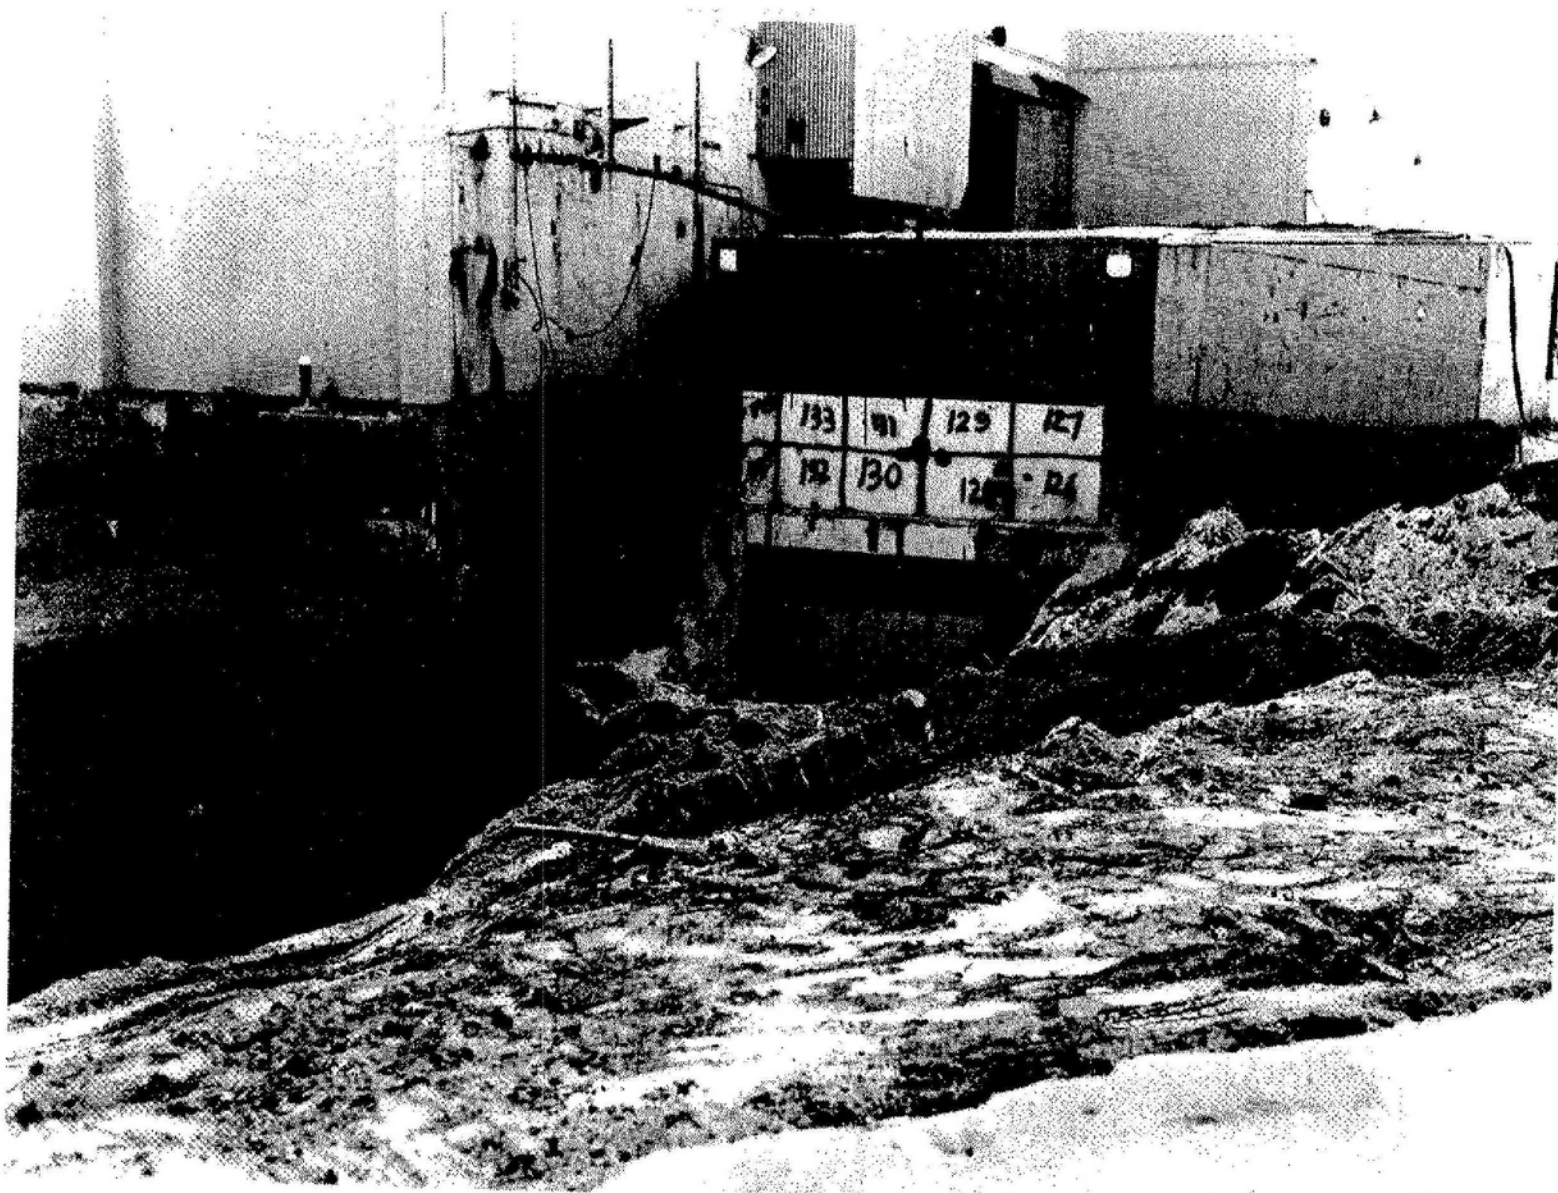
Figure 47. Excavation East of Primary Fill Tank Vault

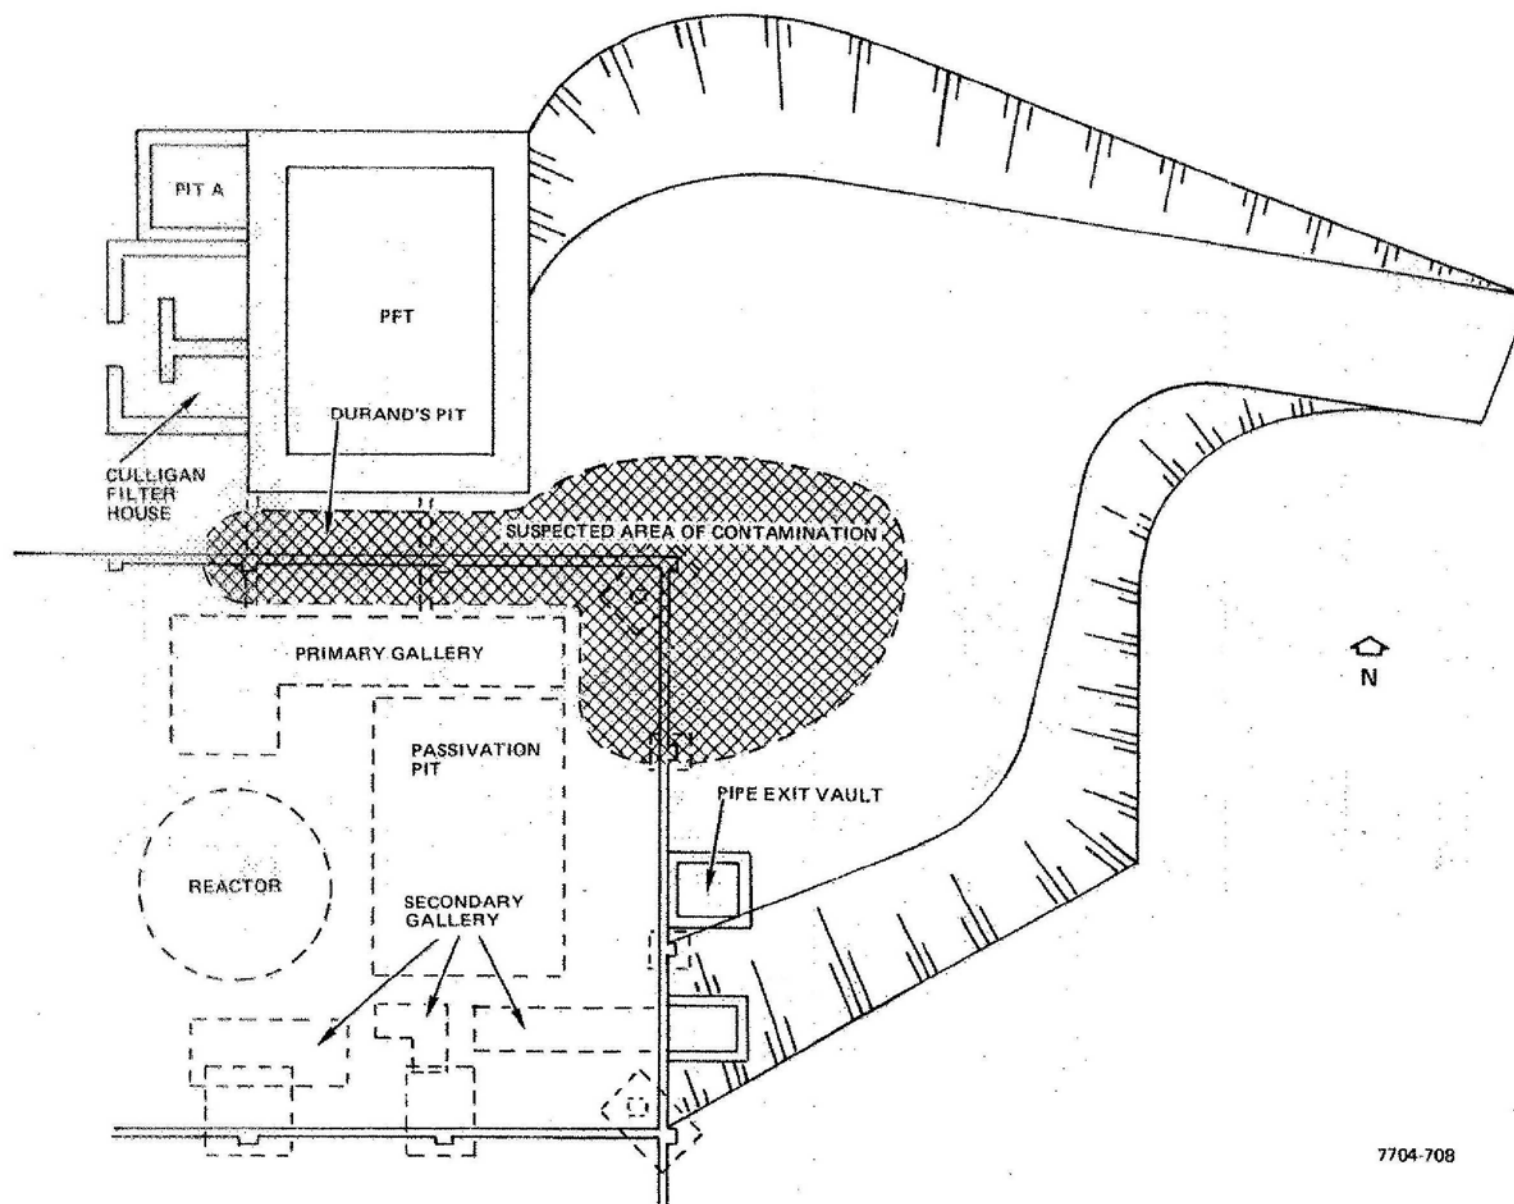
Figure 48. Access Ramp to High-Bay Excavation and Suspected Area of Contamination

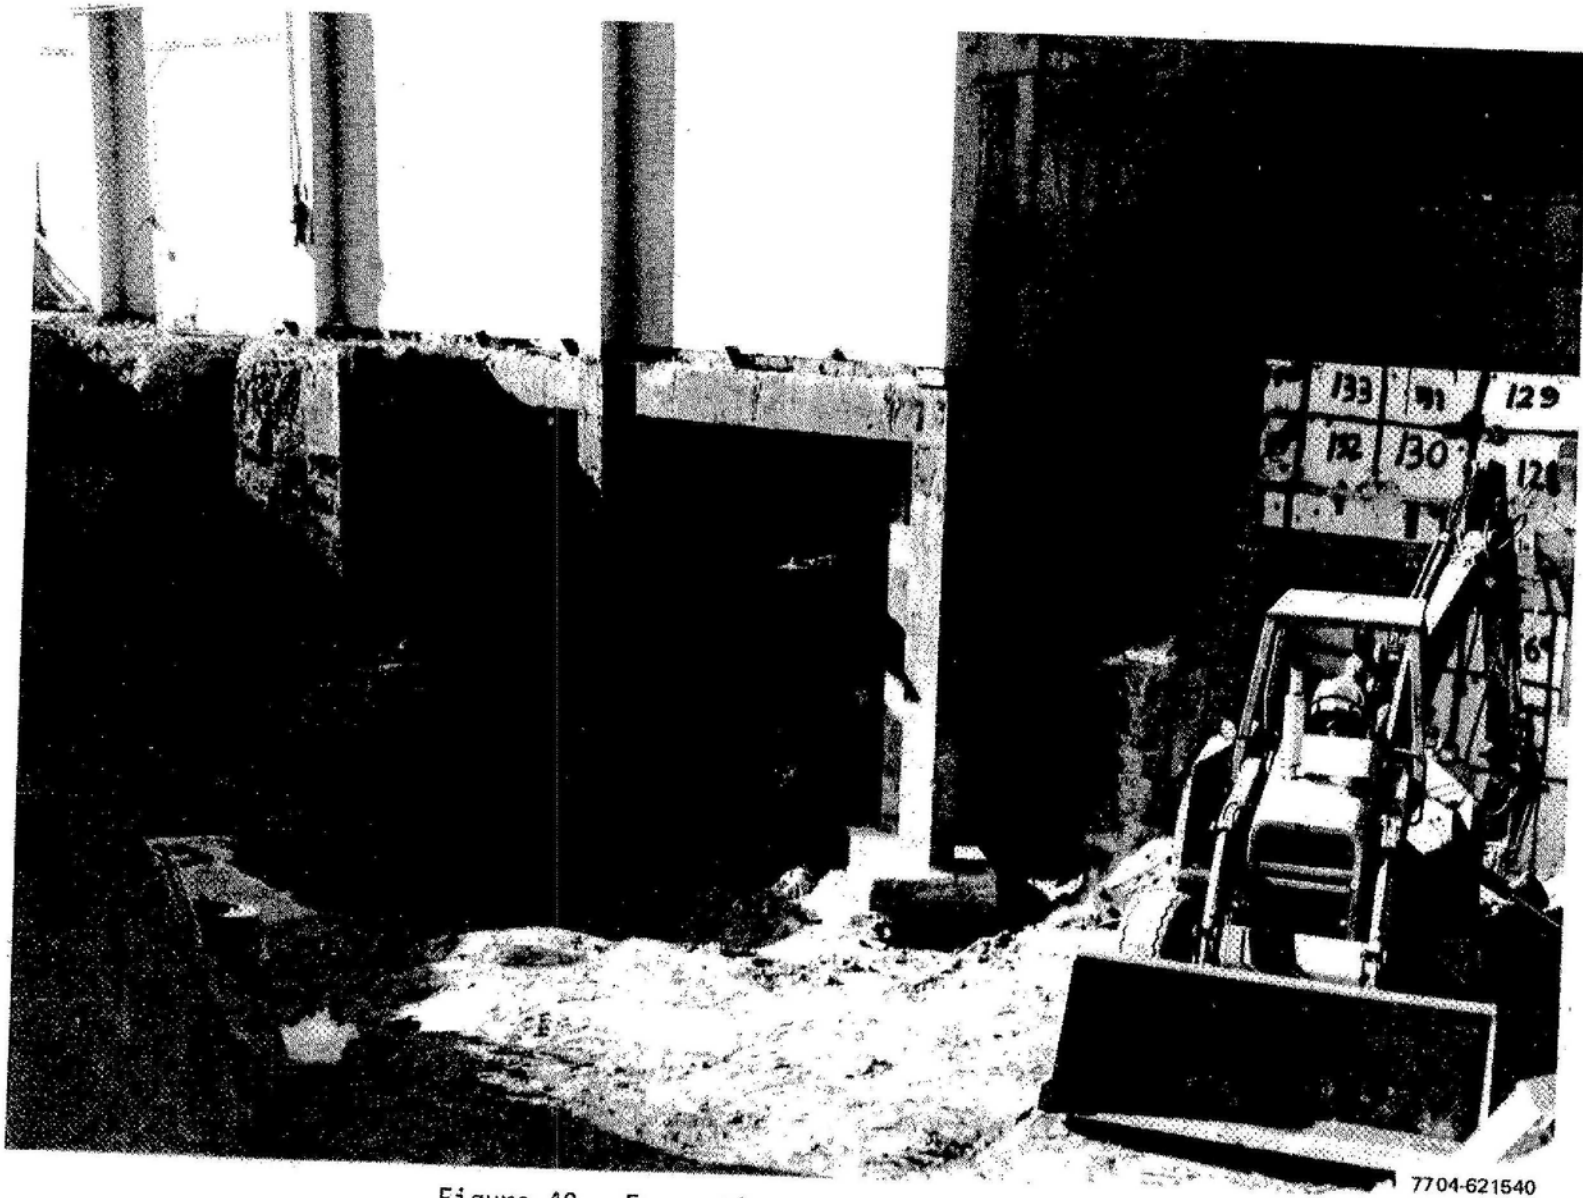
During this excavation, contamination above the Table 3 limits was found in the soil surrounding the footing at the northeast corner of the high bay. Further excavation uncovered contamination as high as 13,000 pCi/g located in cracks in the bedrock east and north of the high bay (see Figure 48). Figure 49 shows the excavation along the east face of the building. Contaminated

Figure 49. Excavation East of SRE High Bay

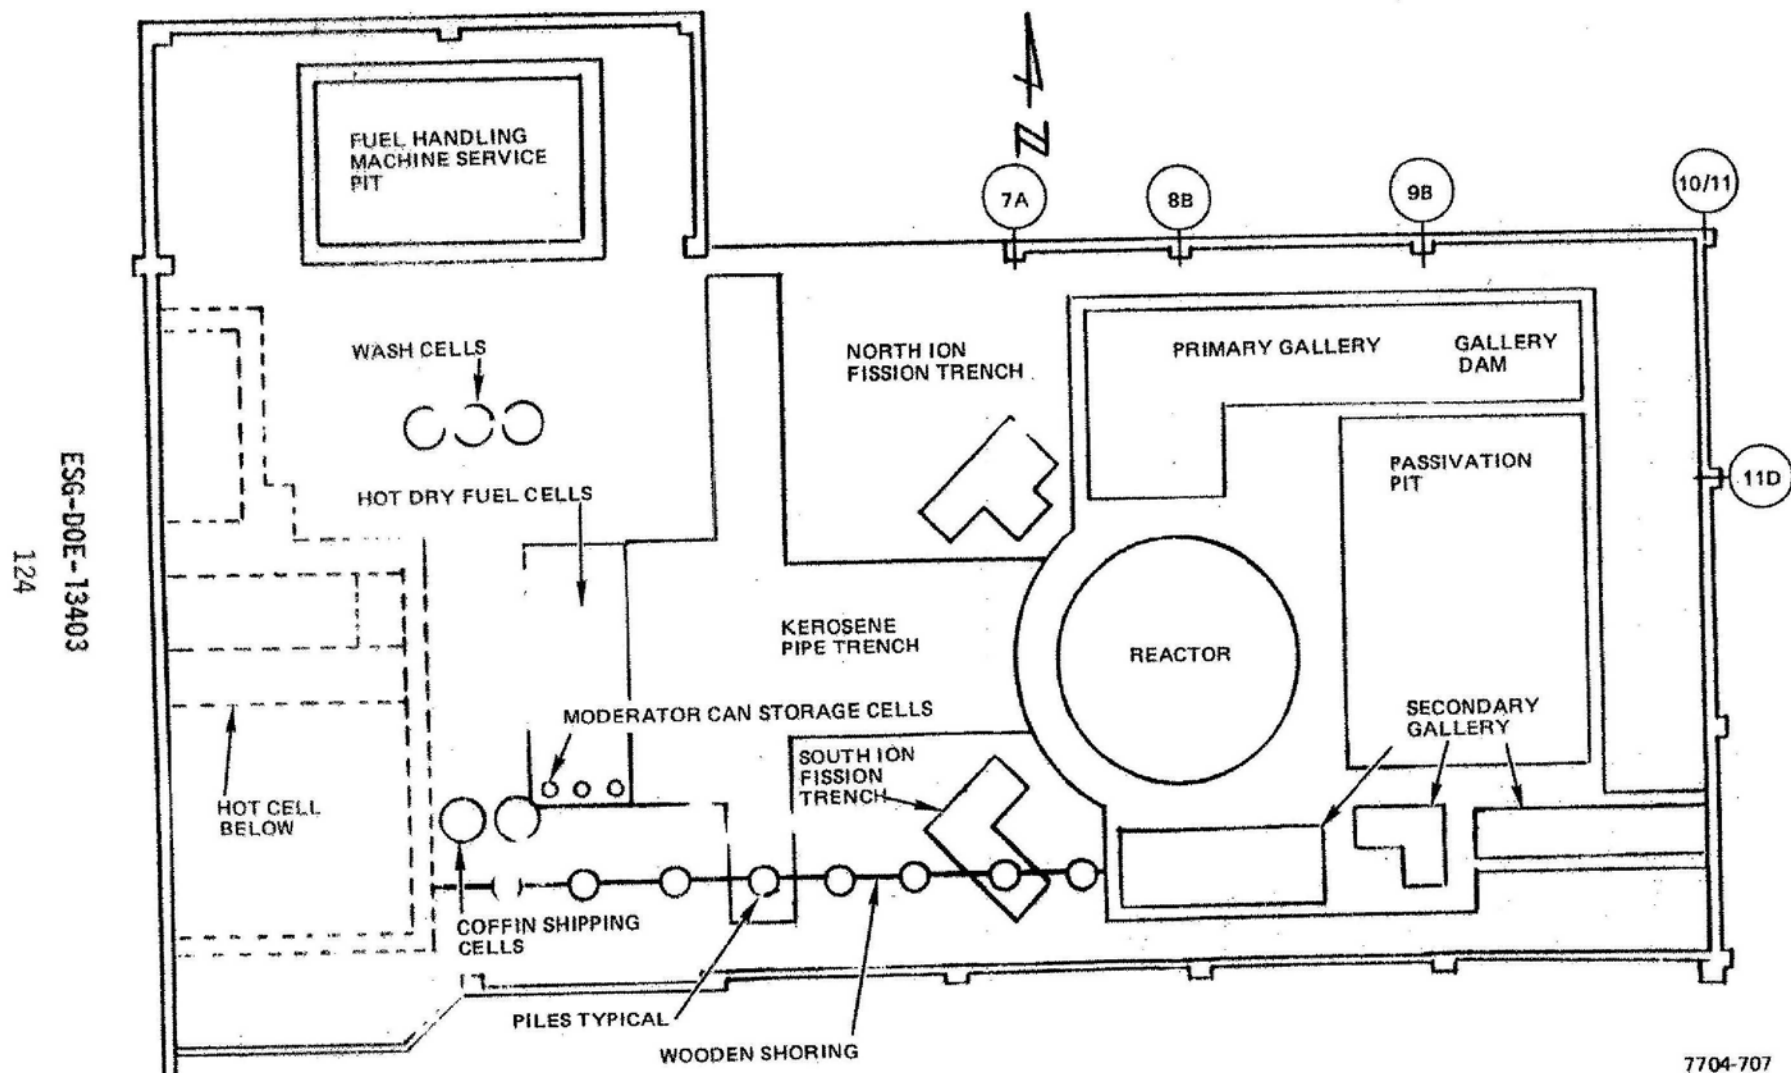
Figure 52. Location of High-Bay Retaining Wall and Column Identification

Contaminated rocks and soil were found around five facility support column footings. Three footings were along the north wall (7A, 8B, and 9B). One was along the east wall (11D). And one footing was at the corner where the north and east walls meet (10/11) (see Figure 52). The structural consultant previously contacted was again brought in on contract. A series of temporary footings, cross bracing, and support columns needed to be installed if excavations were required near or below these five column footings. Exploratory excavations in this area were performed using jackhammers and hand tools. Rock and soil samples were analyzed, and the results were compared with previous samples. Extrapolation was used to estimate the depth of radioactive contamination in several visible cracks. Based on this information, it was apparent that the only solution was to remove the contaminated soil from beneath the footings.

- 2) The 75-ton bridge crane should be down rated to 5 tons and stored at the far west end of the high bay when not in use.
- 3) A retaining wall should be built at the southern limit of the excavation in the high bay between the hot cell wall on the west and the auxiliary secondary gallery wall on the east (see Figure 52). The retaining wall was to consist of 50-ft-deep, steel-reinforced concrete pilings with 4 by 12 wooden shoring secured in channels imbedded in the piles. Figure 53 shows the installation of the wooden shoring. As the excavation deepened, additional shoring could be added.
- 4) Seismic bracing had to be added when the excavation was completed.
- 5) Additional bracing had to be added if excavations went below the bottom of a footing.

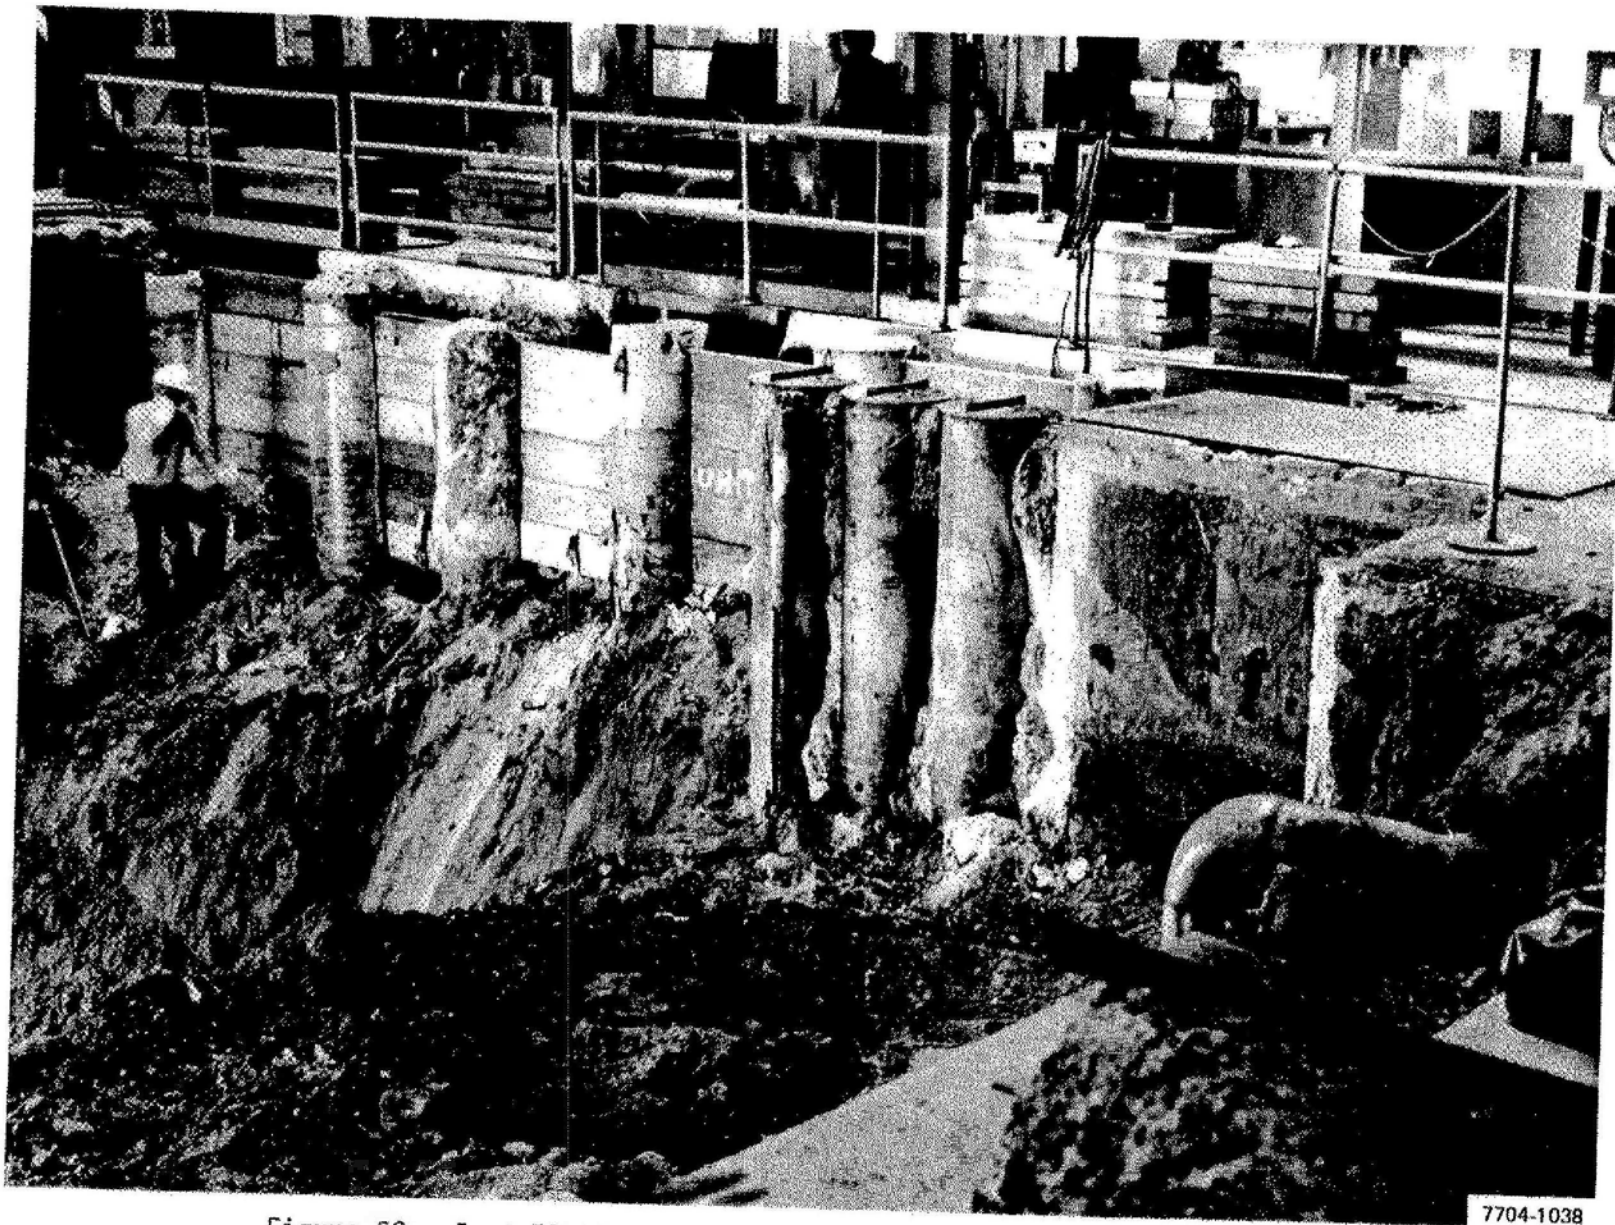
Figure 53. Installation of Wooden Shoring in High-Bay Retaining Wall

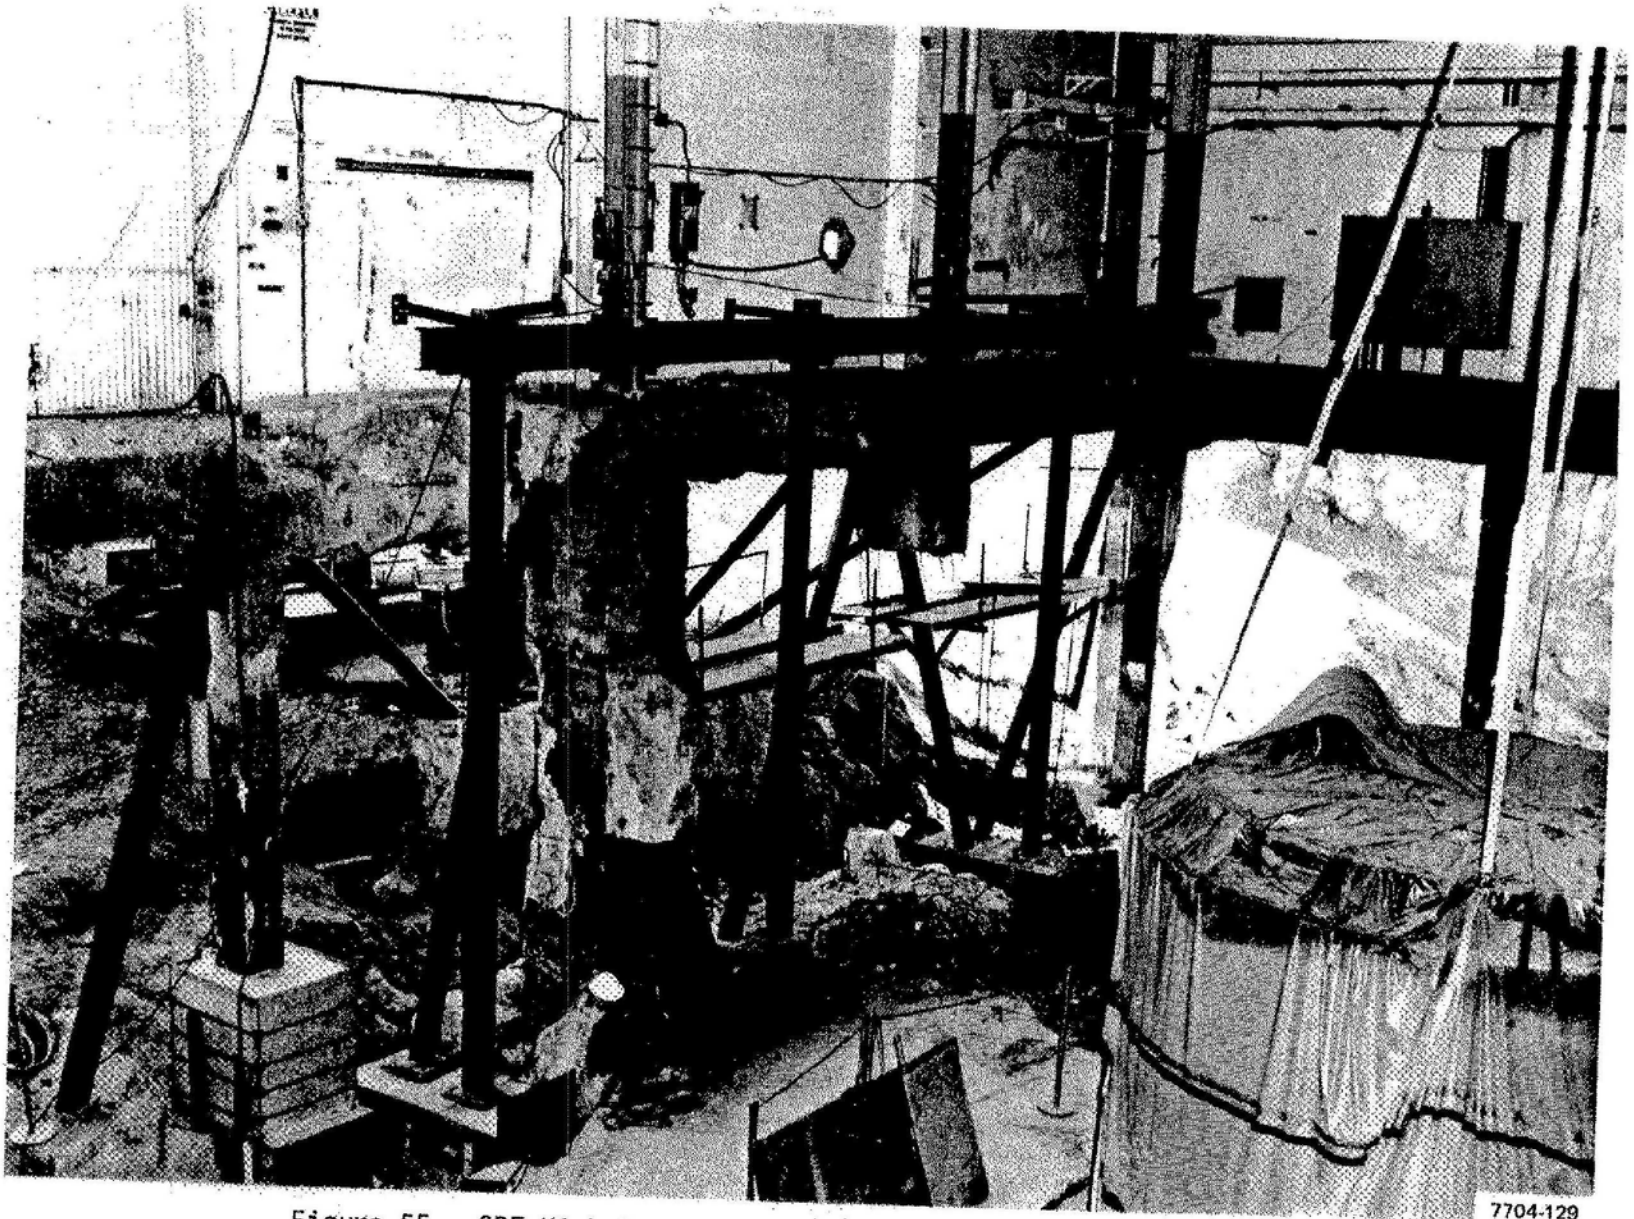
Figure 55. SRE High-Bay North Wall Column Supports Interior View

The level chosen for a specific column footing was based on the extrapolated amount of contamination expected. One column was partially undermined (10/11). Two columns were totally undermined (7A and 11D). And two columns and footings were removed and later replaced (8B and 9B). The installation of temporary footings and columns was subcontracted. Only one column was worked on at a time, and a full, 28-day cure was permitted on a foundation or column before work was started on an adjacent footing. Figure 54 shows the column supports and the seismic braces anchored to the floor of the primary fill tank vault. Figure 55 shows the column bracing inside the high bay. Column 7A, on the left, already has a new foundation and reinforced footing in place. Note that Column 9B has been removed.

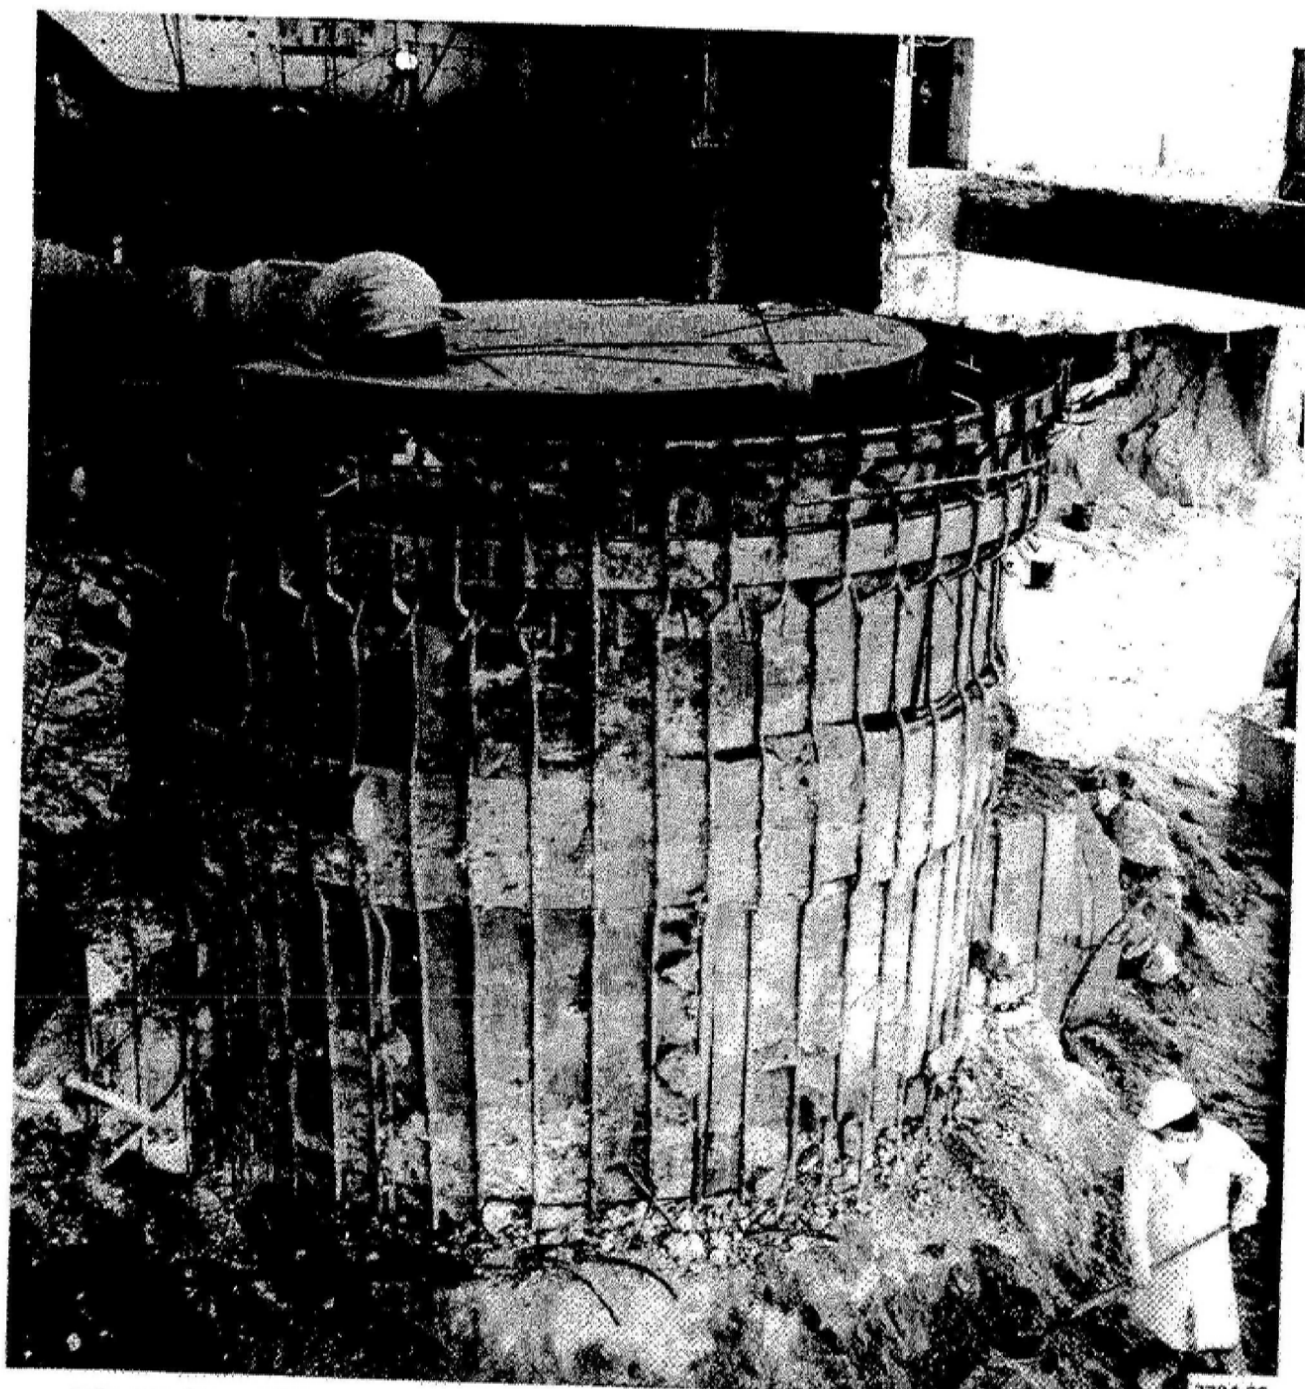
Figure 58. SRE Core Cavity Liner after Demolition of Biological Shield

After all of the core components, tanks, and insulation were removed, the reactor core cavity liner was removed. The upper 3/4 section of the 1/4-in.-thick steel liner was cut into sections using a hand-held oxygen-acetylene torch. The lower 1/4 section of the core cavity liner was cut with a torch and pryed loose from the biological shield using a hydraulic Hy-Ram. Removal of the liner was phased with the biological shield removal to take advantage of having the concrete removed from behind the liner. The sections were packaged in wooden crates for disposal.

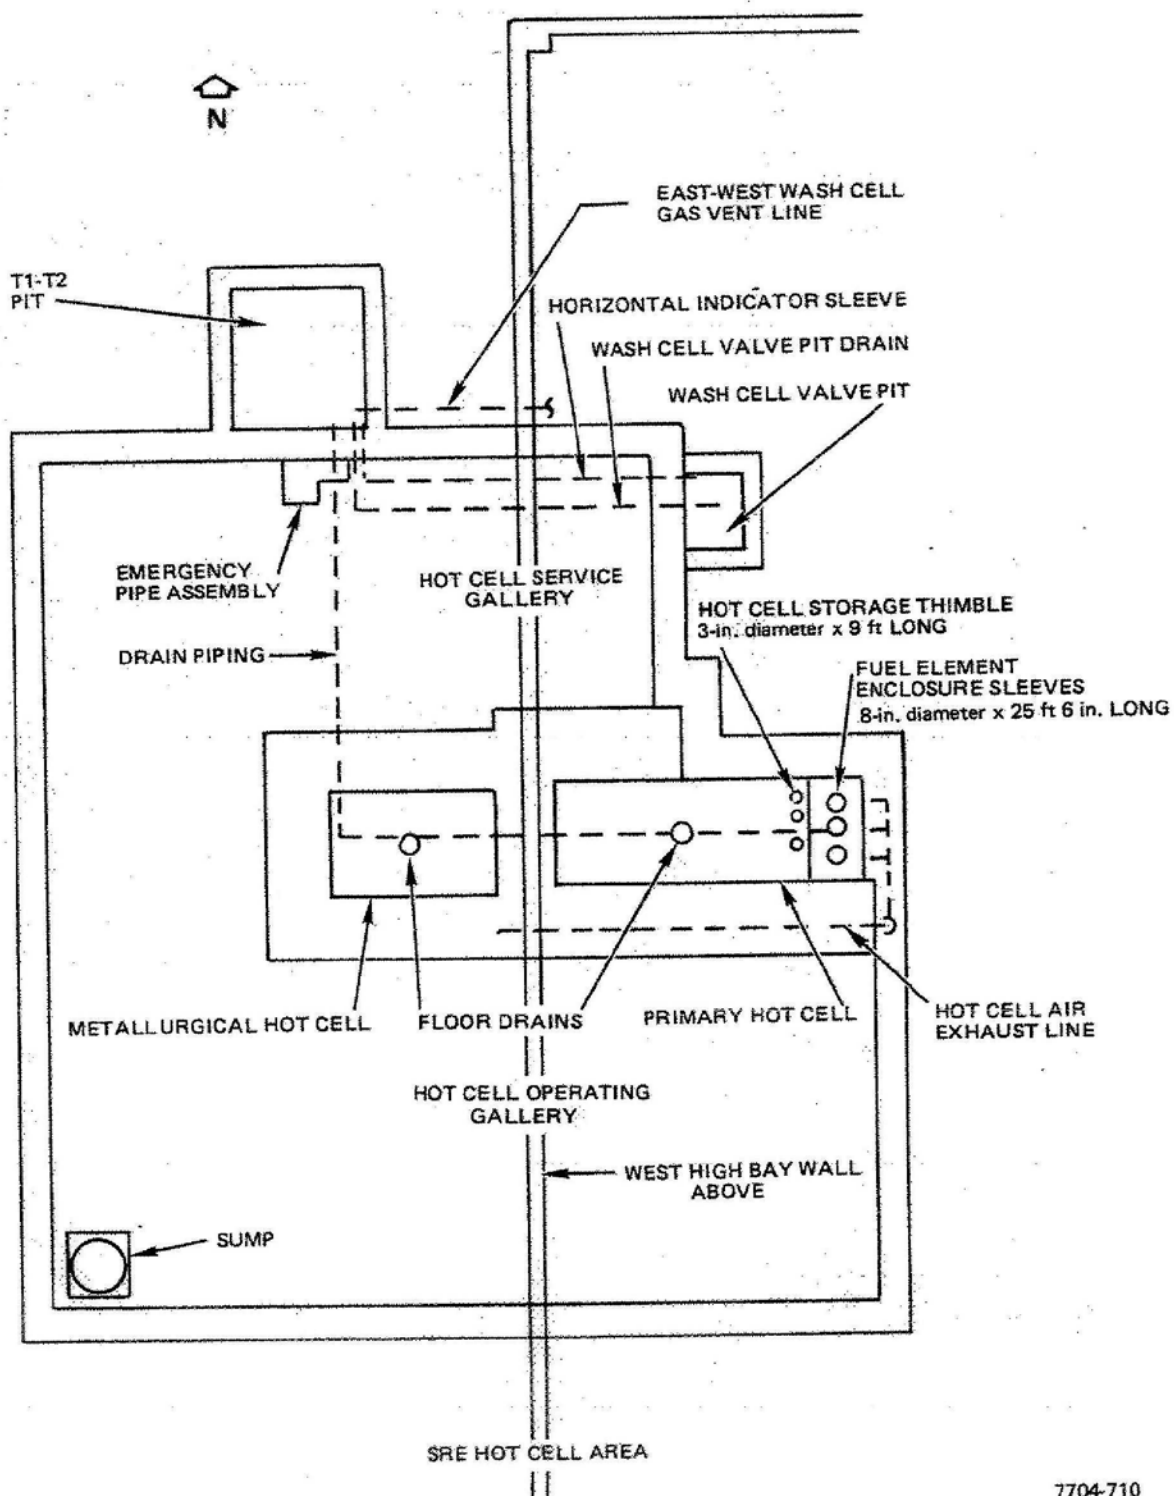
The fuel element enclosure sleeves were the deepest elements in the SRE facility. The two sleeves were located within a 6-ft-deep pit at the bottom of the primary hot cell. Figure 65 is a sketch of the SRE hot cell area. The hot cell floor was 20 ft below the high-bay floor. This meant that the tops of the sleeves were 26 ft below grade. The sleeves themselves were 8 in. in diameter by 25 ft 6 in. long. Thus, the bottom of the sleeves were over 50 ft below the original high-bay floor.

When the sleeves were uncapped, they were found to contain 2 to 4 ft of water. Analysis of samples indicated levels above the maximum permissible concentration for mixed fission products. The small side diameter of the sleeves made decontamination of the interior surface virtually impossible. It was decided to remove the sleeves. The Hy-Ram was used to expose the top section of the two units. It quickly became apparent that the small backhoe/Hy-Ram combination would not be capable of excavating a hole deep enough to reach the bottom of the sleeves. The preliminary excavation also showed that the two units were most likely encased in concrete for their entire length.

Figure 65. SRE Hot Cell Area

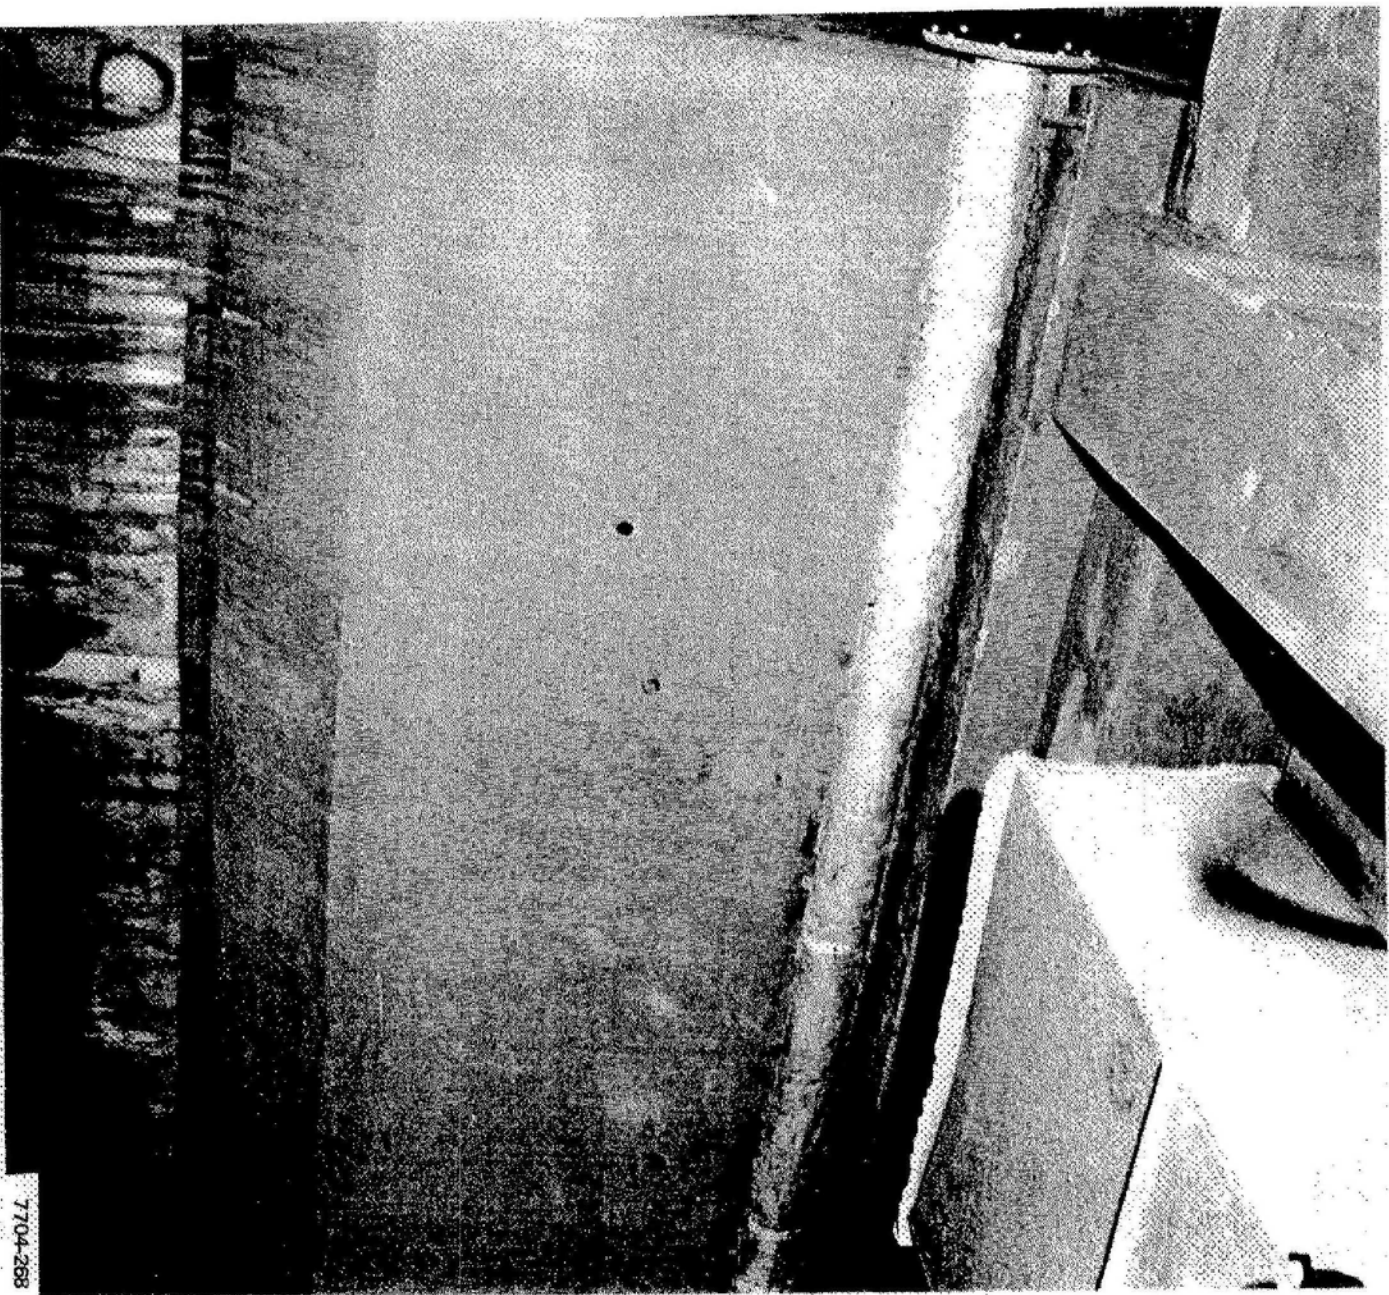
The in-cell floor drains and the hot cell air exhaust line were removed. The exhaust line was an 8-in.-diameter, thin wall tube used to discharge the primary cell atmosphere to the above-grade radioactive exhaust system. The tubing was embedded in the concrete wall between the primary hot cell and the hot cell operating gallery, inches away from the grade beam supporting the west wall of the high bay. A method was found to remove the tubing without endangering the structural integrity of the building. A combination of concrete sawcutting and jackhammering by hand was successful. The exhaust line was removed intact without damage to the facility. Figure 72 shows the primary cell wall and the exposed exhaust line.

Figure 72. Exposed Primary Hot Cell Exhaust Line

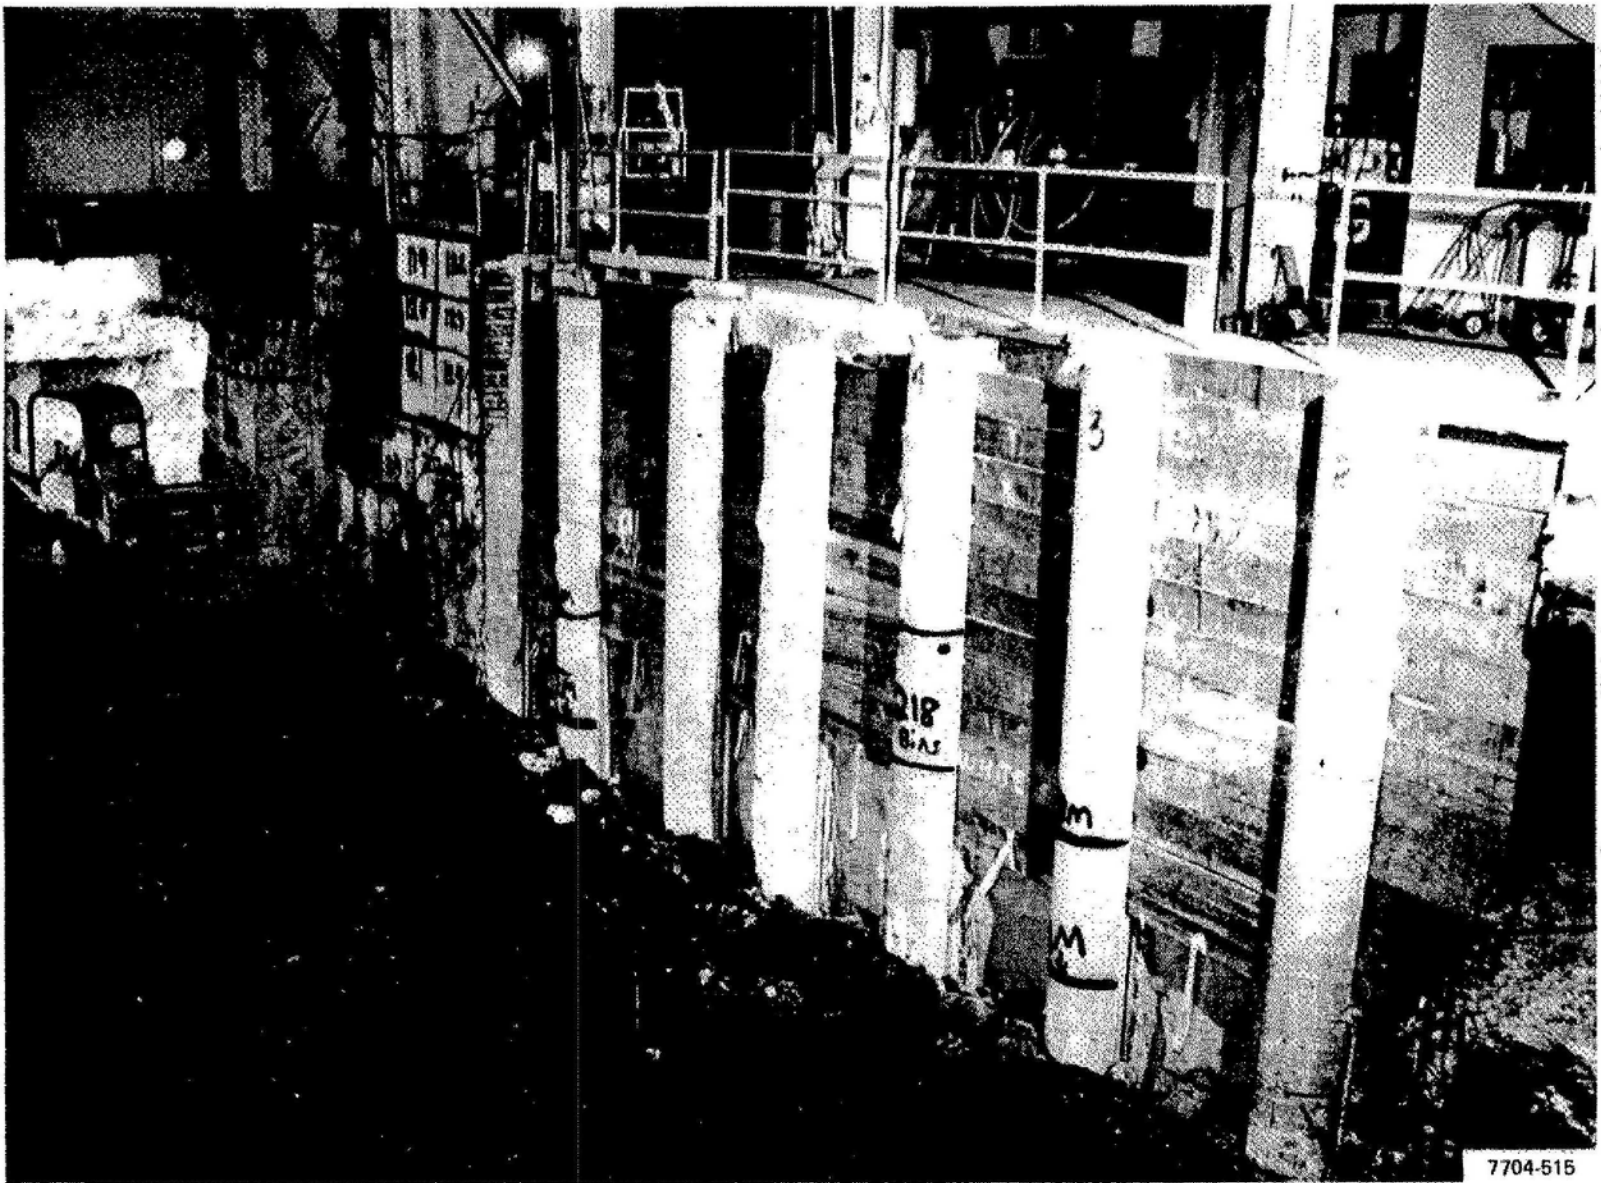
Figure 73. High-Bay Excavation Retaining Wall with Lower Wooden Shoring Removed

The wooden shoring wall was removed from the bottom up, as the backfill soil raised the level of the high-bay excavation (see Figure 73). The column support bracing was removed when the soil level reached the tops of the temporary footings. Seismic bracing installed outside the high bay was also removed when the backfill soil reached the footings. Figure 74 shows the high-bay excavation during the early phase of backfill and compaction.

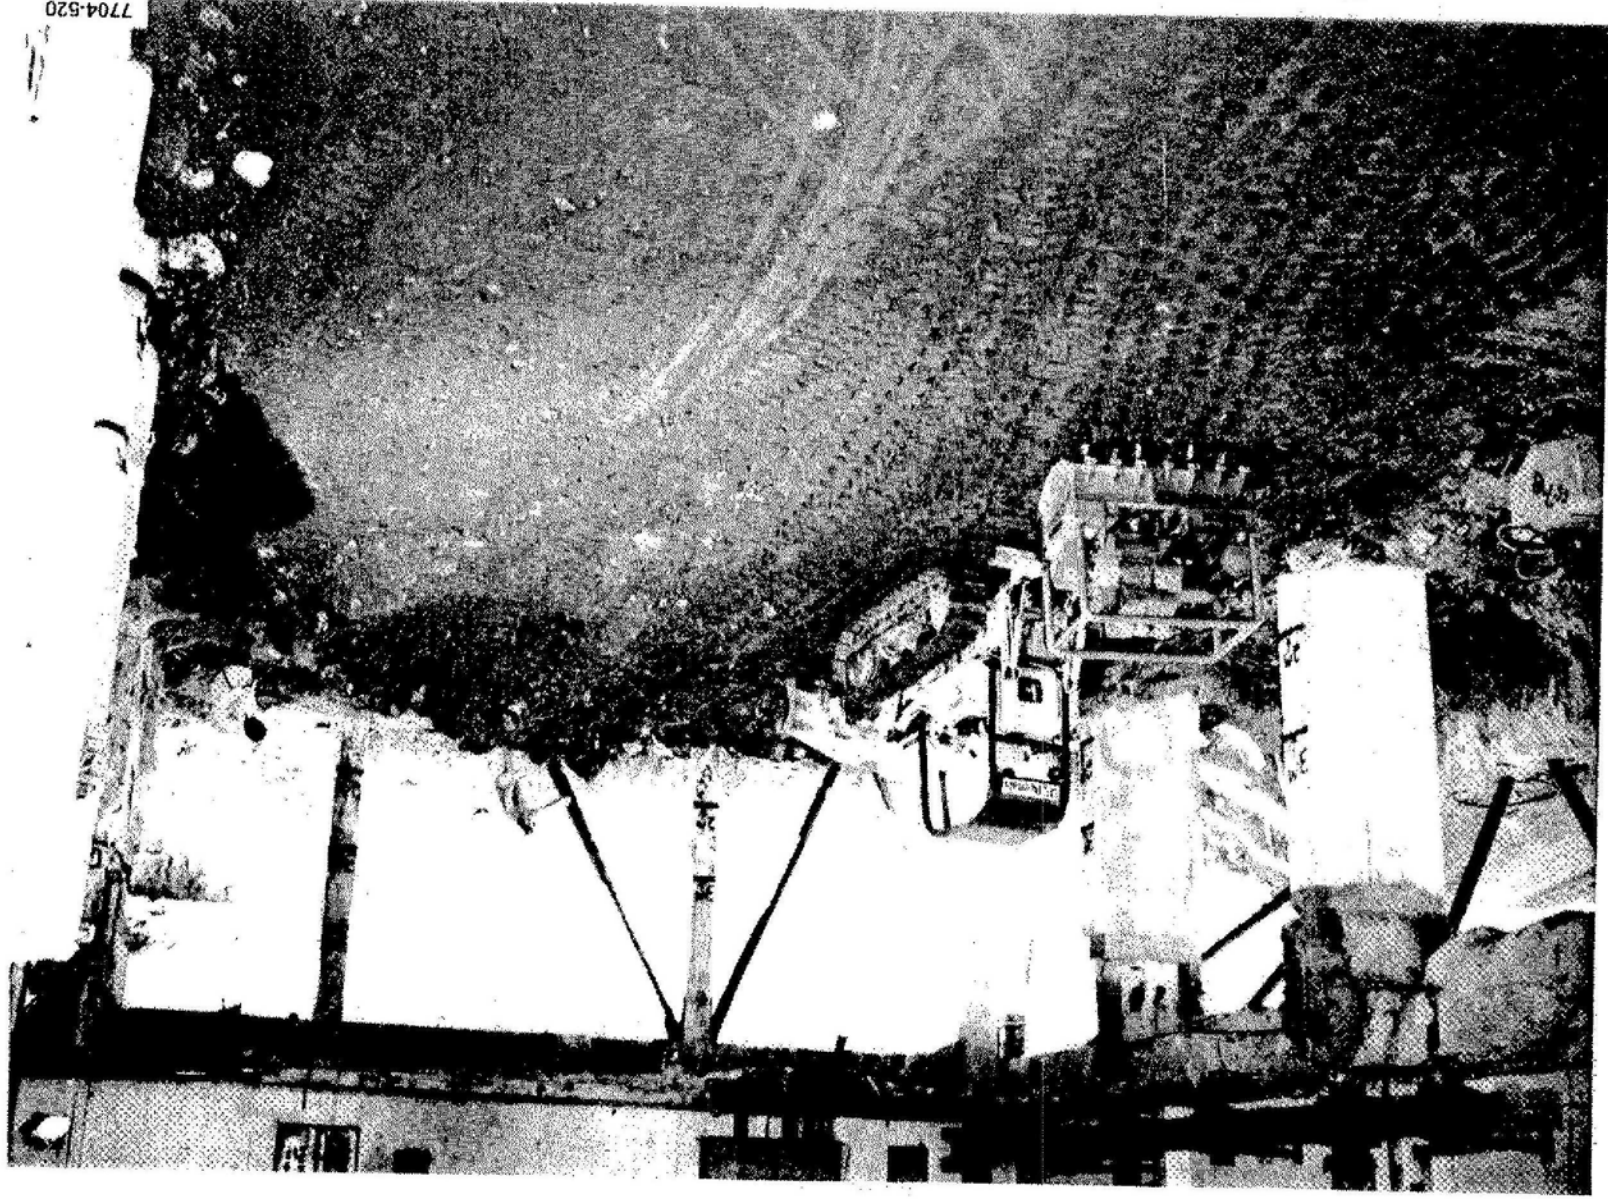
Figure 74. SRE High-Bay Excavation Backfill and Compaction in Progress
