Plugging of Exhaust Gas Recirculation Coolers

Michael J. Lance, John M.E. Storey, C. Scott Sluder, Samuel A. Lewis Sr., and Hassina Bilheux
Oak Ridge National Laboratory

October 19th, 2012

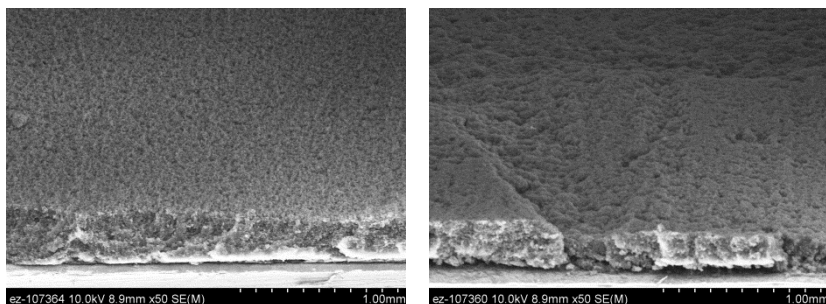
EGR Cooler Deposits were Removed Through Flow-Induced Shear

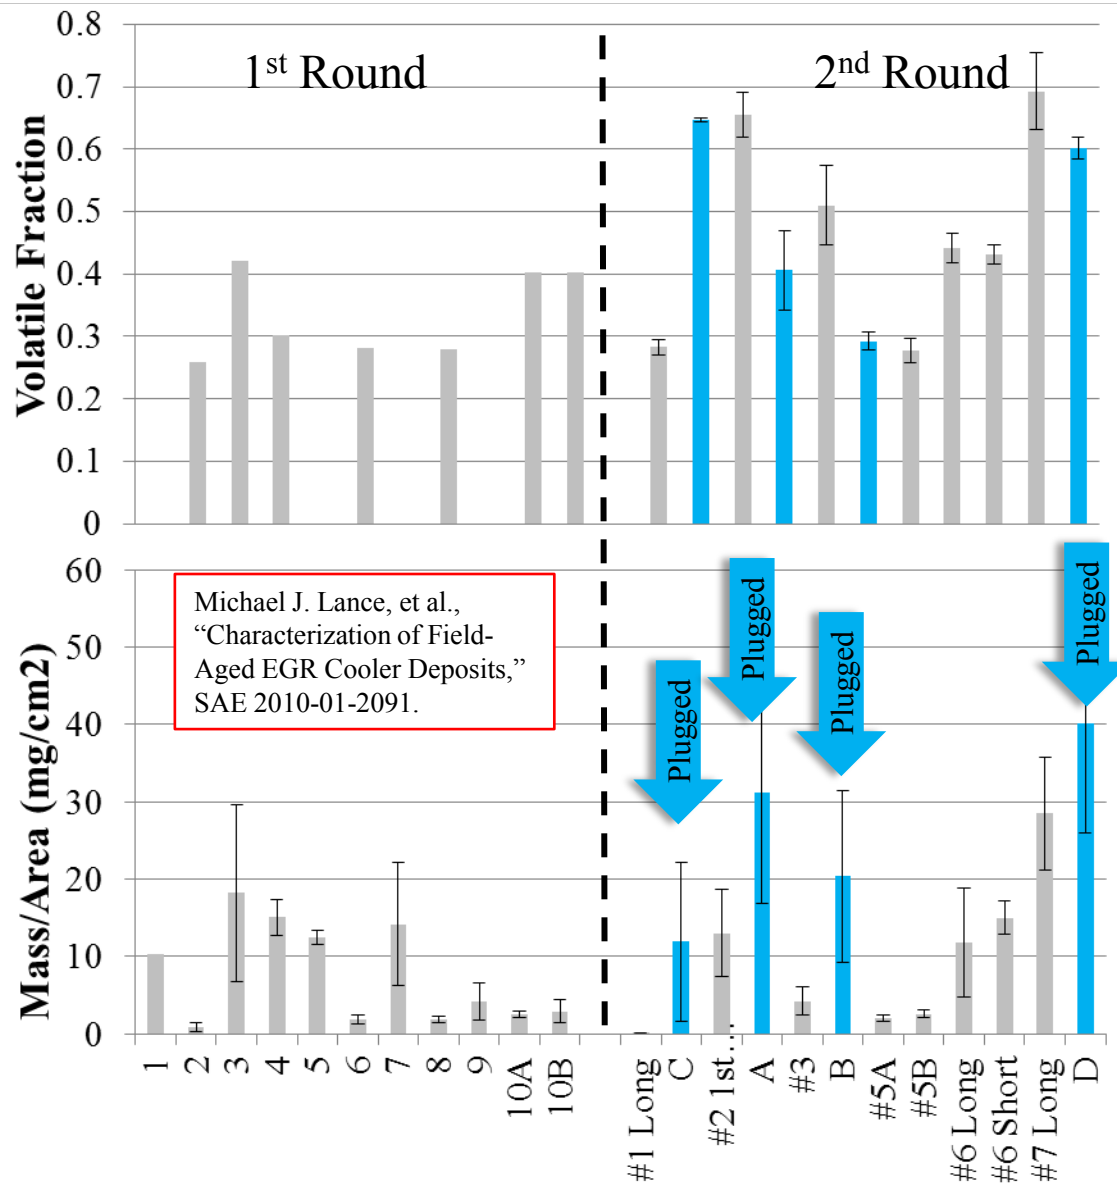
- First round of industry-provided “half-useful-life” coolers came with little information.
- A second round was requested with more information about cooler origins.
- Coolers tended to show the plugging failure mode from applications requiring long idling times; school buses, delivery trucks, etc.
