**U.S. Department of Energy
Portsmouth/Paducah Project Office**

Type B Accident Investigation Report

**THE JULY 12, 2007
FORKLIFT AND PEDESTRIAN ACCIDENT
AT
THE PADUCAH GASEOUS DIFFUSION PLANT**

April 2008

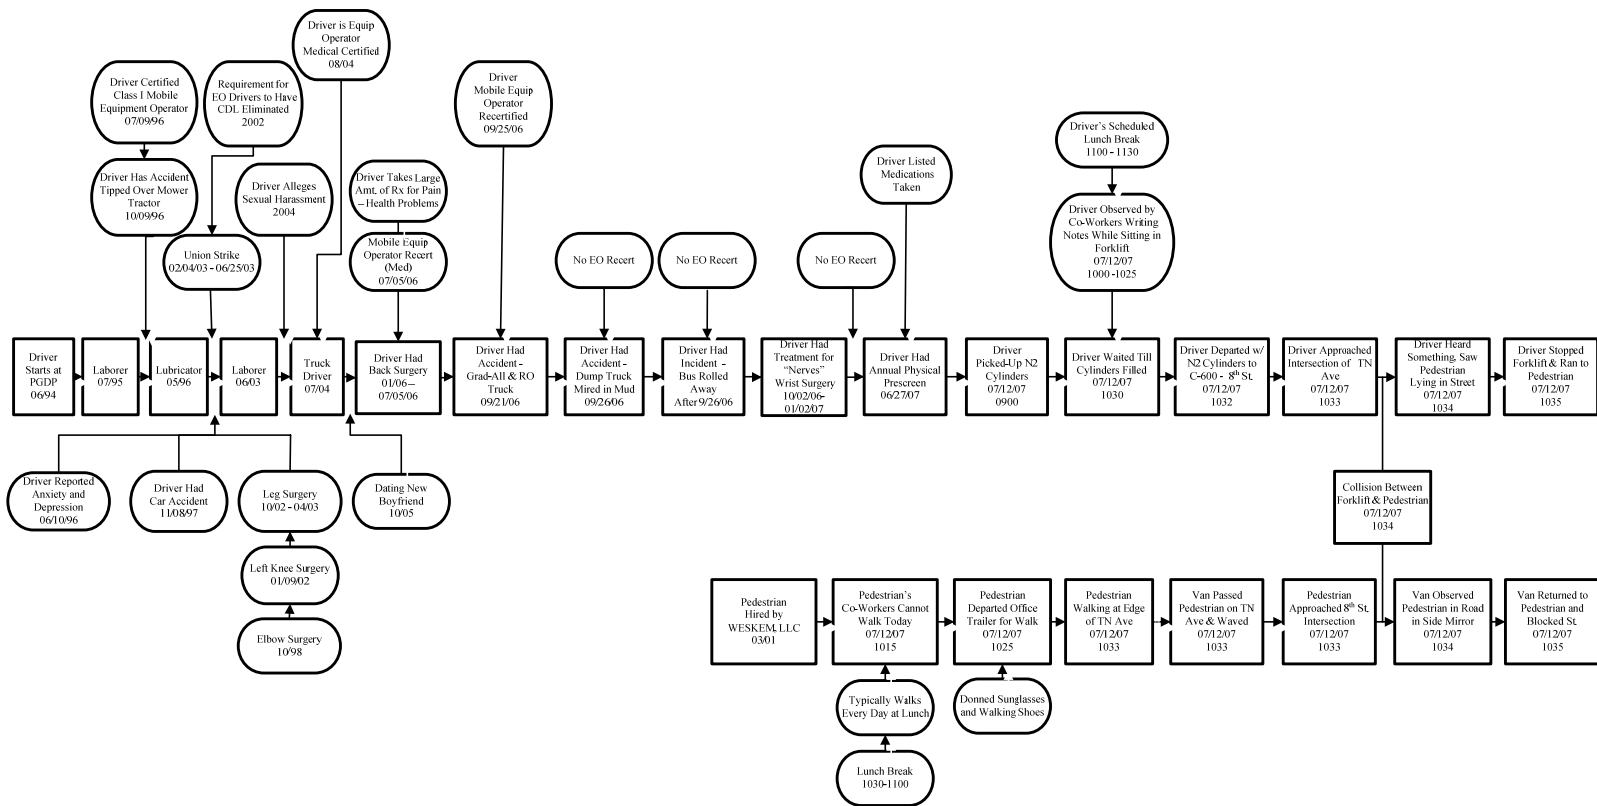
Events & Casual Factors Chart
Figure 4.1-1

Because the E&CF wall chart contained a huge amount of detailed information, the wall chart was eventually condensed to represent a fairly high level of information that would serve as a useful diagram to understand the events and conditions that contributed to the accident. This resulted in two separate diagrams, see Figures 4.1-1 and 4.1-2.
