Type B
Accident Investigation Board Report
On the February 25, 2009
Abdominal Injury
To a Passenger in an Electric Cart
Waste Isolation Pilot Plant
Carlsbad, New Mexico

April 2009

U.S. Department of Energy
Carlsbad Field Office

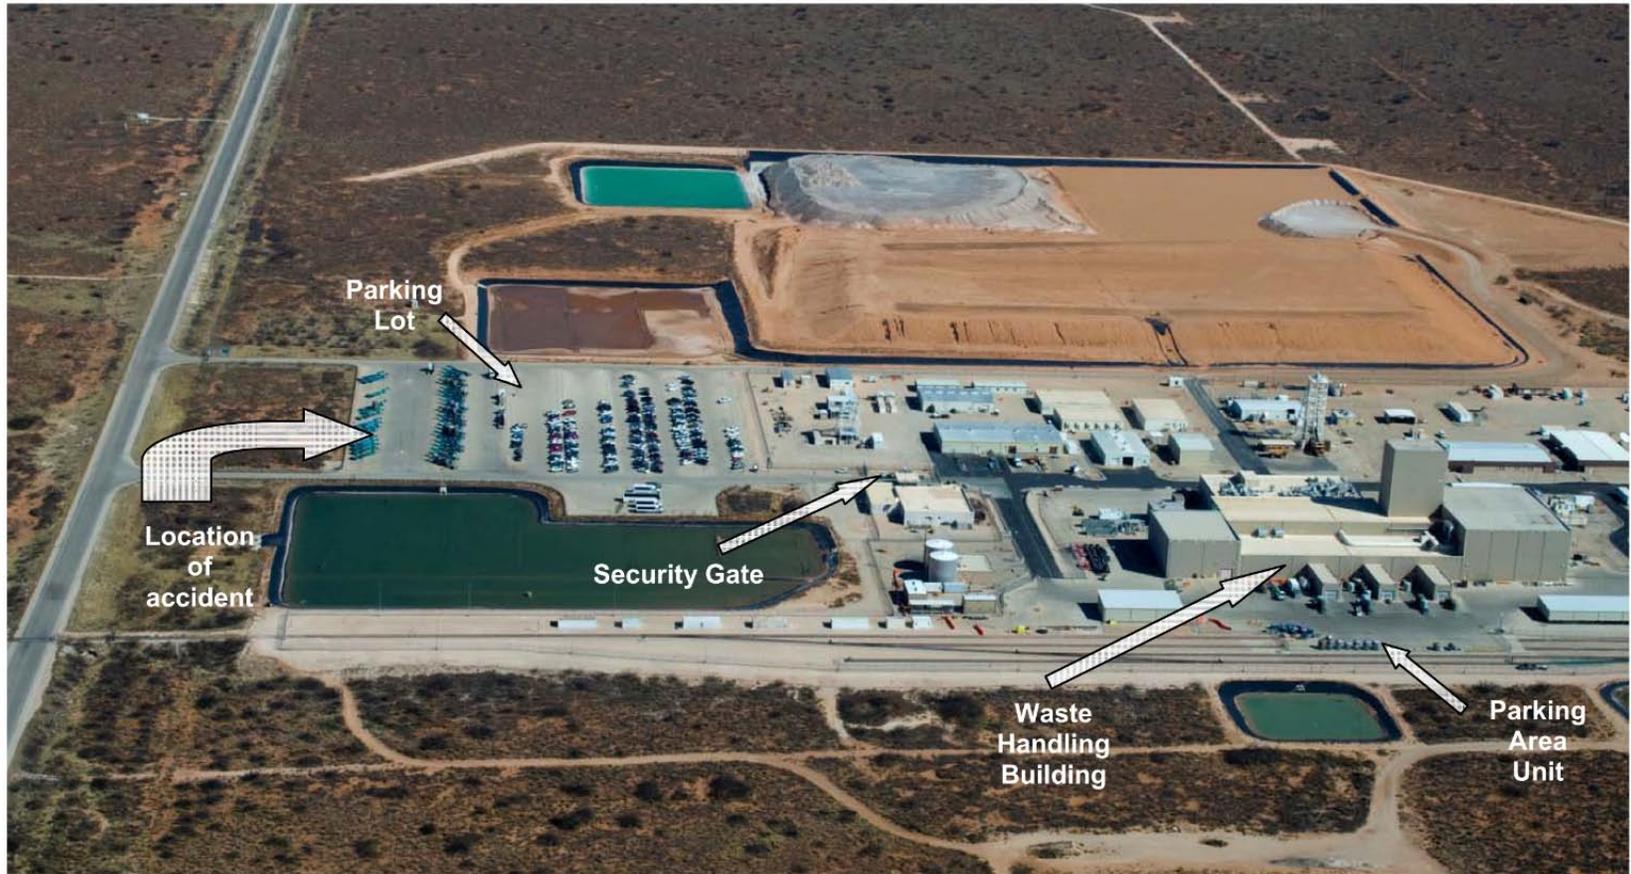
Figure 2: WIPP Surface Facilities

- Guard and Security Building. Houses the security monitoring and alarm systems.
- Parking Lot. The east portion of the front parking lot is used for employee parking, and the two west rows of the lot are designated for trailer storage and staging of empty TRUPACTs for DOE carrier transport to the generator sites and trailer maintenance facility (location of the accident – see Figure 2).
