July 2009

DOE/RL-2009-83

Type B Accident Investigation Report

**Washington Closure Hanford, LLC
Employee Fall Injury on July 1, 2009,
at the 336 Building, Hanford Site,
Washington**

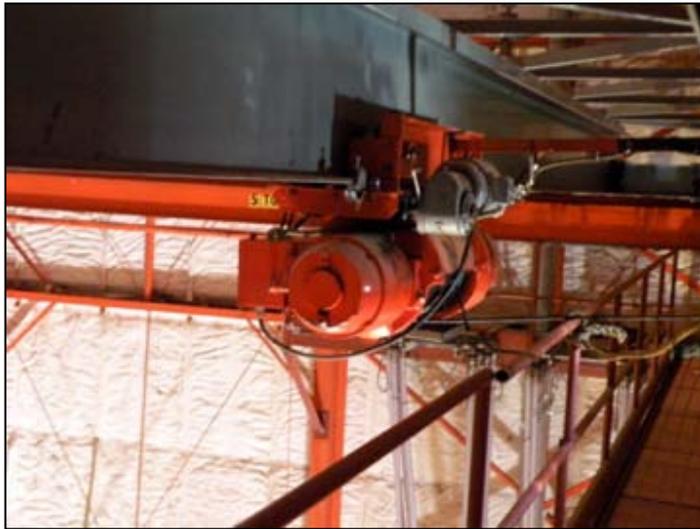
Figure 2-5. Catwalk view of trolley

Up on the catwalk, Rigger 3 and Millwright 1 began a discussion about securing the trolley and recognized that this task would be easier and safer to accomplish if the crane was rolled closer to them. They decided to move the crane from each end by turning the crane wheels. Rigger 3 proceeded to the set of crane wheels on the east end of the building. Millwright 1 walked towards the set of crane wheels on the west end of the building, heading directly toward the open hatch.

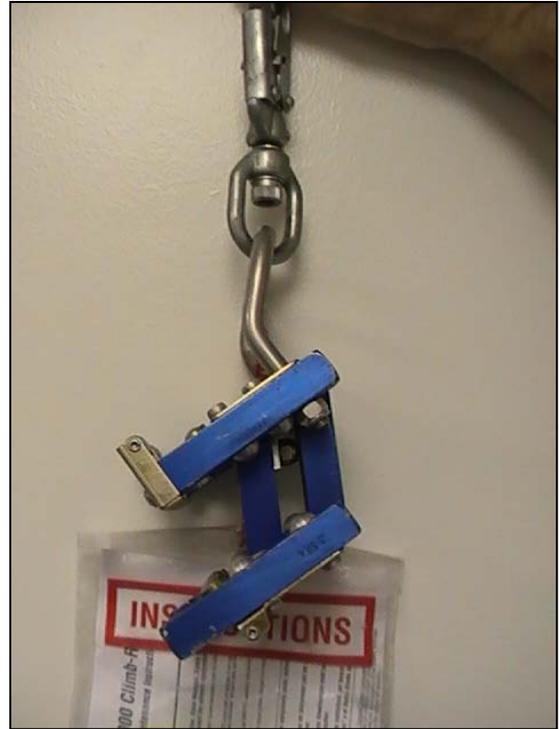
Figure 3-2. Sellstrom/RT 2000 Climb-Rite

The ladder had an engineered ladder safety system; however, the PSRs only made a cursory attempt to locate the device. Contributing to the failure to obtain the safety device was determined to be an unfamiliarity of the Planner and PSRs regarding WCH's facility transition process. The Board was able to locate and obtain the engineered ladder safety device (Sellstrom/RT 2000 Climb-Rite) in less than an hour. Not using this device exacerbated control of the catwalk hatch since the retractable lanyards that were used rubbed on the hatch when it was in a closed position.

The 336 Work Supervisor/300 Area D4 Superintendent and 336 PSR were involved in the decision to allow the free climb based on the "fitness and experience" of the rigger. The 324/327 PSR stated that he was "uncomfortable" with the free climb decision, but did not overtly object to it. Contributing to this decision was Rigger 2's ascertain that free climbing was safer than using the double-hook method to climb the ladder. The OSHA ladder standard, 29 CFR 1926.1051(b) and 29 CFR 1926.1053(a)(18), do not allow free climbs and require the use of fall protection systems, cages, or ladder safety devices when the length of the ladder exceeds 24 feet.
