Re: Type B Accident Investigation Board Report

**Type B
Accident Investigation Board Report
On the August 25, 2004
Head Injury to Miner
Waste Isolation Pilot Plant
Carlsbad, New Mexico**

On August 25, 2004, an employee of Washington TRU Solution, LLC (WTS) sustained a head injury when he was struck by a C-clamp and rope attachment that broke loose from a piece of metal vent line that was being dragged. This occurred as part of the development and recovery of an existing drift for underground disposal of waste at the Waste Isolation Pilot Plant (WIPP).

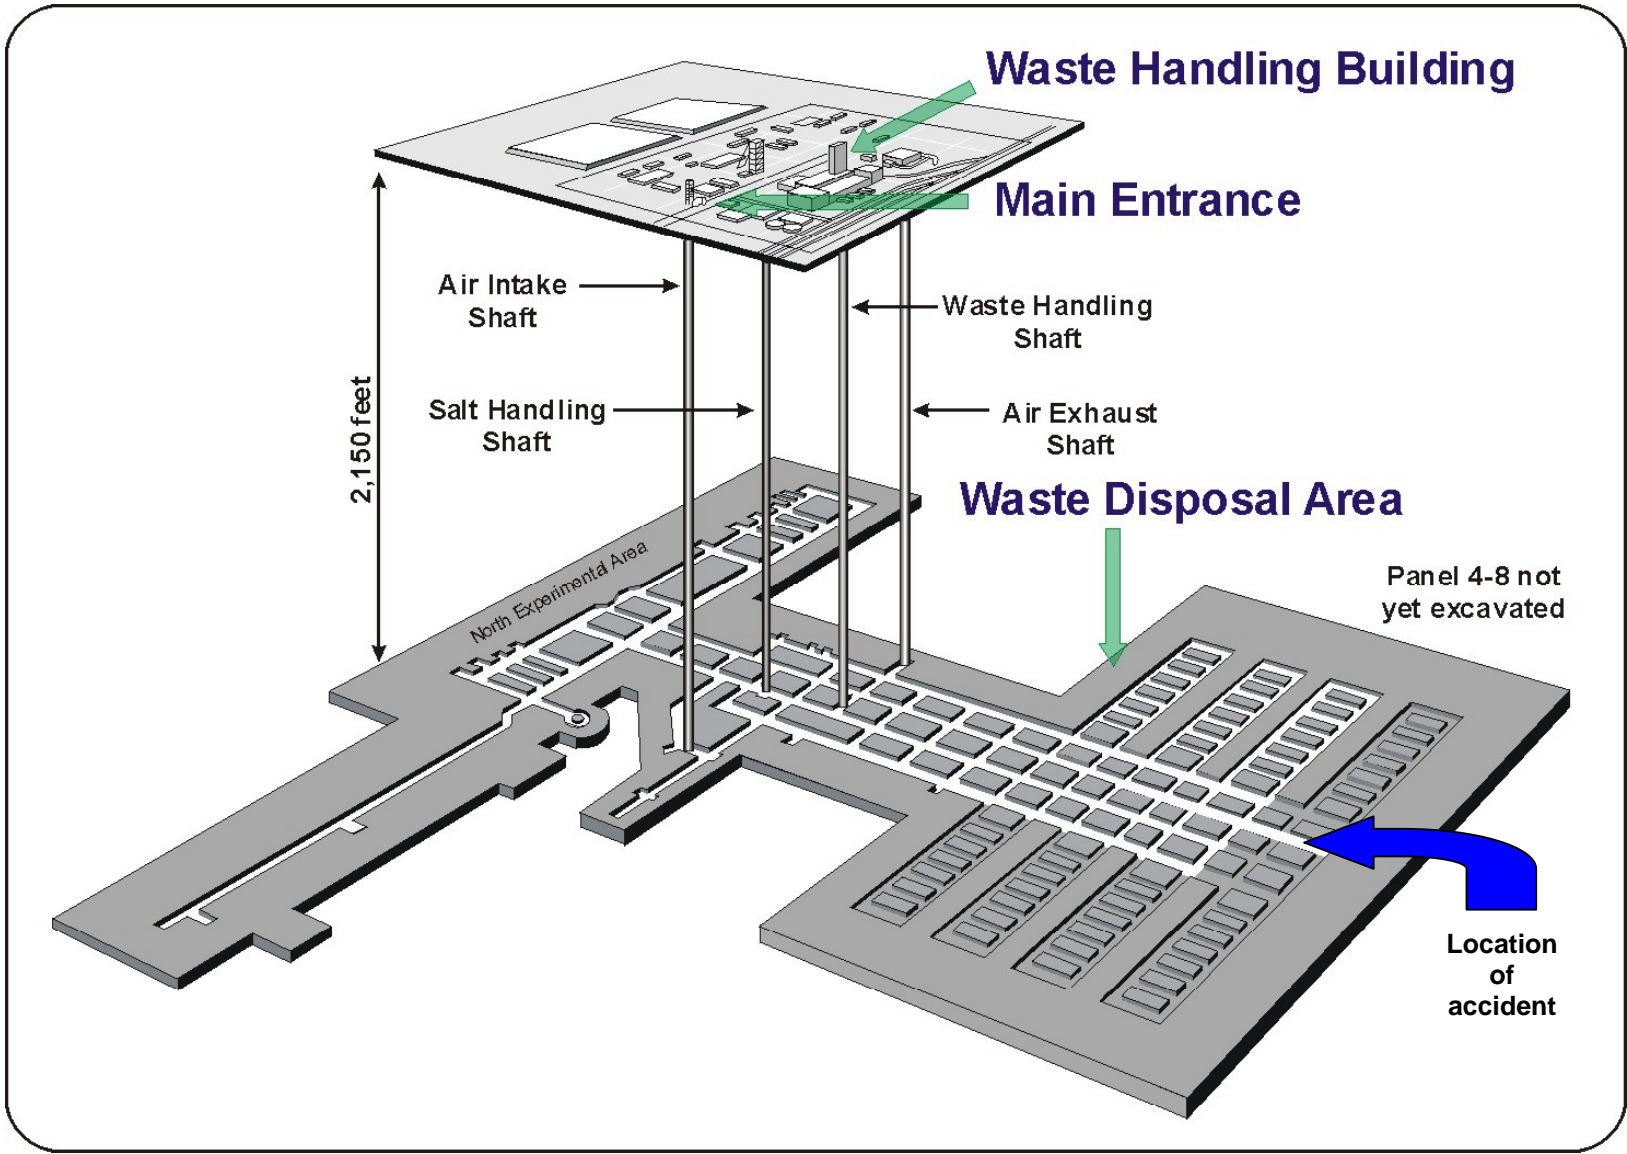
Figure 1: Location of the accident scene

Vertical shafts, including the waste shaft, the salt handling shaft, the exhaust shaft, and the air intake shaft, extend from the surface to the underground horizon as shown in Figure 1. These shafts are lined from the shaft collar to the top of the salt formation, approximately 850' (259m) below the surface, and are unlined through the salt formation.
