Section Four

ALARA Activities at DOE

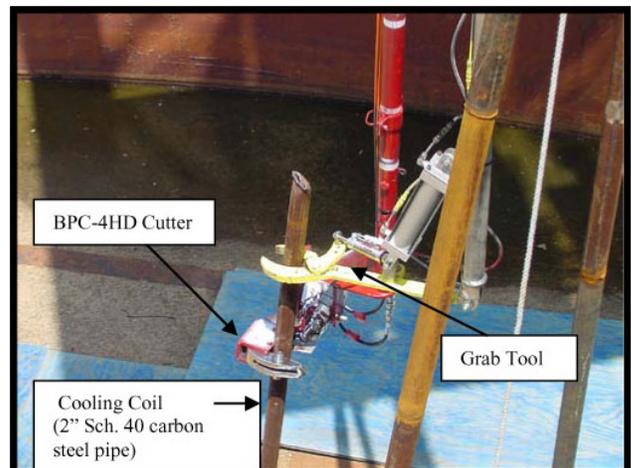
Exhibit 4-8:
Mock-up of Mega-Tech Blade Plunging

Operation of the cutting and grab tools was successfully demonstrated at T Area, also known as TNX, prior to use in FTF. Below is a picture taken during the mock-up.

- ◆ The riser was closed during the cutting activities, which eliminated the need for fall protection. The shield plate designed for the riser opening would reduce overall exposure to the individuals performing the task from 2 rem/hr to 28 mrem/hr.
- ◆ A stainless steel sleeve was fabricated and inserted into the riser opening to reduce spread of contamination from the riser wall to the cutting tool. A camera was inserted inside the riser with the tools. The workers were able to view a split screen monitor inside the hut, which enabled them to manipulate the mechanical arms of the tools.

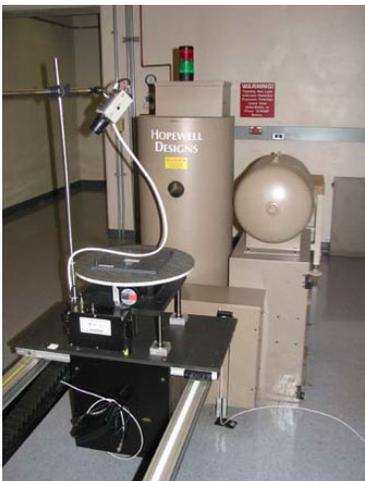
Exhibit 4-9:
GBI System

The Gamma Beam Irradiator (GBI) (see *Exhibit 4-9*) is located in building 735-2B at the Health Physics Calibration Laboratory. It contains 3 cobalt-60 and 3 cesium-137 sources and 1 dummy source (non-radioactive). Each source is encapsulated in a rabbit, a small aluminum container, and stored in a carousel 10 feet below the floor. The center of the rabbit contains a source, 2 washers, and a spacer (see *Exhibit 4-10*). The rabbit lid is screwed down and held in place with a set screw. These sources are used to calibrate radiation monitoring instruments used at the Savannah River Site.

During routine operation, in June 2007, the vacuum failed to capture and hold one of the Co-60 sources (1 Ci) at the suction cup. Several attempts were made, but all attempts failed. The carousel was then rotated to another source position and an attempt was made to transport it to the top of the transport tube. Instead, the carousel jammed. A time-out was called and the HPS Technical Director was notified.

The HPS Technical Director decided to insert a boroscope into the source transfer tube to determine the cause of the obstruction. The boroscope revealed the rabbit's lid containing the 1 Ci Co-60 source had become unscrewed causing the obstruction (see *Exhibit 4-11*). The HPS Technical Director notified the vendor and scheduled an appointment to come out to resolve the jam.

All other sources in the GBI had a second, longer set screw added to ensure that their rabbit's lid would remain intact during operation of the GBI.

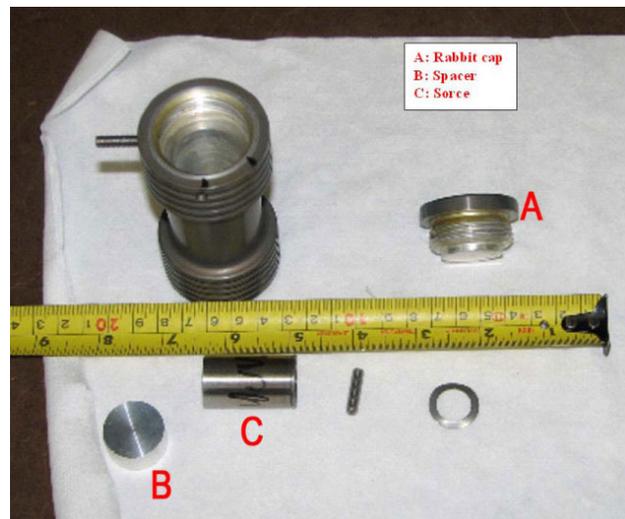
Exhibit 4-10:
Rabbit, spacer, source, washer and set

In July 2007, the vendor returned to remove the source and rabbit from the GBI. The vendor used the appropriate tools and removed the source and failed rabbit from the GBI. All rabbit internal parts (2 washers and spacer) were accounted for.

The rabbit and associated internal parts smeared <20 dpm α /100 cm², <200 dpm $\beta\gamma$ /100 cm² and probed no detectable. A visual inspection of the sealed source via boroscope indicated the source was not compromised. The source is currently inside an engineered shipping cask, temporarily stored in the GBI Room.

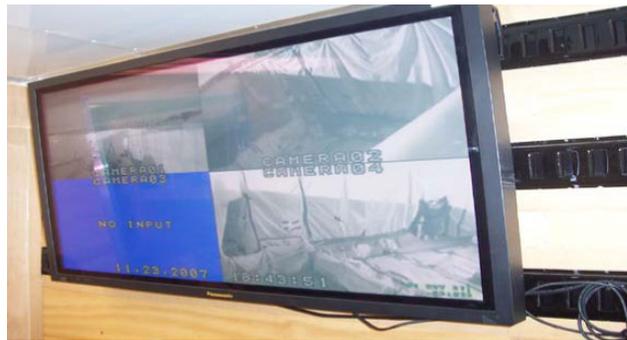
Exhibit 4-15:
Plasma screen with multiple camera

- ◆ A ROVER was setup for the command post at the job site.
 - Plasma screens to support all camera feeds
 - Tele Trax system (tracking dose)
 - Communication center
 - Used headsets and hand held radios to communicate into the work area
 - Plasma screen with multiple camera angles (see Exhibit 4-15).

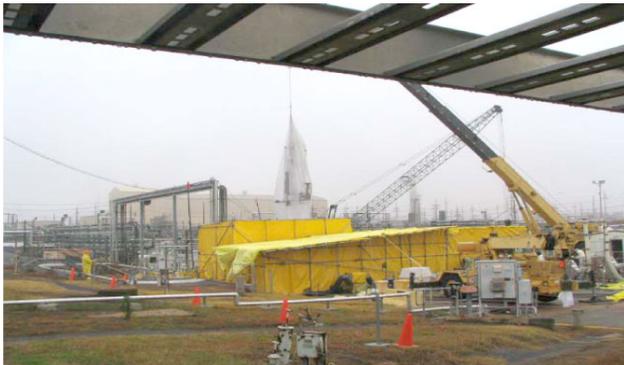
Exhibit 4-16:
Windbreak and two separate huts

- ◆ A windbreak was installed around pump pit-1 and diversion box-2 (see *Exhibit 4-16*).
- ◆ Two (2) separate huts were installed.
 - A repair hut was connected to the windbreak (via false wall).
 - Storage hut (storing large jumpers prior to de-sizing) prior to cutting valve stems to fit in JB-2 box, pending the completion of the photomultiplier tube (PMT).

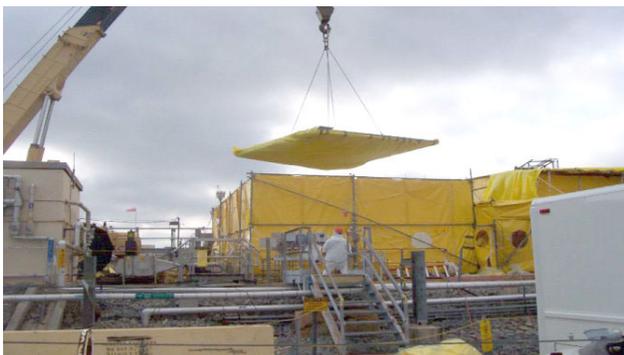
Exhibit 4-17:
Removable roofs to allow access.

- ◆ Removable roofs were installed to allow access for installation and removal of the jumpers (see *Exhibit 4-17*).
- ◆ A wind speed limit of 8 mph was enforced throughout the evolution (during the open pit/cell and while the hut roofs were removed), to minimize the risk of spreading contamination.

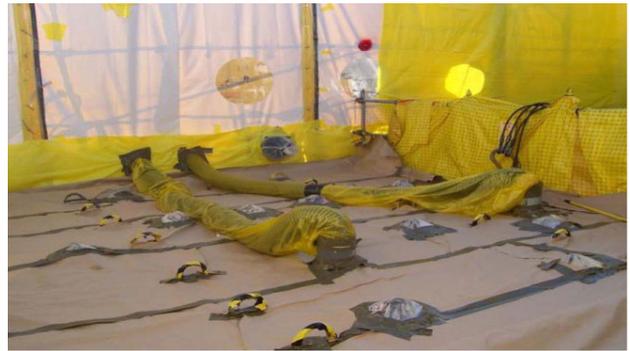
Exhibit 4-18:
Secondary portable HEPA exhausters.

- ◆ The installed pump pit ventilation system was the primary ventilation with the secondary ventilation of 2 newly designed 2500 cmf portable HEPA exhausters (see *Exhibit 4-18*). (Note: The negative airflow into the pit was at a minimum at best).

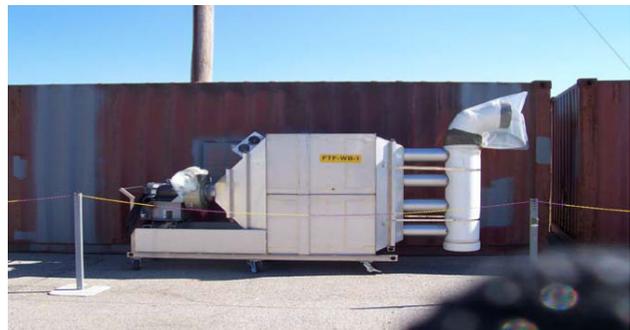
Exhibit 4-19:
Mock-up of adapter design.

- ◆ Mock-ups were performed to design an adapter (see *Exhibit 4-19*), to be lowered into the cell area (approximately 3 ft.).

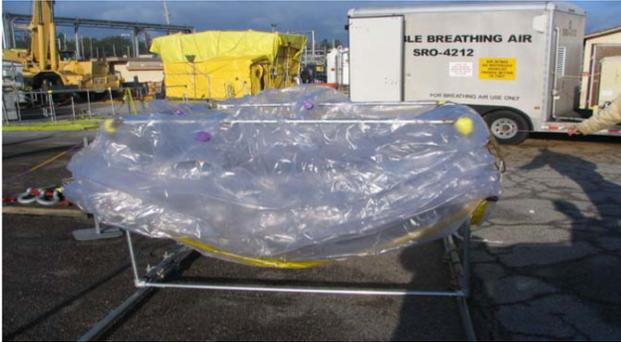
Exhibit 4-20:
Sleever containment for jumpers.

A uniquely designed containment for sleeving the jumpers was a Sleever Device (see *Exhibit 4-20*).

- ◆ Mock-ups were performed with the sleever and improvements were made to the sleever during the mock-ups and throughout the job.
- ◆ The sleever was staged across the pump pit (including the heavy sleeving and choker).
- ◆ After the choker was connected to the jumper, the crane started lifting the jumper through the sleever. The sleeving deployed off the sleever with a hands-off approach.

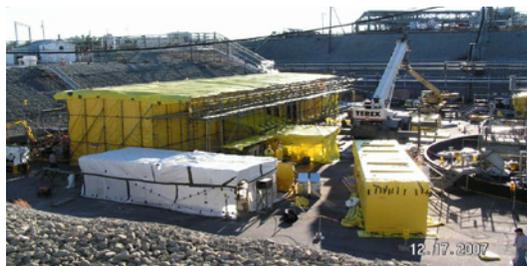
Exhibit 4-23:
HDB-2 and Tank 11 Overview

HDB-2 re-jumpering and Tank 11 transfer pump replacement field activities were completed without incident and with minimum personnel exposure (see *Exhibit 4-23*).
