# Los Alamos National Laboratory Plutonium Facility (PF-4) Seismic Safety

*October 22, 2014*

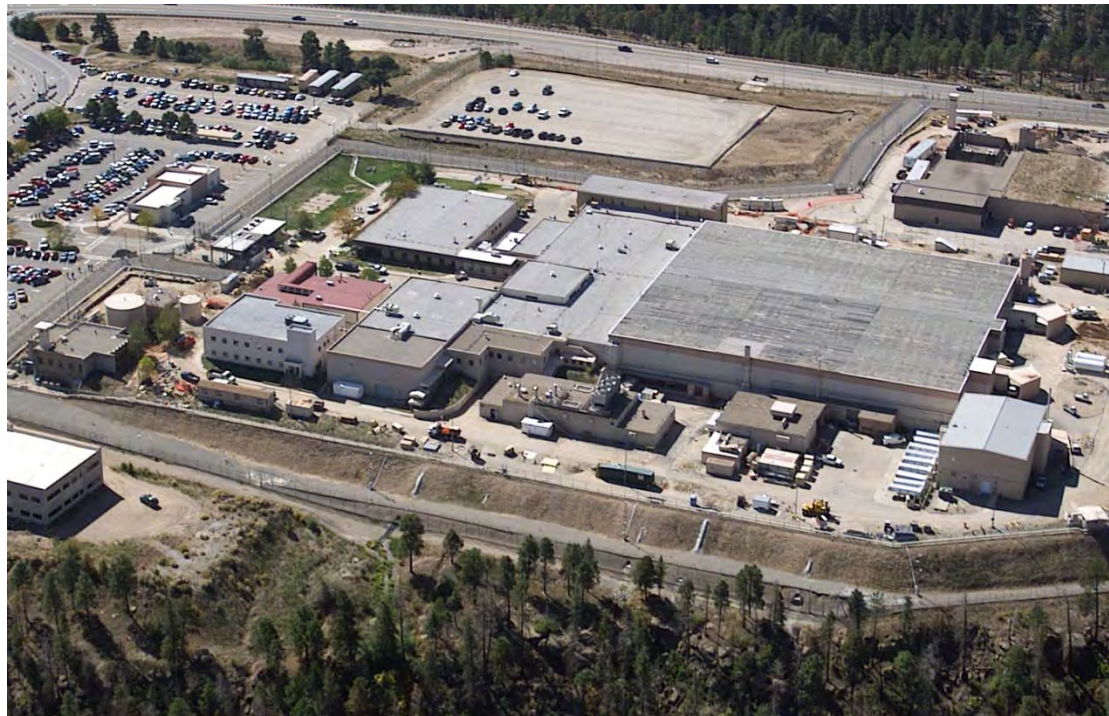
- PF-4 is the nation's enduring Pu R&D and production capability
- Designed to early 1970's requirements and a less demanding earthquake
- Operational since 1978
- Two-story shear-wall structure, partially embedded on 3 sides
- ~233,000 ft<sup>2</sup> overall

- PF-4 lacks modern ductile detailing: there is little additional margin between an earthquake that initiates failures and a slightly larger one that induces collapse
- PF-4 lacks redundant load-carrying path-ways; failure of one component (e.g., a roof girder) could lead to a progressing failures of adjacent components

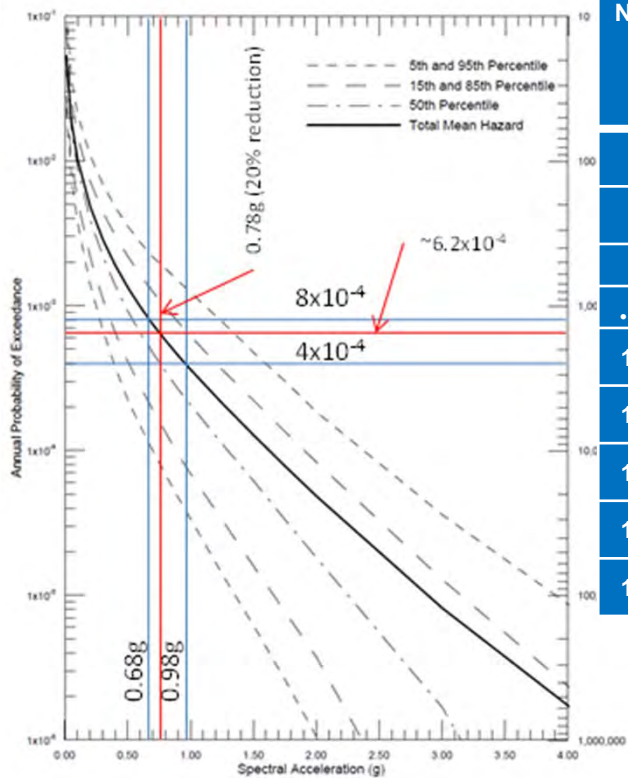
TA-55 Seismic Hazard Curve  
(Spectral Accelerations @ 5Hz)

- The LANL seismic hazard curves limited the hazard-level reduction to 80%
- With this relief, as-is, PF-4 meets the alternate acceptance criteria

No.	Component Failure Mode	0.8xDBE*	Cond	1.2xDBE	Cond
			P <sub>F</sub> ** @0.8xD BE	*	P <sub>F</sub> ** @1.2xD BE
1	Shear failure of interior roof girder on Gridline 8 leading to collapse	0.8056	0.7%	1.2084	4.5%
2	Tension-shear failure interior roof girders leading to collapse	0.8056	0.4%	1.2084	3.0%
3	Shear failure of exterior roof girder	0.644	0.2%	0.966	1.5%
...					
10	Flexure yielding of exterior roof girder leading to large vertical displacements and possible collapse	0.644	<0.1%	0.966	0.1%
11	Tension-Flexure yielding of interior roof girder leading to large vertical displacements and possible collapse	0.8056	<0.1%	1.208	<0.1%
12	Probability of failure based on combined fragility of lateral and vertical failure modes.	0.8056	<b>0.8%</b>	1.2084	<b>4.8%</b>
13	Probability of failure based on combined fragility of vertical mechanisms	0.8056	<b>0.8%</b>	1.2084	<b>4.8%</b>
14	Probability of failure based on combined fragility of lateral mechanisms	0.6376	<0.1%	0.9564	0.7%
