## Building America Case Study

# Investigating Solutions to Wind Washing Issues in Two-Story Florida Homes: Phase 2

**Project Name:** Investigating Solutions to Wind Washing Issues in Two-Story Florida Homes: Phase 2

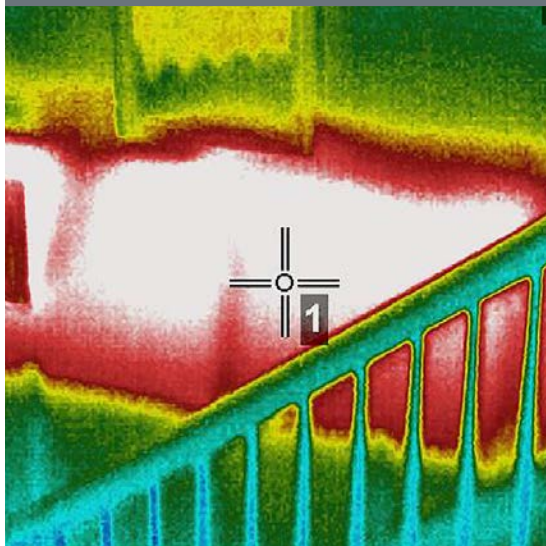
Figure 1. Wind washing is caused by air movement into the soffit, then into the attic, and finally into the floor space. Wind-driven attic air is pushed into the space between floors, bypassing house air and thermal boundaries.
