Accident Investigation Report

Phase 2 Radiological Release Event at the Waste Isolation Pilot Plant, February 14, 2014

April 2015

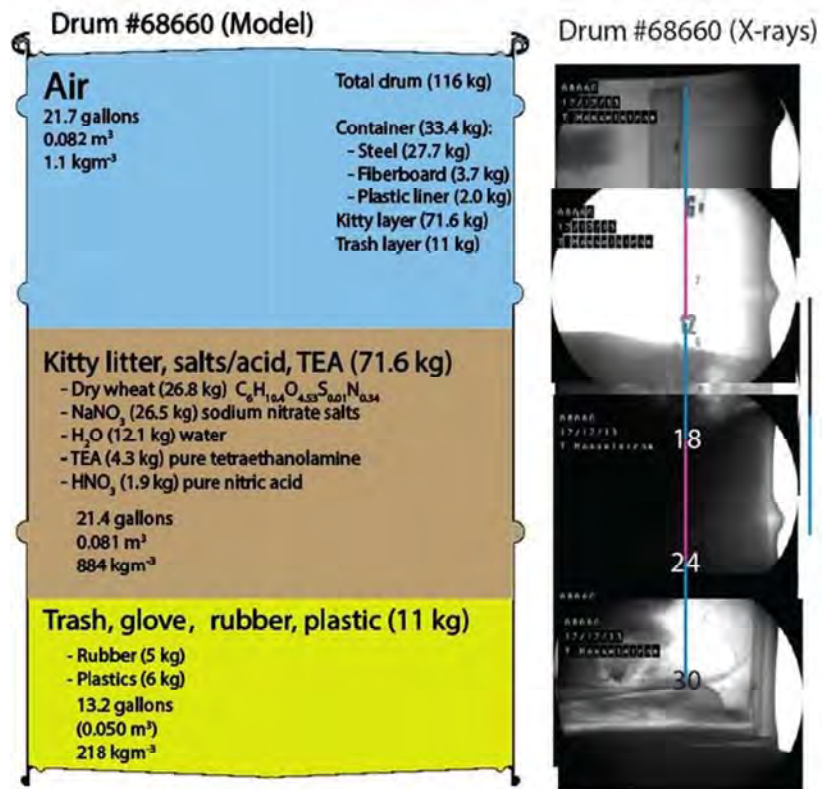
Figure 5-1: Drum 68660 Model Contents

On December 4, 2013, ES remediated parent drum S855793 in accordance with the glovebox procedure, producing daughter drums LA00000068660 (68660) and LA00000068685 (68685). Drum 68660 was repackaged by first adding some secondary waste including a tungsten-lined glovebox glove.

Approximately two gallons of free liquid were decanted from the parent drum. The pH was measured and recorded to be 0 (zero). The pH was adjusted using KOLORSAFE® to an unspecified final pH. Swheat Scoop® organic kitty litter was added as the absorbent and was placed in the drum. Additional bags of nitrate salt were absorbed and placed in the drum. See Figure 5-1 for a drum contents model.

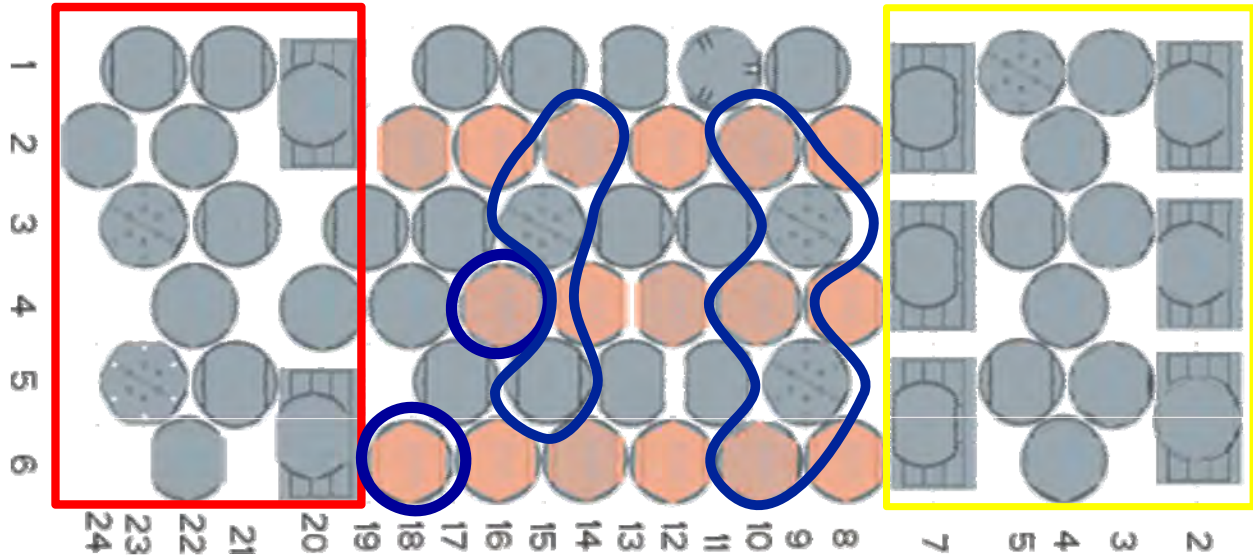
Figure 6-2: Panel 7 Room 7 Array Arrangement

The visual inspections found evidence of slight localized discoloration of the Panel 7 Room 7 south rib (wall) that was the result of fire exposure. There were no such discolorations of the north rib, back (overhead), or bulkhead and no significant accumulations of soot on these three surfaces. This evidence indicates that flashover in Room 7 did not occur. The inspection demonstrated that the primary fire damage was intermittently dispersed in the array between Rows 8 through 18 (Figure 6-2). No physical damage was evident for waste containers in Rows 2 through 7 (yellow box in Figure 6-2), or Rows 19 through 24 (red box in Figure 6-2). The most significant damage occurred in the regions marked in blue on Figure 6-2.

NOTE: Significantly damaged MgO Super Sacks shown in peach.

The significant fire damage in the waste array was centered on locations with the most exposed combustible materials. These areas included Rows 9 and 10; Rows 14 and 15, R16:C4 and R18:C6 (Figure 6-2). The extent of damage ranged from complete loss of exposed material (fiberboard and polyethylene slip sheets, reinforcement plates, stretch wrap, cardboard stiffeners

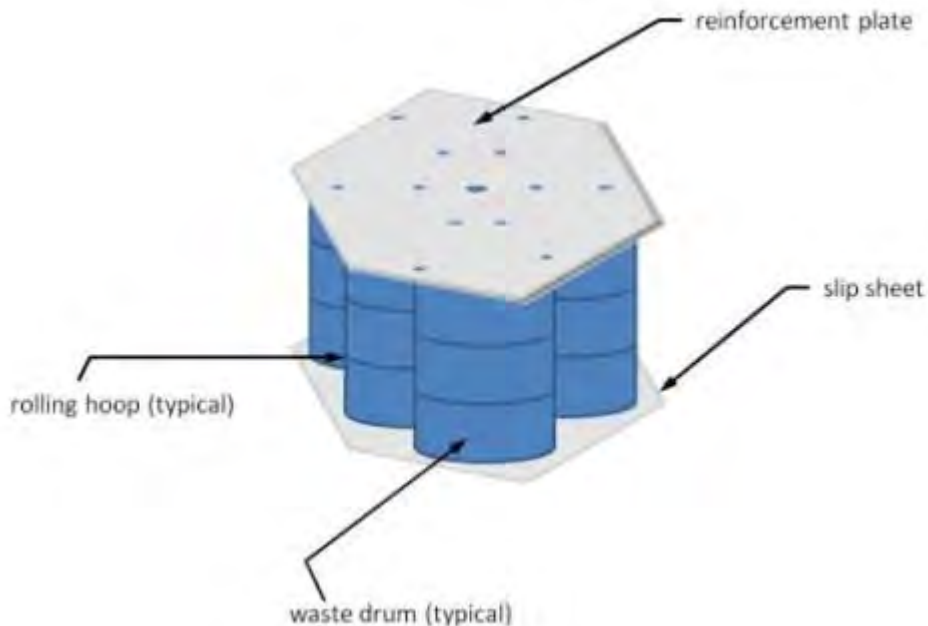
Figure 6-3: Drum Waste Assembly with Slip Sheet and Reinforcement Plate

Visual damage within the waste array was most severe at, or near, locations with 55GD and 100GD. These were locations with higher quantities of combustibles external to the waste containers such as fiberboard and polyethylene slip sheets, reinforcement plates, stretch wrap, cardboard stiffeners and polypropylene super sack fabric (Figure 6-3). Evidence of both melting and ignition were identified at these locations. Polyethylene is categorized as an easy-to-ignite material and has a melting temperature range of 122 – 135°C (NFPA 921, pp 51) and the observed damage was consistent with this information.

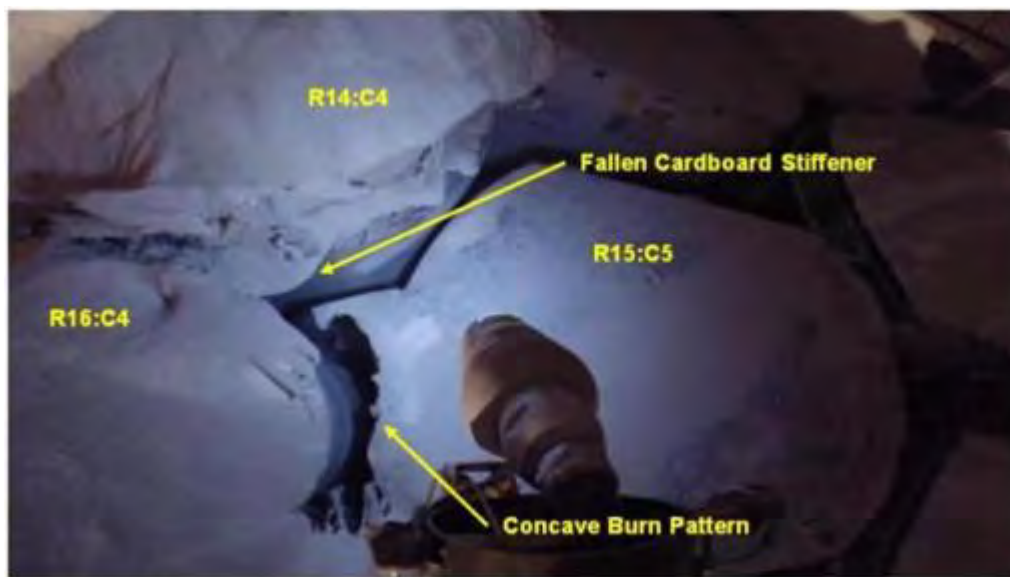
Figure 6-6: Evidence of Flaming Combustion Irregular Edge Surfaces at R15:C5

The cardboard stiffeners collapsed into multiple final orientations: hanging from a stack edge, cantilevered over the edge of a waste package, bridging between two stacks, or resting on the floor. Some of the locations where the stiffeners were cantilevered or bridging exhibited irregular edge surfaces (Figure 6-5). At R15:C5 there was a concave burn pattern in the portion of the cardboard that was cantilevered over the edge of the lid of a standard waste box (SWB) (Figure 6-6). The burn-pattern is typical of horizontal material exposed to a flame from below. Similar materials may burn as long as exposed to an external flame, but will likely self-extinguish once the flame is removed. There were also smaller cardboard remnants lying on the lid. These remnants display striations of the corrugated layer within the original cardboard matrix.

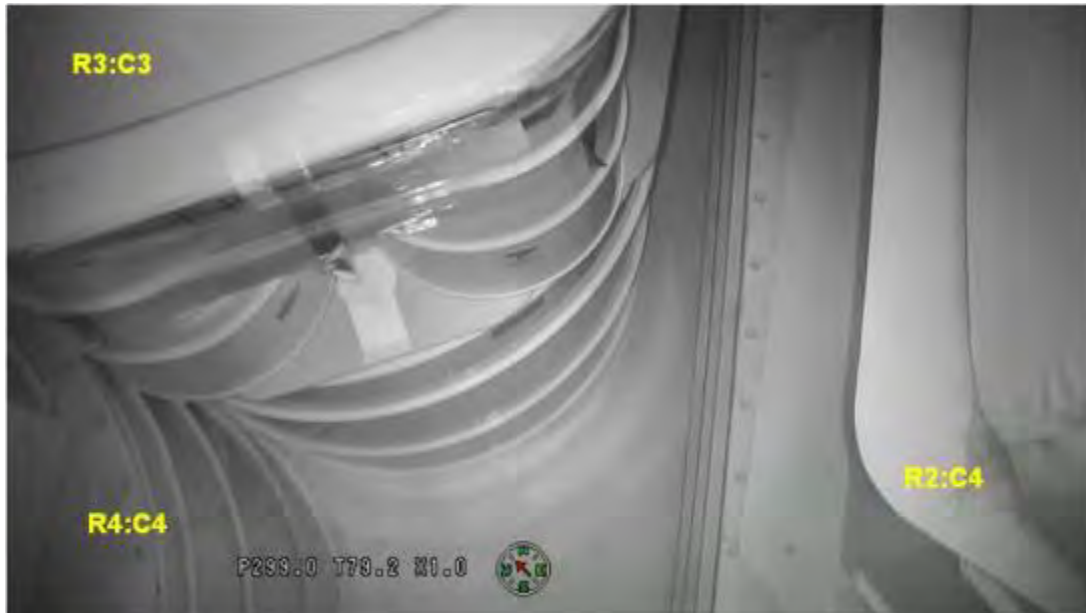
Figure 6-8: Undamaged Stretch Wrap at R3:C5

Rows 2 through 7 contained a mix of TDOPs, SWBs, 55GD assemblies, 100GD assemblies, and Standard Large Box Type 2s. These rows were closest to the bulkhead. The inspection identified no fire-related damage to the polyethylene stretch wrap or the polypropylene super sacks in these rows. The lack of damage to the polyethylene stretch wrap in these rows establishes that the bulk air temperature passing over the array was low, nominally below 135°C, which is the upper value of the melting temperature range of the polyethylene stretch wrap¹² (Figure 6-7, Figure 6-8 and Figure 6-9).

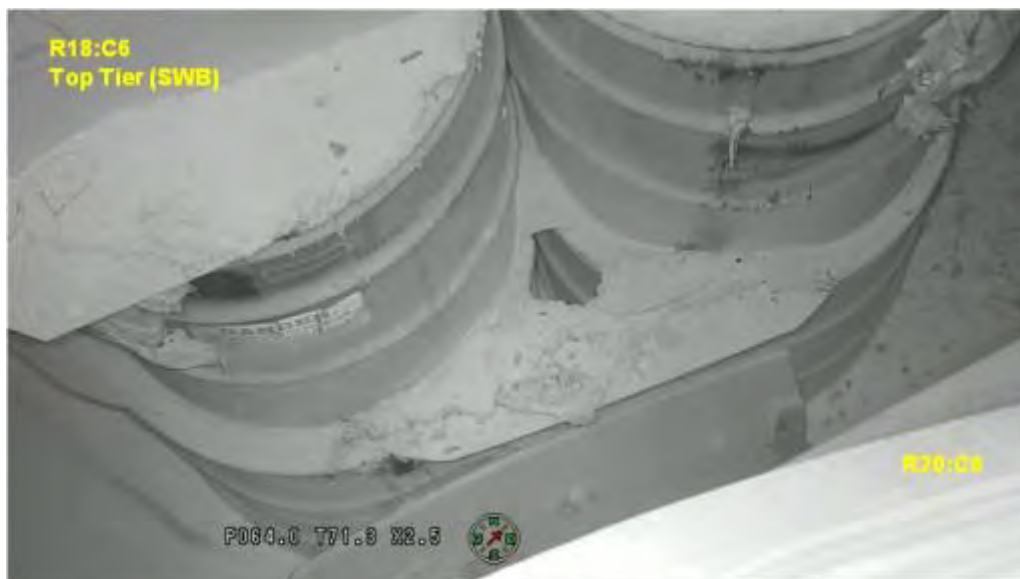
Figure 6-12: Face Side (west) of R18:C6 Middle Tier

Based on the orientation of the stack, the stack damage, and the ventilation direction, a hot or flaming ember is considered a plausible means of fire propagation to R18:C6. This ember landed on the fiberboard slip sheet that was below this SWB and caused ignition of the fiberboard. The fire consumed the exposed fiberboard above the two west drums (the drums on the face-side of the array, Figure 6-11). The reinforcement plate below the fiberboard burned and melted with the remaining material following the contour of the two west drums (Figure 6-12). The middle-tier stretch wrap on the west side was also damaged. There are streaks of polyethylene on the sides of the waste drums. The slip sheet and reinforcement plate between

This fire-propagation mechanism likely occurred at R18:C6, where the exposed MgO super sack fabric or a slip sheet ignited when the ventilation perturbation occurred following the failure of waste drum 68660 (Figure 6-12).

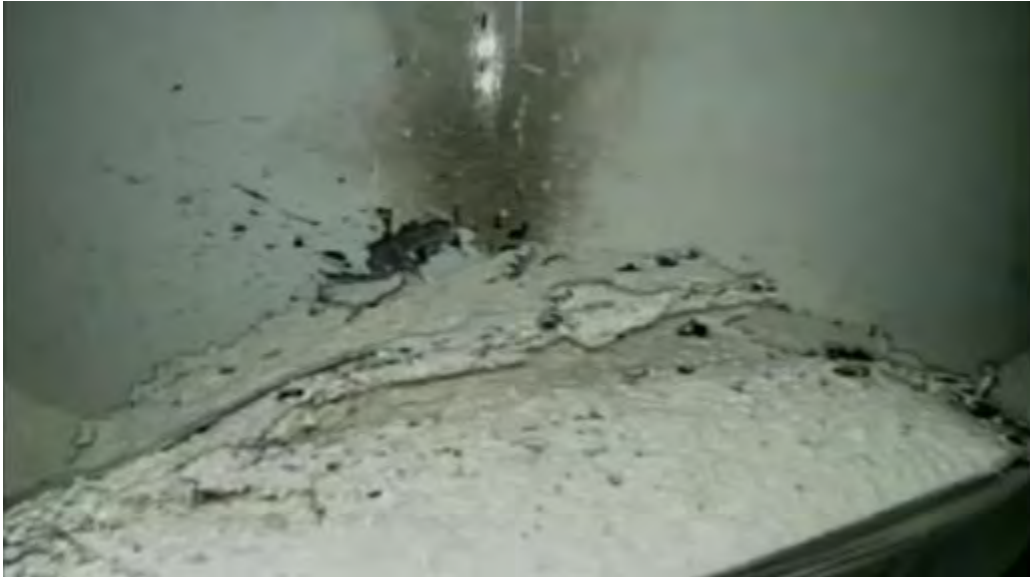
the middle and bottom 55GD assemblies appears to be intact although a variety of debris have accumulated on the top of the reinforcement plate. In some locations fallen material has combusted resulting in discoloration of a waste container. In one location sufficient flame exposure occurred to leave a clean burn pattern where all of the dirt, paint, and soot has burned away leaving a bright metal surface (Figure 6-13). The stretch wrap on the north-west corner of the lower tier was also damaged by flames (Figure 6-14). Except as noted, no other damage to the stretch wrap was identified in this stack.

Figure 6-13: Face View (west) Base of Middle Tier Drum at R18:C6

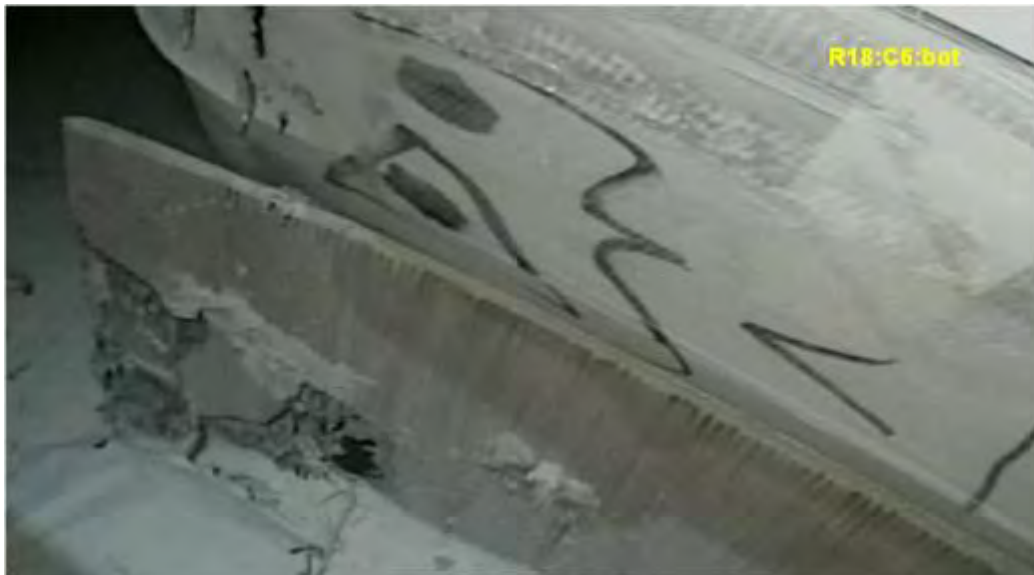
The MgO super sack was damaged by the fire. The polypropylene fabric melted, burned or fell from all sides of the super sack. On the north side the cardboard stiffeners and fabric were trapped between the MgO and the SWB lid. The stiffener and fabric formed a cantilevered bridge that supported a pile of displaced MgO (Figure 6-15). On the west side, a stiffener fell to the floor where it was partially covered by MgO (Figure 6-16). The vertical edges of this

Figure 6-16: Face View (west) – Debris at Base of R18:C6

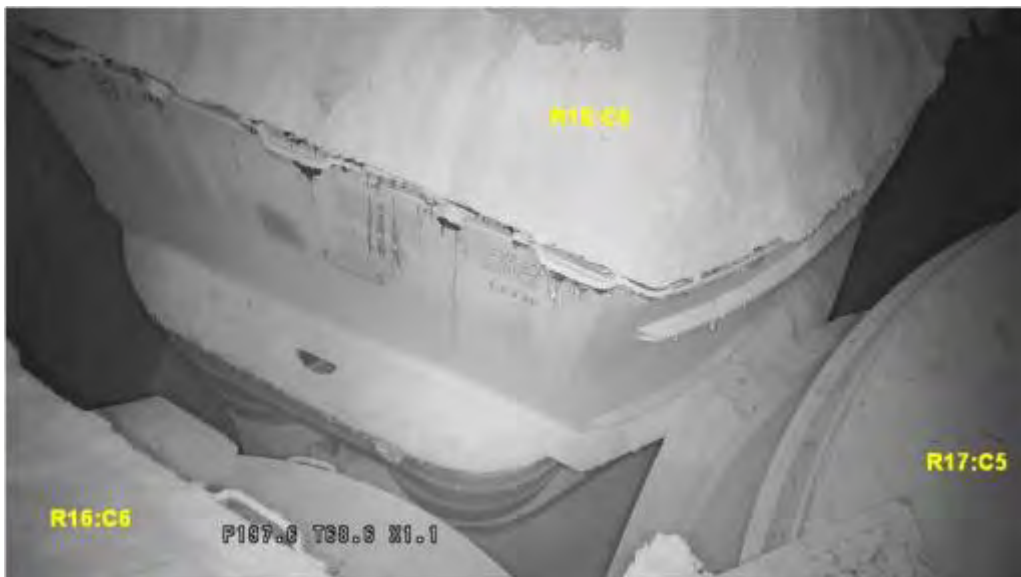
Figure 6-18: Bulkhead Side of R18:C6

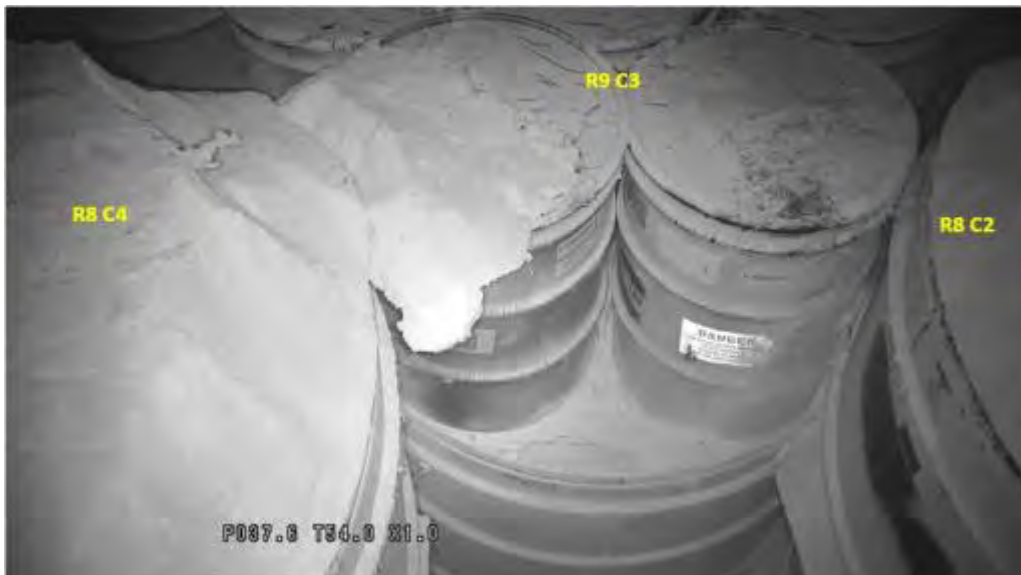
had no observable fire damage, stretch wrap at each of the other five stacks was damaged or missing. The 55GD assembly reinforcement plates at R9:C3 and R9:C5 melted, mixed with MgO, solidified on the drum lids, and cracked into pieces (Figure 6-19, Figure 6-20, Figure 6-21, Figure 6-22, Figure 6-23 and Figure 6-24). There was no evidence of reinforcement plate remaining between the drums. In some instances melting polyethylene formed streaks on the on the side of these drums. In addition, MgO slumped onto some of the drums in both locations.

Figure 6-20: R9:C3 Bulkhead View (east)

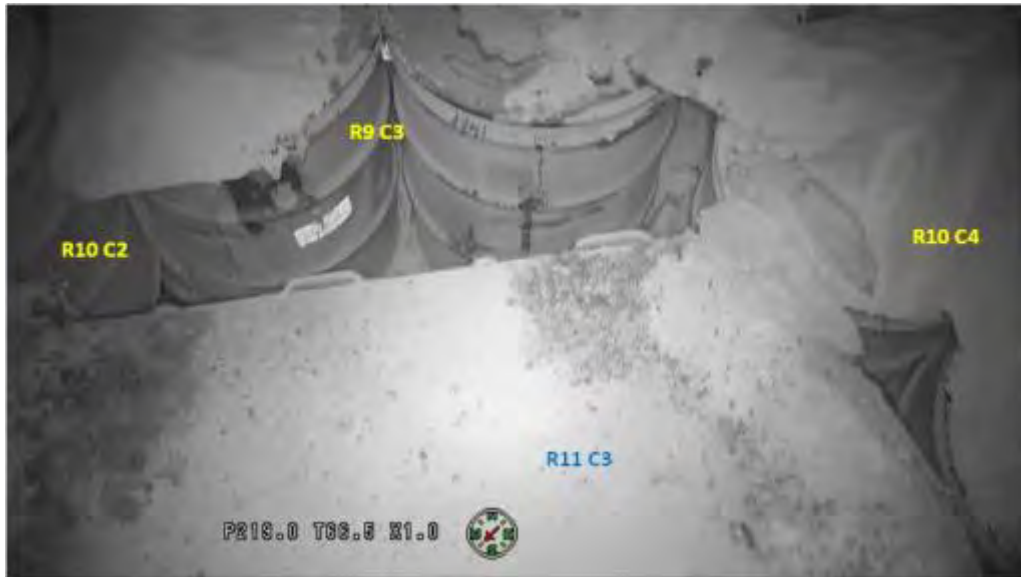
Figure 6-21: R9:C3 West Side

The MgO super sacks in Row 10 were damaged, with most of the fabric melted or gone (Figure 6-21, Figure 6-22, Figure 6-24, Figure 6-25, and Figure 6-26). The residual MgO formed conical piles consistent with the outline of the waste containers on the top tier at each stack. At R10:C6 the 100GD assembly slip sheet, the middle tier reinforcement plate and slip sheet, were partially damaged and conformed to the outline of the drums (Figure 6-27). Many locations had

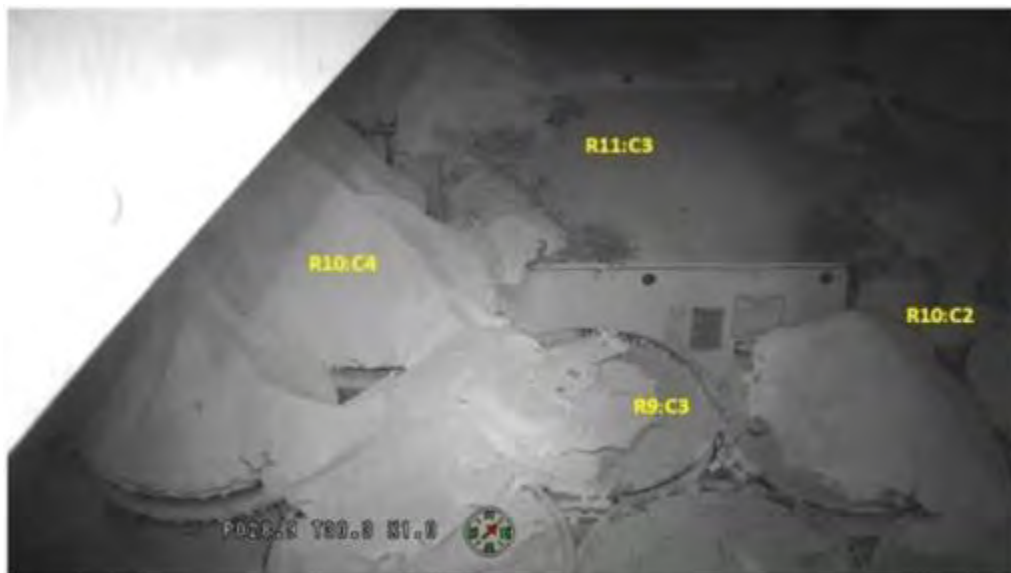
Figure 6-24: R10:C2, R9:C3 and R10:C4 East (Bulkhead) View

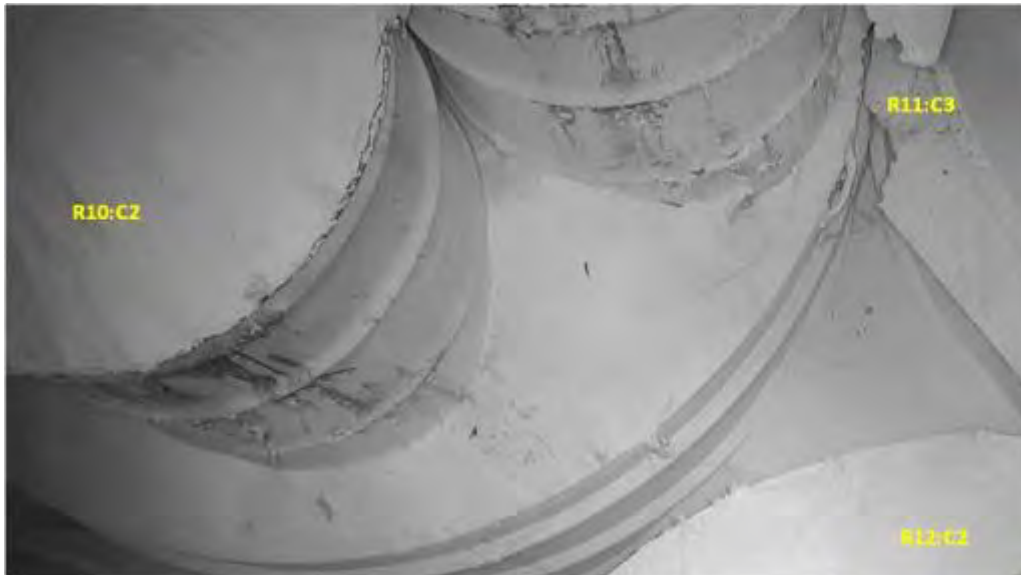
Figure 6-26: R10:C2

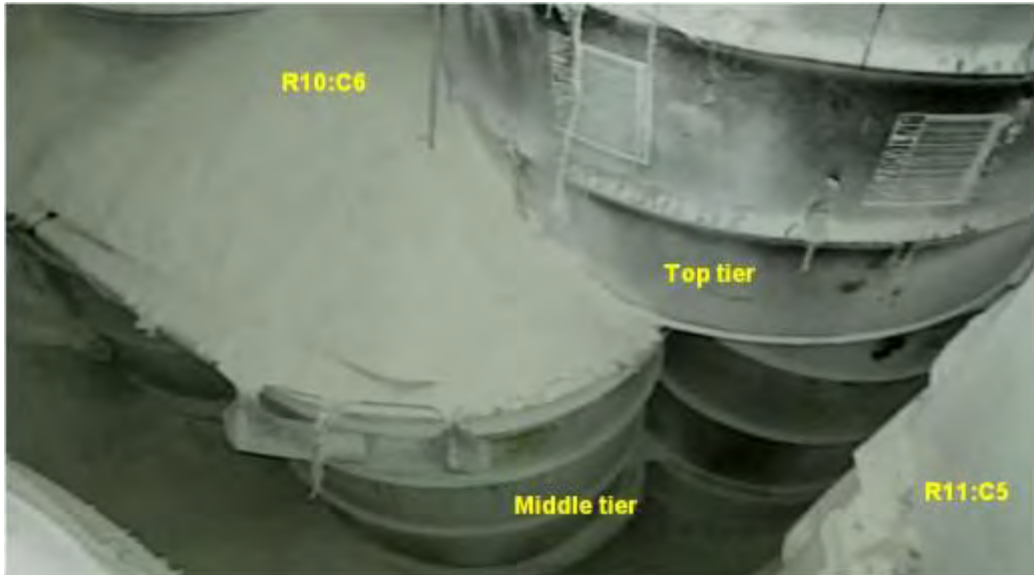
Figure 6-27: R10:C6

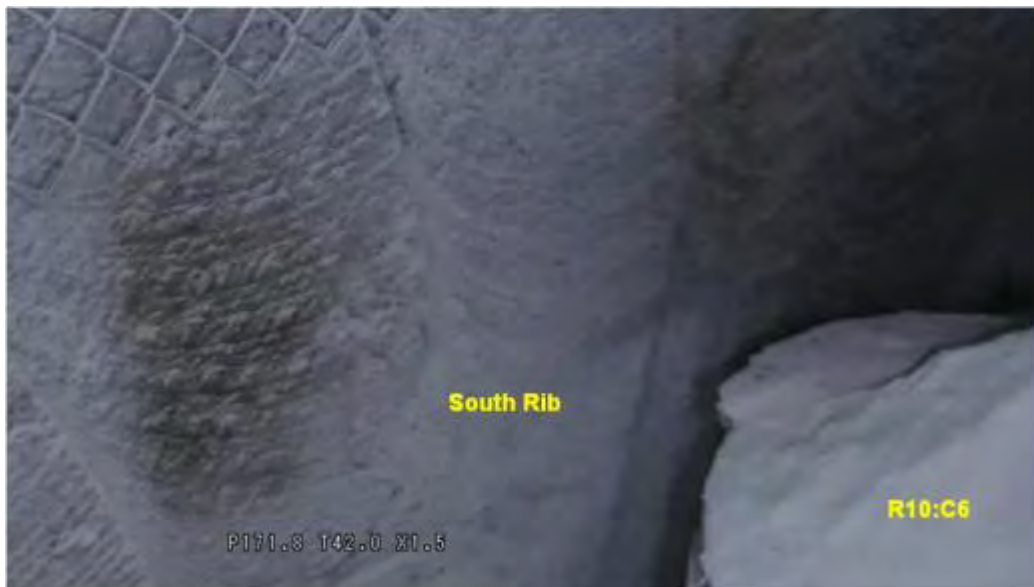
evidences of black discolorations on the sides of the waste drums. There was also evidence of flame impingement on the south rib (Figure 6-28).

Figure 6-28: Flame Impingement Evidence on South Rib near Row 10

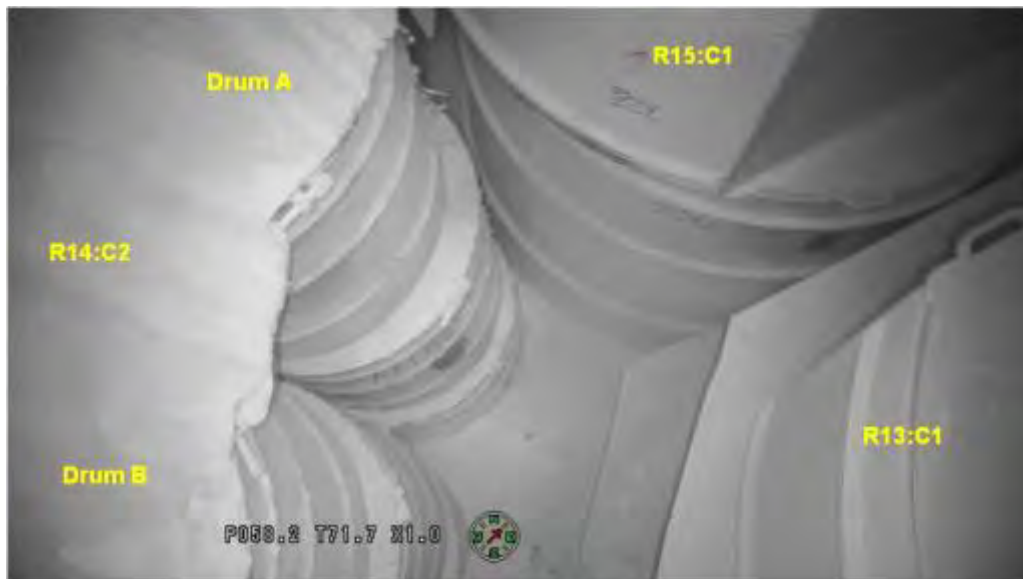
The exposed plastics (fiberboard and polyethylene slip sheets, reinforcement plates, stretch wrap, cardboard stiffeners and polypropylene super sack fabric) in stack R14:C2 were severely damaged. The polyethylene plastic burned and melted to the outline of the waste drums (Figure 6-29 and Figure 6-30). The MgO formed three conical piles on the three top-tier drums (Figure 6-31). The 100GDs were originally a glossy black, but were covered with a coating of fine white powder (Figure 6-32).

Figure 6-29: North View

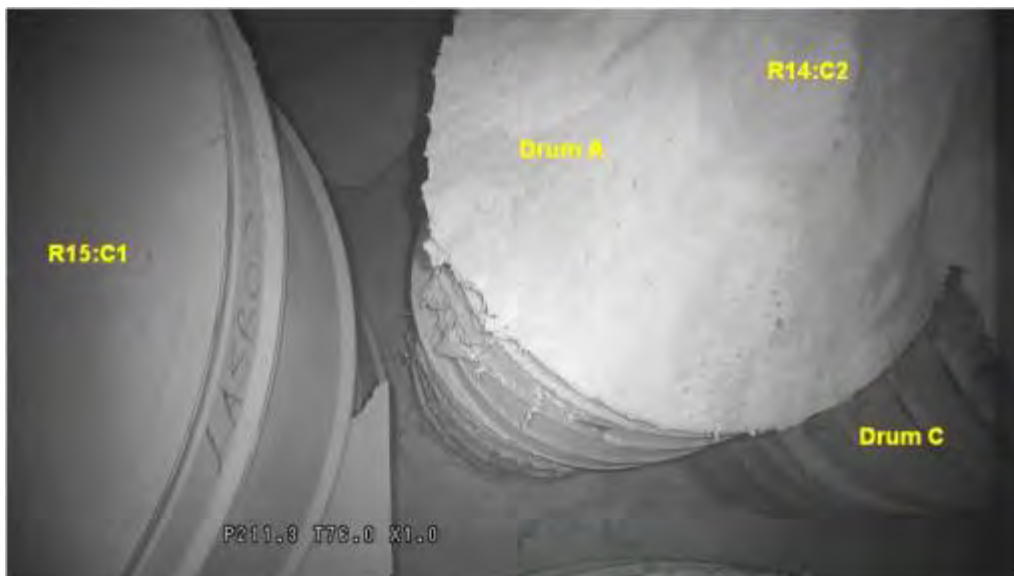
Figure 6-30: West (face) View

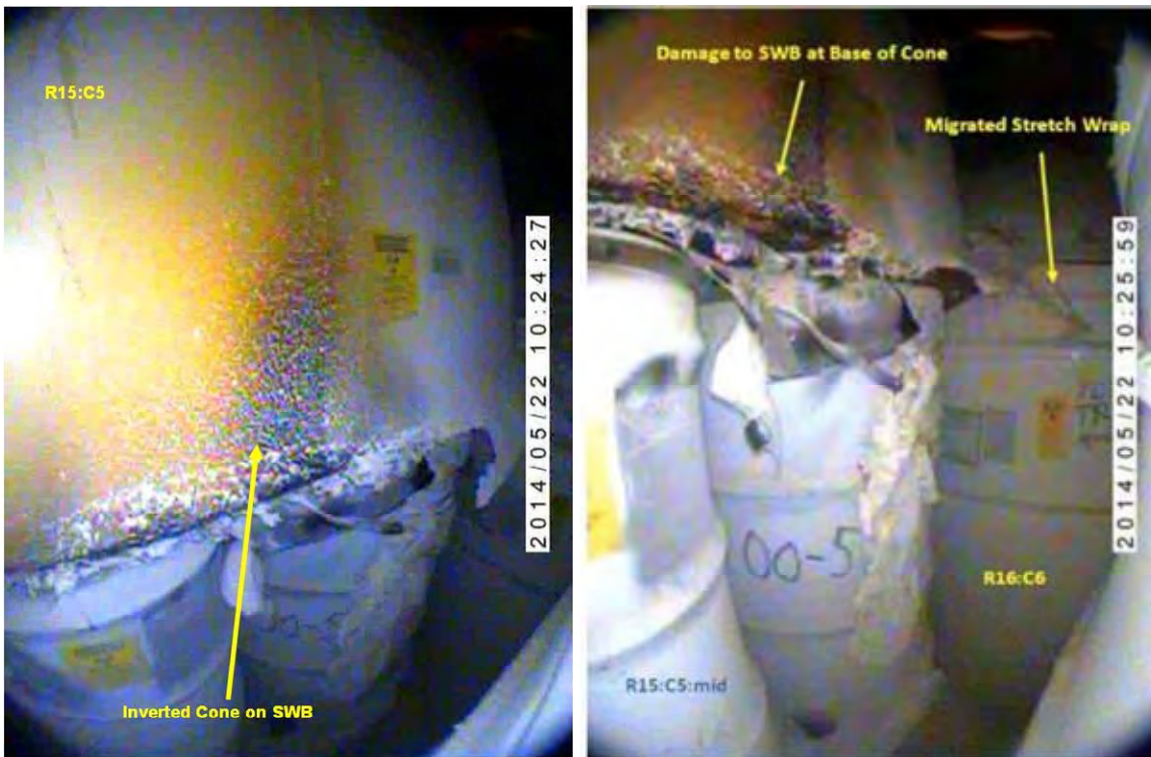
Figure 6-36: Side of SWB at R15:C5:top

The reinforcement plate and fiberboard slip sheet between the middle and top tiers of R15:C5 was severely damaged and partly burned on the west (face) and north sides. Much of the polyethylene stretch wrap was missing from these locations. There was discoloration indicative of overheating on the west side of the SWB near the seal (Figure 6-35). There was an inverted-cone pattern on the SWB centered between the two west-most middle-tier drums (Figure 6-36). The fiberboard slip sheet had a U-shaped damage pattern (Figure 6-37). This is indicative of flame exposure to the fiberboard from below. When the flame exposure ceased, combustion of the horizontal fiberboard likely stopped. The fiberboard slip sheet and reinforcement plate were badly damaged below the north end of the SWB (Figure 6-38). Char from the slip sheet conformed to the middle tier 55GDs.

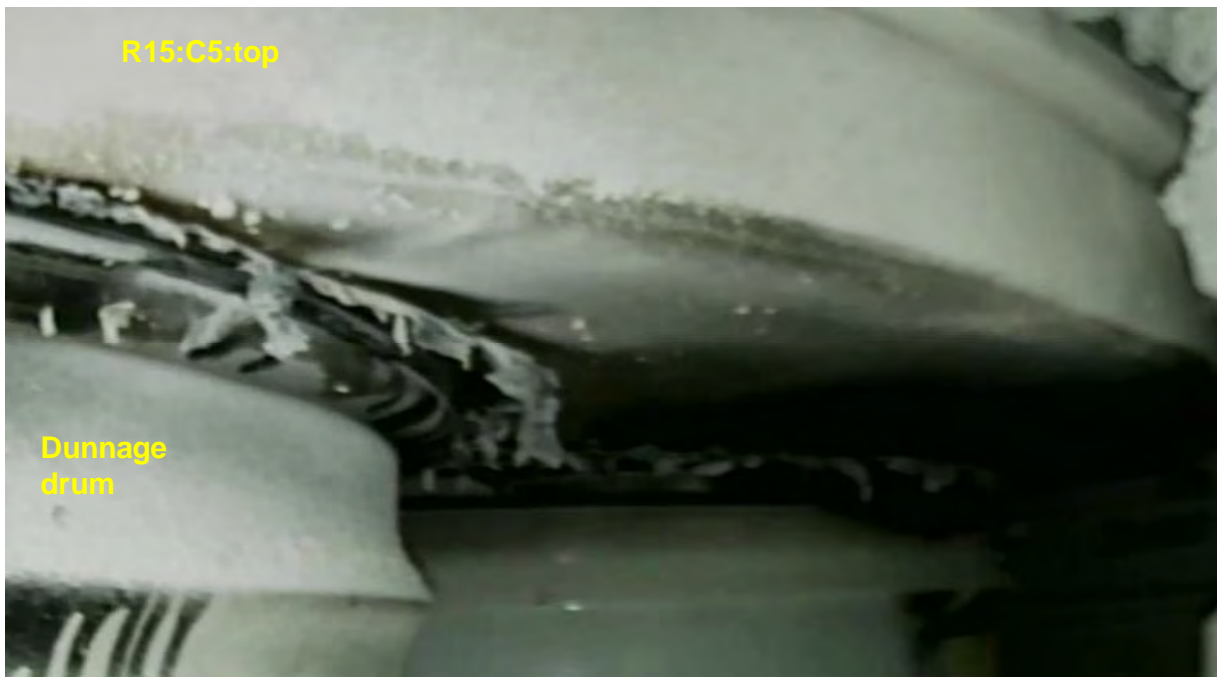
Figure 6-38: North View of R15:C5, Bottom of SWB on Top Tier

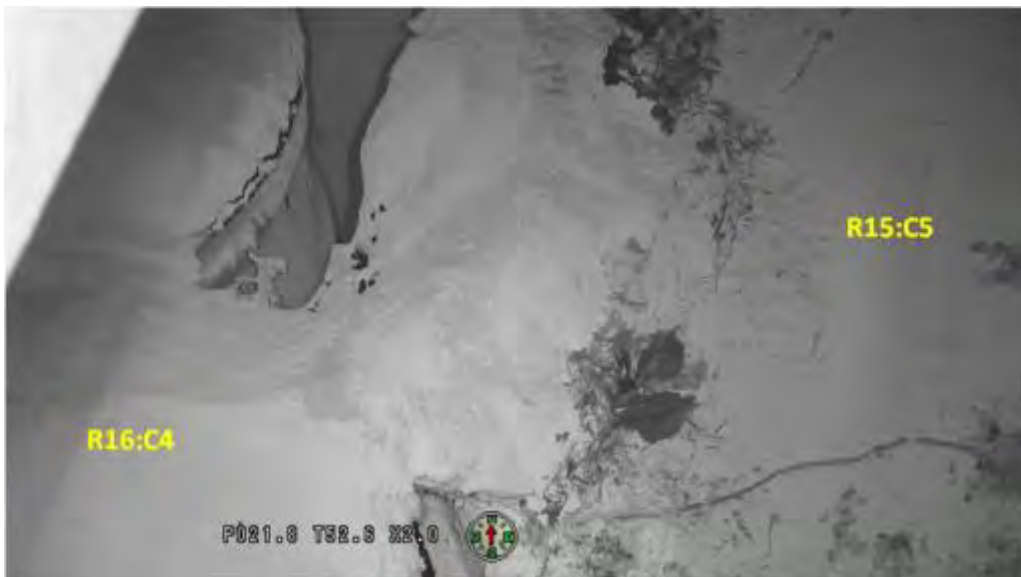
There was a moderate quantity of clumped material and MgO spillover on the SWB lid at R15:C5 (Figure 6-41). The depth of this material was greatest on the northwest corner where the stack is in close proximity to R16:C4 (Figure 6-42). The north end of the lid had evidence of combusted cardboard stiffener material from the MgO bag that was placed on top of R16:C4. Additionally, there was a fallen cardboard stiffener lying on the north end of the lid. There were two spots on the southeast and southwest corners of the lid where white MgO was seen on top of the discolored material spread across the remainder of the lid. This suggests that the MgO sacks on R16:C6 and R14:C6 spilled their contents sometime after the clumped material dispersed across the lid surface.

Figure 6-42: Bridge between the R15:C5 SWB Lid and R16:C4

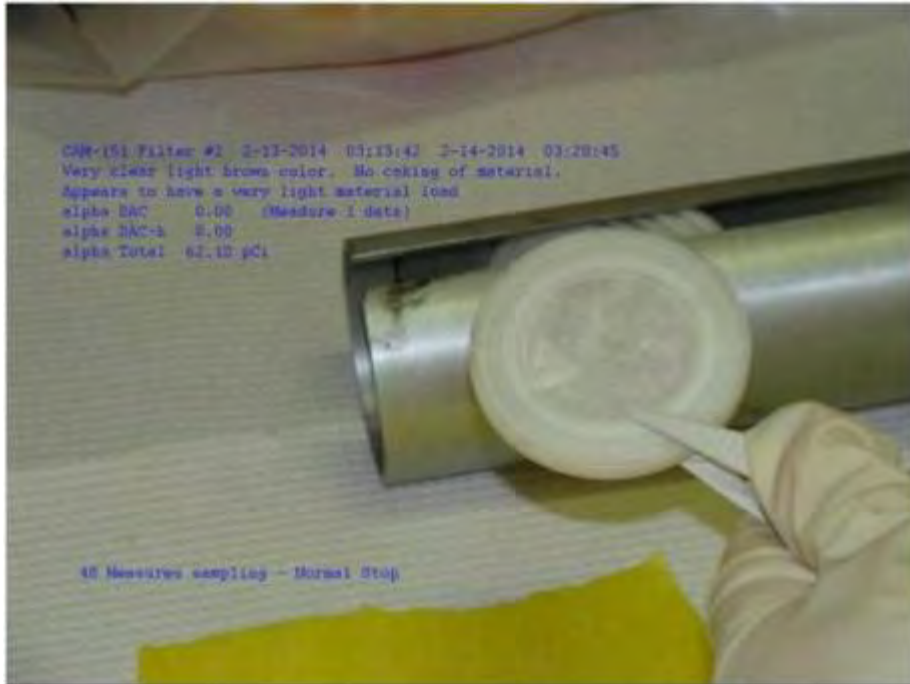
Following the event, the CAM (Figure 6-47) filter housing was disassembled at SRNL. Each filter was assigned a specific number based on the order in which the filters were removed from the CAM cartridge, visually examined, and recorded. Each CAM filter was then screened by gamma pulse height analysis. The first six CAM filters were white and had low levels of activity; three of these are from routine monitoring before the event took place. The following 10 sample filters had various shades of black and brown, and had high levels of activity. Table 6-5 summarizes sampling start and stop time for each CAM filter and the DAC-hr value as recorded by the CAM, as well as total gamma emitting activity as measured by gamma pulse height analysis. CAM 151 filter papers are numbered and described in the order in which the filter paper was removed from the cartridge. The CAM 151 cartridge is loaded with filter papers with the earliest filters first. This means that the first filter used by the cartridge is the last filter paper to be removed. The CAM cache records indicate filter labeling as December 27, 2013 - 6 Filter 01 (Figure 6-48) through December 27, 2013 - 6 Filter 13 (Figure 6-49) during the period starting from February 12, 2014, 0304:43 through February 15, 2014, 0005:34 when the CAM shut down after the radiological event.

Figure 6-48: CAM 151 Filter #2

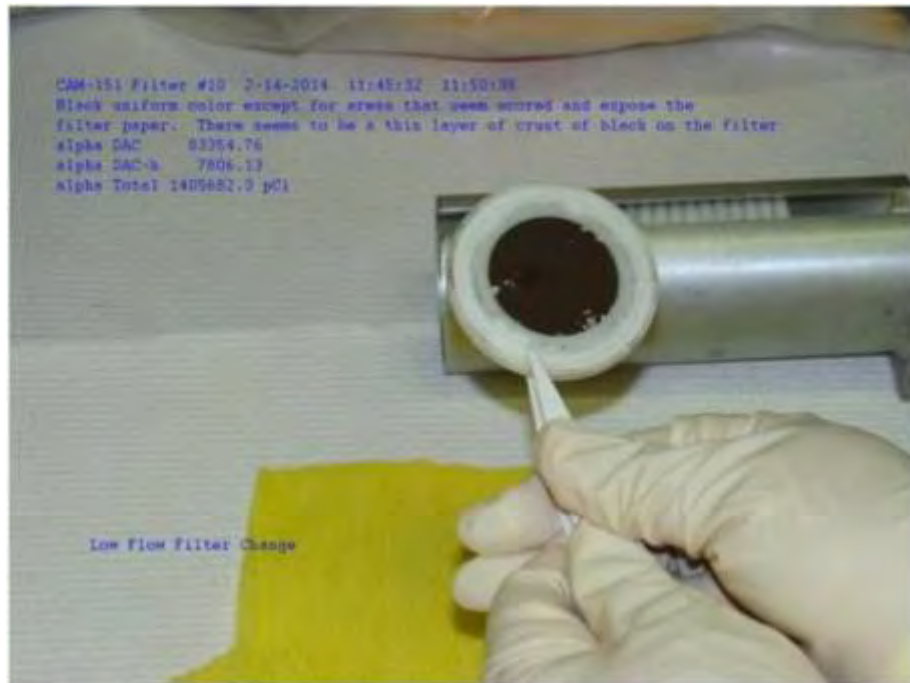
Figure 6-49: CAM 151 Filter #10

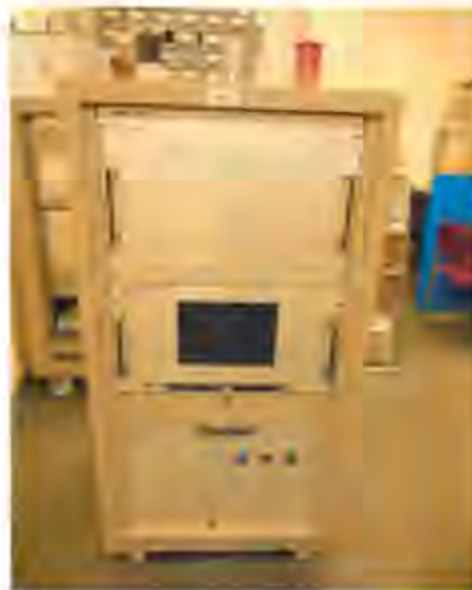
Figure ES-1: RADOS Continuous Air Monitor

On Friday, February 14, 2014, at approximately 2314, a "HI HI" radiation alarm was received in the Central Monitoring Room (CMR) at the DOE WIPP facility approximately 27 miles east of Carlsbad, New Mexico. The alarm was triggered from a CAM (Figure ES-1) in the U/G which was monitoring airborne radioactivity levels in air exhausting from Panel 7, an active waste panel where TRU waste was being emplaced for disposal.

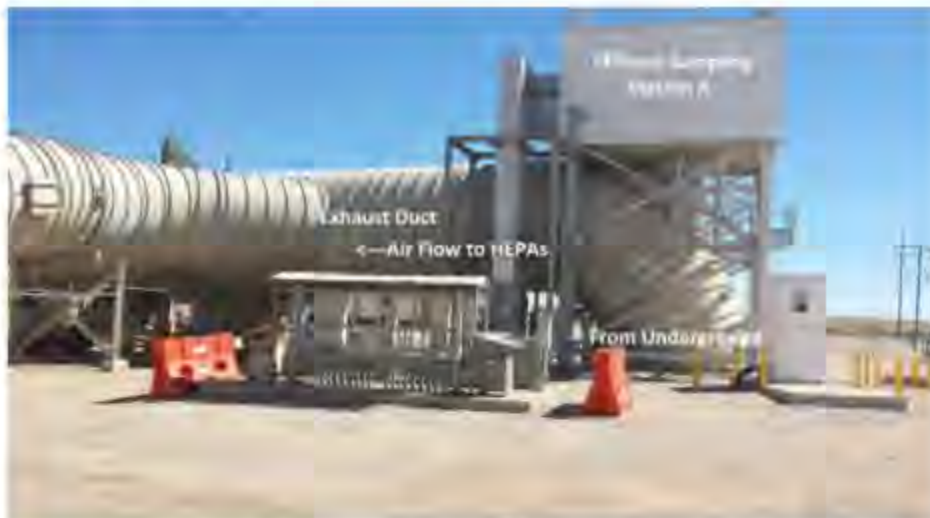
Figure ES-2: Exhaust Air Shaft and Effluent Sample Station A

On Saturday, February 15, 2014, the filters were counted at 0715; the RCM reported 4.4 million disintegrations per minute (dpm) alpha contamination on the filters from the effluent sample station upstream from the HEPA filters (Station A) (Figure ES-2). Preliminary data indicated the presence of TRU materials.

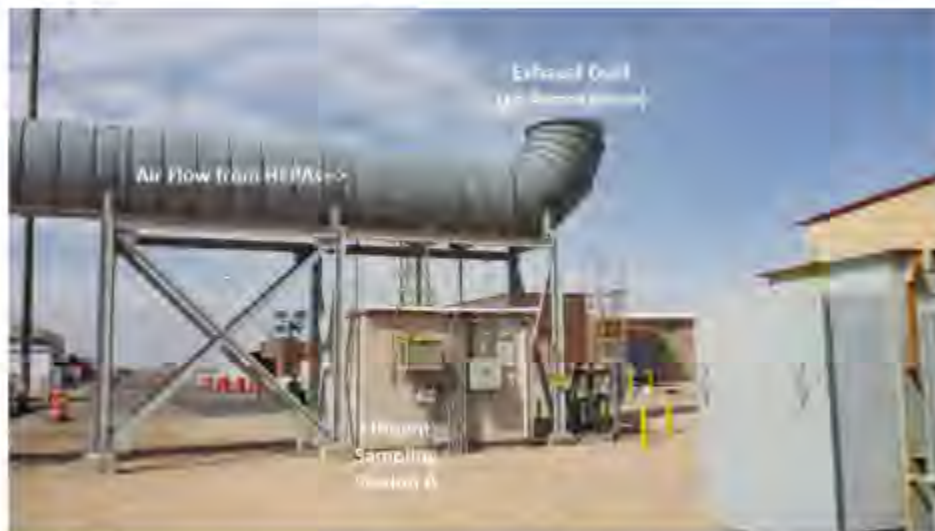
Figure ES-3: Station B and Exhaust Duct

Results from analysis of filters from the effluent sample station downstream of the HEPA filters (Station B) and at the discharge point to the atmosphere (Figure ES-3) were reported at 0915 and indicated 28,000 dpm alpha and 5,900 dpm beta contamination. This was the first indication that there was a release of contamination downstream of the HEPA filters to the environment.
