# 2018 Annual Site Inspection and Monitoring Report for Uranium Mill Tailings Radiation Control Act Title II Disposal Sites

December 2018

**Sherwood, Washington,  
Disposal Site, 2018**

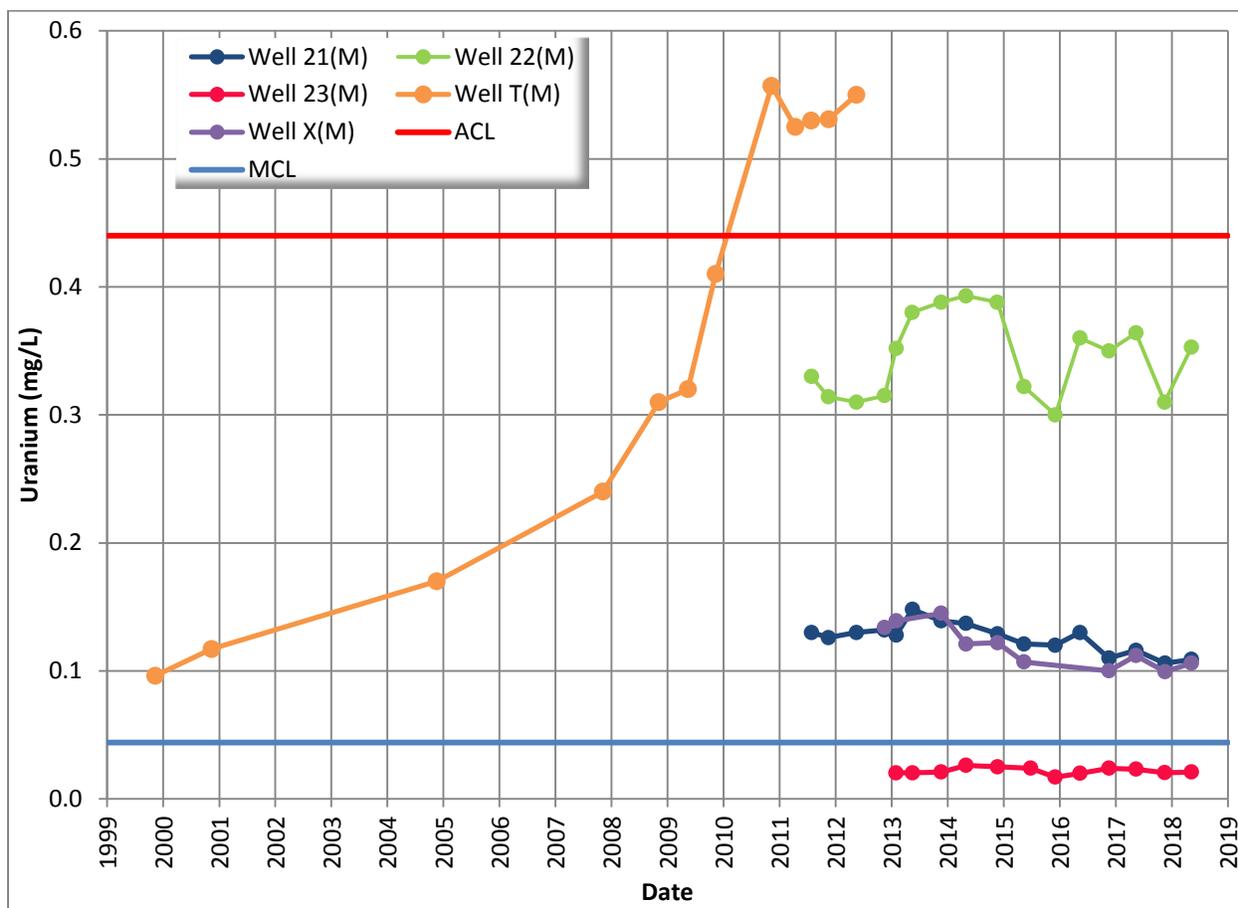
Figure 1-4. Uranium Concentrations in Alluvial Aquifer POC Well T(M) and Downgradient Wells at the Bluewater, New Mexico, Disposal Site

Figure 1-4 shows historical uranium concentrations measured at POC well T(M) and five additional wells screened in the alluvial aquifer. As this figure shows, the uranium concentration at well T(M) trended upward since LM began monitoring the well in 1999, and the November 2010 concentration of 0.557 mg/L was the first of five uranium concentrations that exceeded the ACL of 0.44 mg/L. LM notified NRC of the exceedance upon receiving the 2010 results from the laboratory. Well T(M) dried up following a May 2012 sampling as a result of drought and continuing declines of water levels in the well, and the well has since remained dry. Well 21(M) in the southeast corner of the site and POE well X(M) near the site's east boundary show a slightly decreasing trend in uranium concentration since 2013 (Figure 1-4). However, the elevated uranium concentrations at these two wells in recent years indicate that alluvial groundwater with uranium concentrations exceeding the New Mexico groundwater standard (0.03 mg/L) is discharging from the site toward the southeast.

NRC requested that LM evaluate the performance of the main tailings disposal cell to assess whether seepage losses from the cell between 2005 and 2010 had increased above previous losses to the extent they were responsible for the elevated uranium concentrations measured at POC well T(M) (see Figure 1-4) before it dried up. An assessment of the disposal cell cover and an accompanying evaluation of the water balance for the main tailings disposal cell (including the 2013 radon study referred to in Section 1.4.2.1) concluded that the increase in uranium concentrations in well T(M) could not be attributed to a compromise of the disposal cell's performance and that there was no surge of tailings-fluid seepage from the main tailings cell since it was closed (DOE 2014). It was further concluded that water levels in well T(M) decreased so much during the early 2000s that they were at or below the contact between the alluvium and underlying Chinle Formation from 2008 to 2012. The simultaneous increase in uranium concentration was attributed to the declining water level and the influence of contaminated groundwater migrating through and interacting with weathered Chinle Formation materials, with the resulting fluids obscuring the water chemistry of groundwater in nearby portions of the alluvial aquifer that remained saturated (DOE 2014).

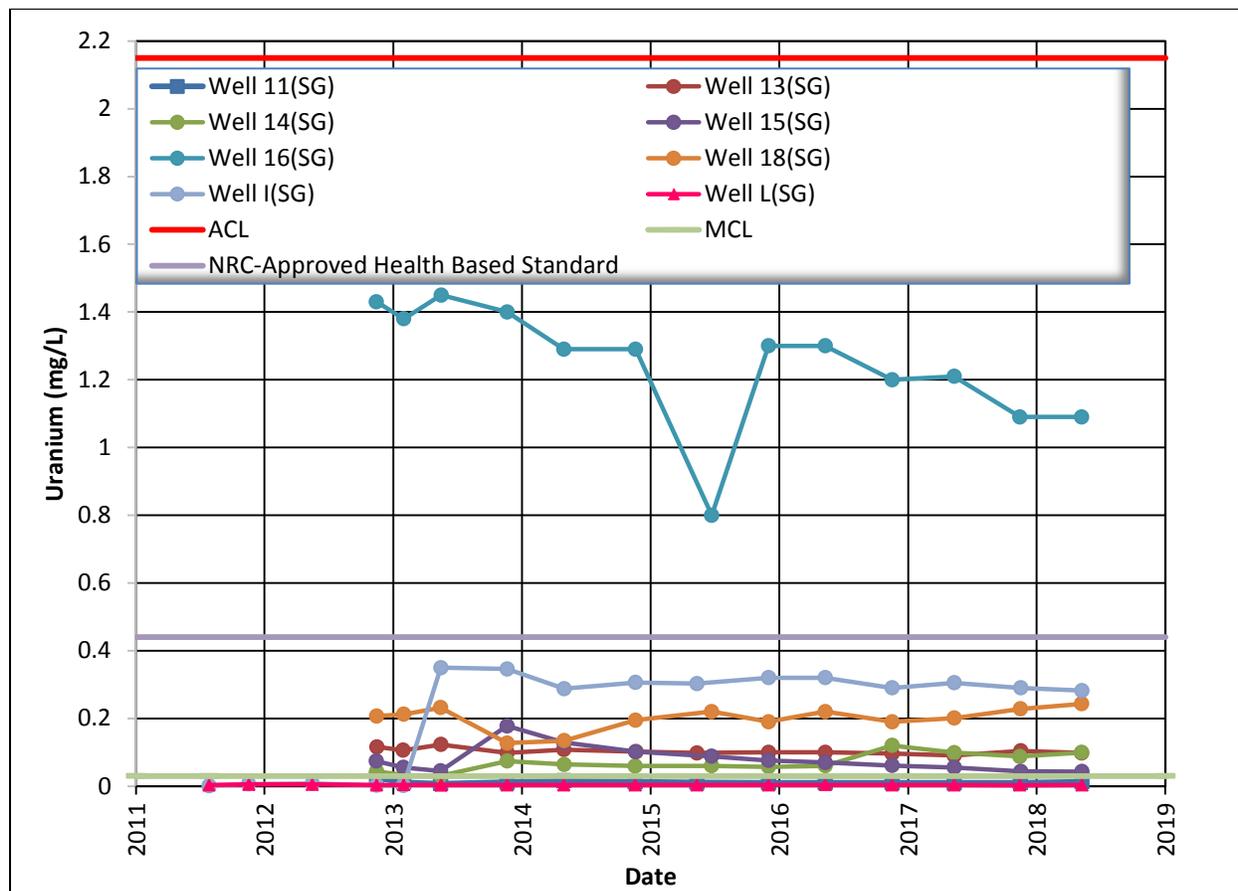
Figure 1-5. Uranium Concentrations in the San Andres/Glorieta Aquifer at the Bluewater, New Mexico, Disposal Site

Uranium concentrations in the SAG aquifer are shown in Figure 1-5. Uranium concentrations in well I(SG) before 2013 are not shown because they were erroneously low due to an incorrect sampling depth in the well. Uranium concentrations at POC wells OBS-3 and S(SG) are not shown in Figure 1-5 because the well screens are encrusted with iron scale that has resulted in erroneously low uranium concentrations since LM began sampling the wells.

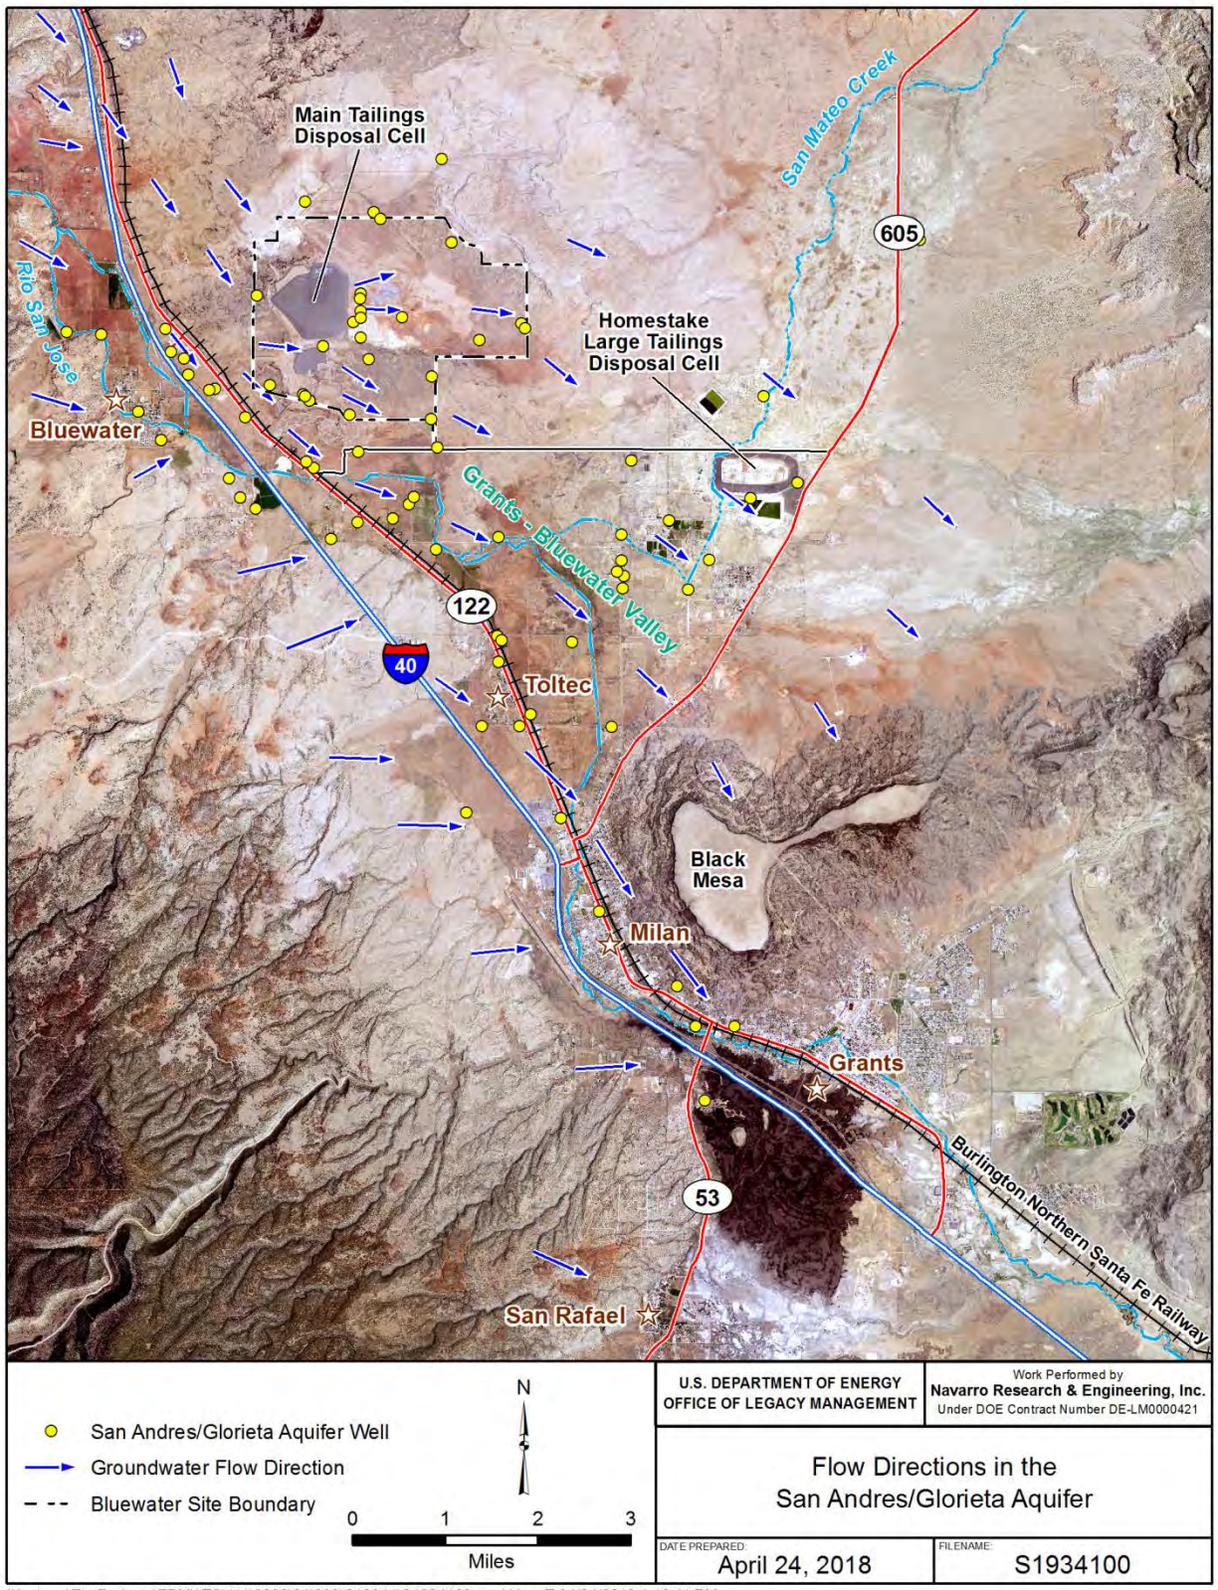
Figure 1-6. Groundwater Flow Directions in the San Andres/Glorieta Aquifer at the Bluewater, New Mexico, Disposal Site

The extent of uranium contamination in the SAG aquifer and the potential risk to downgradient groundwater users was evaluated in LM's groundwater conceptual model (DOE 2014) and in an update to the plume maps (DOE 2018). Evaluation of previous groundwater studies in the region and available groundwater data indicated that the flow path of the groundwater in the aquifer from the site is to the east-southeast. The groundwater from the site passes under the Homestake mill site and turns south toward Grants due to the influence of a major fault that passes under Grants (San Rafael Fault). The flow path from the site is substantially north of the Milan municipal wells (Figure 1-6).

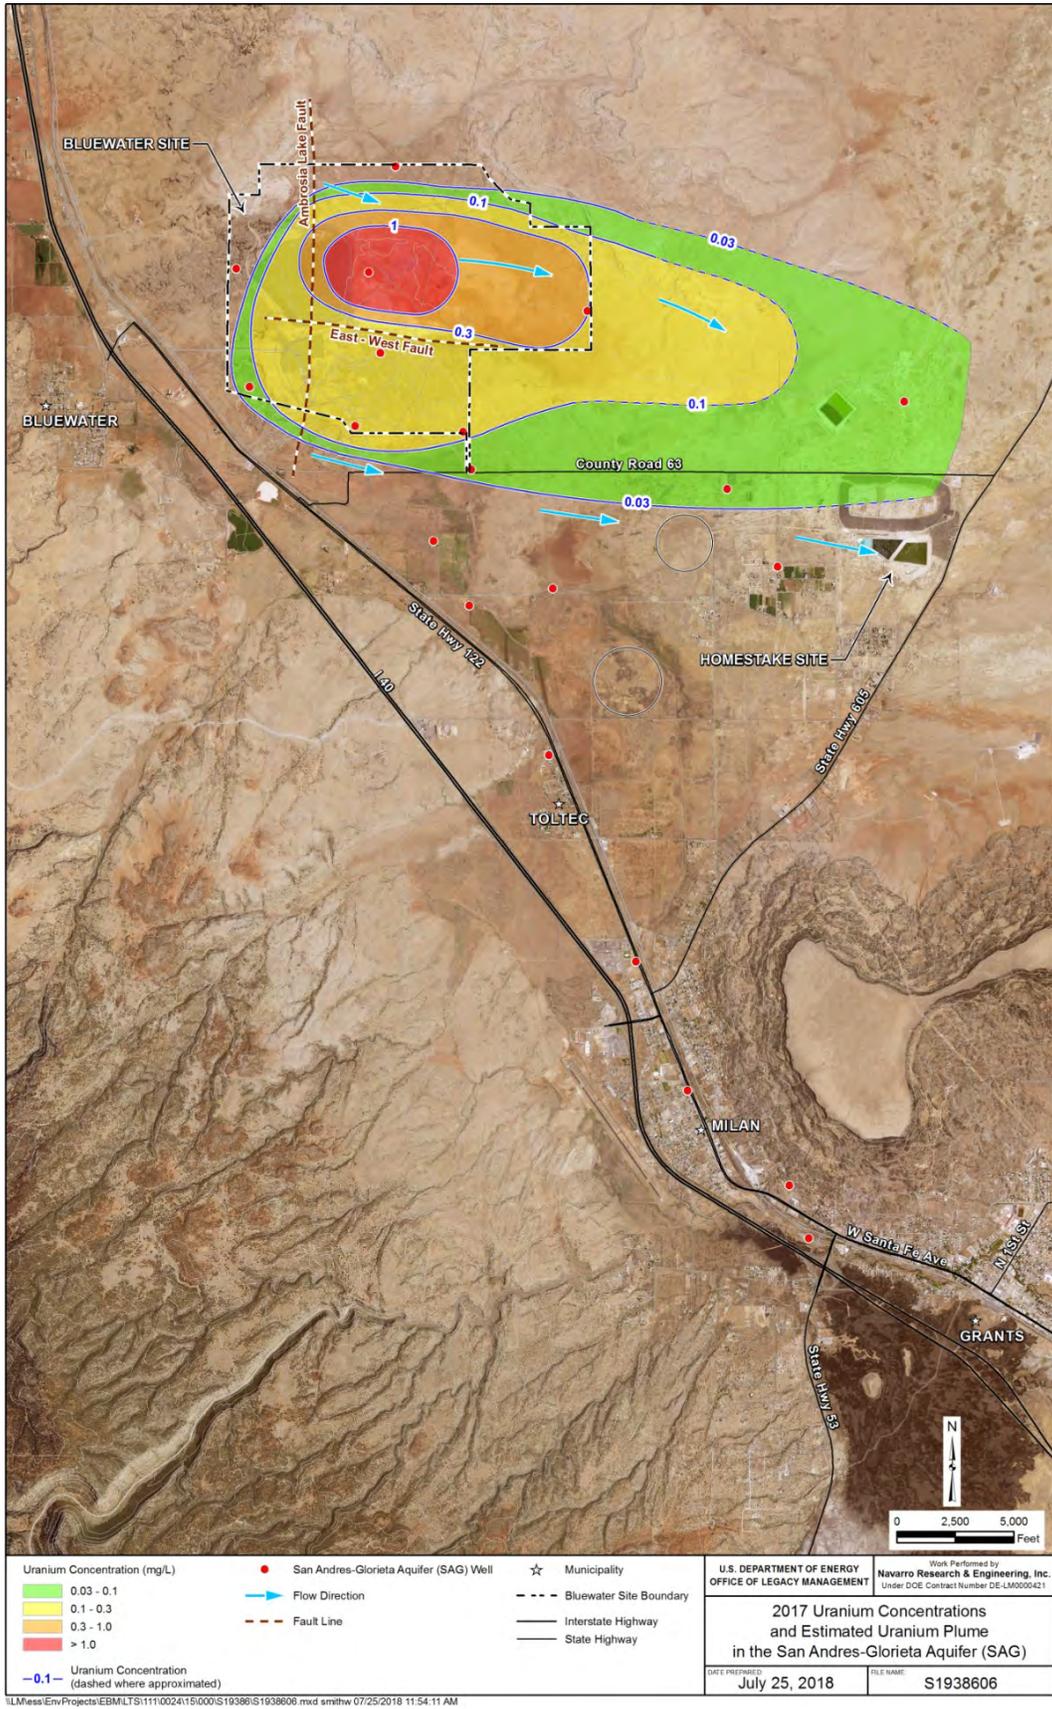
Figure 1-7. 2017 Estimated Uranium Plume in the San Andres/Glorieta Aquifer (DOE 2018)

The estimated extent of the uranium plume, described in the updated groundwater model (DOE 2018), is shown in Figure 1-7. The uranium plume follows the groundwater flow path, and the leading portion is near the Homestake site. Groundwater monitoring results obtained by various entities over the last several decades indicate that uranium contamination from Bluewater mill operations reached the Homestake site by 1980 and that the plume has essentially stabilized (i.e., it is not continuing to migrate to the east). Uranium concentrations attenuate with distance from the site primarily through dispersion instead of chemical reduction because of the absence of a reducing environment in the aquifer formations (DOE 2014). No known drinking water wells are completed within the uranium plume, and site-derived uranium contamination in the SAG aquifer is not expected to impact the Milan or Grants municipal water supplies that are pumped from SAG aquifer wells.

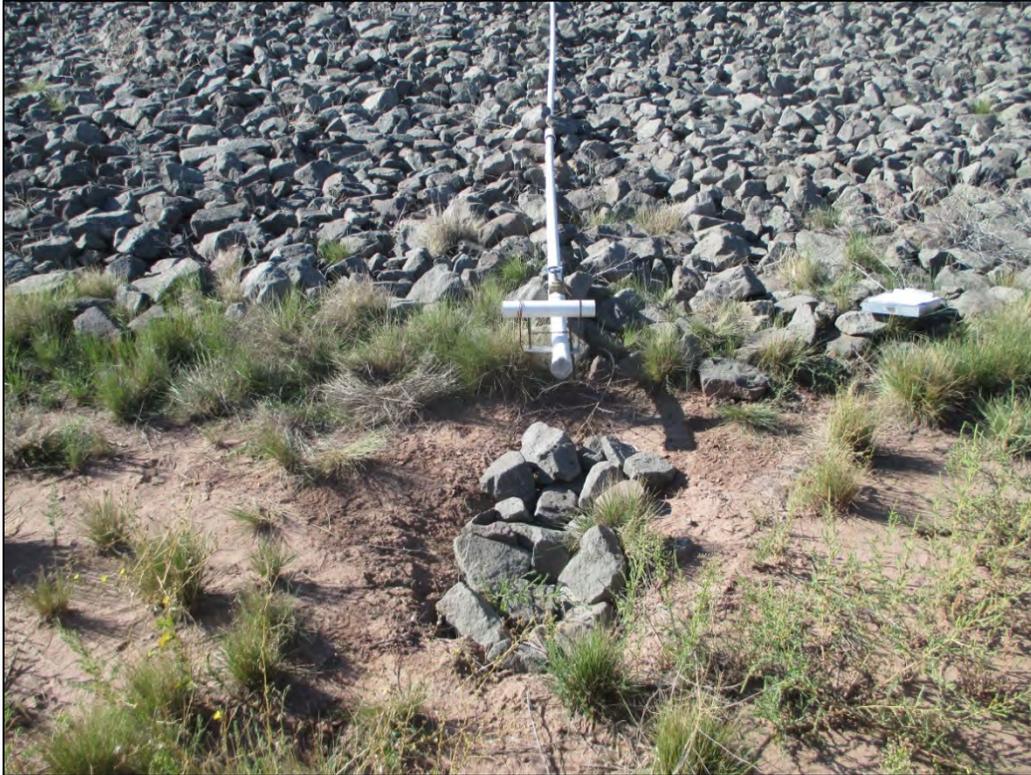
*PL-9. Outlet of Siphon at Toe of Main Tailings Disposal Cell*

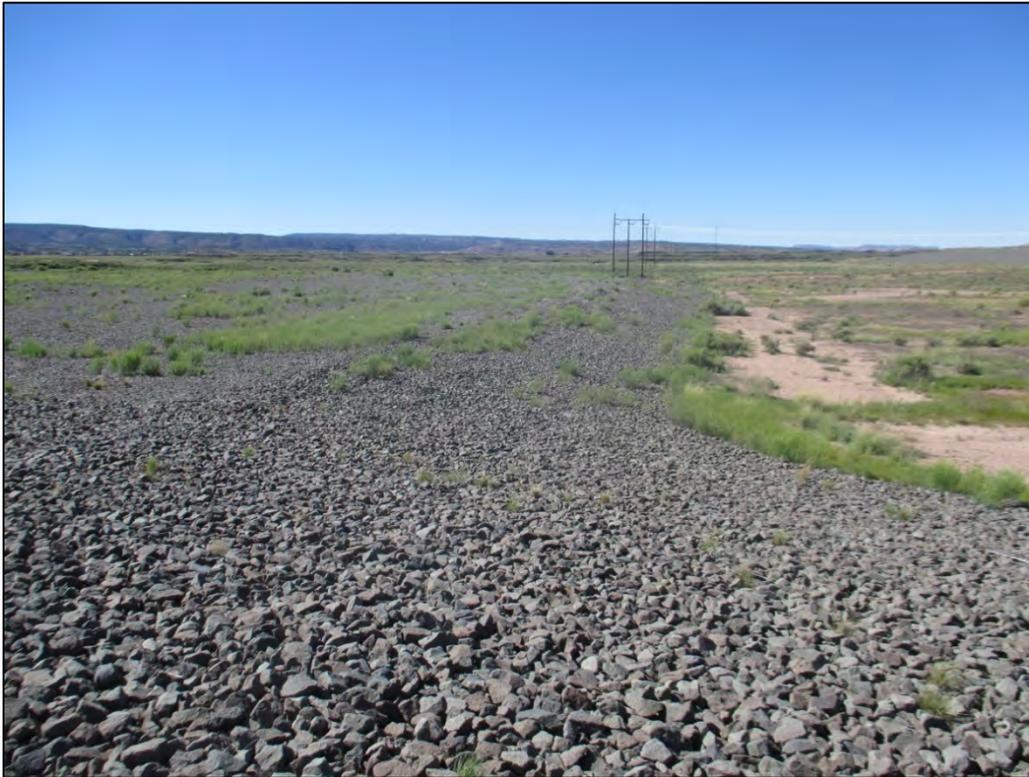
*PL-11. Northeastern Side Slope of Northwestern Extension of Carbonate Tailings Cell*

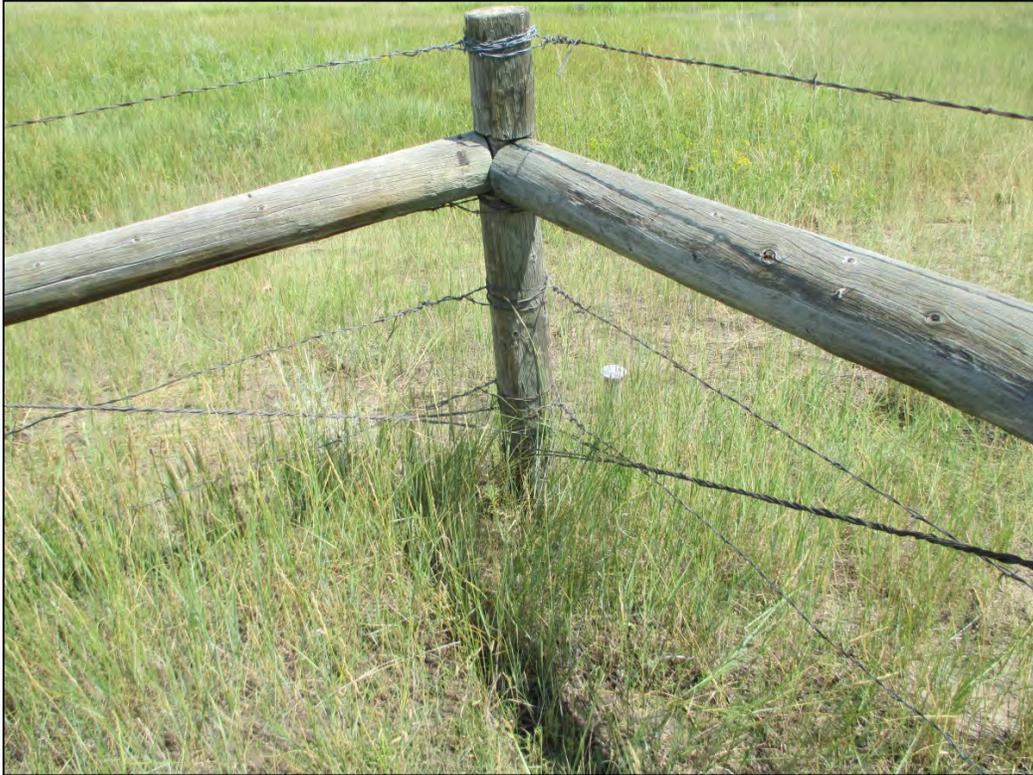
There are four boundary monuments, each at a corner of the property (PL-7). All boundary monuments were inspected, and no maintenance needs were identified.

*PL-7. Boundary Monument BM-2*

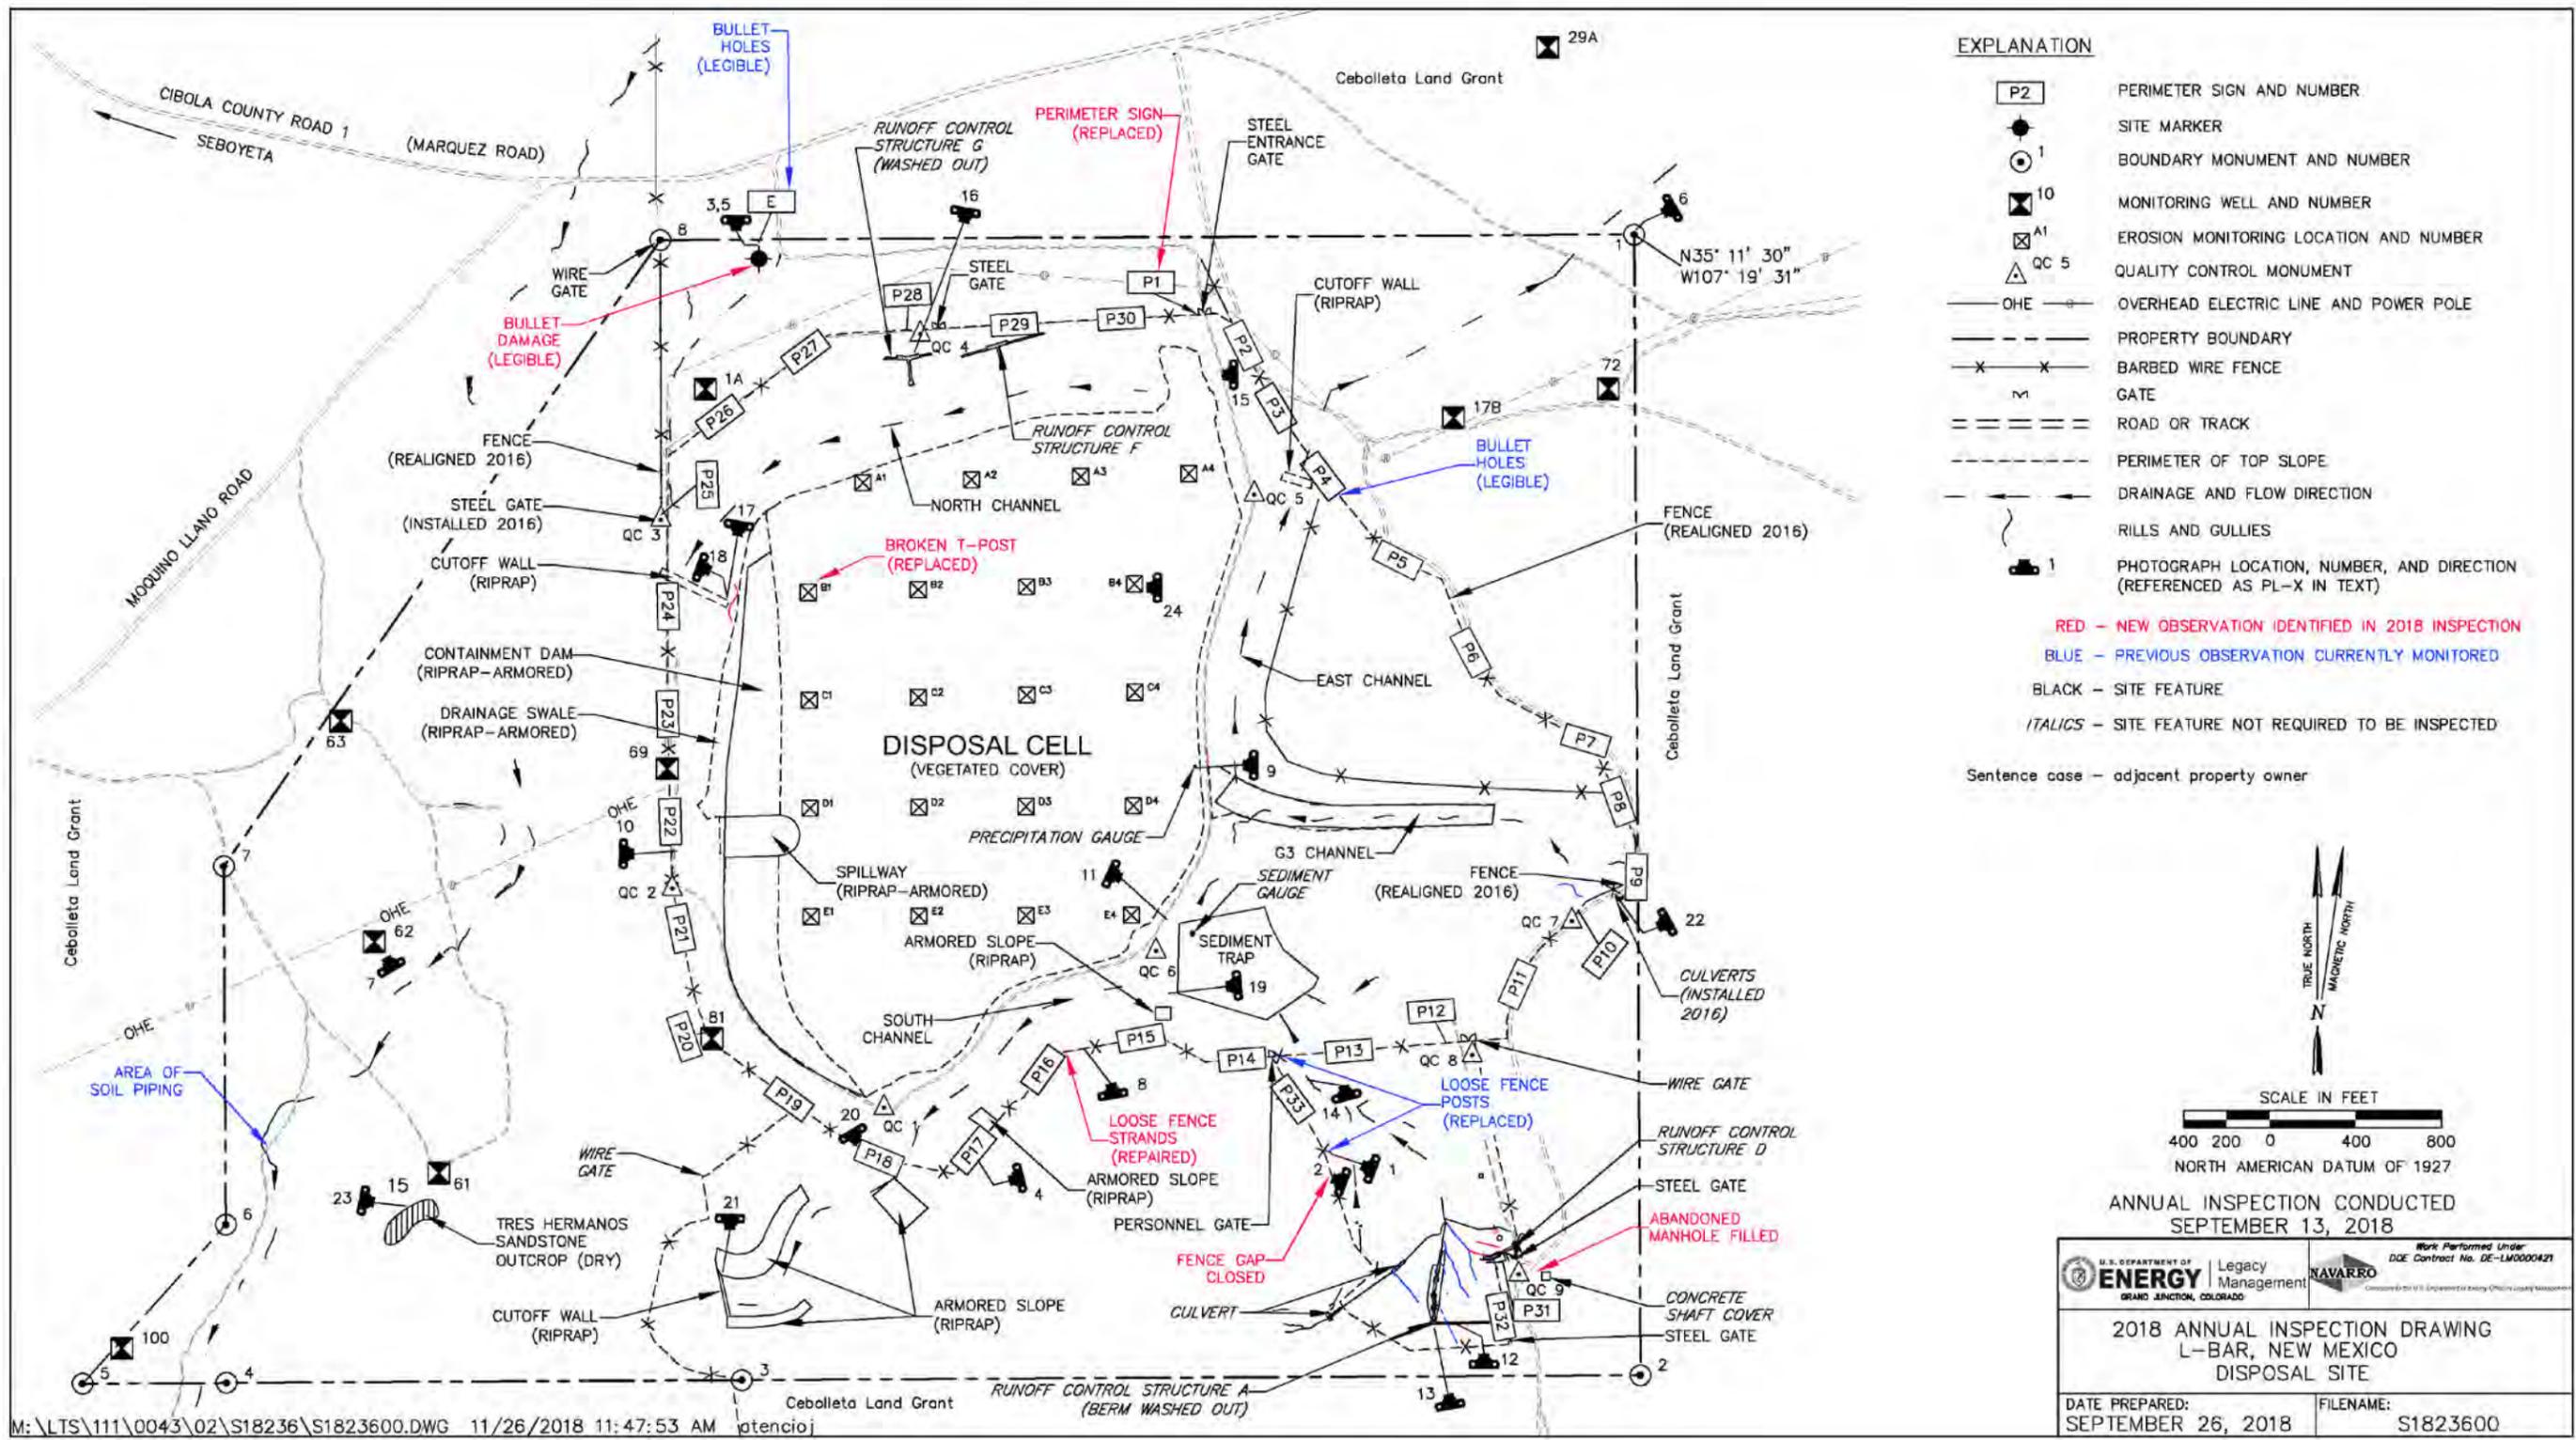
Figure 3-1. 2018 Annual Inspection Drawing for the L-Bar, New Mexico, Disposal Site

A tributary channel (G3) was constructed to divert runoff from a smaller watershed into the east channel (Figure 3-1). Gullies have formed along the side slopes of the G3 channel. The erosion and sediment deposition are not impairing the function of the channel.

A Tres Hermanos Sandstone unit of the Mancos Shale crops out in the southwest corner of the site (Figure 3-1). This unit is reported to be hydraulically connected to contaminated groundwater under the disposal cell, and the outcrop is considered a potential evapotranspiration area. The outcrop was dry at the time of the inspection (PL-23), and there is no evidence that seepage has occurred. This location will continue to be monitored for seepage and recommended for sampling if seep water is present.

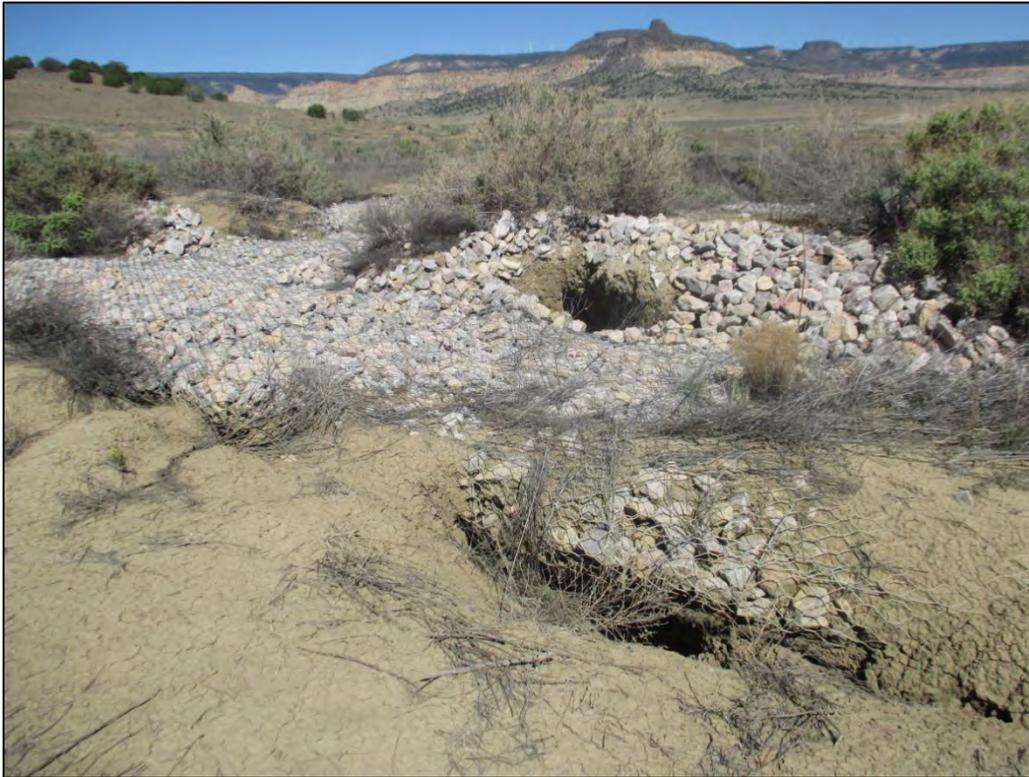
*PL-12. Breach of Runoff Control Structure A Berm*

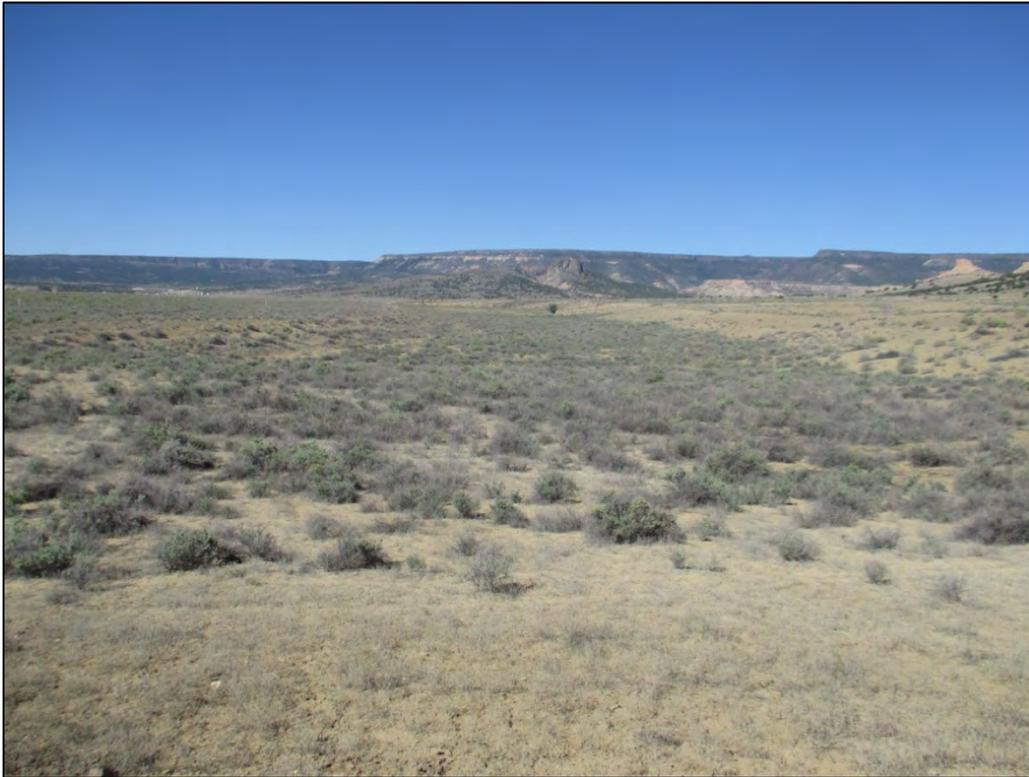
*PL-14. Gully Upgradient of Sediment Trap*

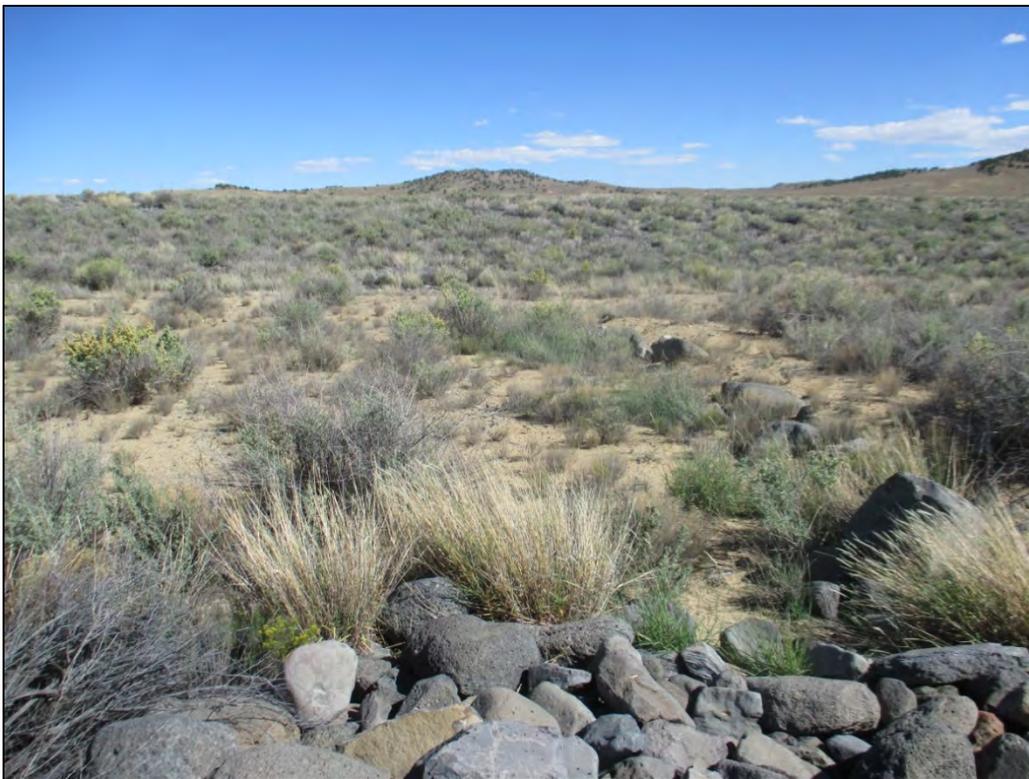
*PL-17. Erosion East of Riprap Cutoff Wall at Outlet of North Channel*

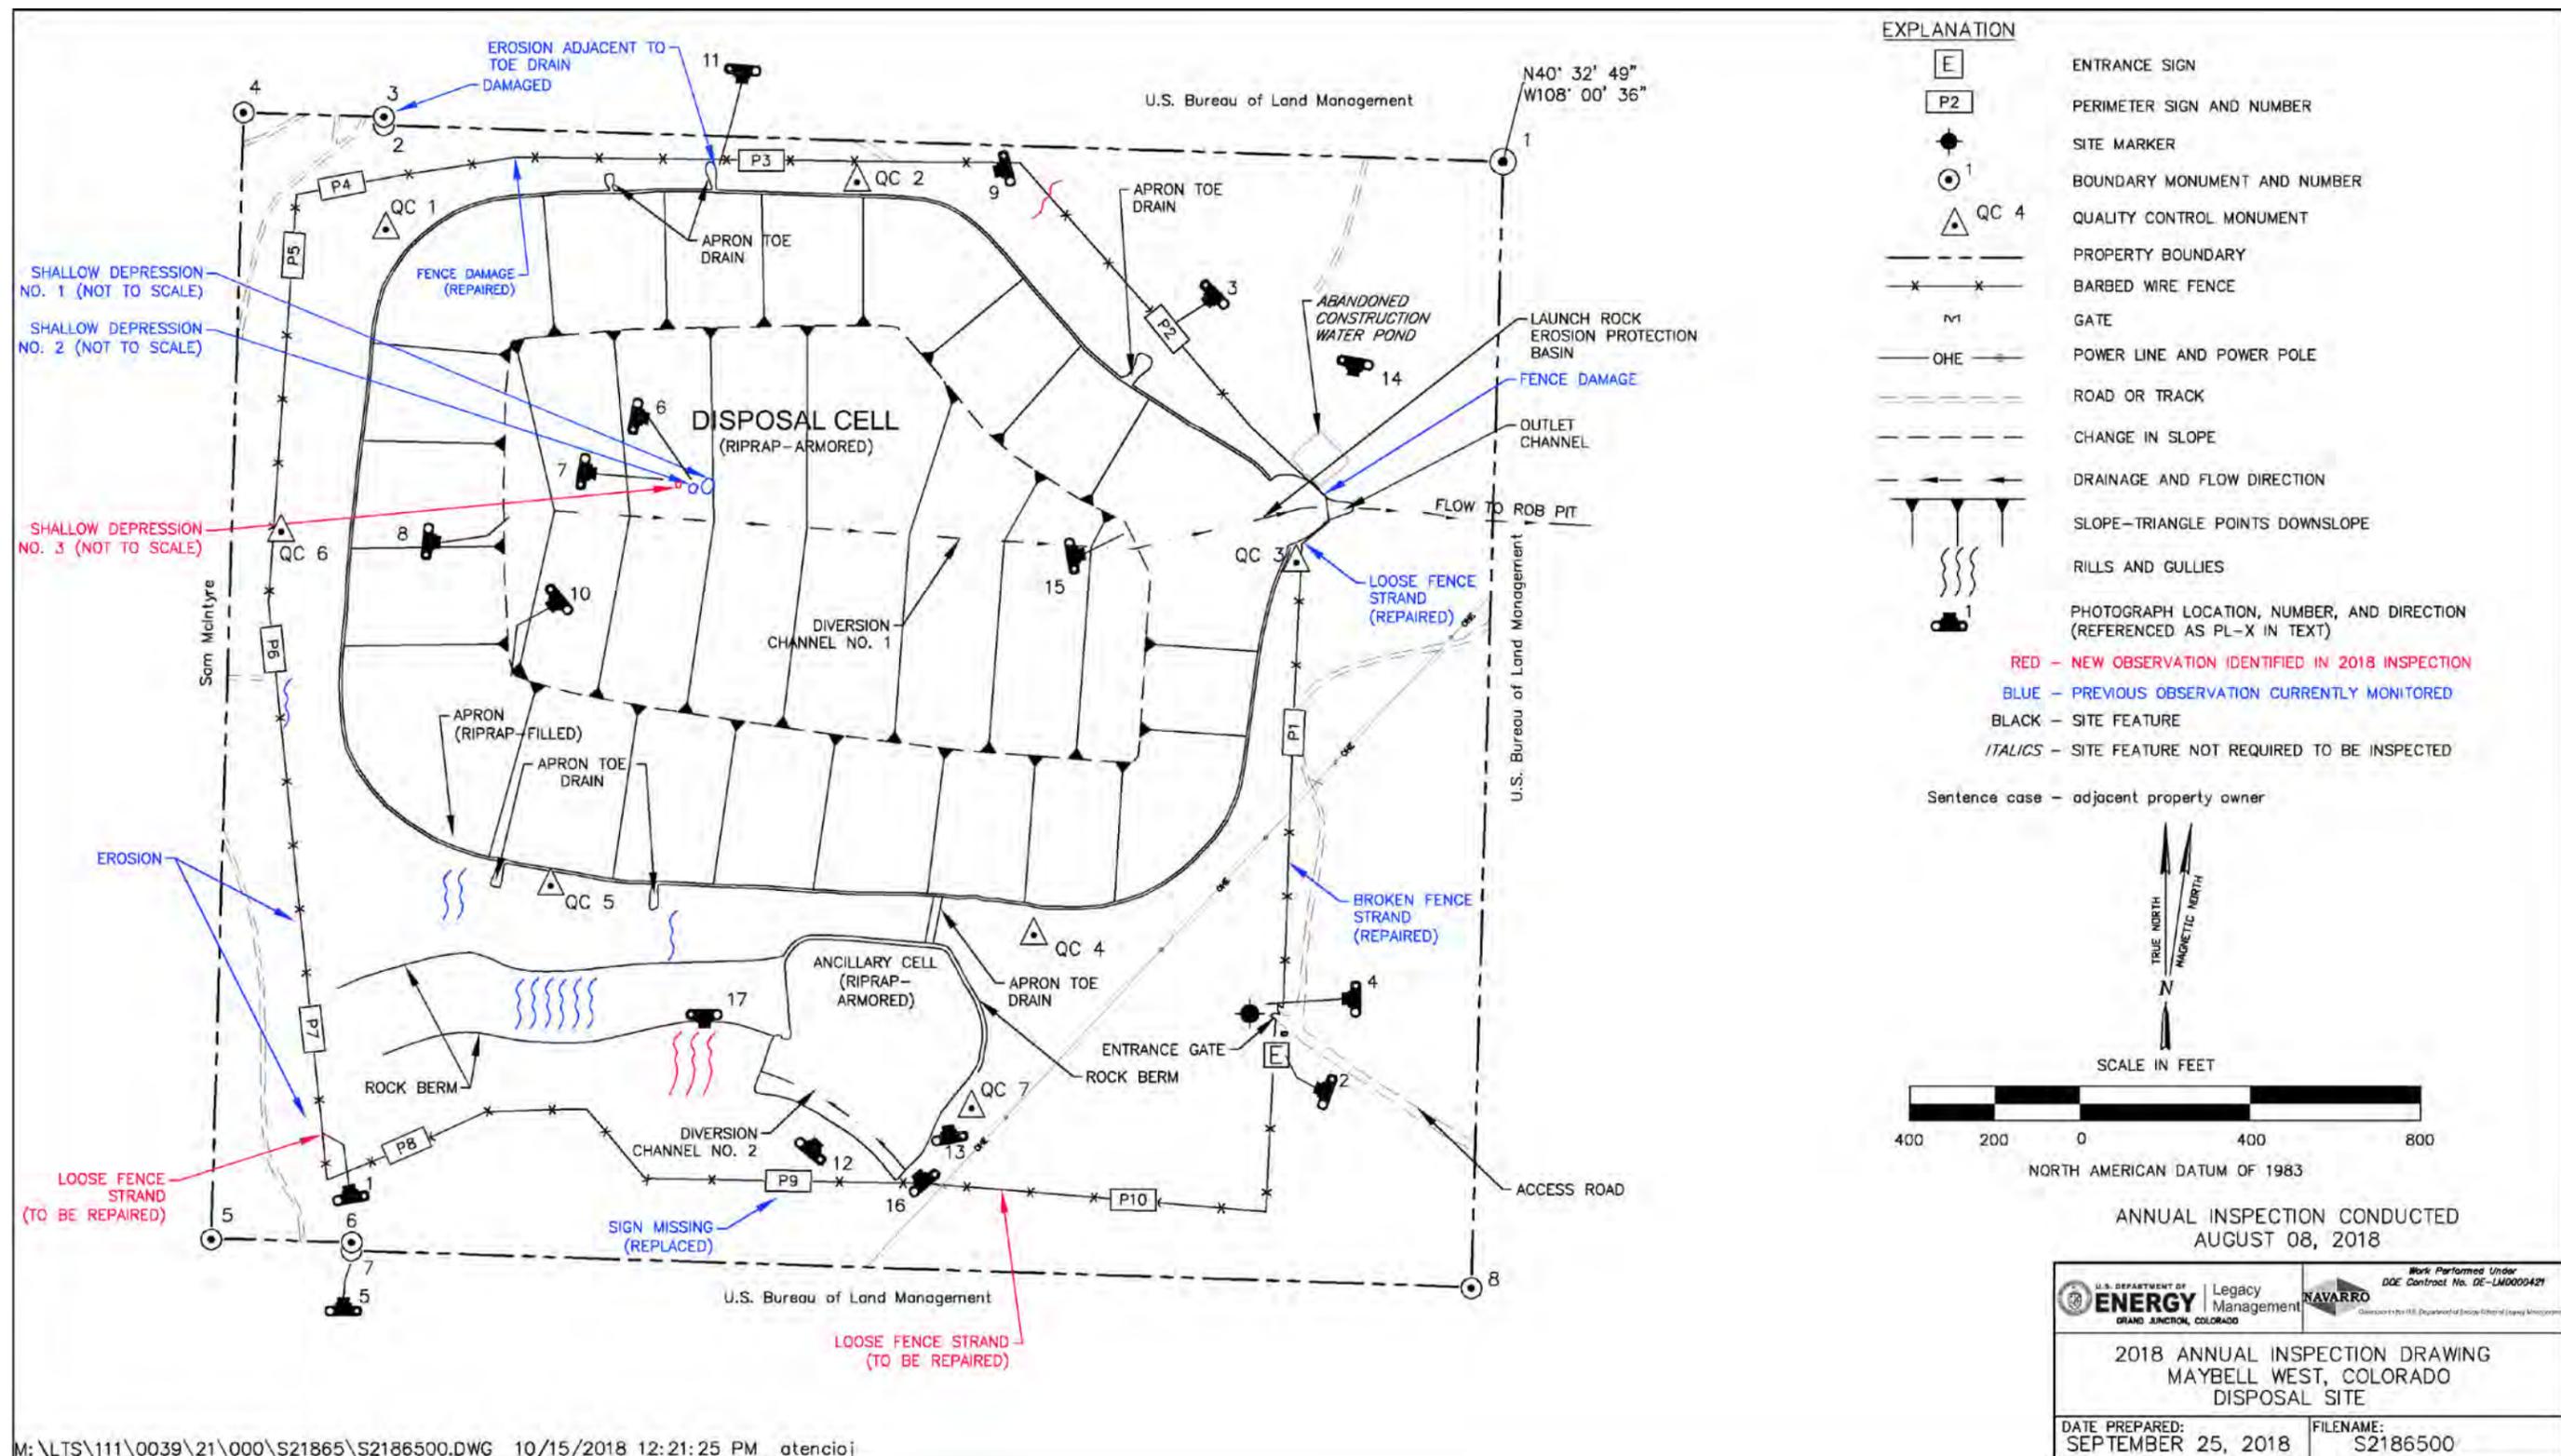
Figure 4-1. 2018 Annual Inspection Drawing for the Maybell West, Colorado, Disposal Site

Figure 4-1 shows the locations of site features in black, including site surveillance features and inspection areas. Site features that are present but not required to be inspected are shown in italic font. Observations from previous inspections that are currently monitored are shown in blue text, and new observations identified in the 2018 annual inspection are shown in red. Inspection results and recommended maintenance activities associated with site surveillance features are included in the following subsections. Photographs to support specific observations are identified in the text and in Figure 4-1 by photograph location (PL) numbers. The photographs and photograph log are presented in Section 4.9.

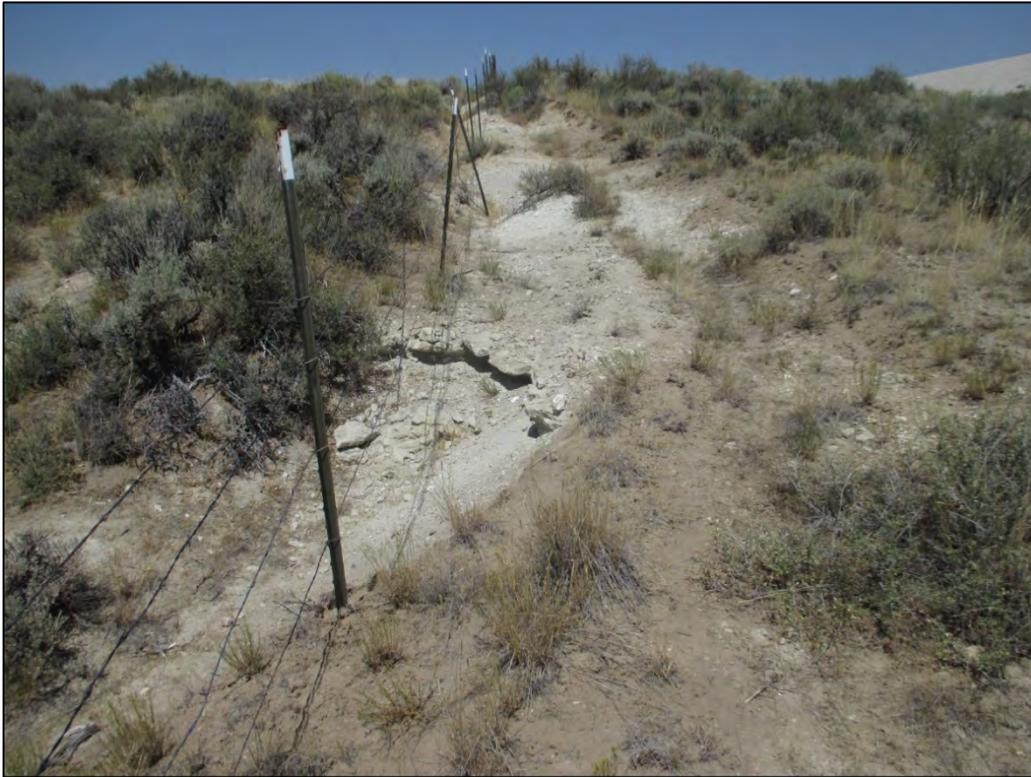
*PL-1. Erosion Near Southwest Corner of Perimeter Fence*

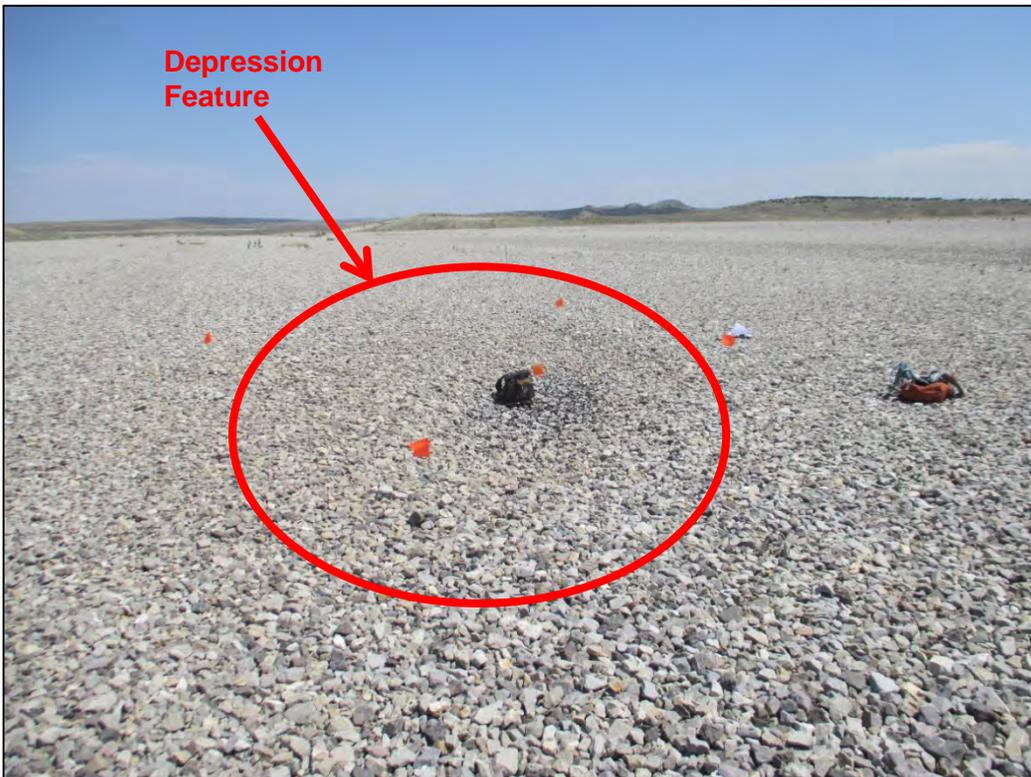
Depression No. 1 is slightly longer and wider than measurements noted during the 2017 annual inspection. A second smaller and shallower depression (Depression No. 2)—approximately 10 feet long, 5 feet wide, and less than 6 inches deep in the center—was first noted just west of the first depression during the 2016 annual inspection. Depression No. 2 appeared during the 2018 annual inspection to be approximately the same size as previously observed. A third, smaller depression (Depression No. 3) was also observed for the first time during the 2018 annual inspection and measures approximately 1 foot long, 1 foot wide, and 9 inches deep (PL-7). This depression is directly northwest of Depression No. 2.

No standing water was observed in any of the depressions during the inspection; however, standing water was observed in the depressions during a site visit in April 2018. The depressions currently do not threaten the integrity or performance of the disposal cell. No maintenance needs were identified.

*PL-6. Depression No. 1 on Top Slope of Disposal Cell*

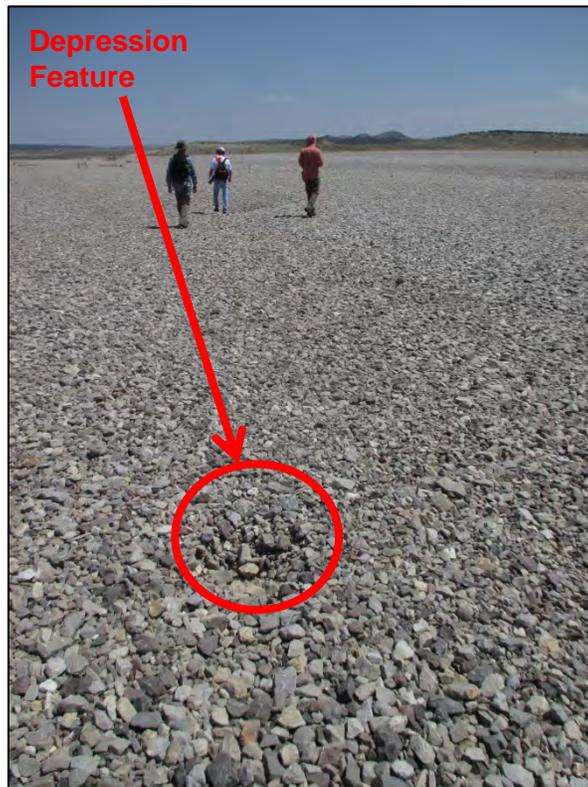
*PL-7. Depression No. 3 on Top Slope of Disposal Cell*
