# 2018 Annual Site Inspection and Monitoring Report for Uranium Mill Tailings Radiation Control Act Title II Disposal Sites

December 2018

**Sherwood, Washington,  
Disposal Site, 2018**

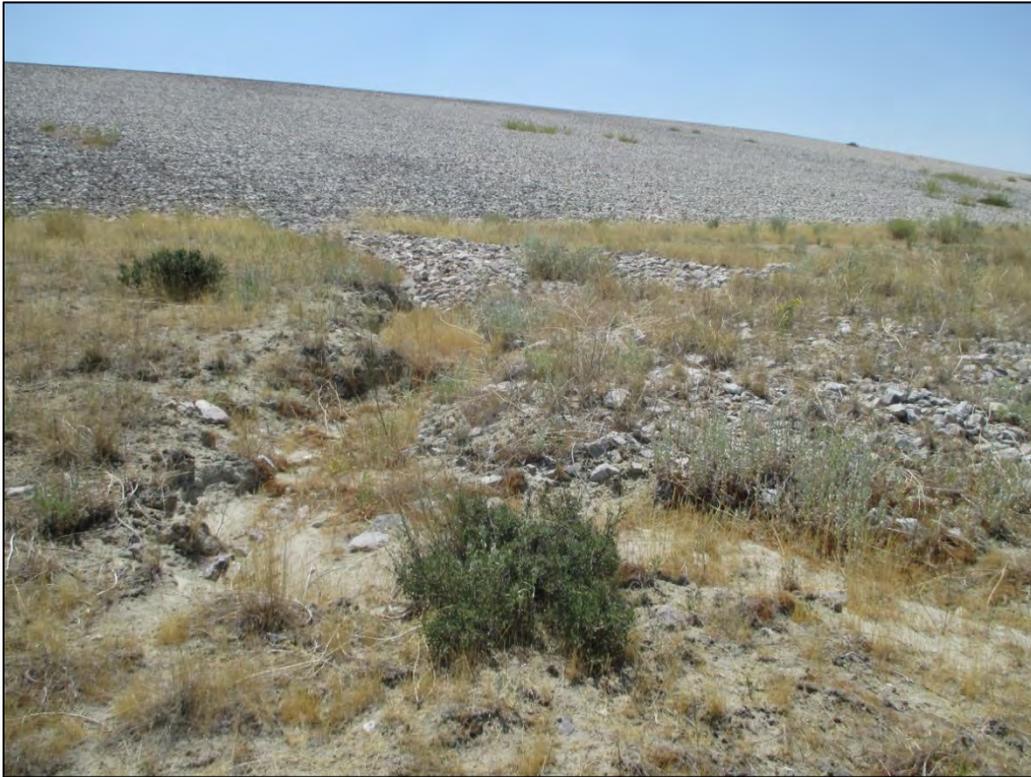
*PL-11. Toe Drain on Disposal Cell North Side Slope and Adjacent Erosion*

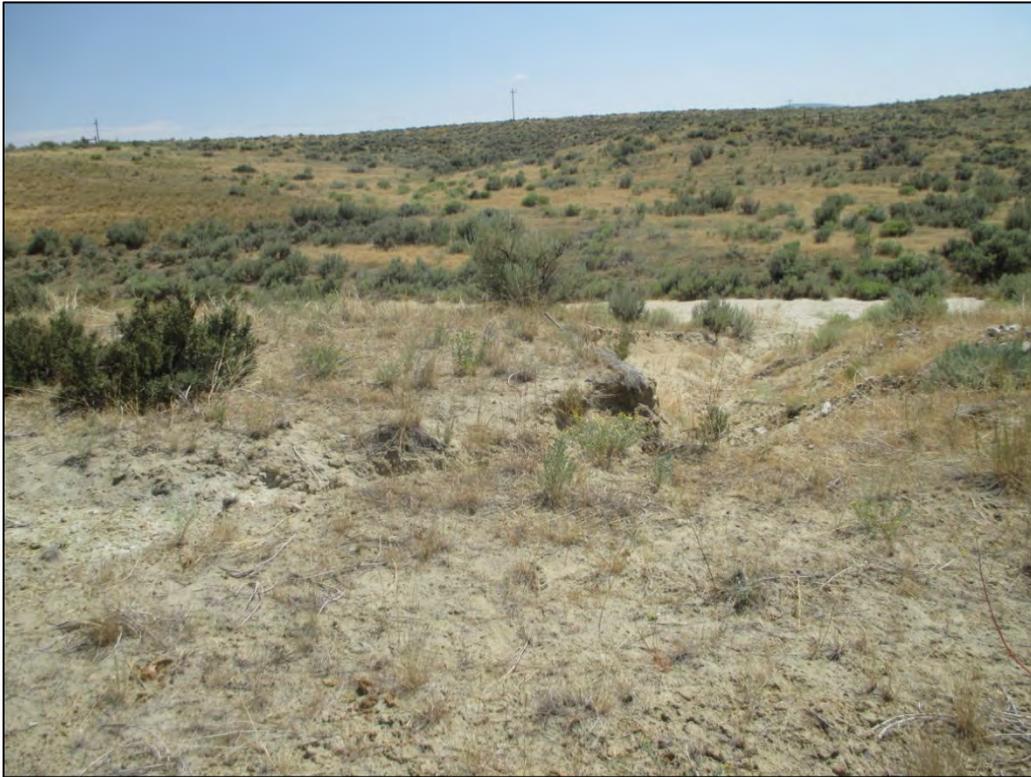
The rock berm that runs along the northern edge of the ancillary cell continues west across the slope south of the disposal cell to protect against erosion. Several gullies and rills have developed on this south slope but do not threaten the integrity of the disposal cell (PL-17). The gullies will continue to be monitored and repaired as needed. The rock berm effectively controls headcutting from these gullies and protects the disposal cell. No maintenance needs were identified.

*PL-17. Gully West of Diversion Channel No. 2*

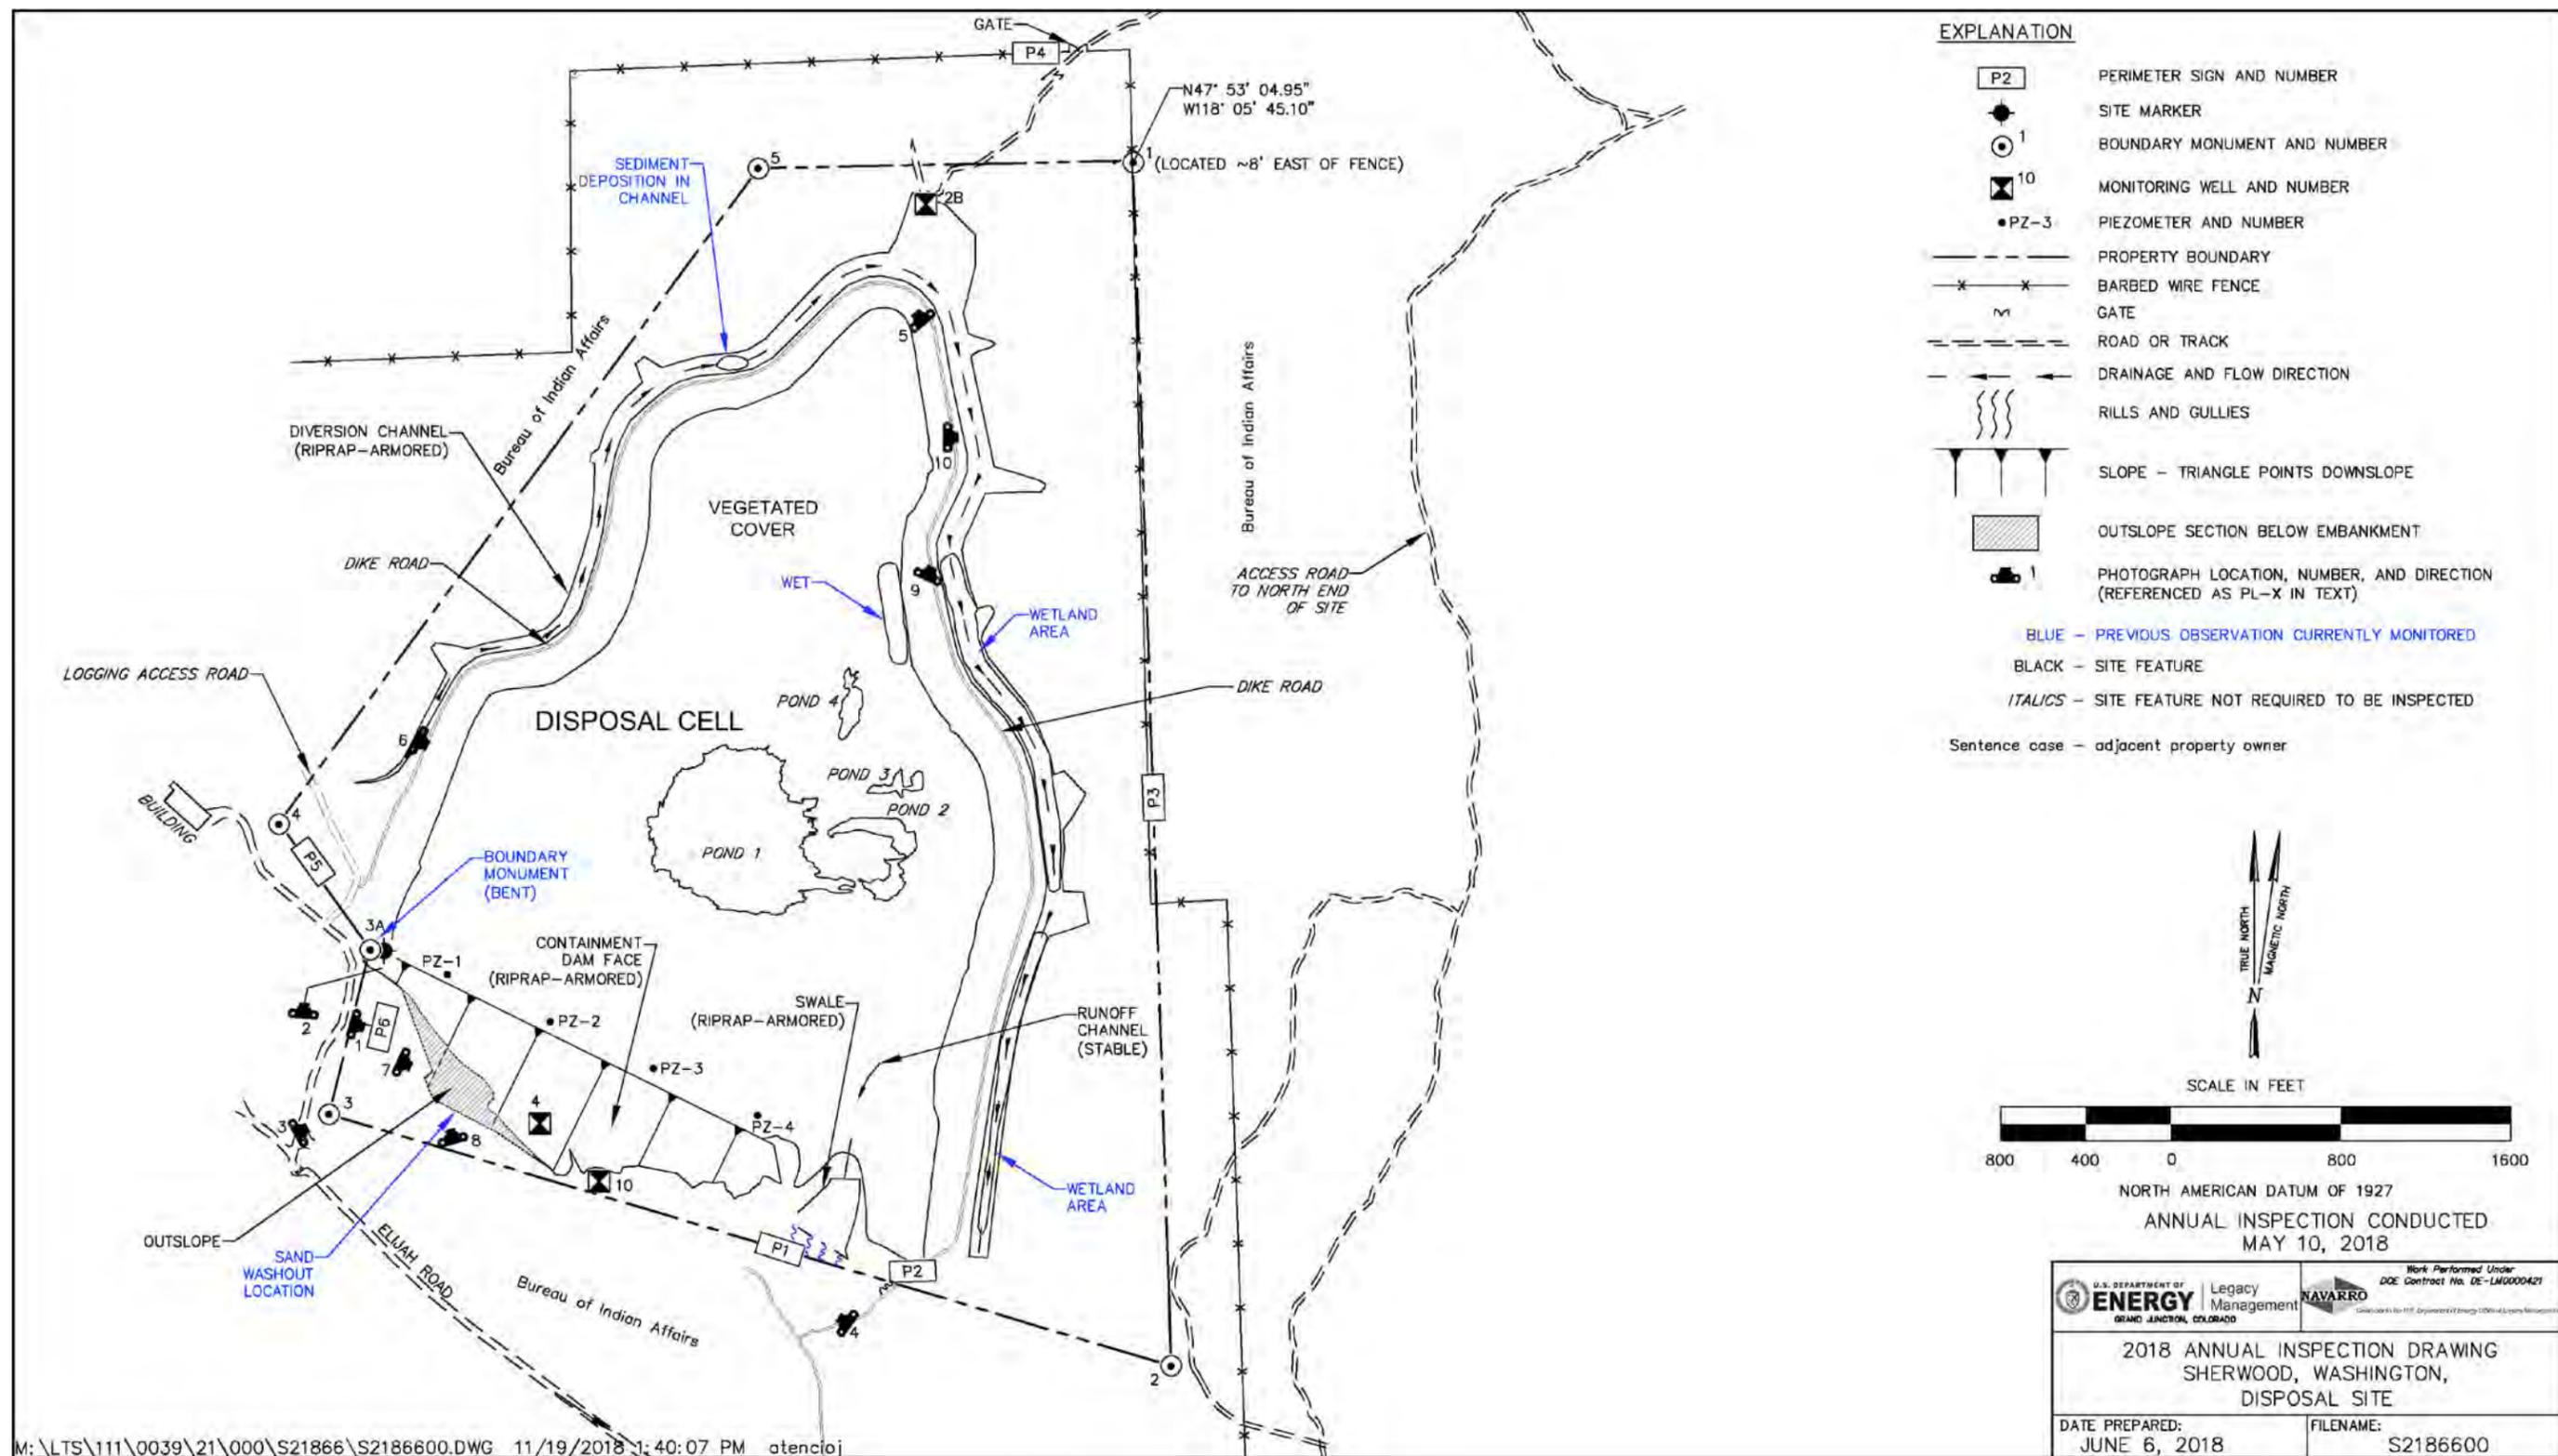
Figure 5-1. 2018 Annual Inspection Drawing for the Sherwood, Washington, Disposal Site

Figure 5-1 shows the locations of site features in black, including site surveillance features and inspection areas. Site features that are present but not required to be inspected are shown in italic font. Observations from previous inspections that are currently monitored are shown in blue text. There were no new observations in 2018. Inspection results and recommended maintenance activities associated with site surveillance features are included in the following subsections. Photographs to support specific observations are identified in the text and in Figure 5-1 by photograph location (PL) numbers. The photographs and photograph log are presented in Section 5.9.

During the 2016 annual inspection, one area at the base of the rock-covered containment dam face was found to have a fan of sand that had washed out from underneath the rock cover (PL-8). A follow-up inspection of the erosion feature was performed on October 4 and 5, 2016. The protective rock cover adjacent to the area of erosion was removed, and the underlying material was examined. The sandy material that was eroded from the embankment was the same as natural undisturbed material nearby. During reclamation, this area of the mill site was used as a source for fill material used to contour the area below the toe of the containment dam. Review of original reclamation and as-built drawings showed that the toe of the containment dam is upslope from the area of erosion. This was confirmed during the investigation conducted before the 2017 annual site inspection and subsequent engineering evaluation, when several small holes were dug upslope to determine the edge of the actual embankment. It was determined that the washout area was in a portion of the dam defined as the outslope in the construction completion report and does not impact the containment dam (Figure 5-1).

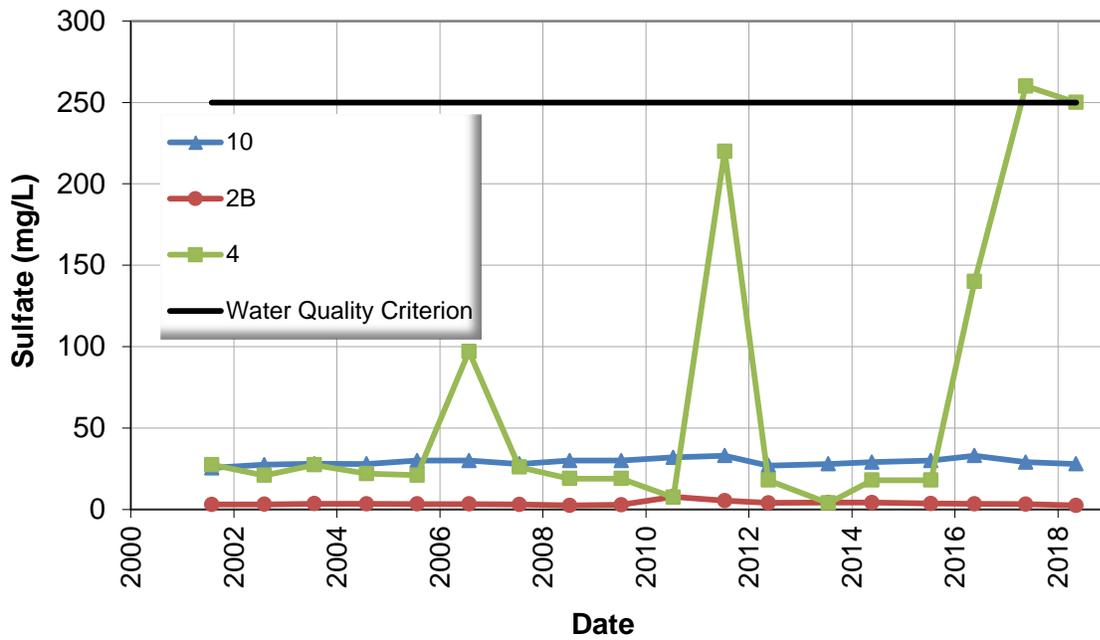
Figure 5-4. Sulfate Concentrations at the Sherwood, Washington, Disposal Site

Table 5-3 presents the May 2018 sampling results. Groundwater constituent concentrations continue to be less than the action levels for confirmatory sampling in monitoring wells 2B and 10; however, sulfate concentration exceeded the action level in monitoring well 4 in 2017 and met it in 2018.

Figure 5-3 and Figure 5-4 show concentrations of chloride and sulfate, respectively, in the three monitoring wells since 2001. Occurrences of slightly elevated chloride levels in well 4 correspond with the higher sulfate levels measured at the same location. Water elevations for each of the monitoring wells are shown in Figure 5-5. These elevations are preliminary and are based on a survey of the elevation of the monitoring wells conducted in August 2018. Groundwater occurs in two hydrostratigraphic units: (1) the alluvium that lies on top of the bedrock surface and (2) the conductive bedrock, including weathered bedrock in the upper portion and unweathered or competent bedrock below. Monitoring well 10 is completed in the alluvium, and wells 2B and 4 are completed in the bedrock.

A borehole camera was used to evaluate conditions in the three monitoring wells, specifically to determine if there were any well issues that could have caused the exceedance in monitoring well 4. The video showed that the inlet of the dedicated bladder pump used for low-flow sampling was buried in debris at the bottom of the well. The well will be cleaned and redeveloped before sampling in 2019.

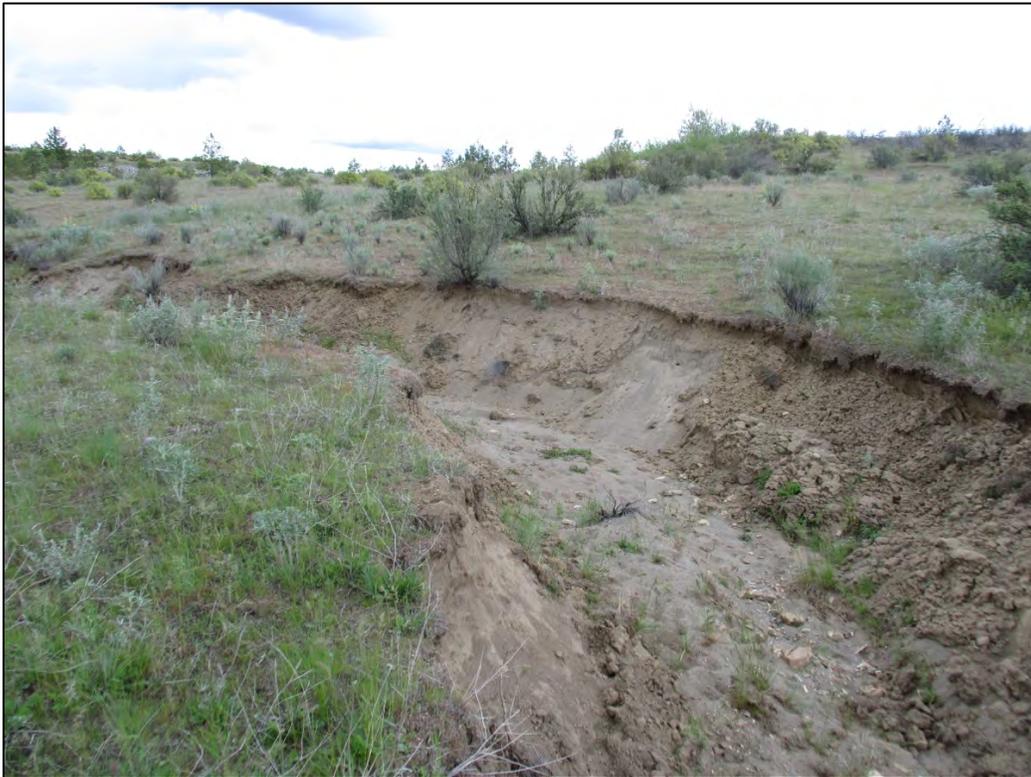
*PL-4. Gully Outside Site Boundary near Perimeter Sign P1*

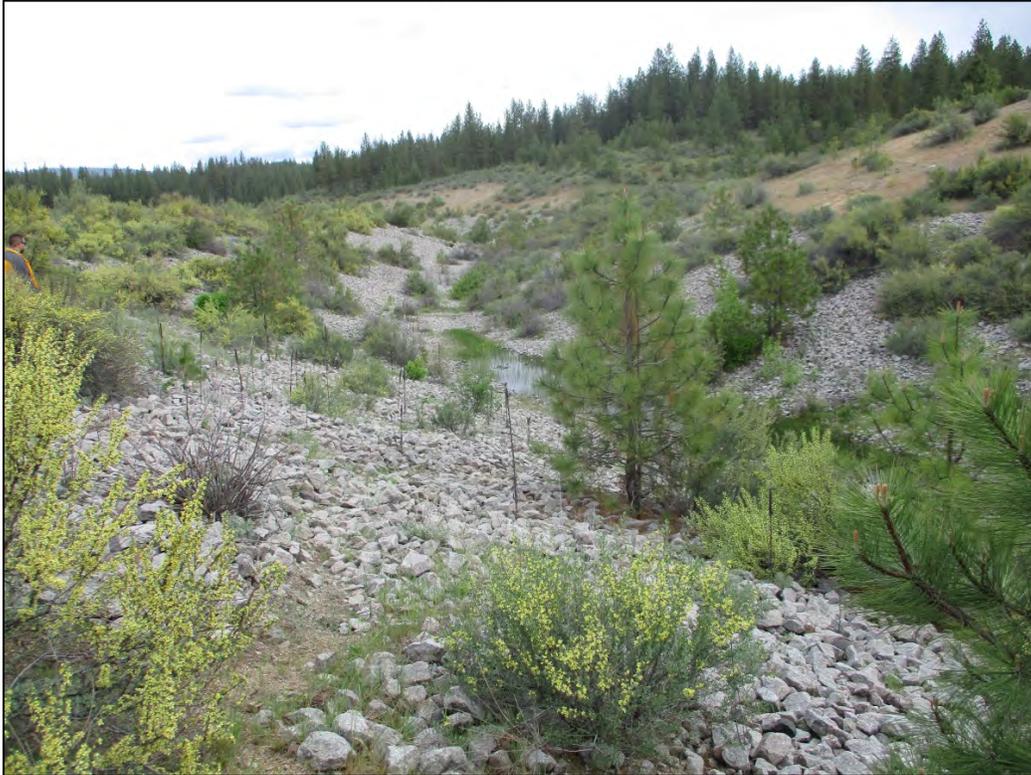
*PL-9. Vegetation in East Diversion Channel*

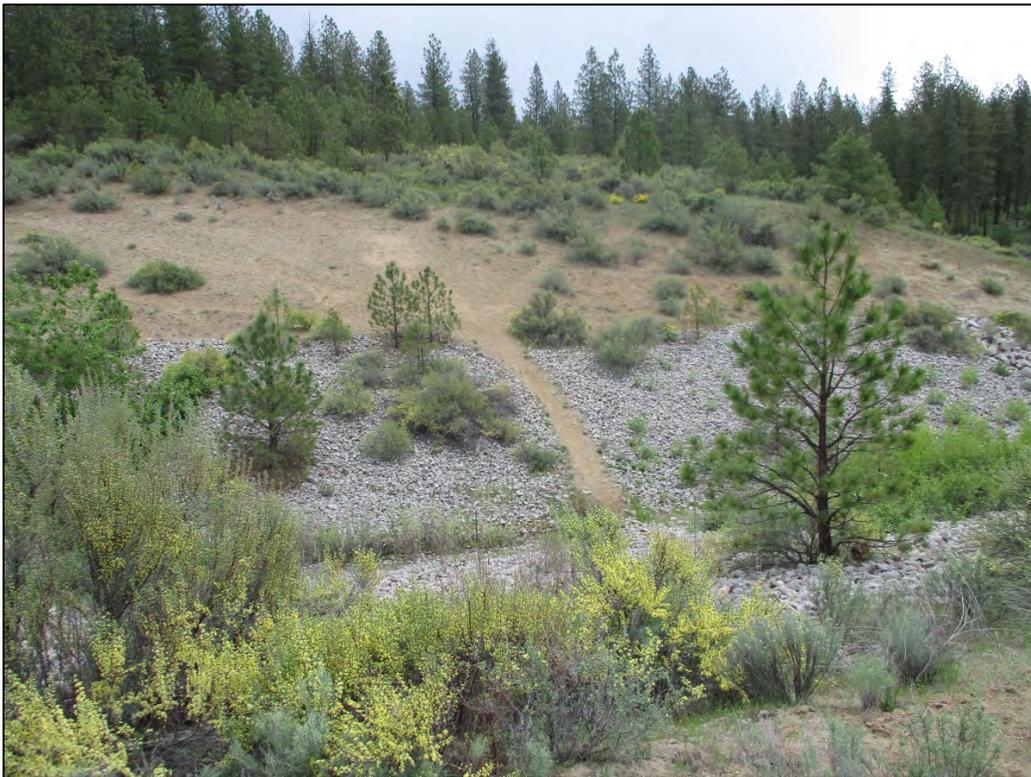
*PL-10. Protective Rock Armor Displaced by Animal Trails*

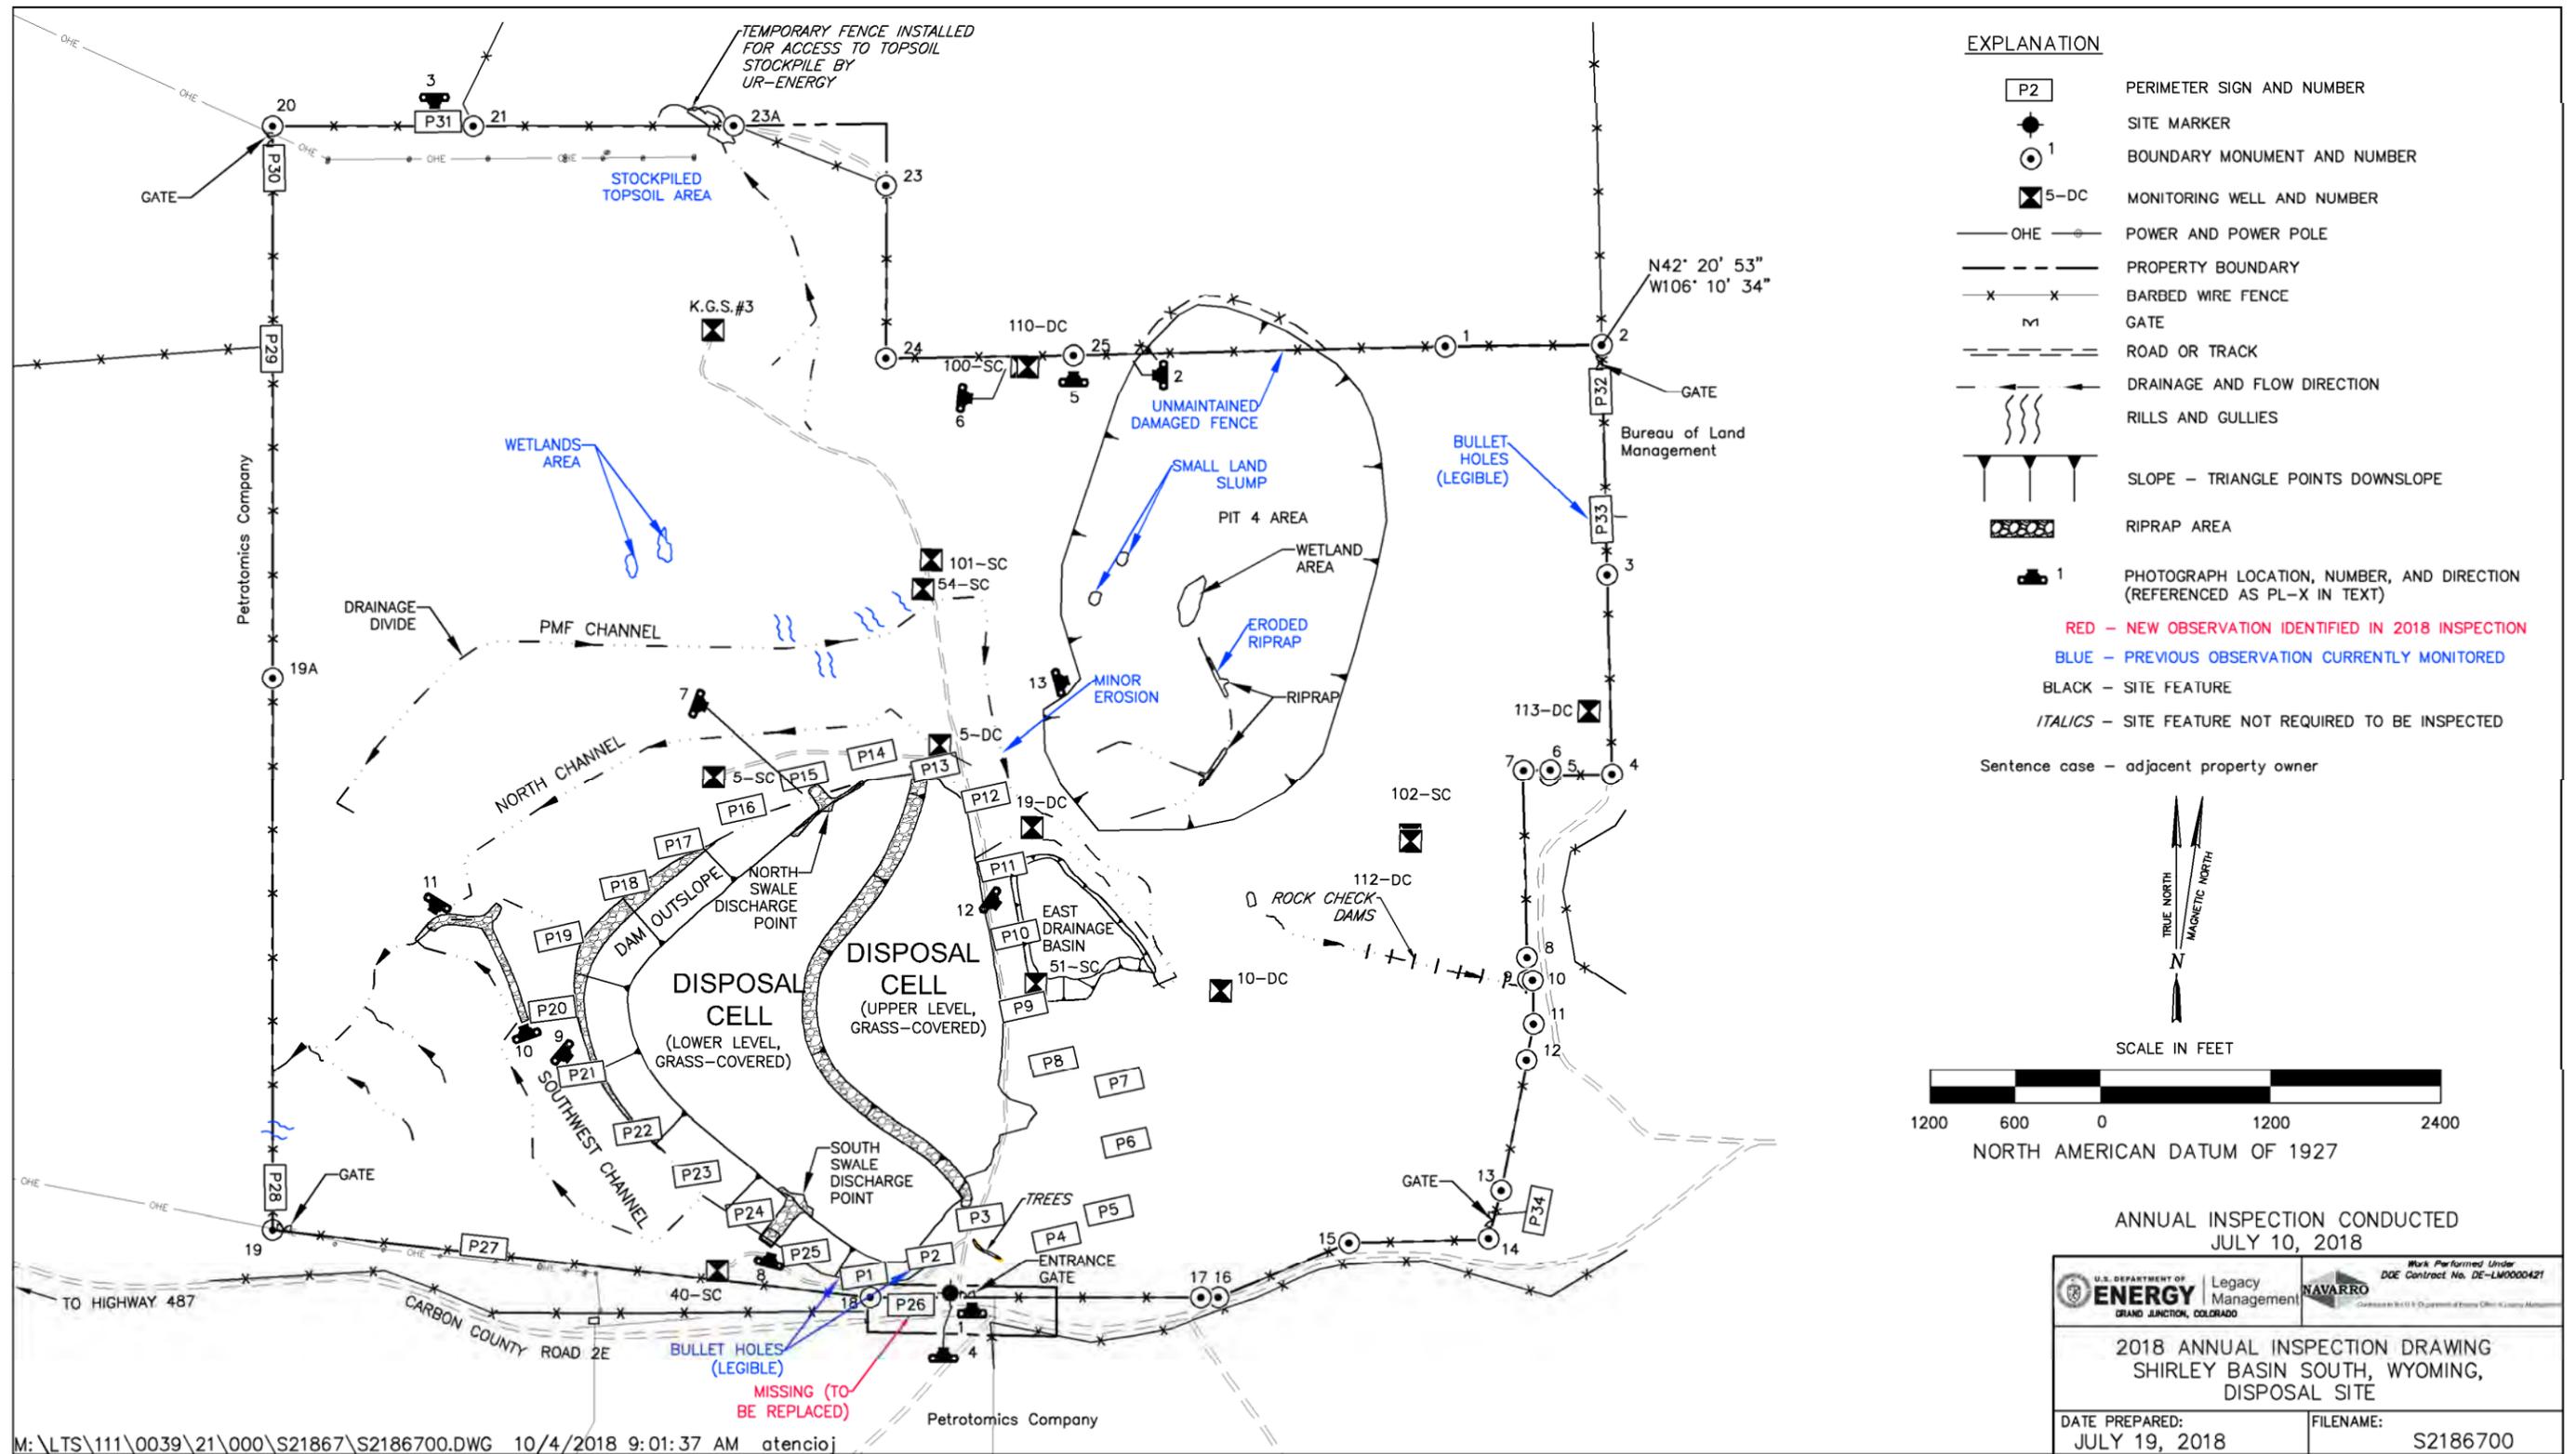
Figure 6-1. 2018 Annual Inspection Drawing for the Shirley Basin South, Wyoming, Disposal Site

Figure 6-1 shows the locations of site features in black, including site surveillance features and inspection areas. Site features that are present but not required to be inspected are shown in italic font. Observations from previous inspections that are currently monitored are shown in blue text, and new observations identified in the 2018 inspection are shown in red. Inspection results and recommended maintenance activities associated with site surveillance features are included in the following subsections. Photographs to support specific observations are identified in the text and in Figure 6-1 by photograph location (PL) numbers. The photographs and photograph log are presented in Section 6.8.

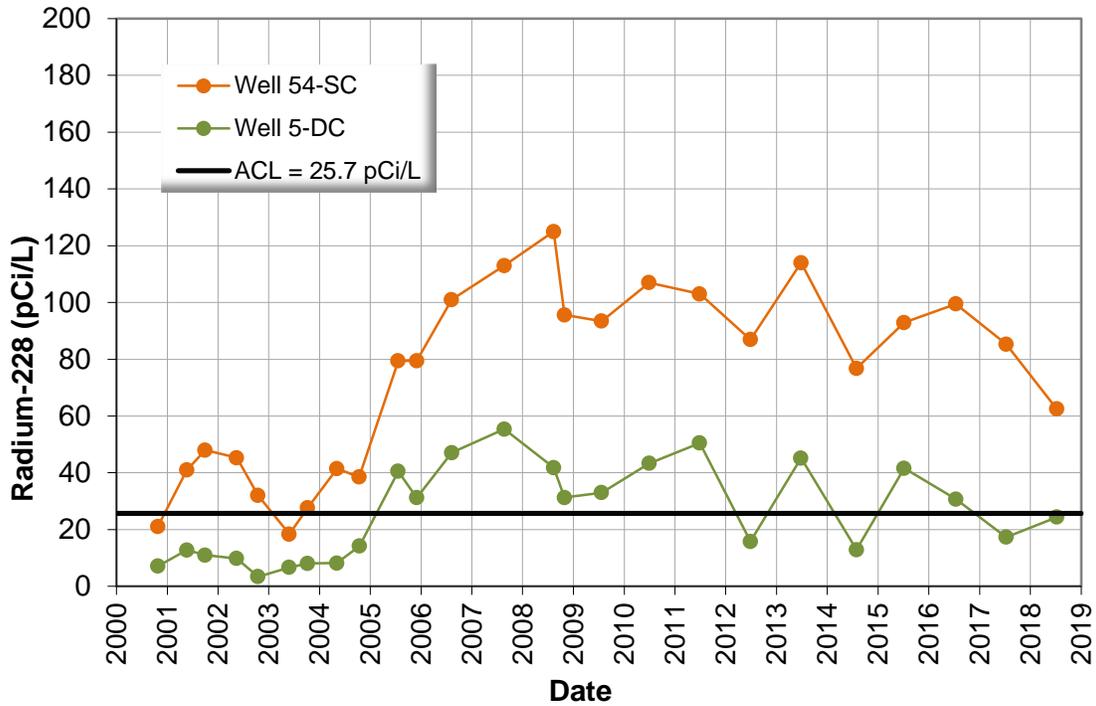
Figure 6-3. Radium-228 Concentrations in Wells 5-DC and 54-SC Since Completion of the Disposal Cell at the Shirley Basin South, Wyoming, Disposal Site

The concentration of cadmium in well 5-SC remained below the ACL since 2005. Radium-228 continued to exceed the ACL in well 54-SC but continues to be below the ACL in well 5-DC (Figure 6-3). Additionally, the ACL for <sup>226</sup>Ra continues to be exceeded in well 110-DC (Figure 6-4).

Although the  $^{228}\text{Ra}$  concentration is elevated in well 54-SC, it is lower than the highest concentration measured in this well in the early 1990s during site groundwater remediation activities. Radium-228 is a decay product of thorium-232 ( $^{232}\text{Th}$ ), which is highly immobile. Because the half-life of  $^{228}\text{Ra}$  is relatively short,  $^{232}\text{Th}$  sources must be near monitoring wells 5-DC and 54-SC. LM attributes the elevated  $^{226}\text{Ra}$  and  $^{228}\text{Ra}$  in the site wells to natural mineralization in the sand units, rather than concluding it is evidence of diminished disposal cell performance or contaminant plumes migrating offsite (DOE 2011). Both the upper and main sand aquifers at the site were dewatered during mining and remediation and are still recovering. Consequently, periodic increases in some constituent concentrations in the groundwater, such as radium-228, may represent a reestablishment of equilibrium of groundwater with naturally occurring constituents in the sand units (Figure 6-3 and Figure 6-4) (DOE 2011).

NRC considers it possible that the elevated radium may represent leakage from the disposal cell. However, NRC has concluded that no additional evaluation of the cause of the elevated radium concentrations by LM is warranted at this time because there is no risk to human health and the environment (Orlando 2012). The groundwater is not a current or potential future source of drinking water due to limited yield and poor ambient conditions resulting from naturally occurring uranium mineralization, and human activities related to uranium exploration and mining that occurred in the area from the late 1950s to the early 1990s. Livestock water at the site is drawn from a separate aquifer, the lower sand aquifer, which is not hydraulically connected to the aquifers of concern and is not impacted by former milling operations.

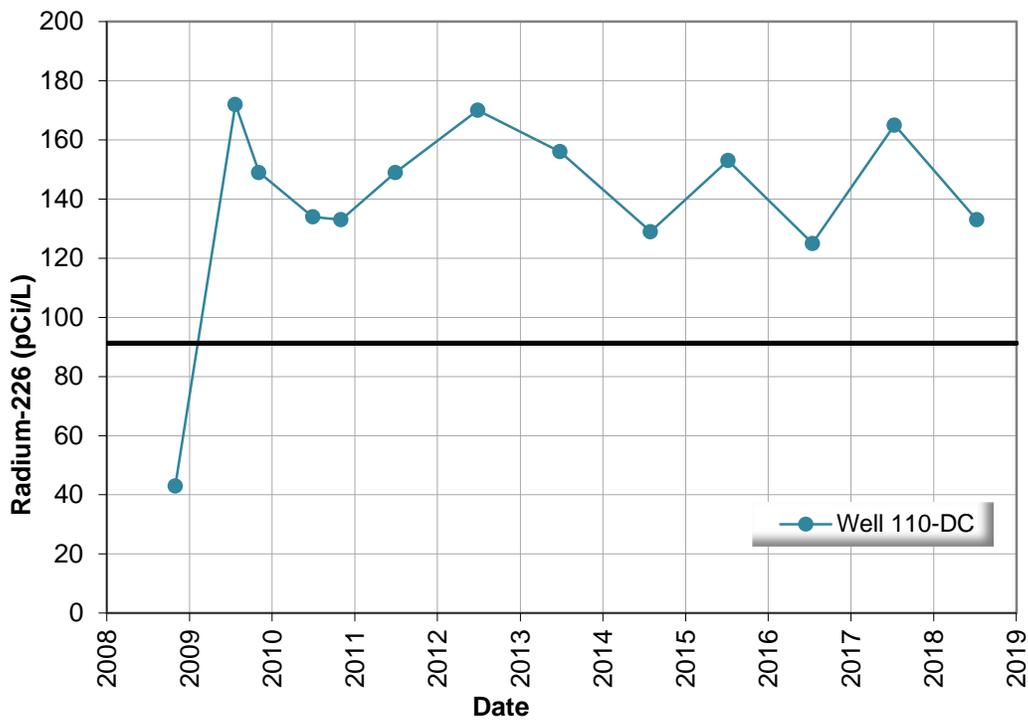
Figure 6-4. Radium-226 Concentrations in Well 110-DC at the Shirley Basin South, Wyoming, Disposal Site

The 2018 water quality results were within the range of historical measurements (Table 6-4 and Table 6-5; Figure 6-3 and Figure 6-4). The exceedances are found in wells near the disposal cell except for the  $^{226}\text{Ra}$  exceedance at well 110-DC. Well 110-DC is near a uranium ore deposit, and the  $^{226}\text{Ra}$  concentration is around 29 times that of the upgradient POC well 5-DC. Therefore, the  $^{226}\text{Ra}$  in well 110-DC is probably naturally occurring (DOE 2011).

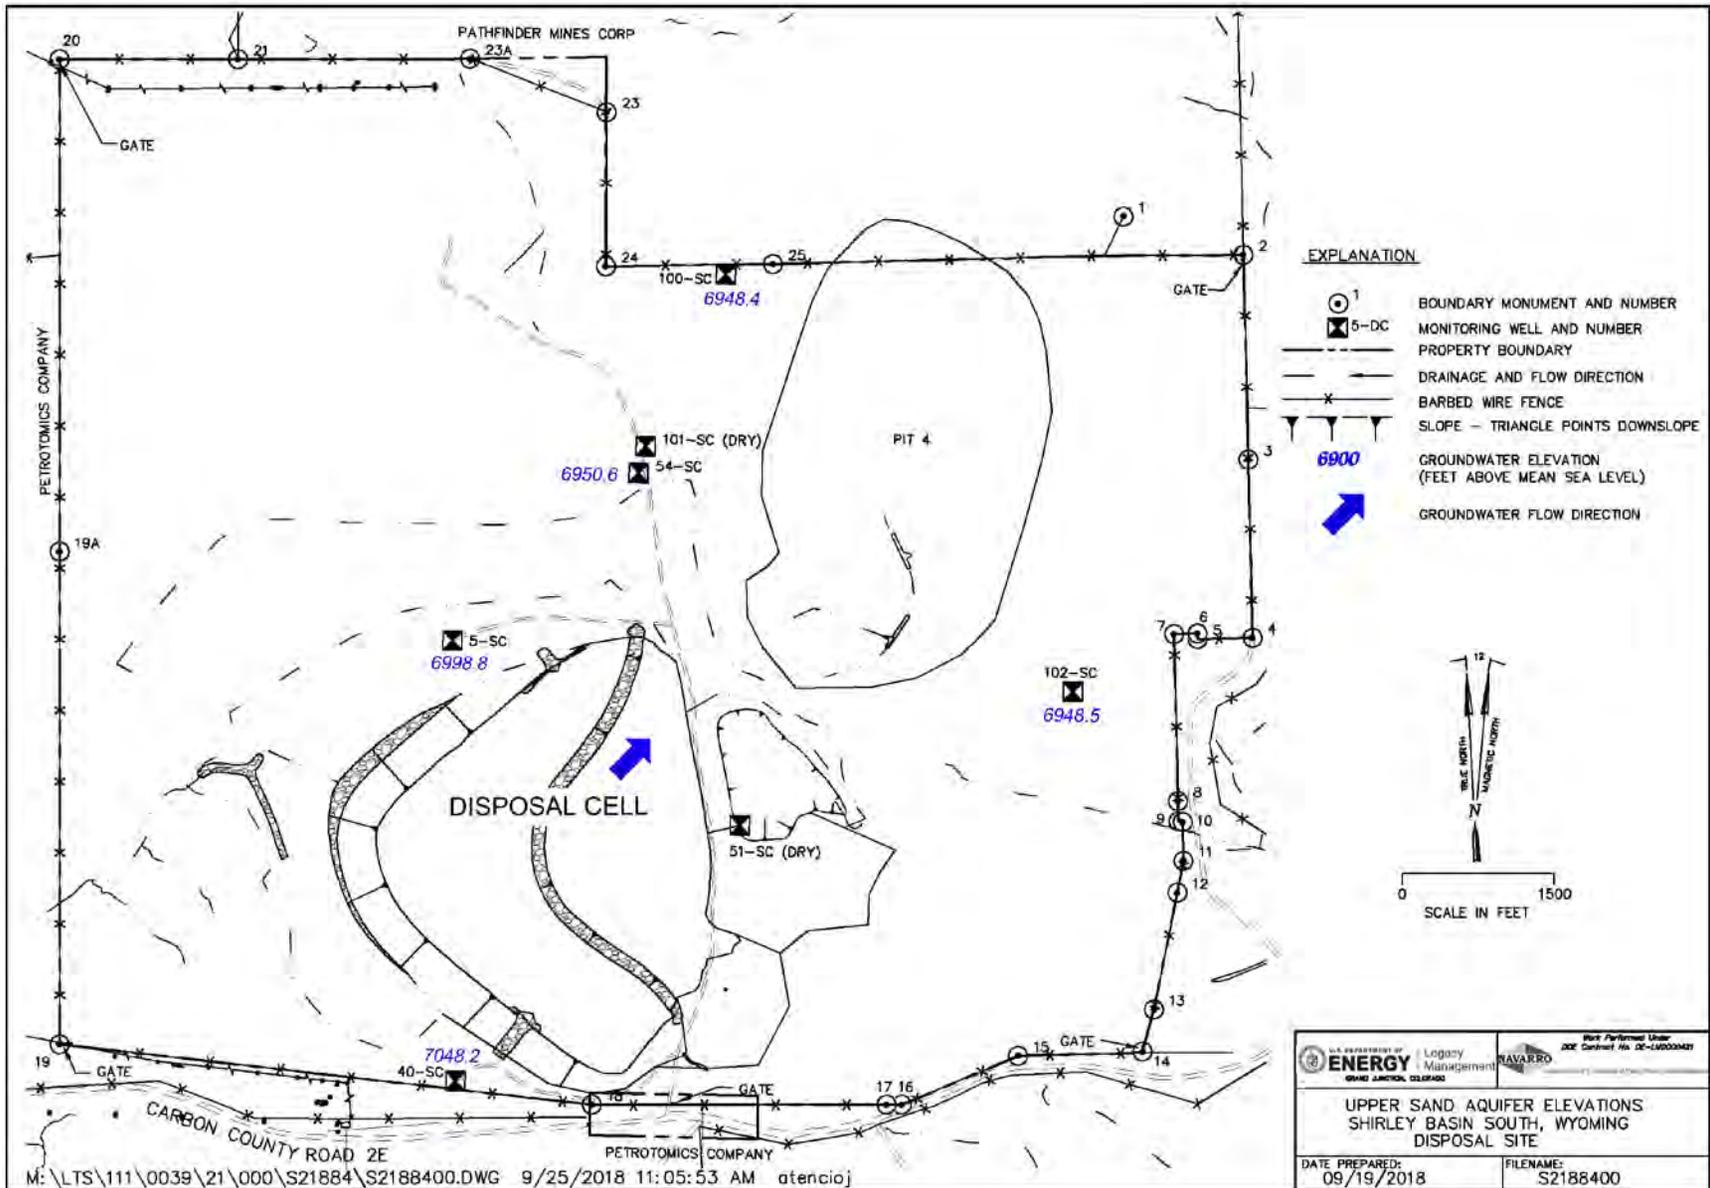
Figure 6-9. July 2018 Groundwater Elevations in the Upper Sand Aquifer at the Shirley Basin South, Wyoming, Disposal Site

Water-level elevations for the upper sand aquifer are shown in Figure 6-9. Water levels are increasing in wells 100-SC and 102-SC, but they are remaining constant in the other upper sand aquifer wells. The apparent flow direction is to the northeast, along the formation dip and toward Pit 4 (DOE 2011). The dry wells (51-SC and 101-SC) indicate that the upper sand aquifer has not recovered near Pit 4. Because the aquifer is no longer confined at the Pit 4 location and because the flooded open-pit mine on the Ur-Energy property downgradient of the site might be a groundwater sink, aquifer water levels on the site might never recover to their premining elevations (DOE 2011).

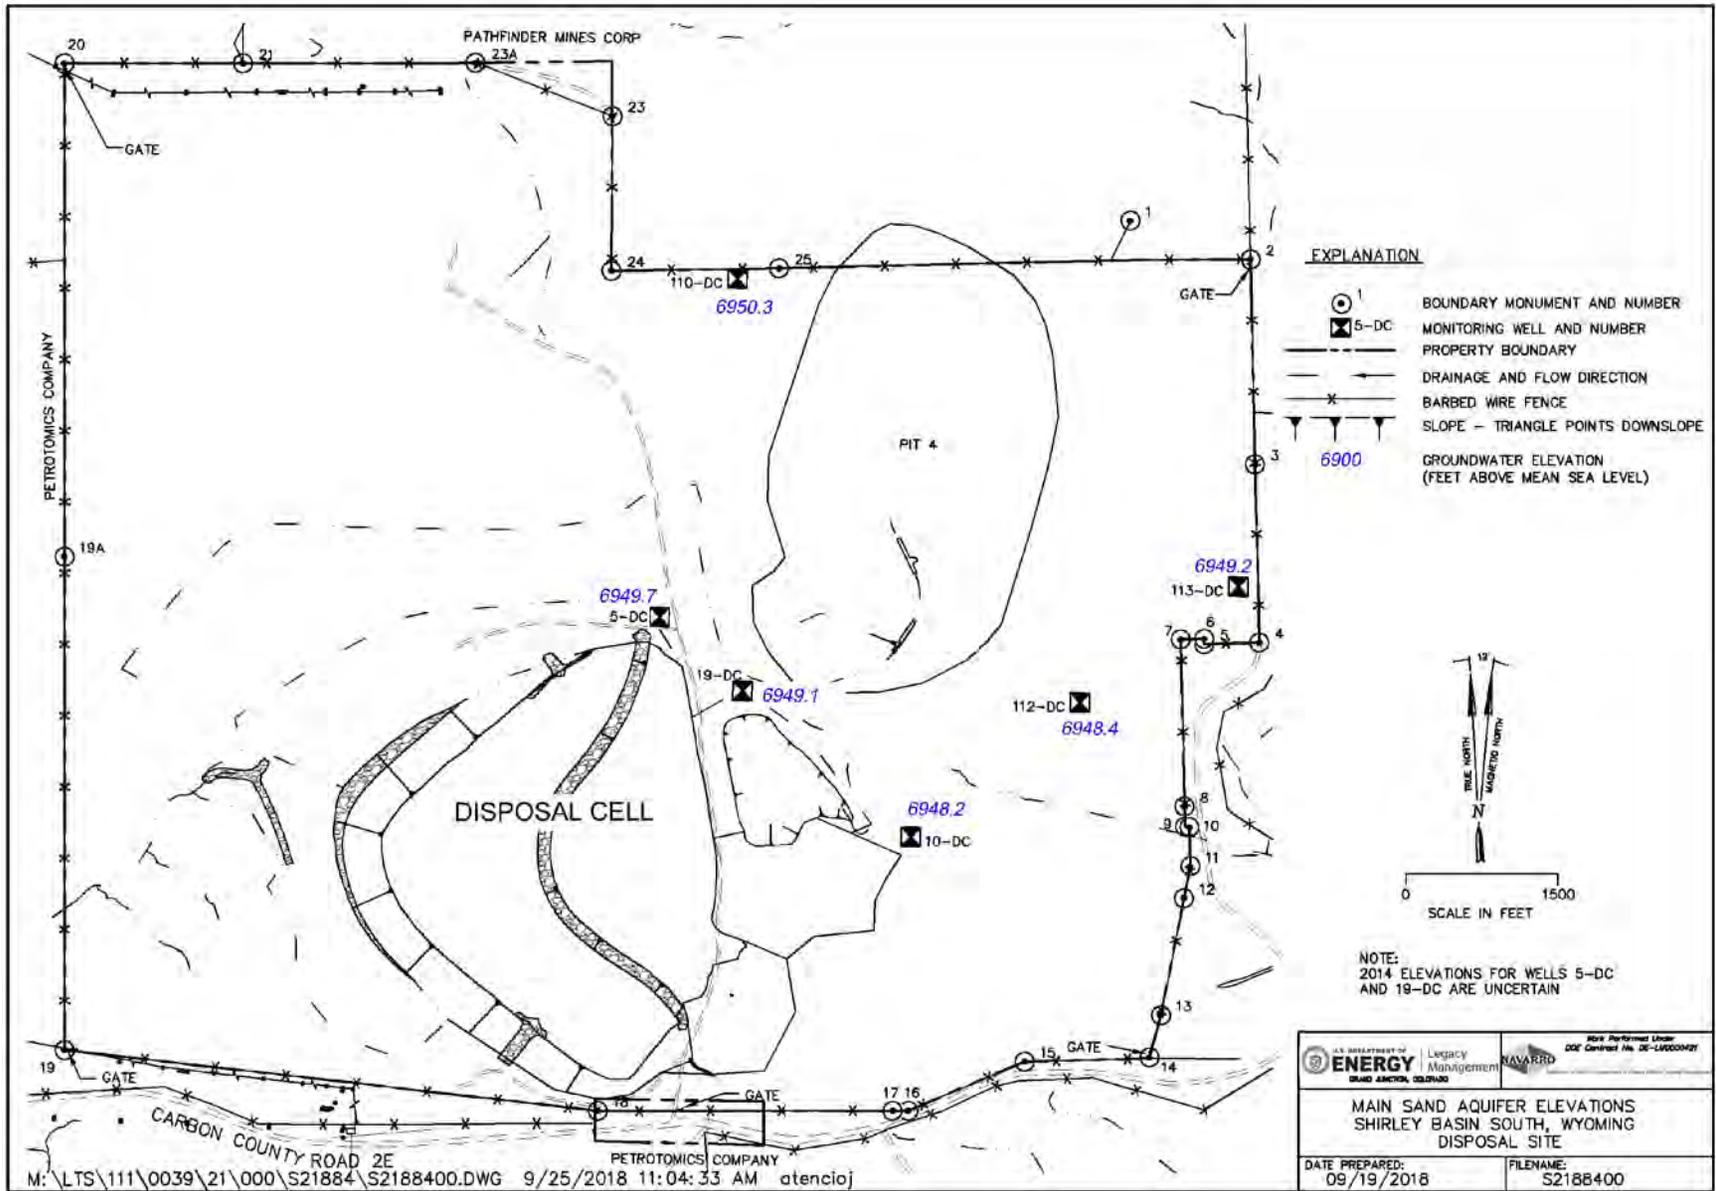
Figure 6-10. July 2018 Groundwater Elevations in the Main Sand Aquifer at the Shirley Basin South, Wyoming, Disposal Site

Main sand aquifer water elevations, shown in Figure 6-10, have been gradually rising at all wells since 2000, with an average rate of increase of approximately 0.9 foot per year since LM began monitoring water levels in 2005 (Figure 6-11). The rising levels indicate a gradual recovery of the aquifer. However, the altered conditions at Pit 4 might prevent a return to premining elevations of the water table. Also, the water surface elevation of the downgradient pit lake on the adjacent Ur-Energy property might control the surface elevation of the aquifers on the site. The groundwater elevations, several of which are from wells near Pit 4, do not indicate a definitive flow direction in the main sand aquifer. Local groundwater flow likely is affected by continued recovery of the aquifer and the hydraulic properties of the backfill material in Pit 4. Therefore, a flow direction arrow is not shown in Figure 6-10.

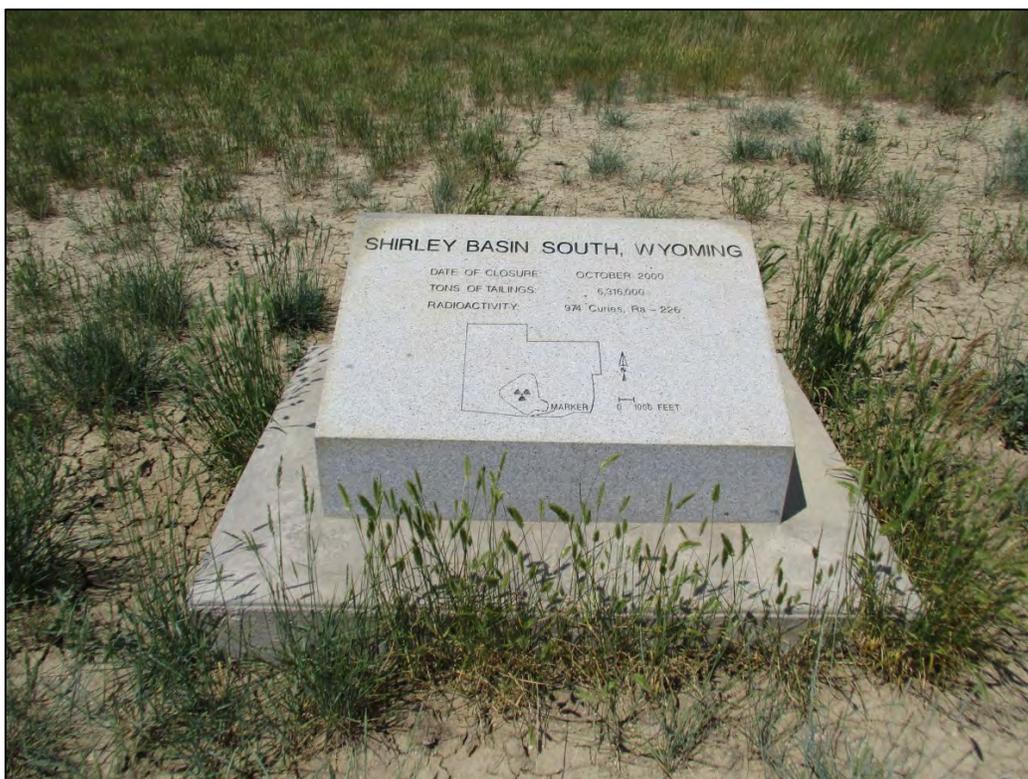
PL-4. Site Marker

The site has one granite site marker near the site entrance gate (PL-4). No maintenance needs were identified.
