U.S. DEPARTMENT OF  
**ENERGY**

Legacy  
Management

# 2019 Annual Site Inspection and Monitoring Report for Uranium Mill Tailings Radiation Control Act Title II Disposal Sites

December 2019

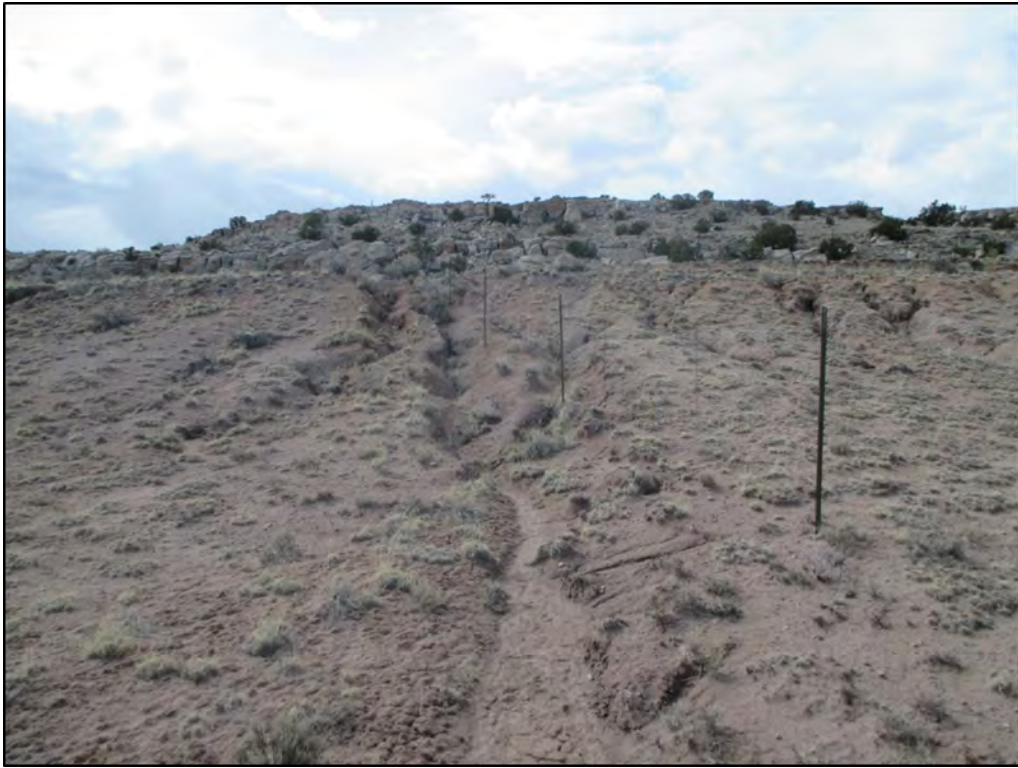
*PL-3. Erosion Along the Perimeter Fence*

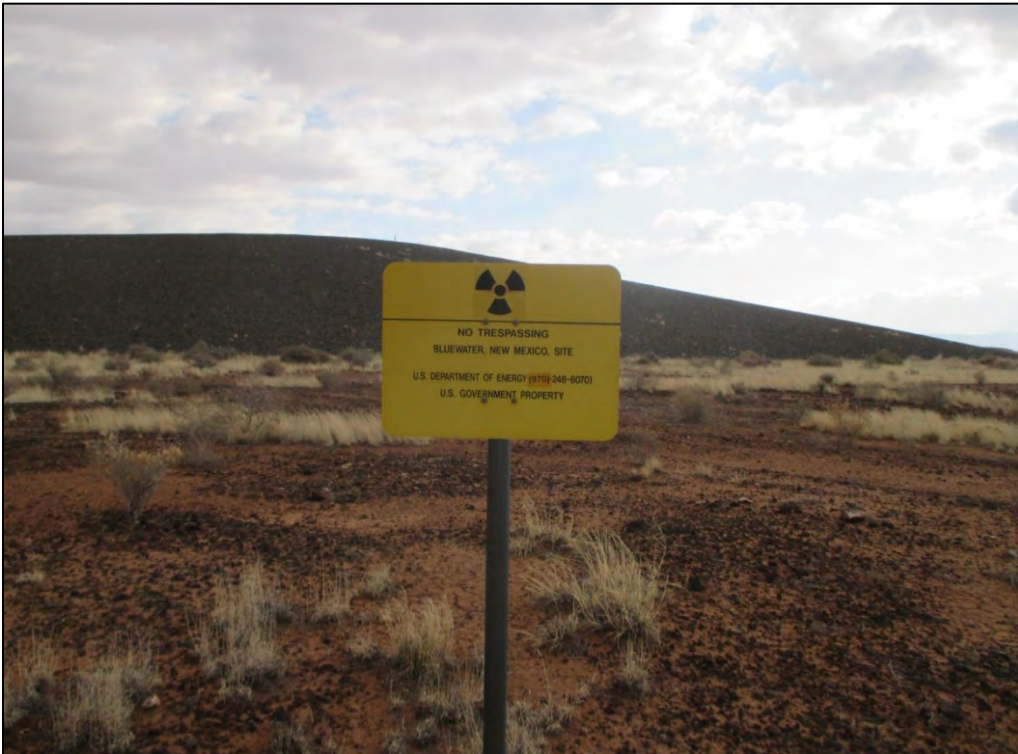
Fifty-five perimeter signs (warning and no-trespassing signs) are mounted on steel posts along the site boundary and around the main and carbonate tailings disposal cells (PL-4). Perimeter signs P3 and P10 have bullet hole damage but are legible. Perimeter sign P9A was faded and replaced following the inspection. No other maintenance needs were identified.

*PL-4. Perimeter Sign P52 and Southwest Corner of the Main Tailings Disposal Cell*

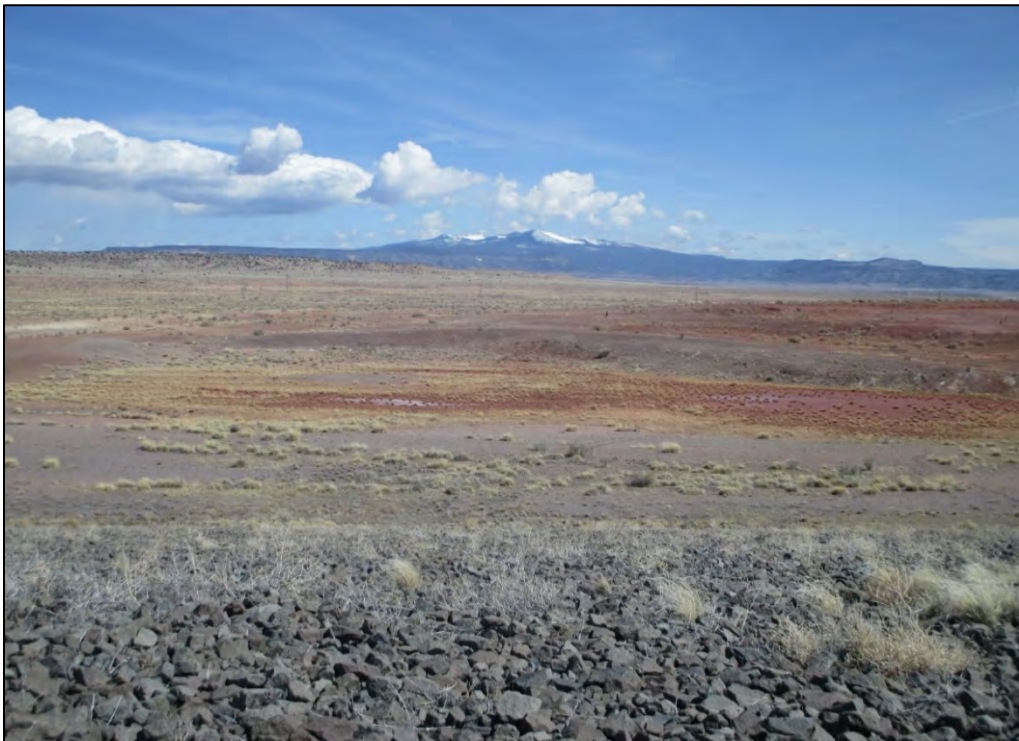
*PL-18. East Side Slope of the Main Tailings Disposal Cell and Ephemeral Ponds (Wet)*

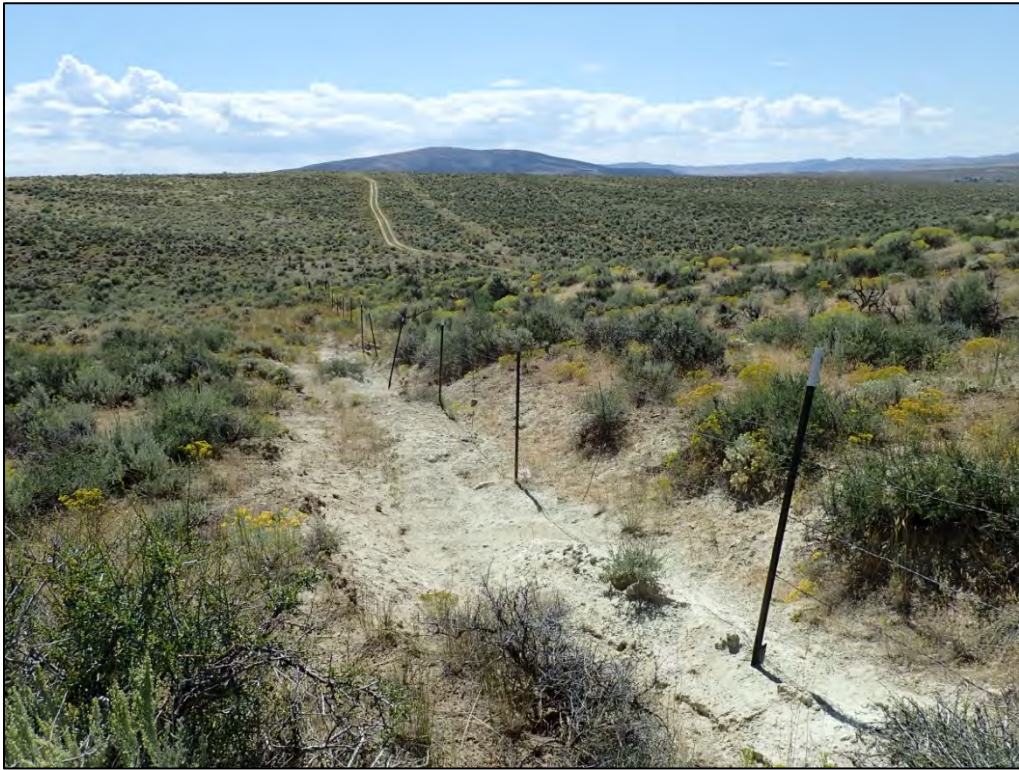
*PL-1. Erosion Along Southwest Perimeter Fence*

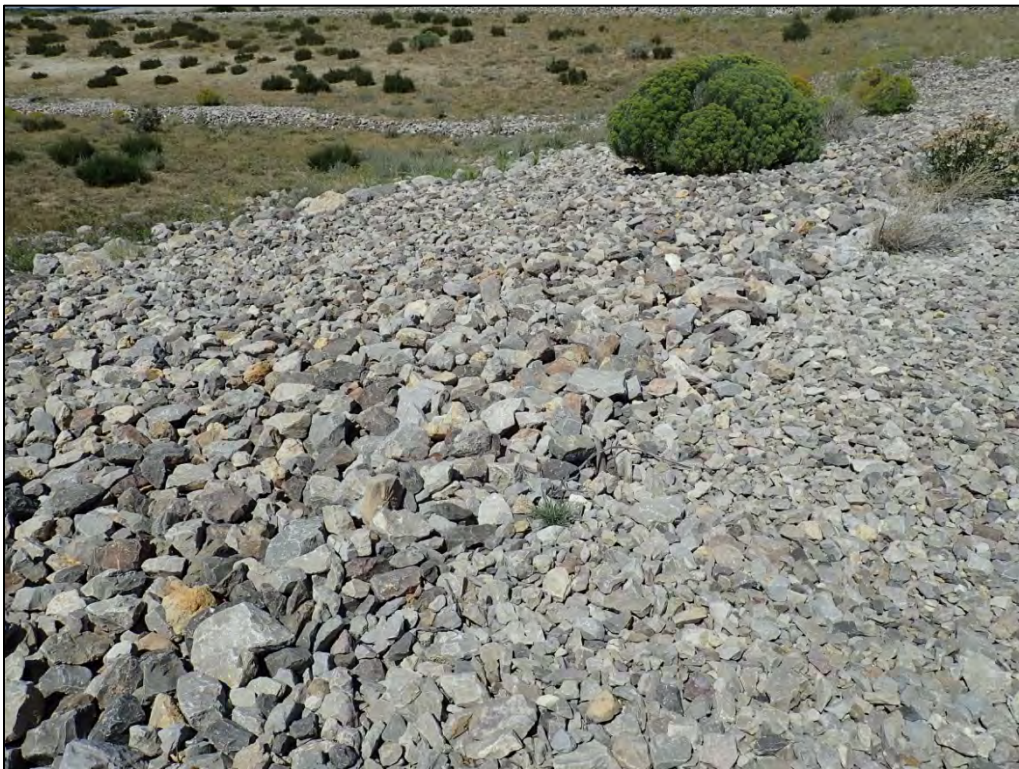
*PL-12. Ancillary Cell West Side Slope with Small Depression on Cell Top Slope in Foreground*

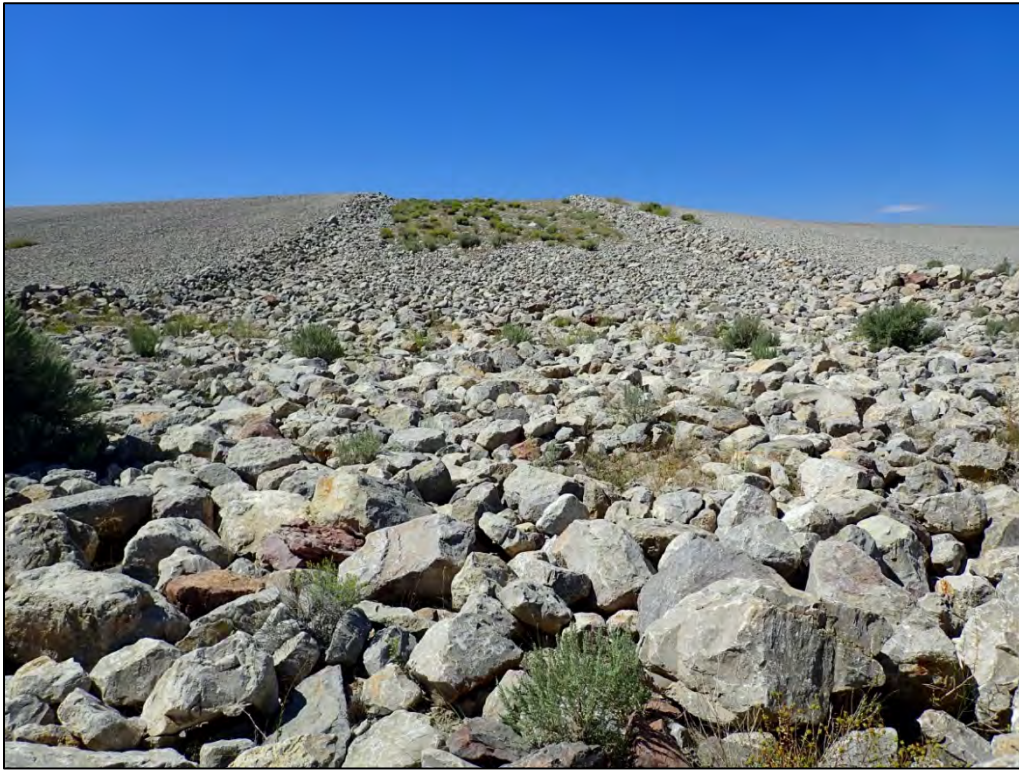
*PL-15. Launch Rock Erosion Protection Basin on Disposal Cell East Side Slope*

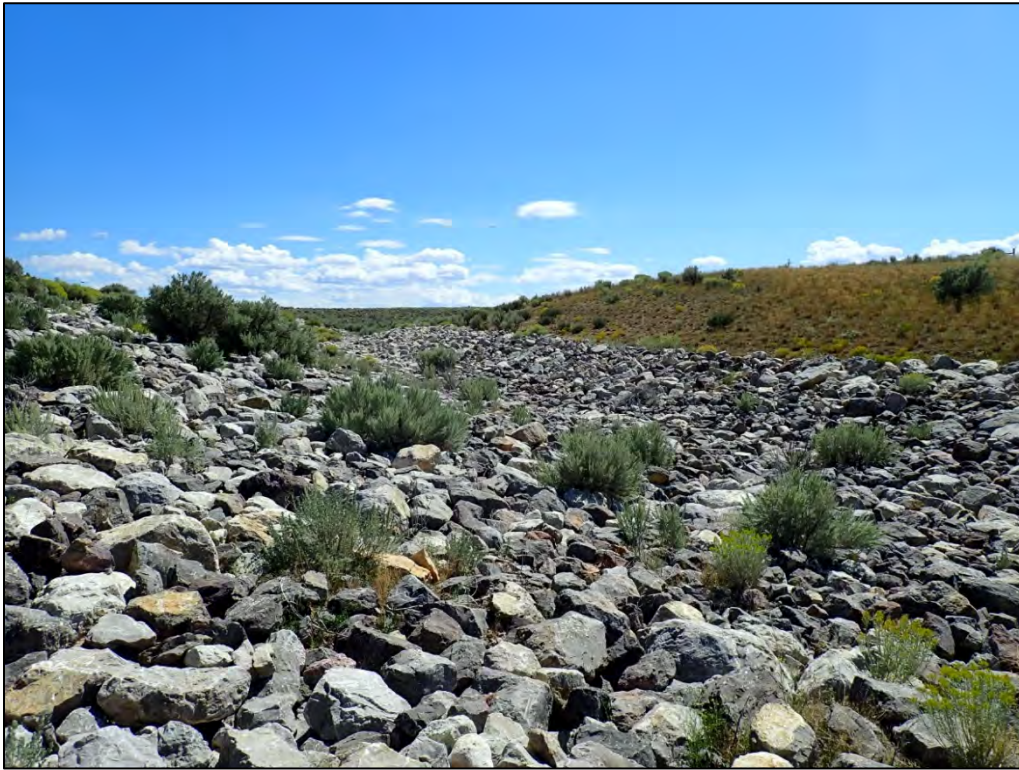
*PL-17. Diversion Channel No. 2*

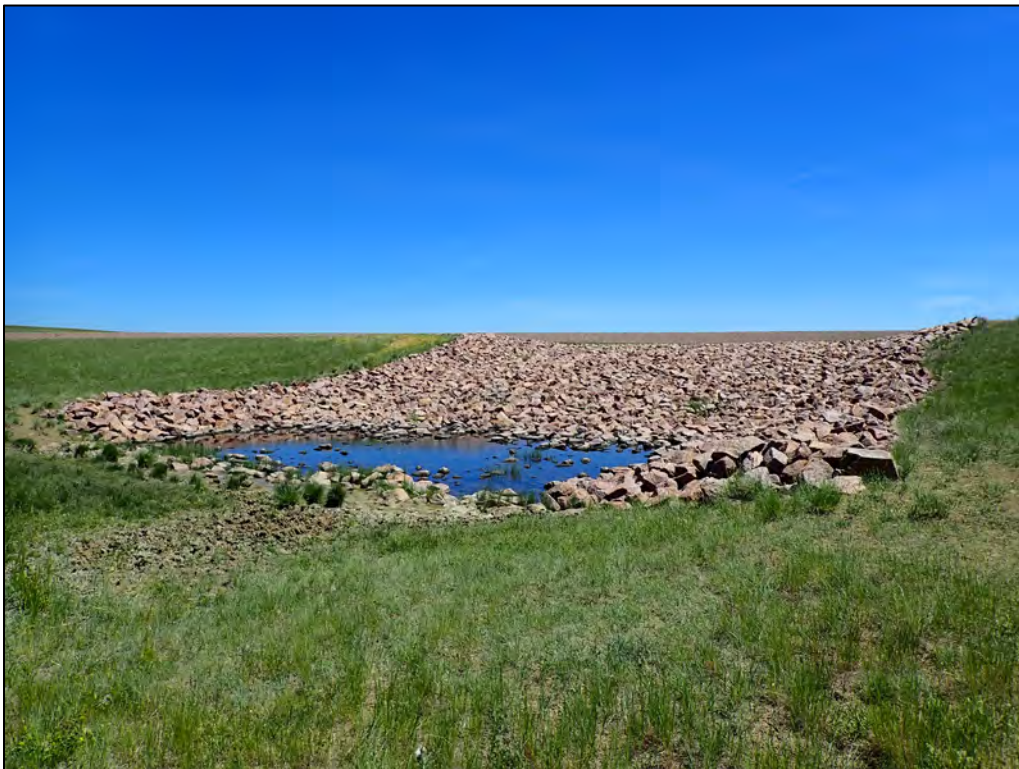
*PL-8. North Swale Discharge Point (Runoff Present)*

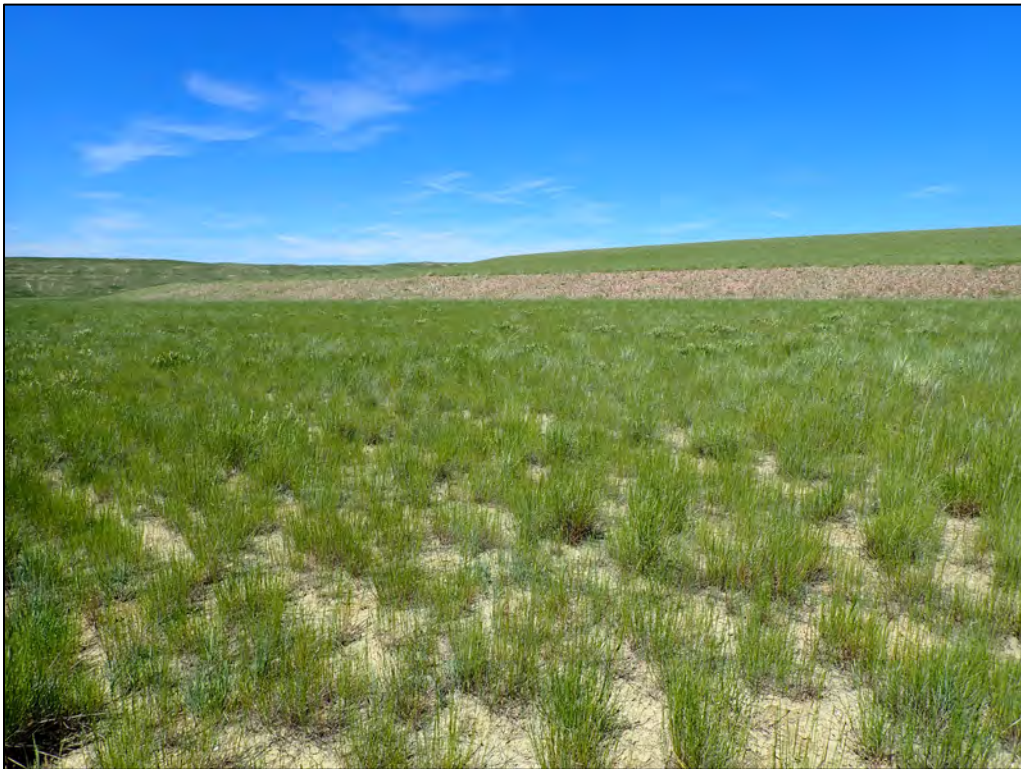
*PL-10. Disposal Cell Dam Outslope*

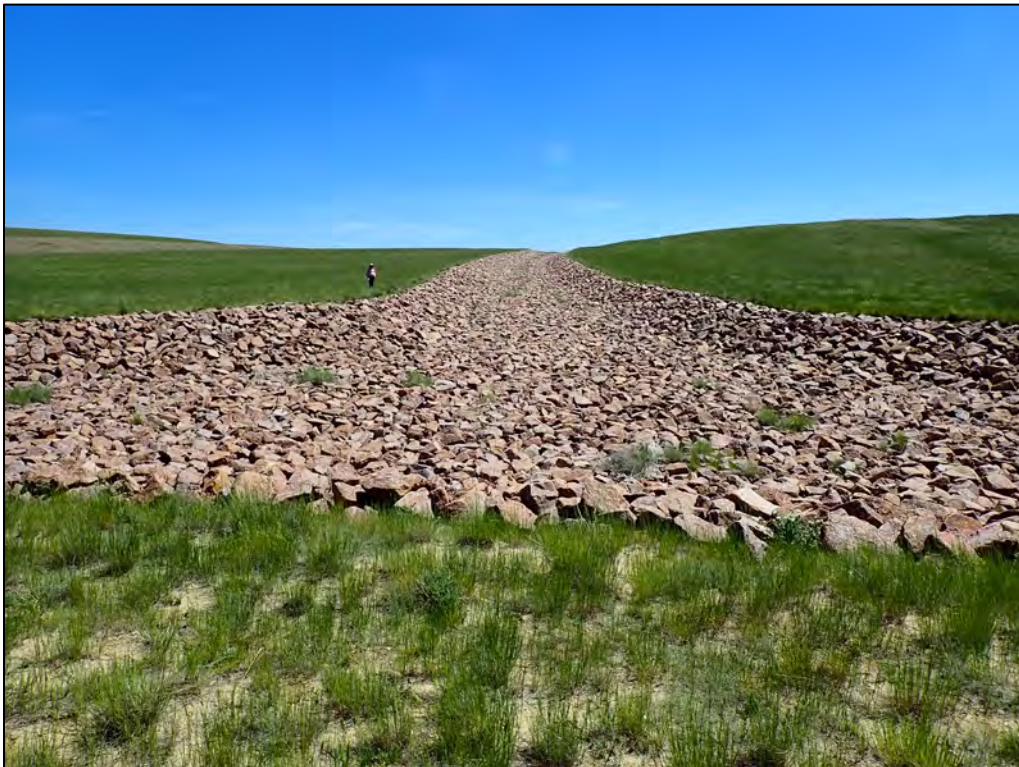
*PL-12. Riprap-Armored Diversion Channel*

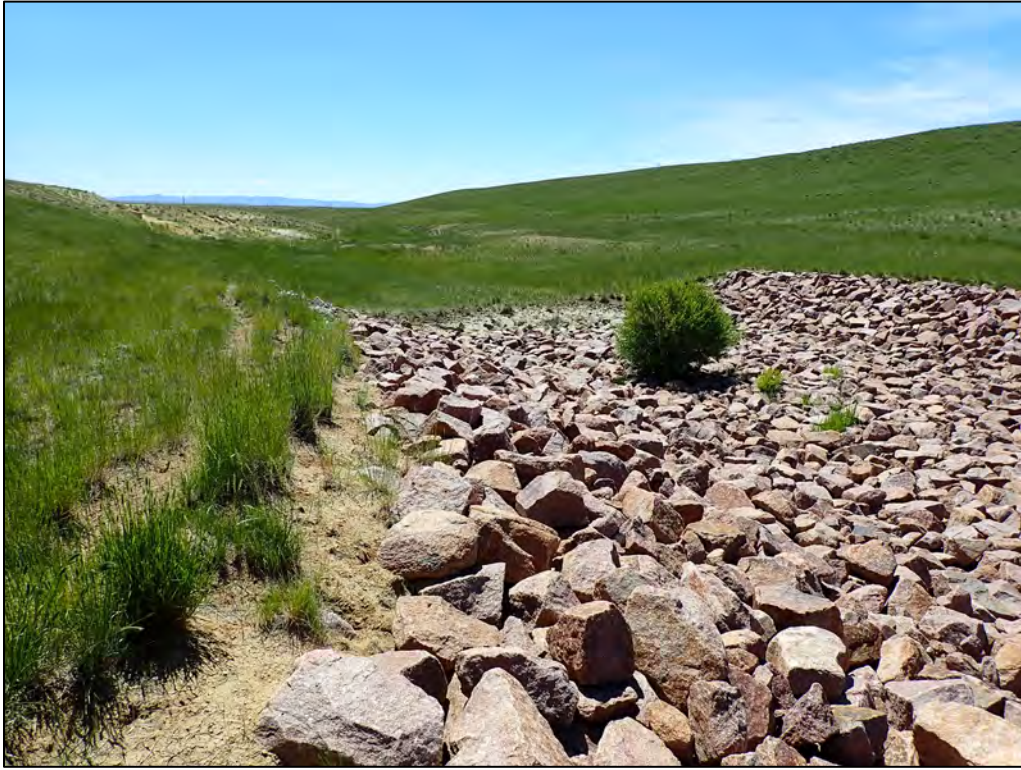
*PL-13. Outlet of Riprap-Armored Diversion Channel*
