**DOE ZERO ENERGY READY
HOME™ CASE STUDY****BPC Green
Builders**

New Fairfield, CT

- Name: Candlewood Hills Rebuild
- Location: New Fairfield, CT
- Layout: 3 bedrooms, 3 baths, 2 floors
- Conditioned Space: 3,052 ft²
- Completion: Dec. 2012
- Climate Zone: 5A
- Category: Custom

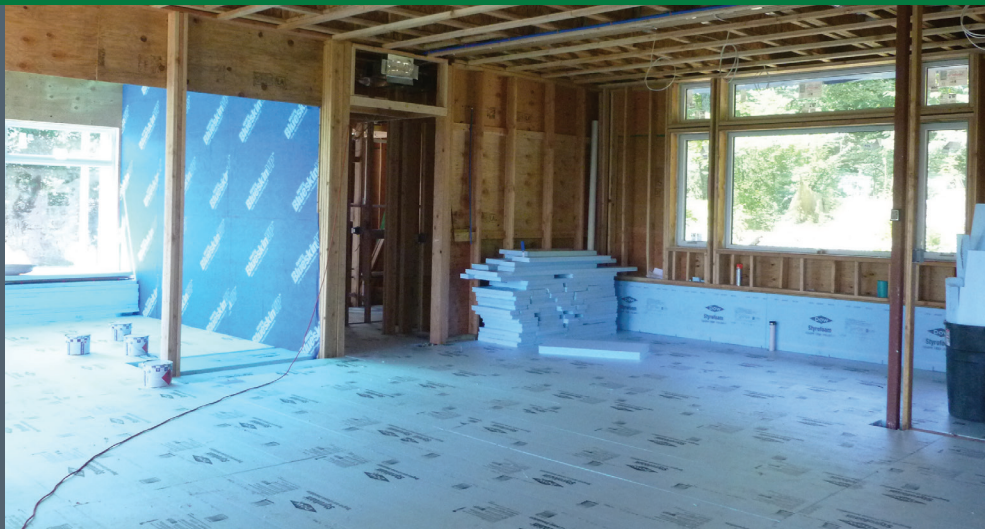
Rigid foam insulation covered the slab foundation, which included some old existing slab plus a new poured slab. The rigid foam also lined the interior and exterior of the foundation walls, providing a snug thermal break and moisture protection for first-floor radiant heating loops, which were set in 2 inches of gypcrete.

Some portions of the old slab were removed and replaced with new concrete slab. Then a liquid gypsum material was poured over both the new and old slab to level the surface. This was covered with R-20 (4 inches) of extruded polystyrene (XPS) rigid foam insulation. The radiant floor tubing was installed on the XPS and 2 inches of gypcrete was poured over this as a base for the tile floors. Rigid XPS (R-15) was installed along the foundation walls, 3 inches thick on the exterior and 1.5 inches thick on the interior, before the slab was poured.

- **Foundation:** R-20 (4 inches) XPS rigid foam insulation over existing slab and under new slab. 3 inches (R-15) XPS exterior, plus 1.5 inch (R-7.5) XPS on interior of foundation walls

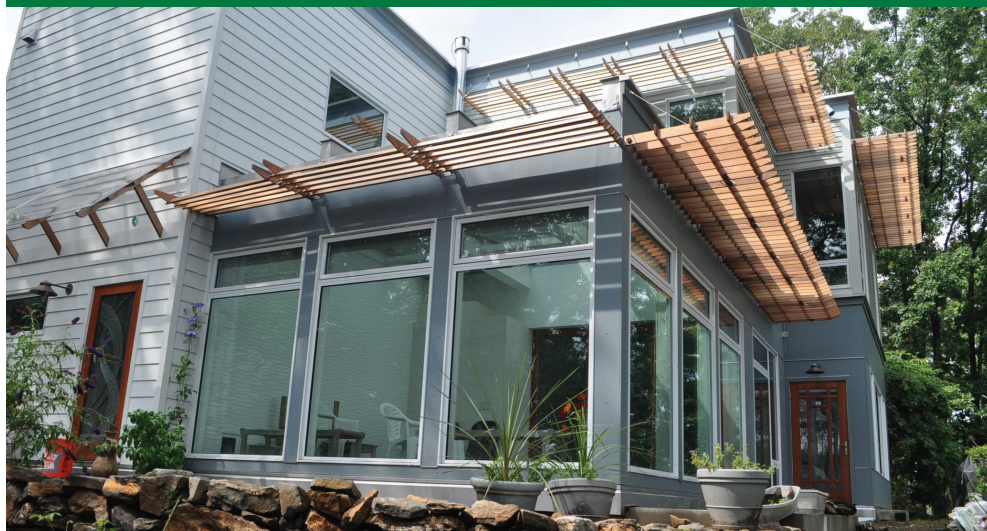
Nearly every room and closet in the home receives natural light through triple-pane low-emissivity windows or insulated solar tubes. Extra attention to air sealing helped the home achieve a very low air leakage rate of 0.45 ACH 50.

The highly insulating envelope was also heavily air sealed with all holes, joints, and cracks caulked or filled with spray foam. The DOE Zero Energy Ready Home program requires that every home be tested for air leakage with a blower-door test. BPC Green Builders achieved a very low score of 0.45 air changes per hour at 50 Pascals pressure.

Every room in the home has natural daylighting via windows or solar tubes, including every closet but one—the closet under the stairs. All but one fixture in the home use LED or CFL bulbs; most are screw-based fixtures to accommodate future improvements in light sources. McKay designed the home's lighting plan, which includes 35 different lighting zones. Indirect lighting above built-in shelves is set by timers to consist of brighter lighting in the morning and warmer tones in the evening to encourage the occupants to wake up and feel sleepy at appropriate times. All of the actual dimmers and switches are high up in the closet, but 7-button, 1-gang controllers were installed on the walls to lump controls into fewer switch plates.
