**DOE ZERO ENERGY READY
HOME™ CASE STUDY****Weiss Building &
Development, LLC**System Home
River Forest, IL

**BUILDER PROFILE****Weiss Building & Development LLC**Brandon Weiss, builder
630-485-1818, Brandon@weissbd.com
Chicago, IL
www.weissbd.com**FEATURED HOME/DEVELOPMENT:****Project Data:**

- Name: Chicagoland's First Certified Passive House
- Location: River Forest, IL
- Layout: 5 bedroom, 4.5 baths, 3 floors
- Conditioned Space: 4,763 ft² w/ bsmnt
- Completion: January 2013
- Climate Zone: 5A
- Category: System

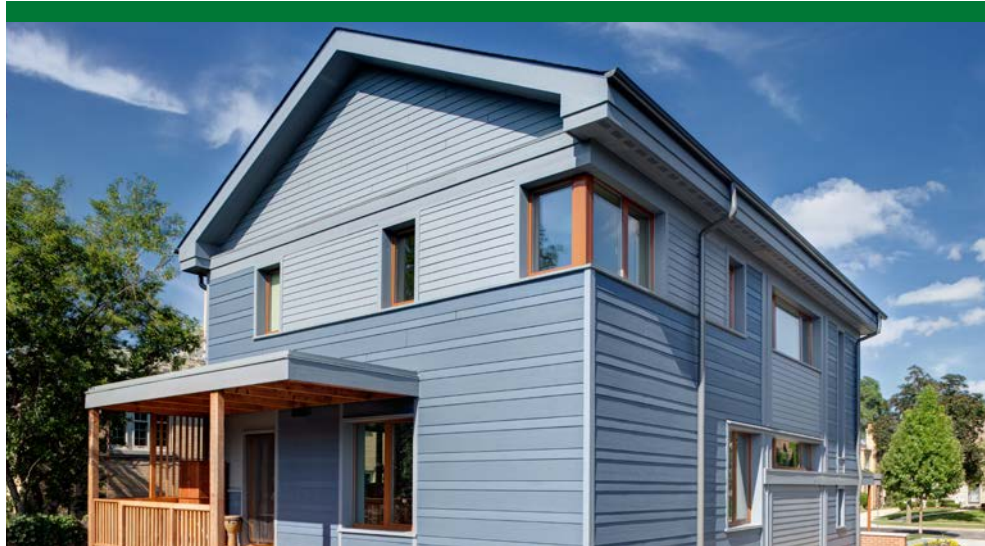
The home meets the Passive House Institute's strict criteria for air tightness and insulation. The builder employed several types of insulation and flashing in the 19-inch-thick walls and roof to provide redundant layers of protection against the elements.

The homeowner had requested concrete walls because of their durability and reputation for withstanding the forces of nature. Weiss selected a concrete construction method known as ICF, using insulated concrete forms, which are like hollow foam blocks that stack like bricks to form two foam walls connected by plastic spacers. The foam walls become the forms for pouring the concrete and then stay in place to provide insulation. In this case, they provided 2.75 inches of rigid expanded polystyrene (EPS) foam on each side of the 6-inch concrete core.

Weiss added 2 more inches of polyisocyanurate rigid insulation on the exterior side of the wall and constructed a 2x4 framed wall on the interior side which was filled with dense-blown fiberglass insulation for 19-inch-thick walls that provided a whopping R-54 of insulation value. To protect the walls from the elements, the polyisocyanurate foam has an integrated weather-resistant coating; when seams in the foam are taped with a proprietary flashing and seam tape, the coating forms a water-shedding barrier. Over this, ¾ inch plywood furring strips were attached vertically every two feet to provide a vented drainage plane behind the engineered wood siding, allowing any moisture that might make its way pass the siding to have a path down and out of the wall. Screening is installed at the top and the bottom of the wall to keep insects out of this venting space.
