SITE CERTIFICATION SUMMARY

This Site Certification Summary provides information about the **Adrian, Michigan, Site**. The U.S. Department of Energy Office of Legacy Management is responsible for long-term stewardship of the site under the **Formerly Utilized Sites Remedial Action Program**.

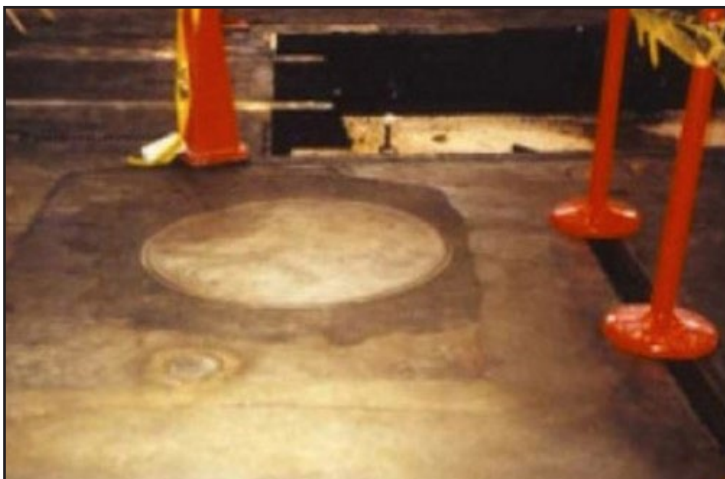
Remediated area at the Adrian site (July 1995).

DOE restored the property to an acceptable condition, with concurrence by the property owner, by backfilling the sumps and manholes, welding the cover plates shut, and plugging and filling all associated piping. DOE removed all residual
