## SITE CERTIFICATION SUMMARY

This Site Certification Summary provides information about the **Fairfield, Ohio, Site**. The U.S. Department of Energy Office of Legacy Management is responsible for long-term stewardship of the site under the **Formerly Utilized Sites Remedial Action Program**.

# Fairfield, Ohio, Site Map

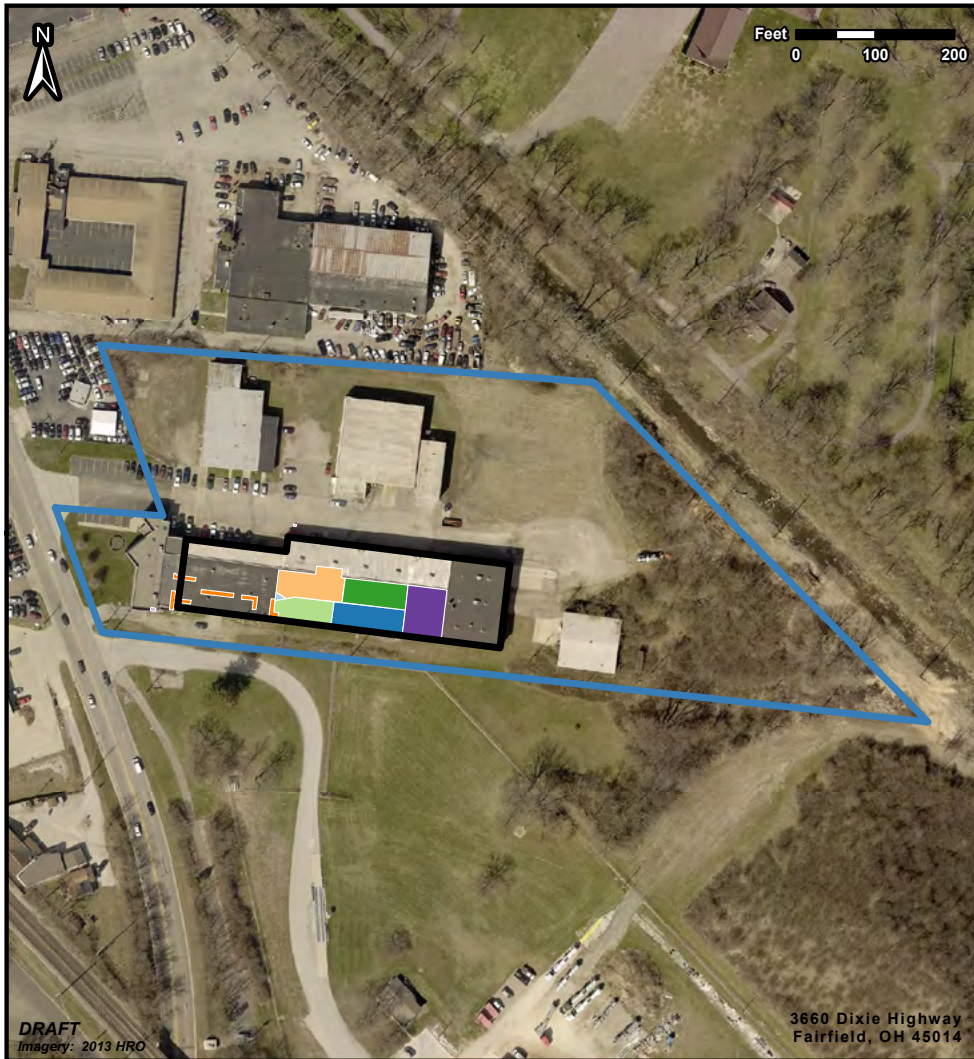
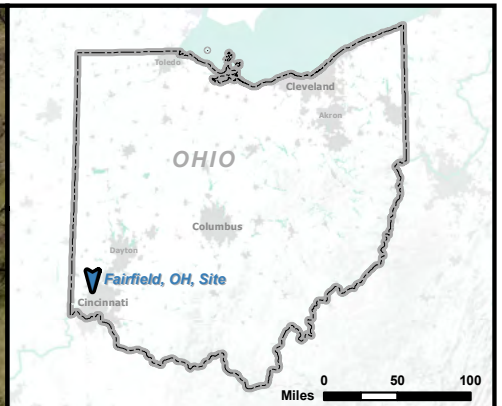
For more detailed results of the post-remediation sampling, see the [Site Certification Data Summary Worksheet](#) on page 4. For a detailed map of the site and sampling locations, see the [Site Overview Map](#) on page 5.
