Office of Health, Safety and Security

## Monthly Analysis of Electrical Safety Occurrences

August 2013

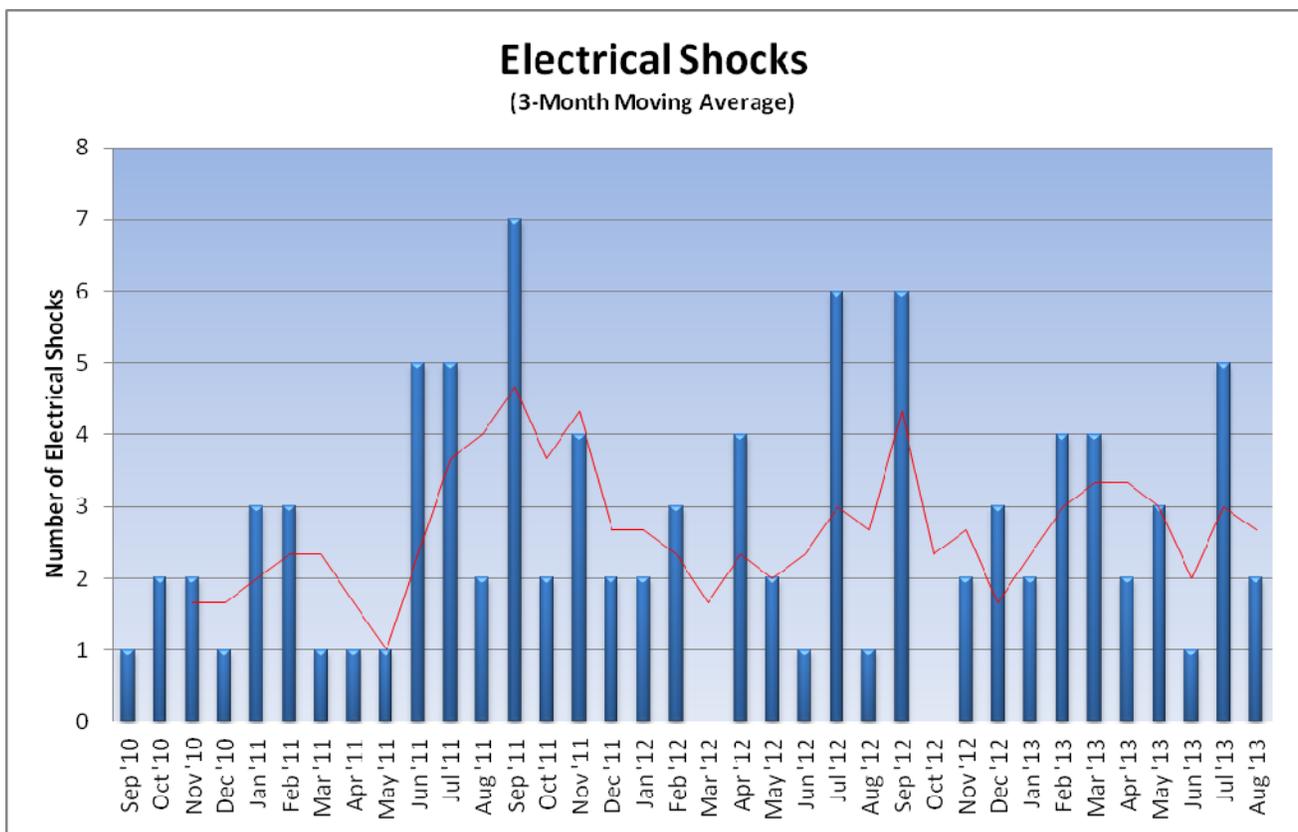
Figure 1 – Three-Year Trend of Electrical Shocks

Figure 1 shows a 3-year trend of electrical shocks for the DOE complex. During this period, the average number of electrical shocks has remained below three (2.6) shocks per month.

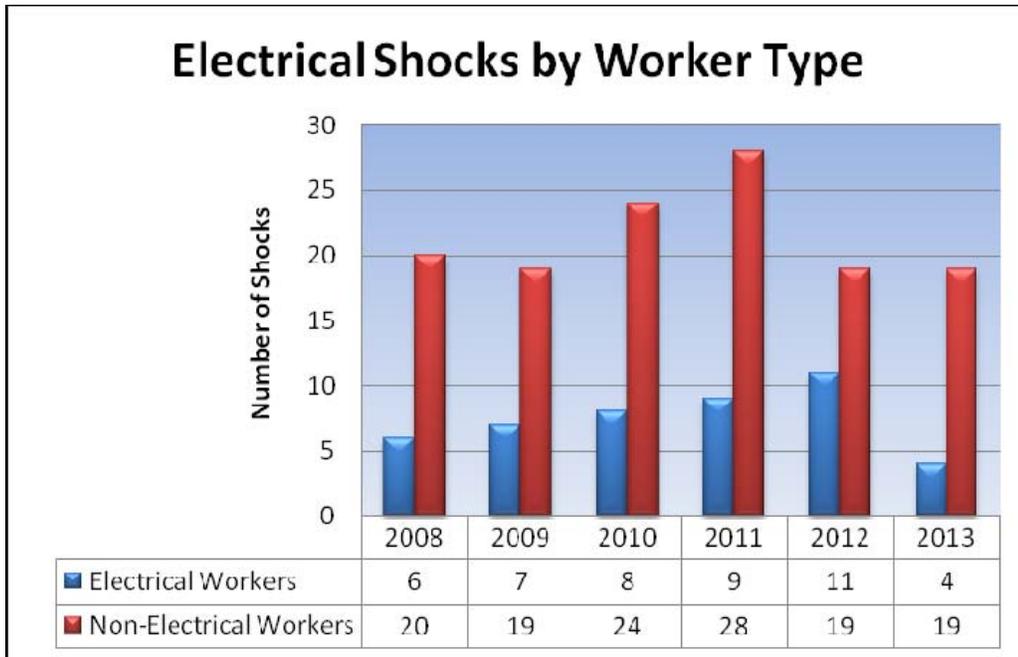
Figure 2 - Electrical Shock by Worker Type

Figure 2 shows electrical shocks by worker type through August 2013. The number of shocks involving electrical workers slowly increased through 2012 and then dropped in 2013. Presently, this is the lowest year since 2008. Shocks involving non-electrical workers decreased after 2011. Since 2008, the majority of shocks (about 74 percent) involve non-electrical workers. So far for in 2013, that percentage is 83.

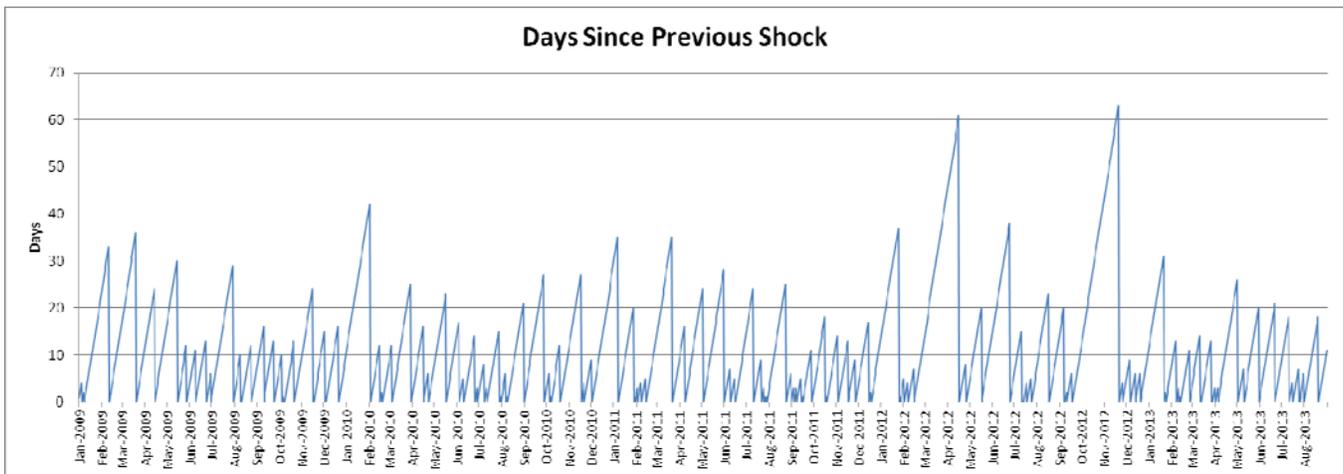
Figure 3 - Days since Previous Shock

Figure 3 shows the number of days since the previous electrical shock for the DOE complex. The longest interval was 63 days (November 20, 2012) and the present interval is 11 days as of August 31.

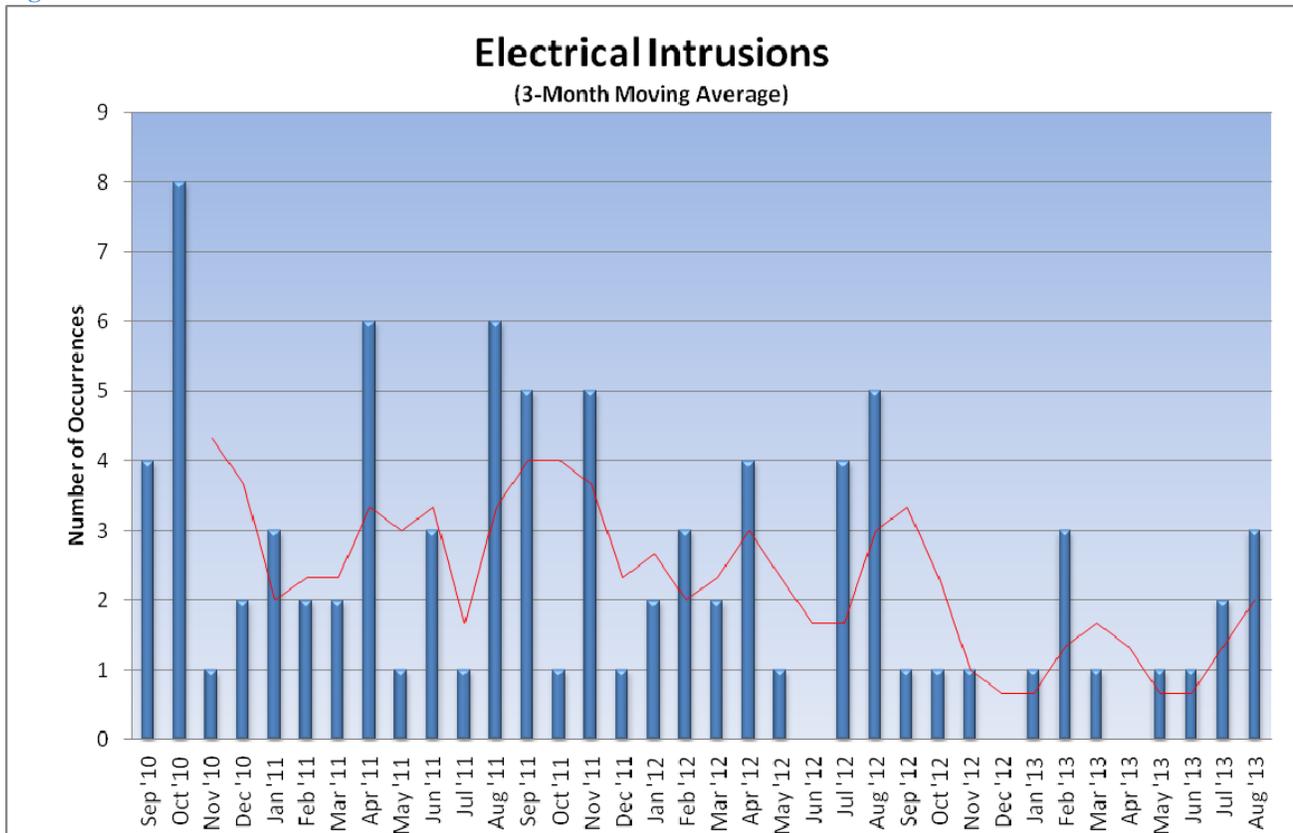
**Figure 4 – Three-Year Trend of Electrical Intrusion Occurrences**

Figure 4 shows a 3-year trend of electrical intrusion occurrences for the DOE complex. During this period we have seen an average of just under 3 occurrences per month (2.4).

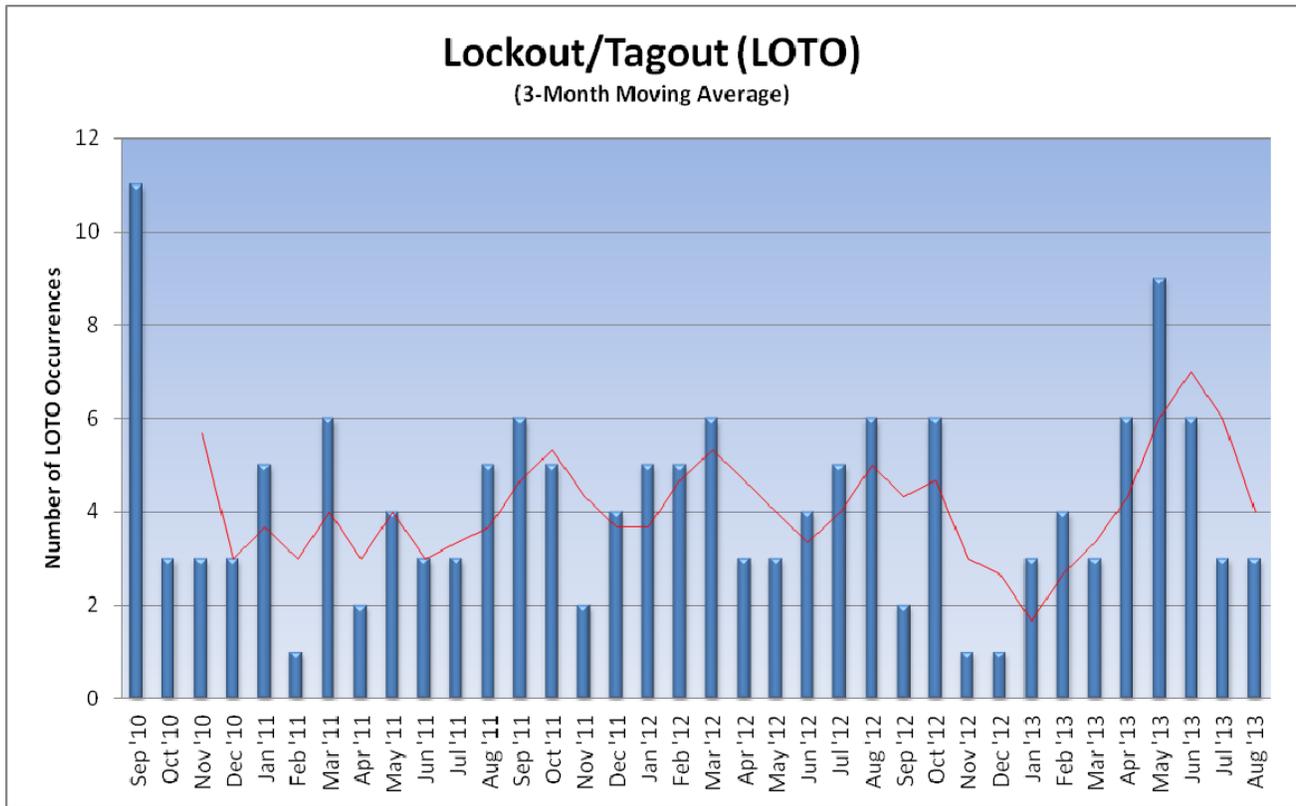
Figure 5 – Three-Year Trend of Lockout/Tagout Occurrences

Figure 5 shows a 3-year trend of LOTO occurrences for the DOE complex. The monthly average is 4.2 occurrences.

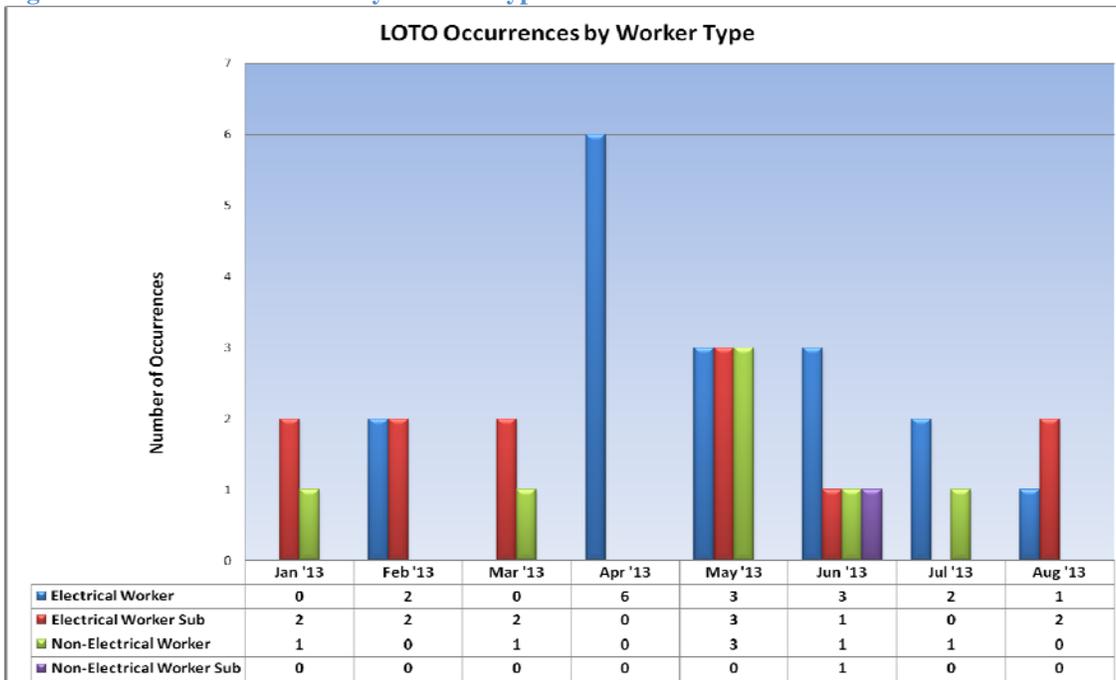
Figure 6 – LOTO Occurrences by Worker Type

Figure 6 shows LOTO occurrences by worker type. The distribution by percentage is 46% for electrical workers, 32% for electrical worker subcontractors, 19% for non-electrical workers, and 3% for non-electrical worker subcontractors.

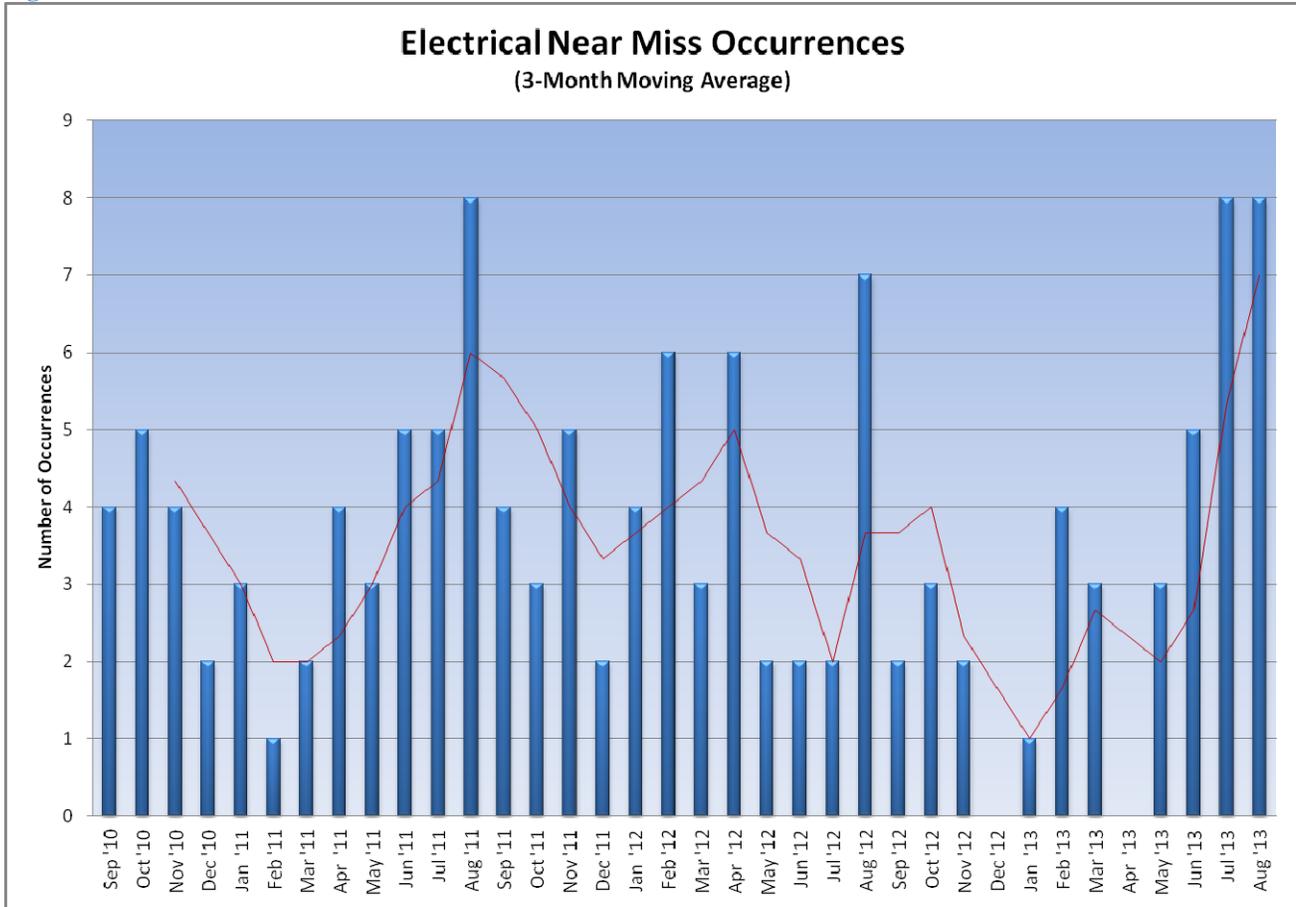
Figure 7 – Three-Year Trend of Electrical Near Miss Occurrences

Figure 7 shows a 3-year trend of near miss occurrences for the DOE complex. The monthly average is 3.6 occurrences.

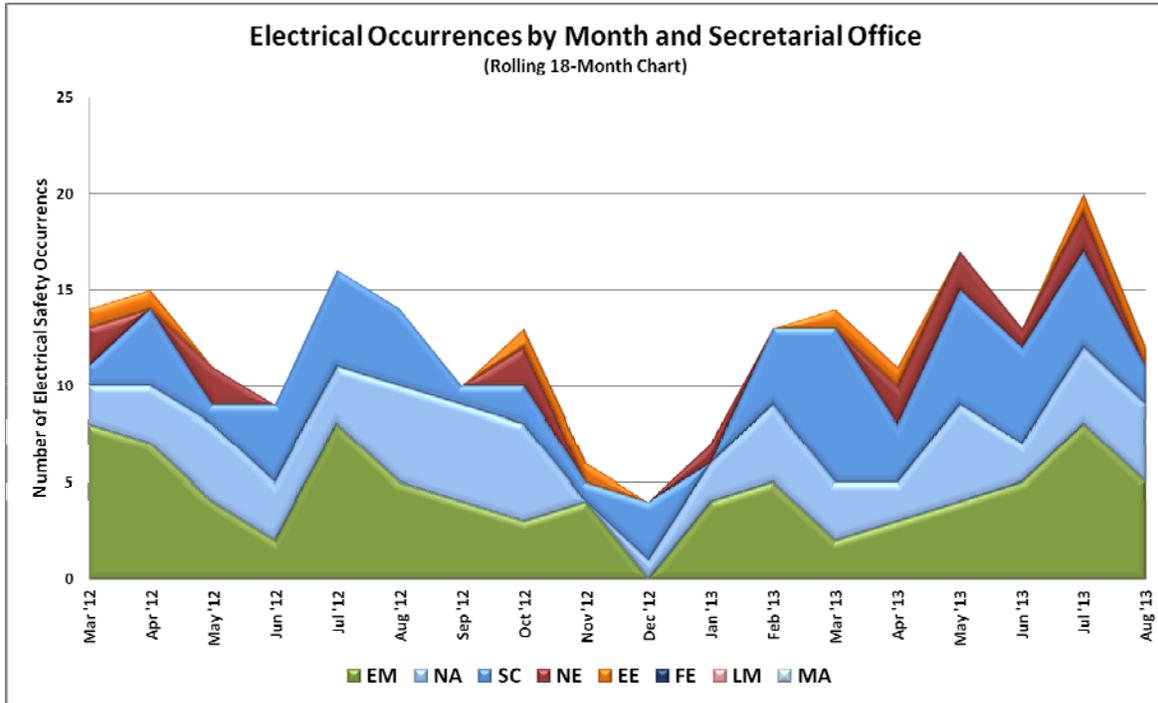
Figure 8 - Electrical Occurrences by Month and Secretarial Office

Figure 8 shows the distribution of electrical safety occurrences by Secretarial Office.

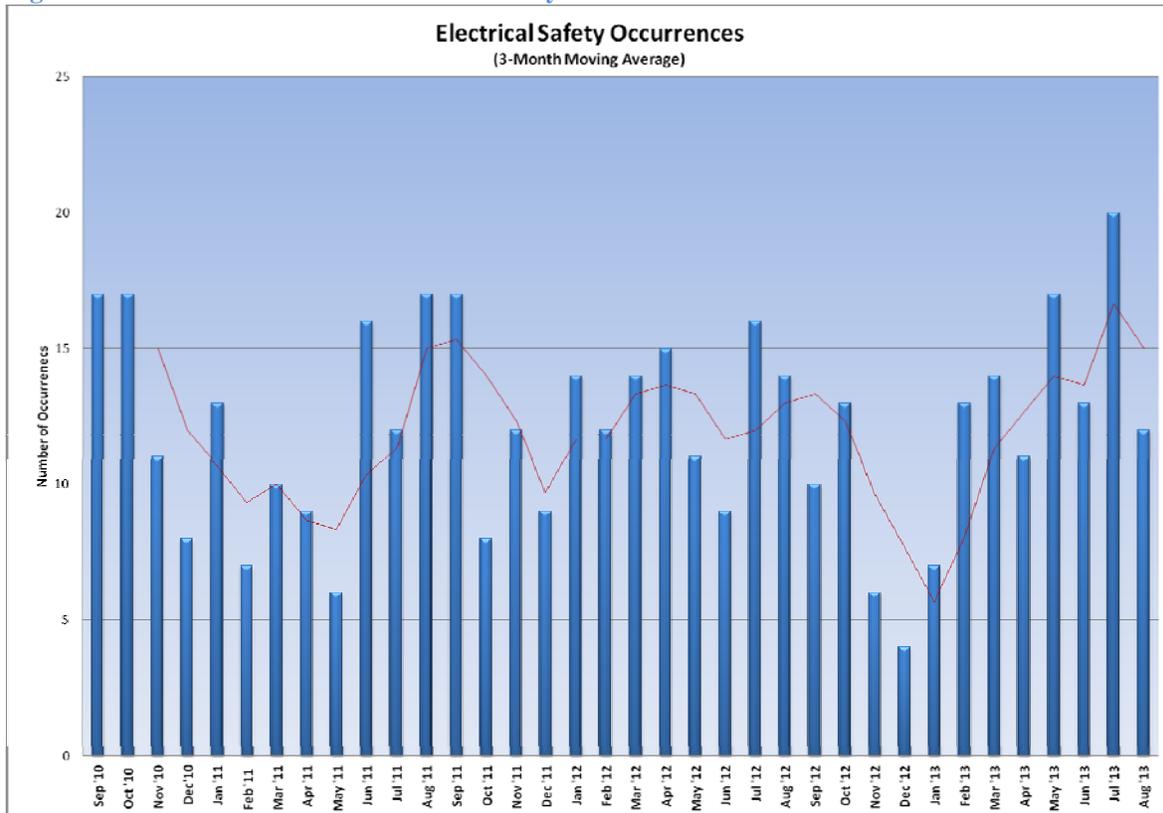
Figure 9 – Three-Year Trend of Electrical Safety Occurrences

Figure 9 shows 3-year trend of electrical safety occurrences for the DOE complex.

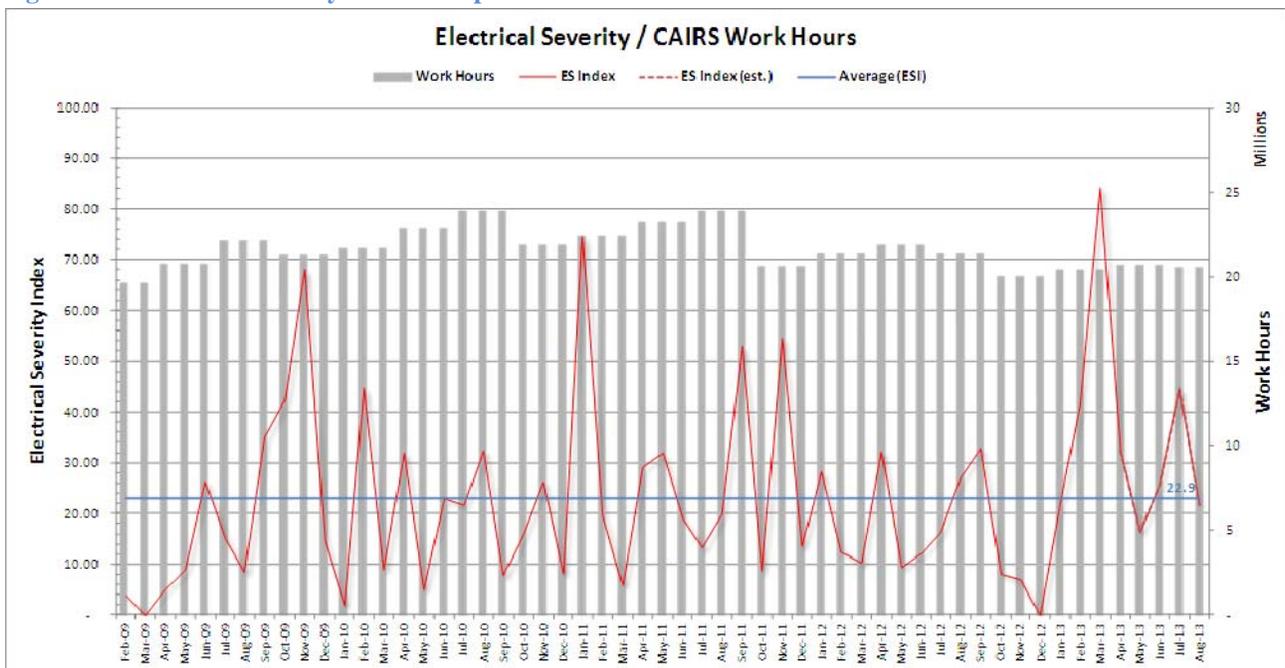
**Figure 10 - Electrical Severity Index Compared to Work Hours**

The Electrical Severity Index (ESI) is a performance metric that was developed to normalize events against organizational work hours. The ESI is calculated monthly and trended. Figure 10 shows a calculated ESI for the DOE complex and Table 4 shows the ESI.

Note: An estimated ESI is calculated until accurate CAIRS man-hours are available. The chart is updated monthly.

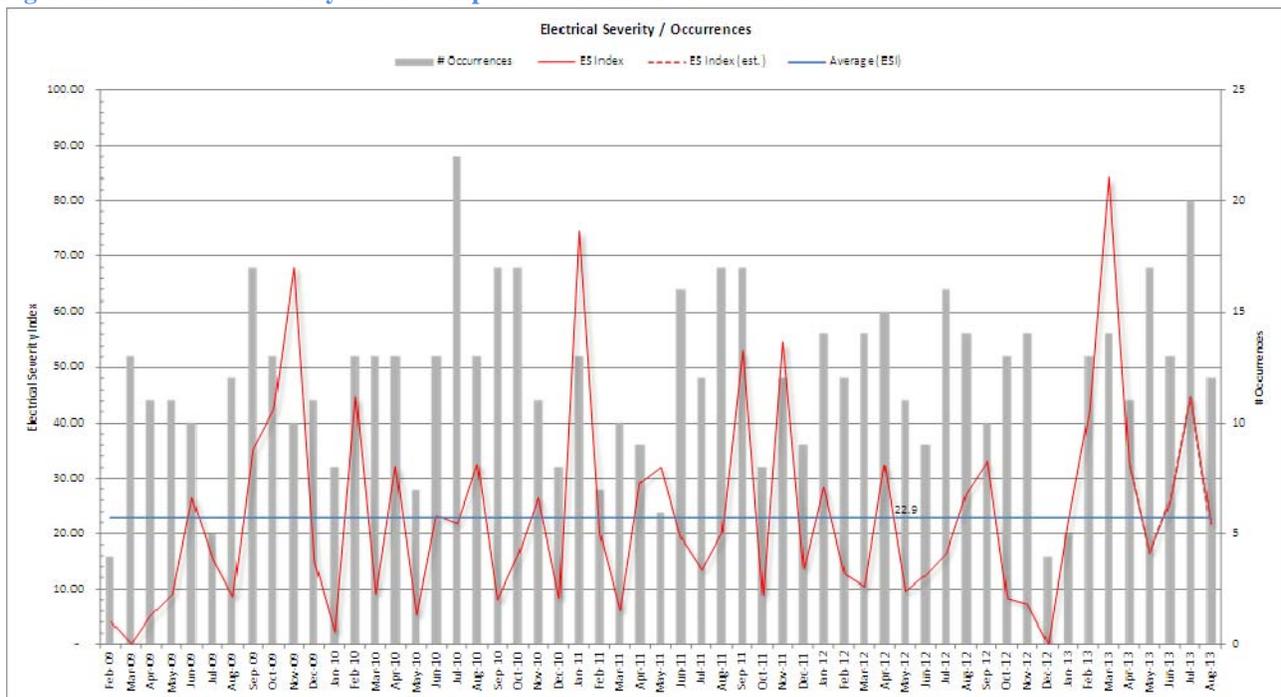
Figure 11 - Electrical Severity Index Compared to Number of Occurrences

Figure 11 shows the ESI with the number of Occurrences instead of Work Hours.

The average ESI (22.9) has remained fairly steady over the last three months following high severity occurrences in March and July. The lowest average ESI was 19.2 in June 2010.

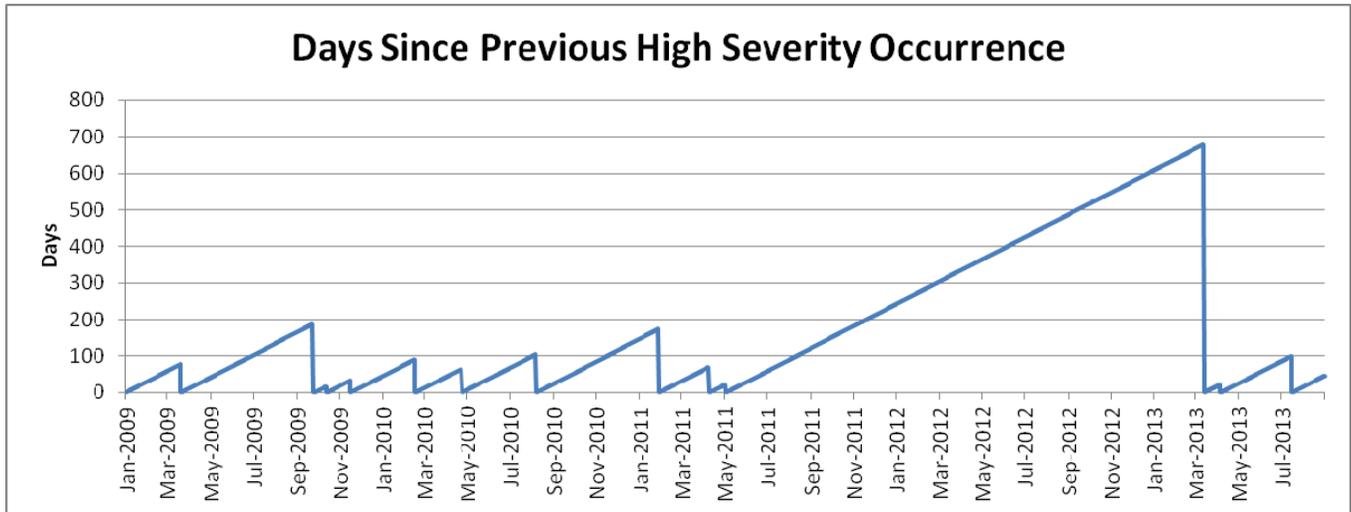
Figure 12 - Days since Previous High Severity Occurrence

Figure 12 shows the number of days since the previous high severity occurrence. The present interval is 47 days as of August 31. The previous longest interval was 679 days ending March 12, 2013.

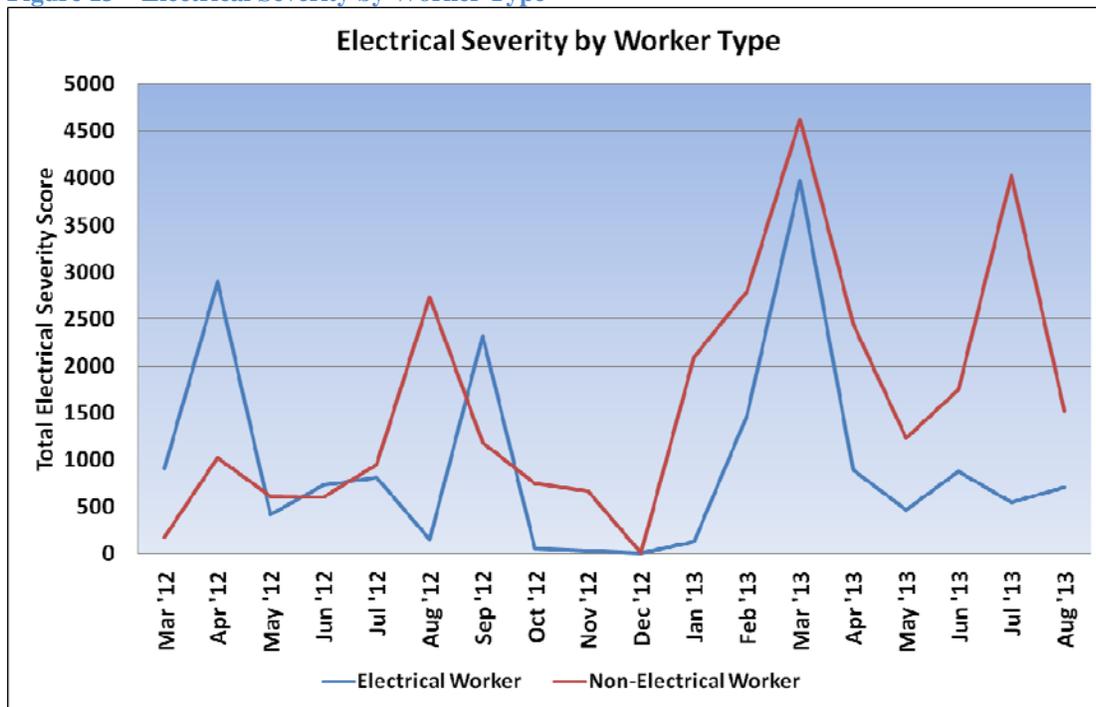
Figure 13 – Electrical Severity by Worker Type

Figure 13 shows the total electrical severity score by worker type for each month.

The present ES score for electrical workers is 710 and 1,520 for non-electrical workers.

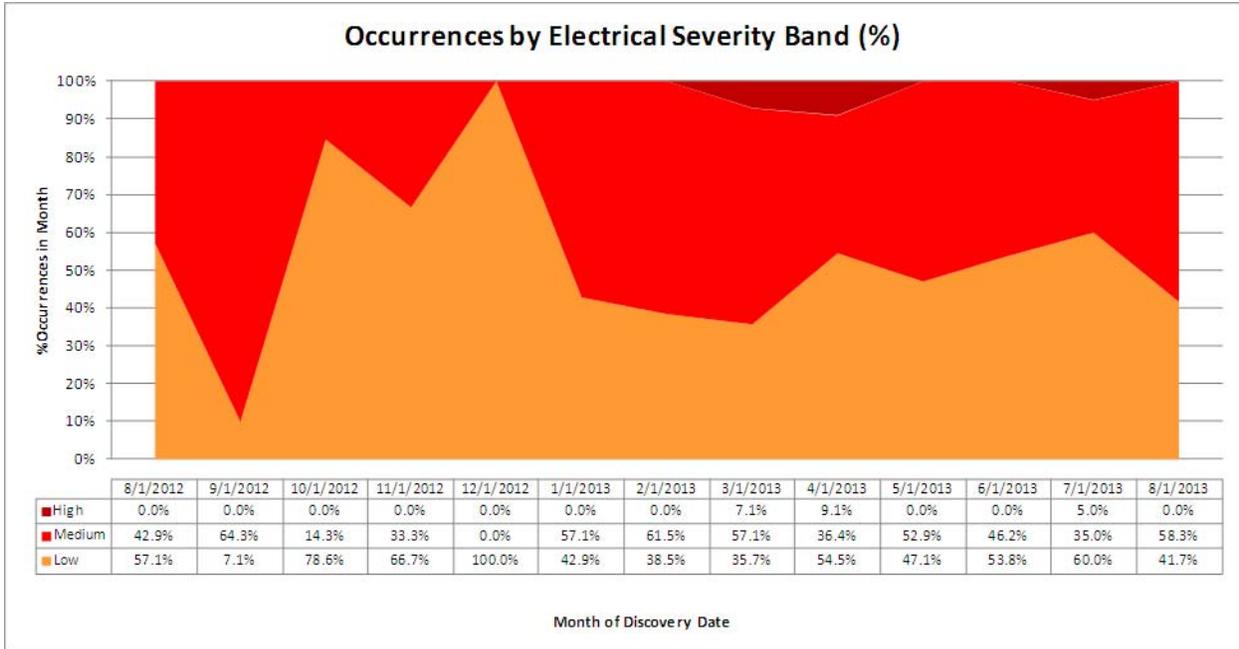
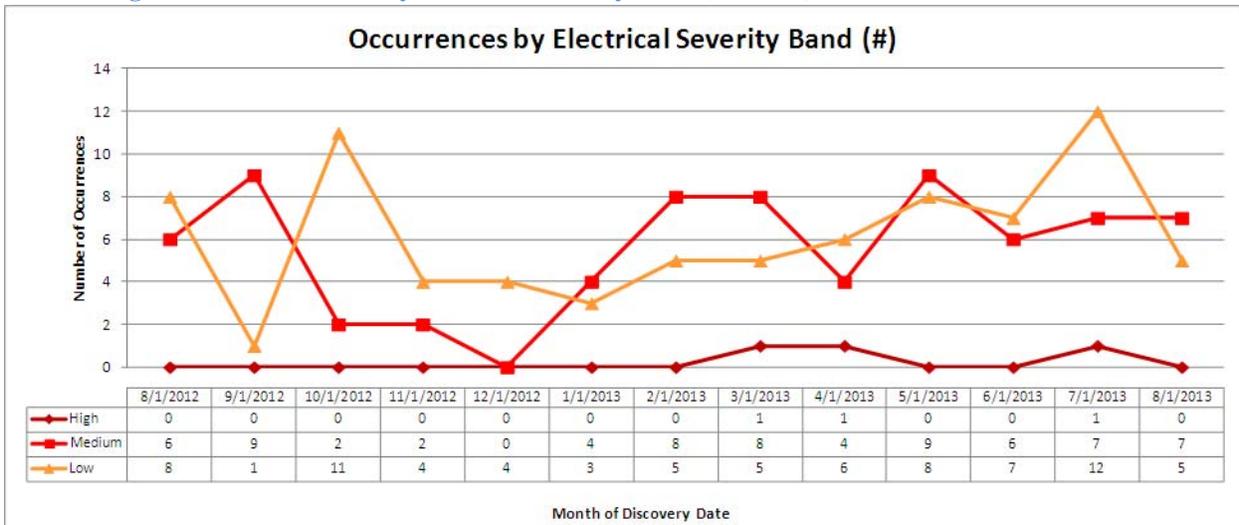
For the interval August 2012 through August 2013 (current month and the past 12), Figures 14 and 15 summarize occurrences by severity band and month of discovery date by percentage of total occurrences in month and number of occurrences in month.

The previous two charts show that a high electrical severity event occurred in March, April and July ending a 679-day period since the last occurrence in May 2011. The number of occurrences with Medium severity scores remained constant while the Low severity scores decreased.

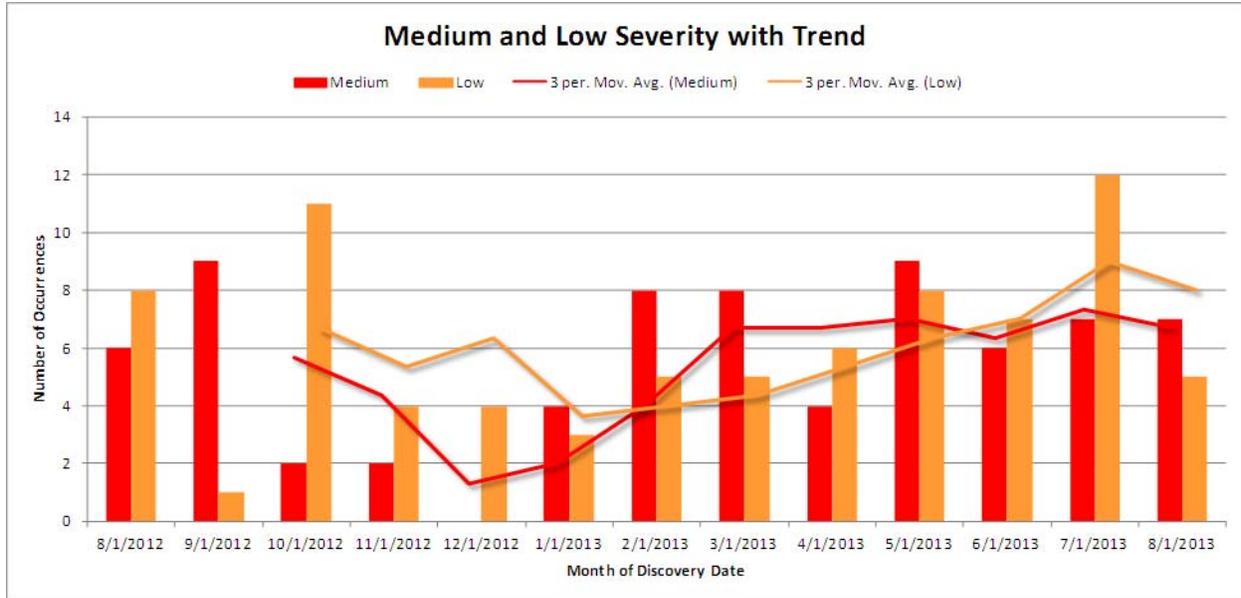
Figure 16 - Trend of Medium and Low Electrical Severity Occurrences

Figure 16 focuses on the Medium and Low severity data series for August 2012 through August 2013. Trend lines are included for each, using a 3-month moving average.

The 3-month moving average shows a slightly decreasing trend for Low and Medium severity occurrences following an increase since the beginning of the year.
