Office of Health, Safety and Security

Monthly Analysis of Electrical Safety Occurrences

November 2011

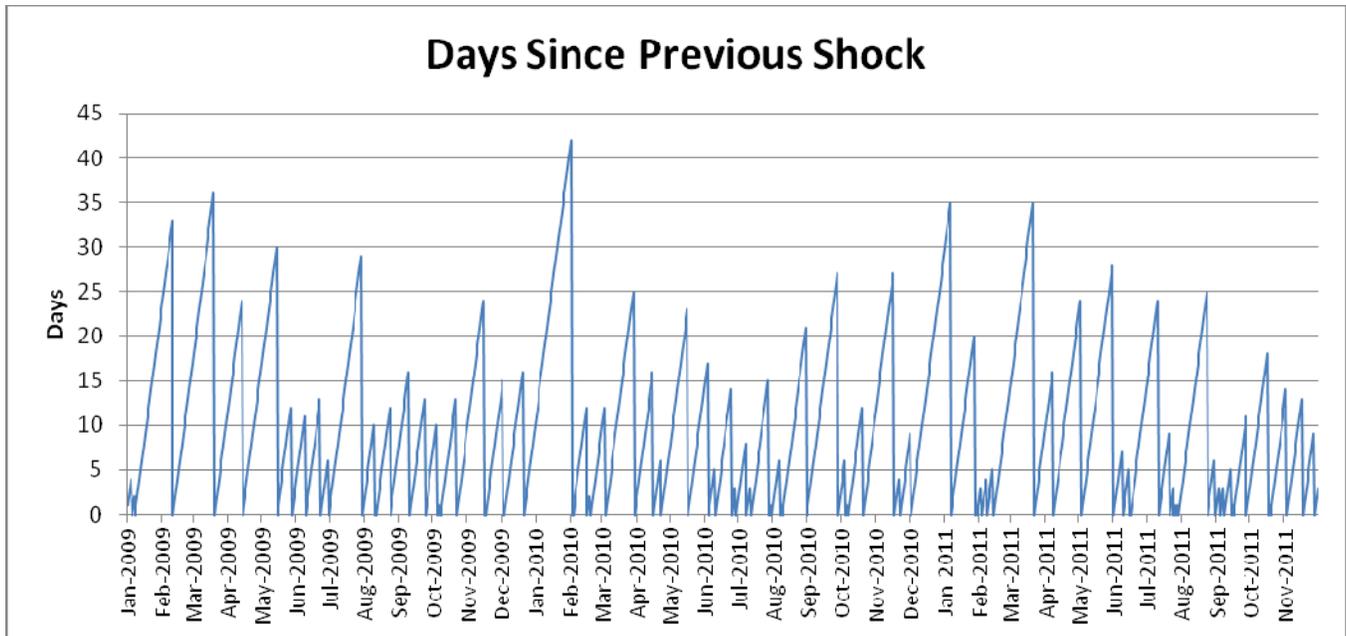
Figure 1 - Days since Previous Shock

Figure 1 shows the number of days since the previous electrical shock for the DOE complex. The present interval is 3 days. The longest interval was 41 days in 2010.

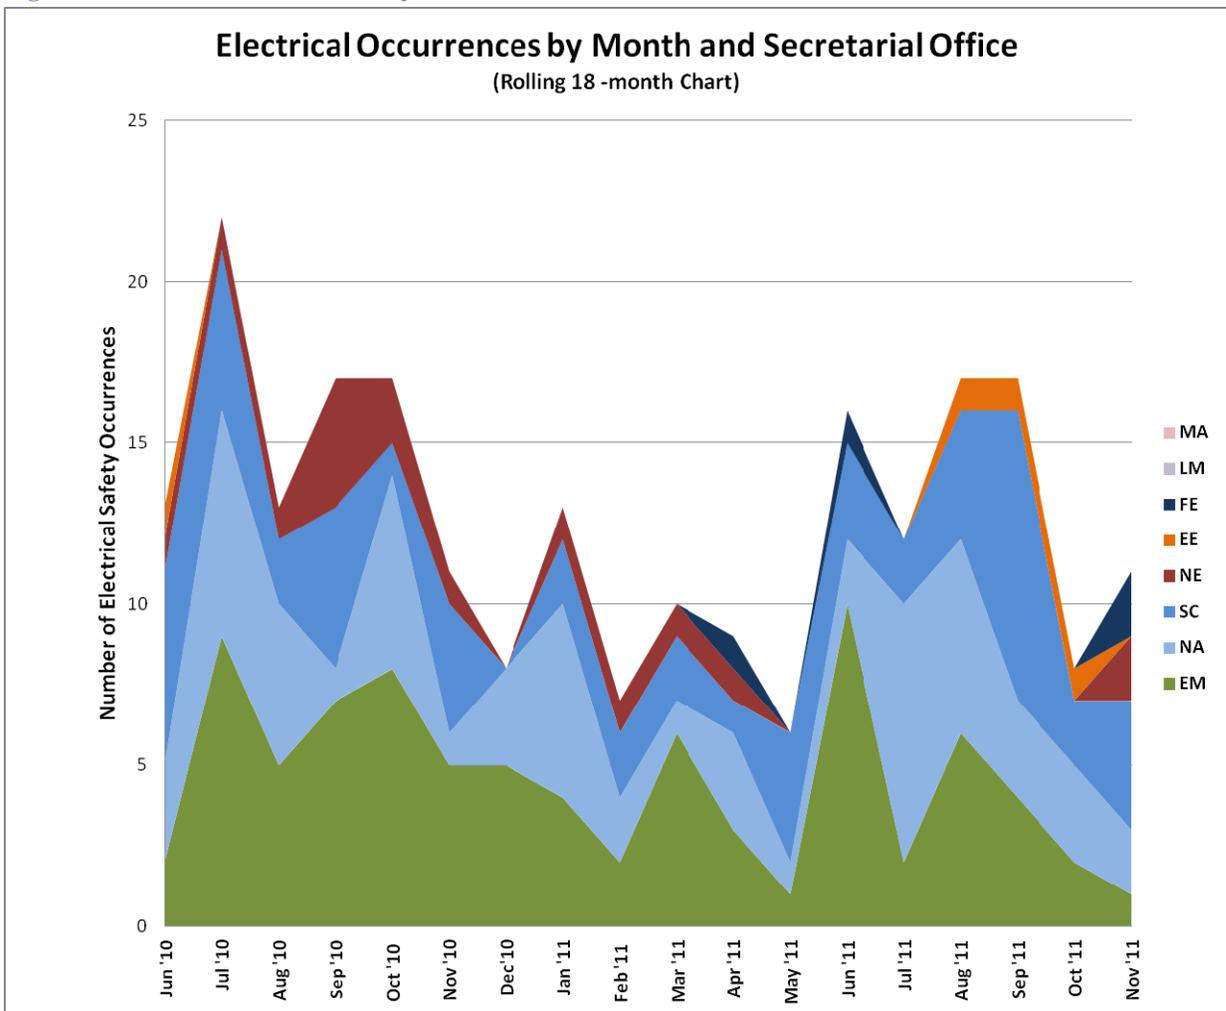
Figure 2 - Electrical Occurrences by Month and Secretarial Office

Figure 2 shows the distribution of electrical safety occurrences by Secretarial Office, with Environmental Management with the fewest reports and Science with the most reports.

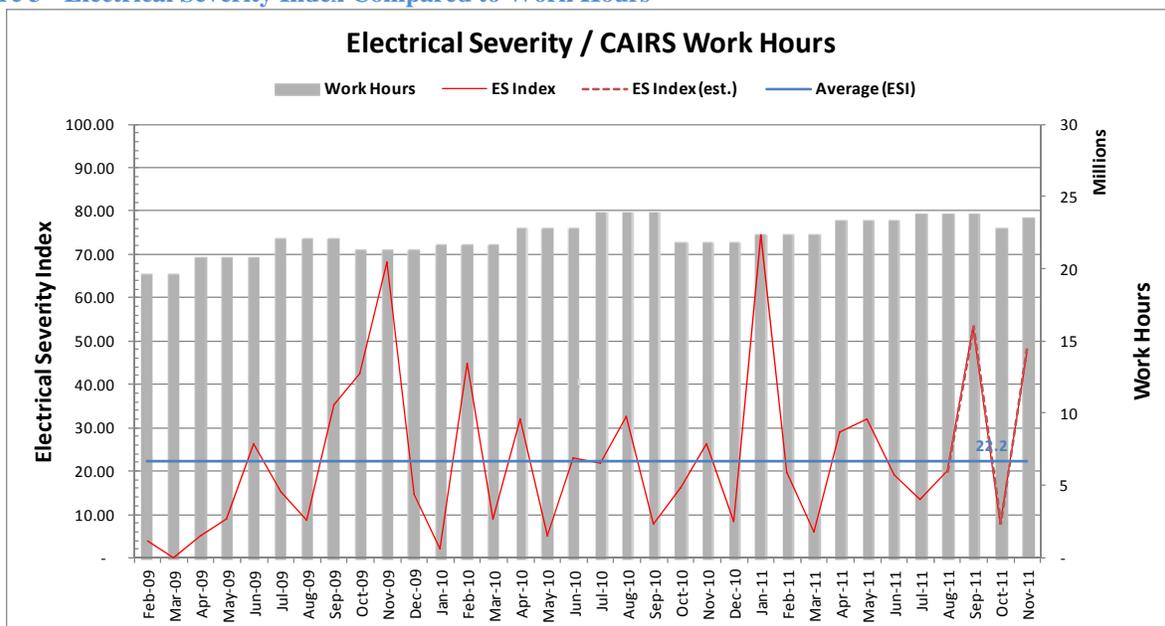
Figure 3 - Electrical Severity Index Compared to Work Hours

The Electrical Severity Index (ESI) is a performance metric that was developed to normalize events against organizational work hours. The ESI is calculated monthly and trended. Figure 3 shows a calculated ESI for the DOE complex and Table 4 shows the ESI and how it has changed from the previous month.

Note: An estimated ESI is calculated until accurate CAIRS man-hours are available. The chart is updated monthly.

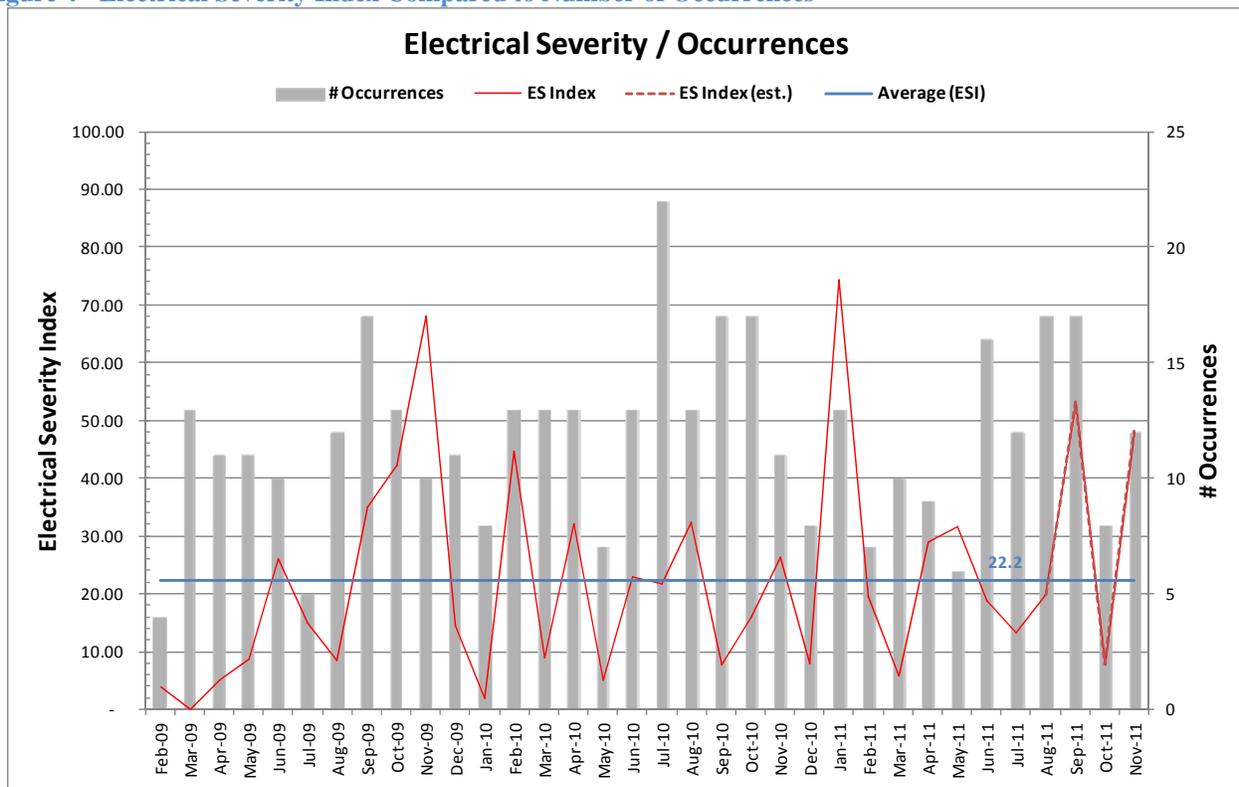
Figure 4 - Electrical Severity Index Compared to Number of Occurrences

Figure 4 shows the ESI with the number of Occurrences instead of Work Hours.

The average ESI has increased from 19.2 in June 2010 to 22.2 in November 2011.

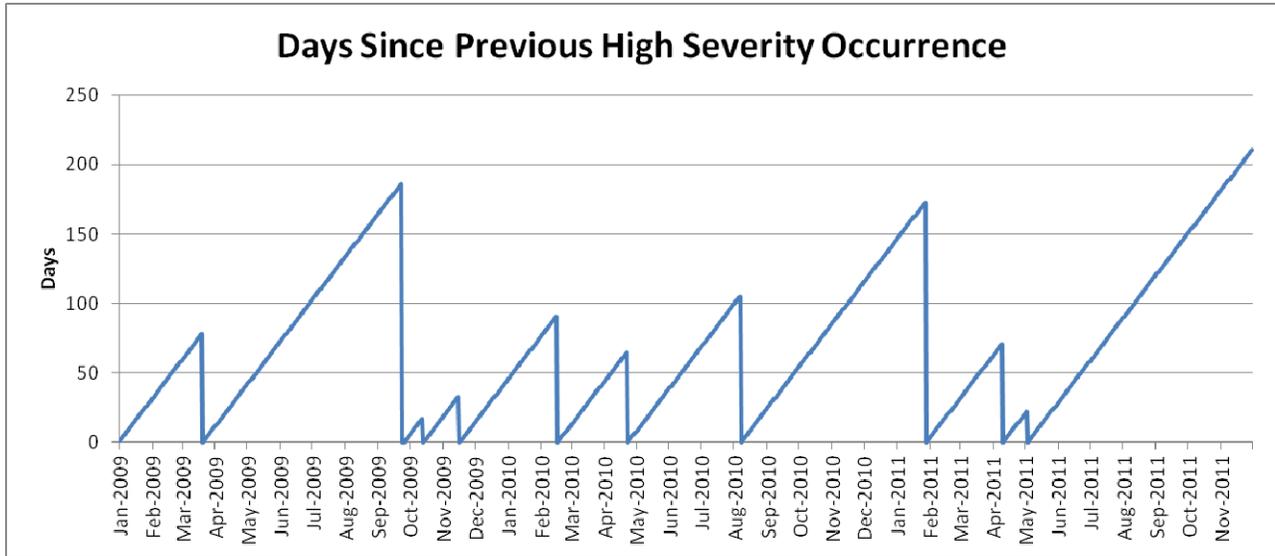
Figure 5 - Days since Previous High Severity Occurrence

Figure 5 shows the number of days since the previous high severity occurrence. The present interval is 211 days. The previous longest interval was 181 days in 2009.

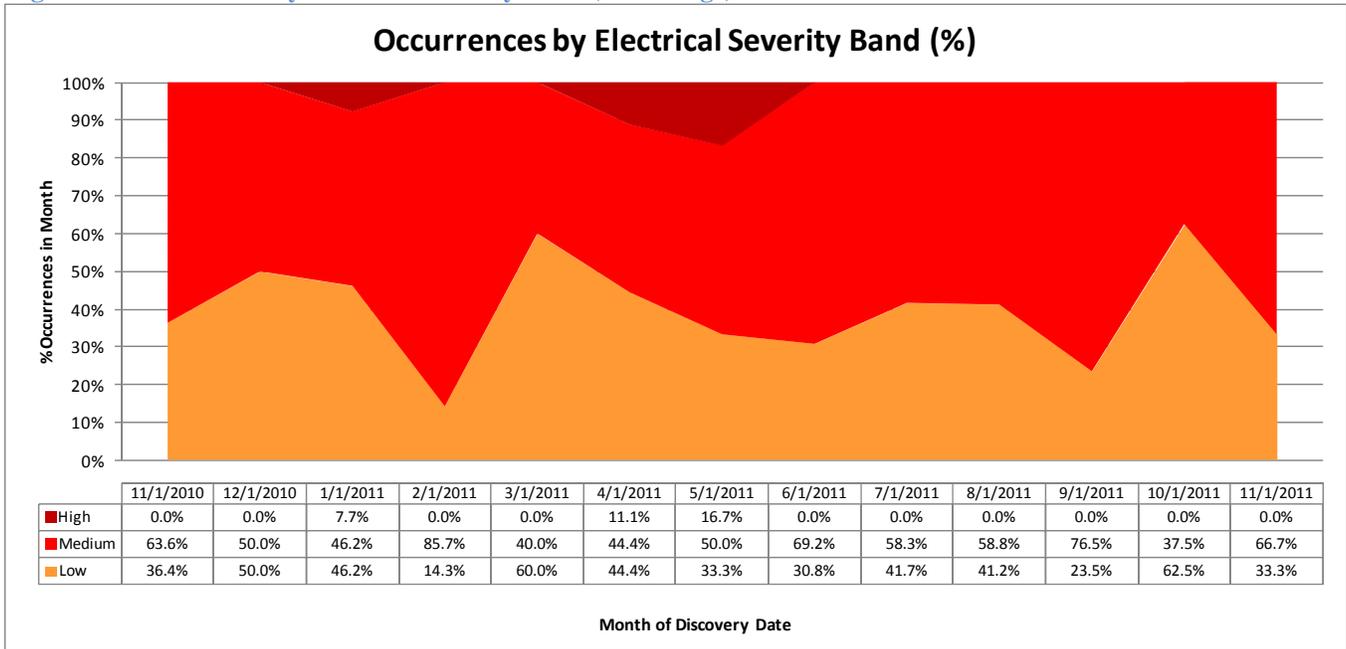
Figure 6 - Occurrences by Electrical Severity Band (Percentage)

For the interval November 2010 through November 2011 (current month and the past 12), Figures 6 and 7 summarize occurrences by severity band and month of discovery date by percentage of total occurrences in month and number of occurrences in month.

What can be seen from the previous two charts is that the number of occurrences with High electrical severity scores has remained at zero for the past six months and that the number of occurrences with Medium scores, following a drop in October, have increased above the number of Low severity occurrences.

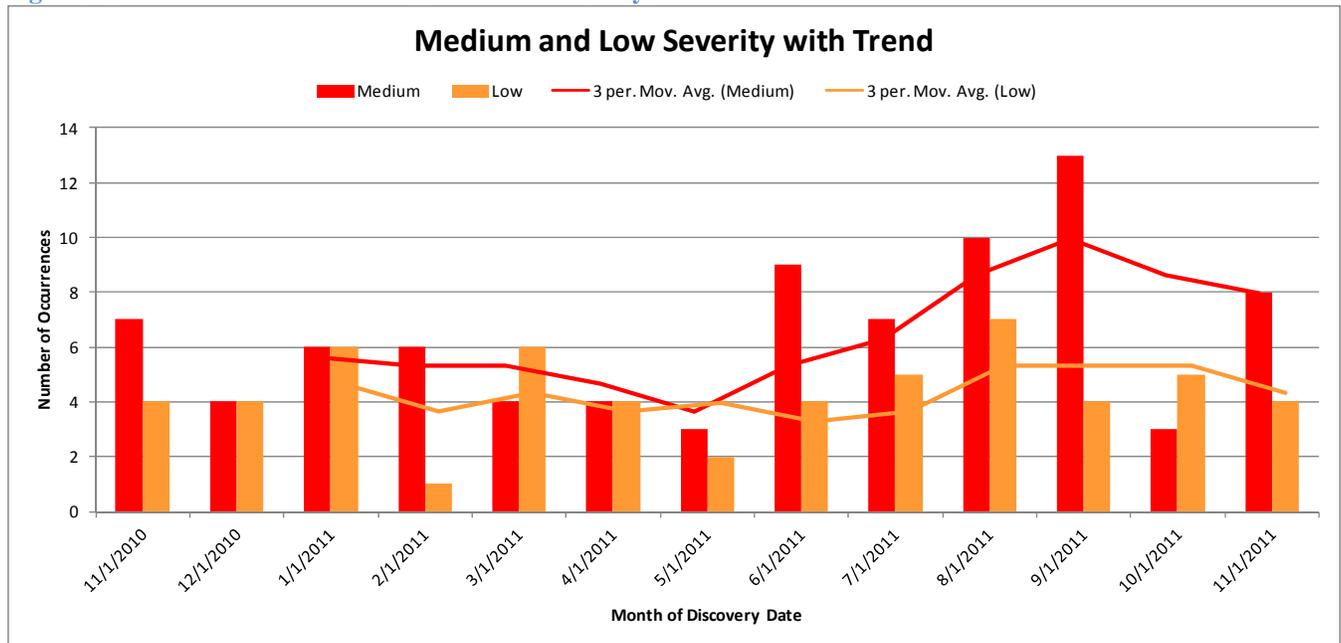
Figure 8 - Trend of Medium and Low Electrical Severity Occurrences

Figure 8 focuses on the Medium and Low severity data series for November 2010 through November 2011. Trend lines are included for each, using a 3-month moving average.

The 3-month moving average shows a decreasing trend in the Medium severity occurrences following the peak in September 2011. However, the number of electrical occurrences with Medium severity scores has started to increase in the last quarter of the year. The figure also shows a leveling off of Low severity occurrences.
