Office of Health, Safety and Security

## Monthly Analysis of Electrical Safety Occurrences

January 2013

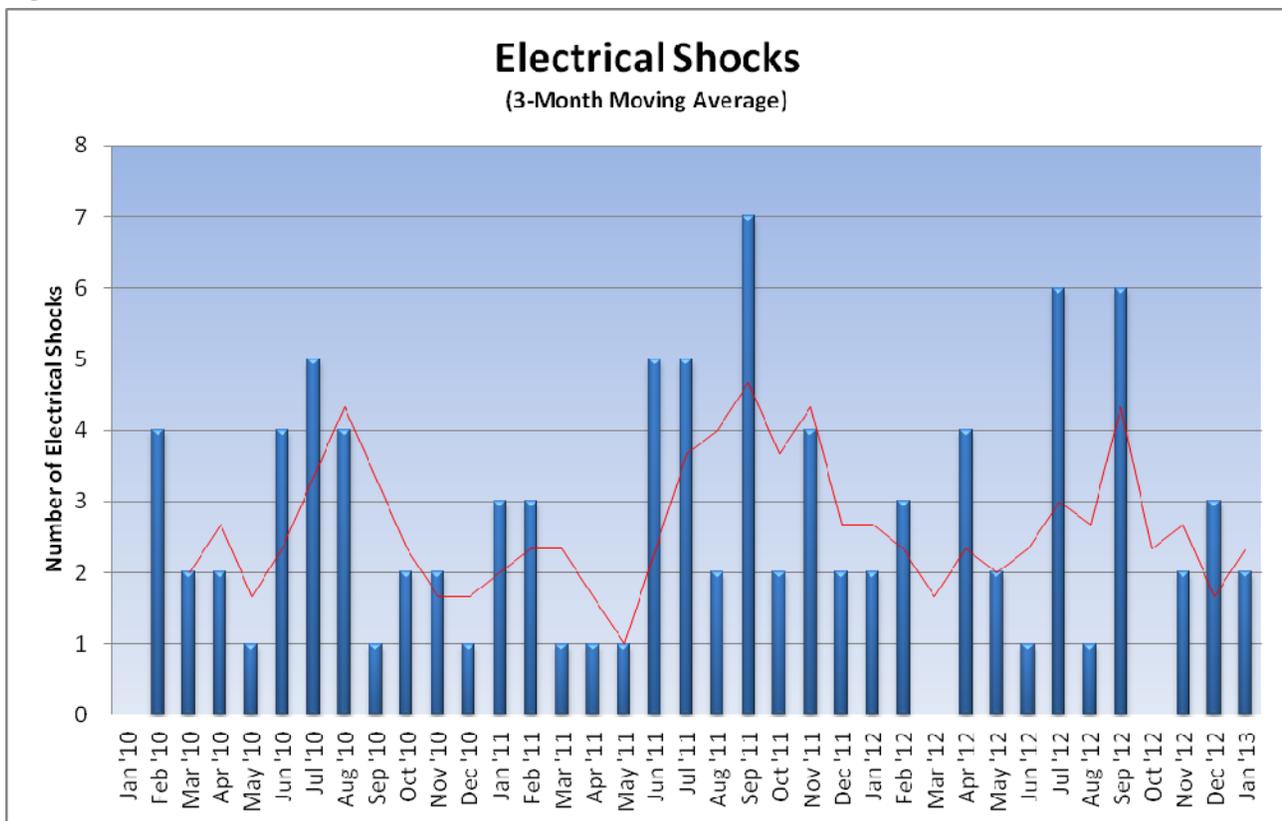
**Figure 1 – Three-Year Trend of Electrical Shocks**

Figure 1 shows a 3-year trend of electrical shocks for the DOE complex. During this period, the average number of electrical shocks has remained below three (2.7) shocks per month.

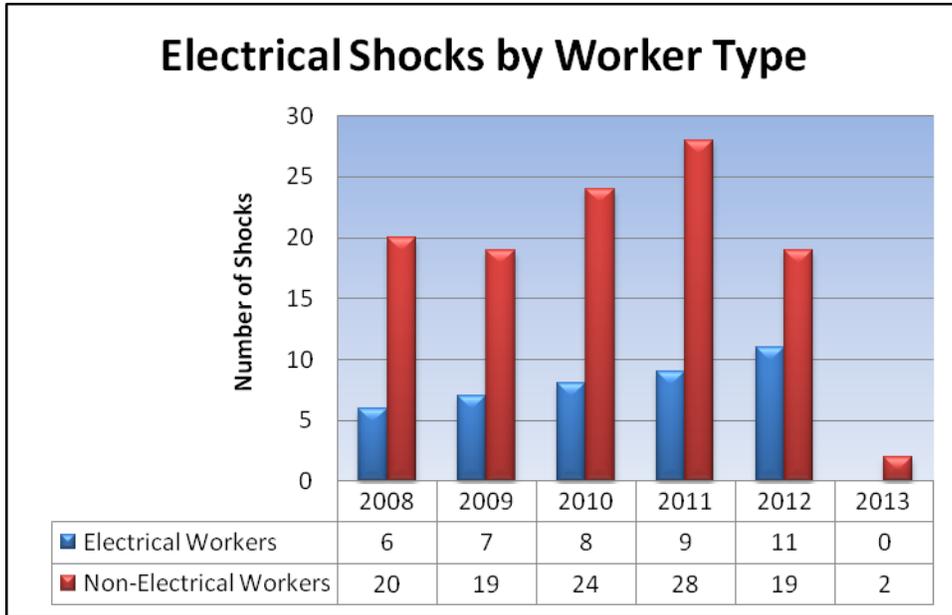
Figure 2 - Electrical Shock by Worker Type

Figure 2 shows electrical shocks by worker type. The number of shocks involving electrical workers has slowly increased through 2012, while those involving non-electrical workers decreased after 2011. Since 2008, the majority of shocks (about 73 percent) involve non-electrical workers.

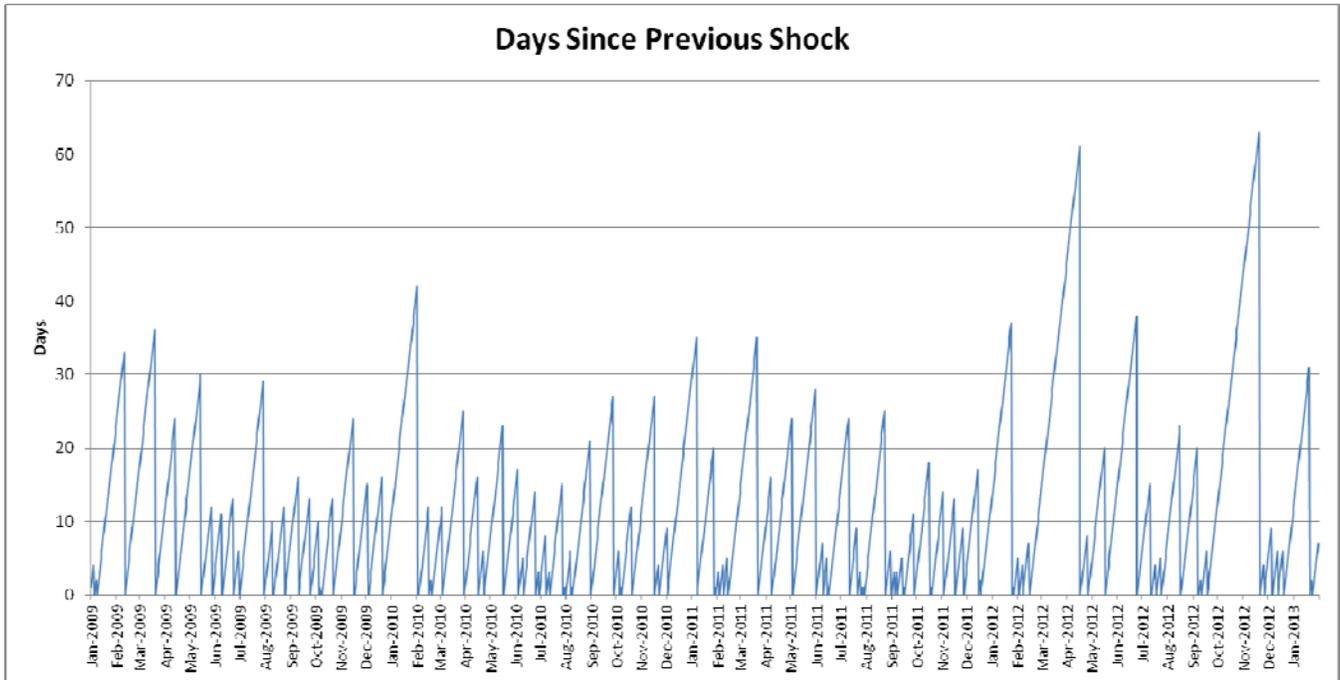
Figure 3 - Days since Previous Shock

Figure 3 shows the number of days since the previous electrical shock for the DOE complex. The longest interval was 63 days (November 20, 2012) and the present interval is 7 days as of January 31.

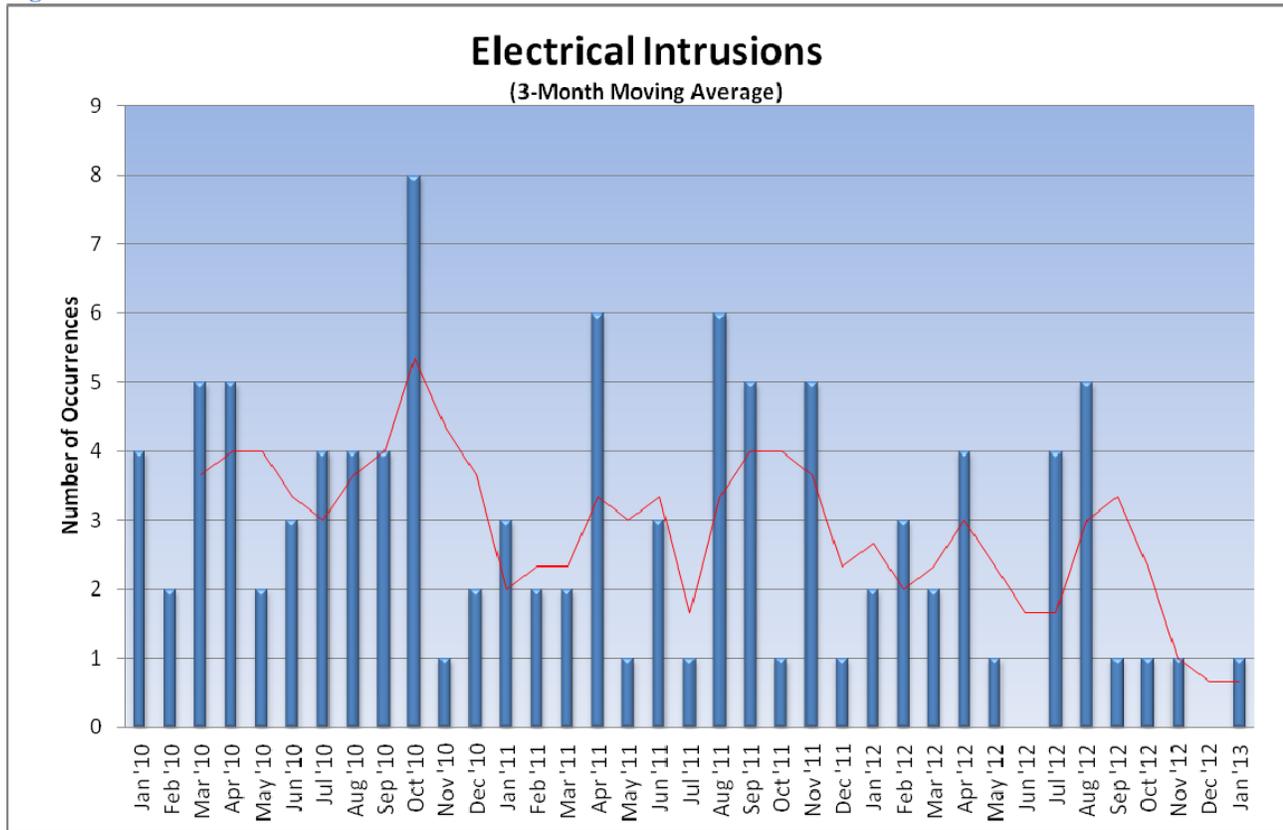
**Figure 4 – Three-Year Trend of Electrical Intrusion Occurrences**

Figure 4 shows a 3-year trend of electrical intrusion occurrences for the DOE complex. During this period we have seen an average of just under 3 occurrences per month (2.8).

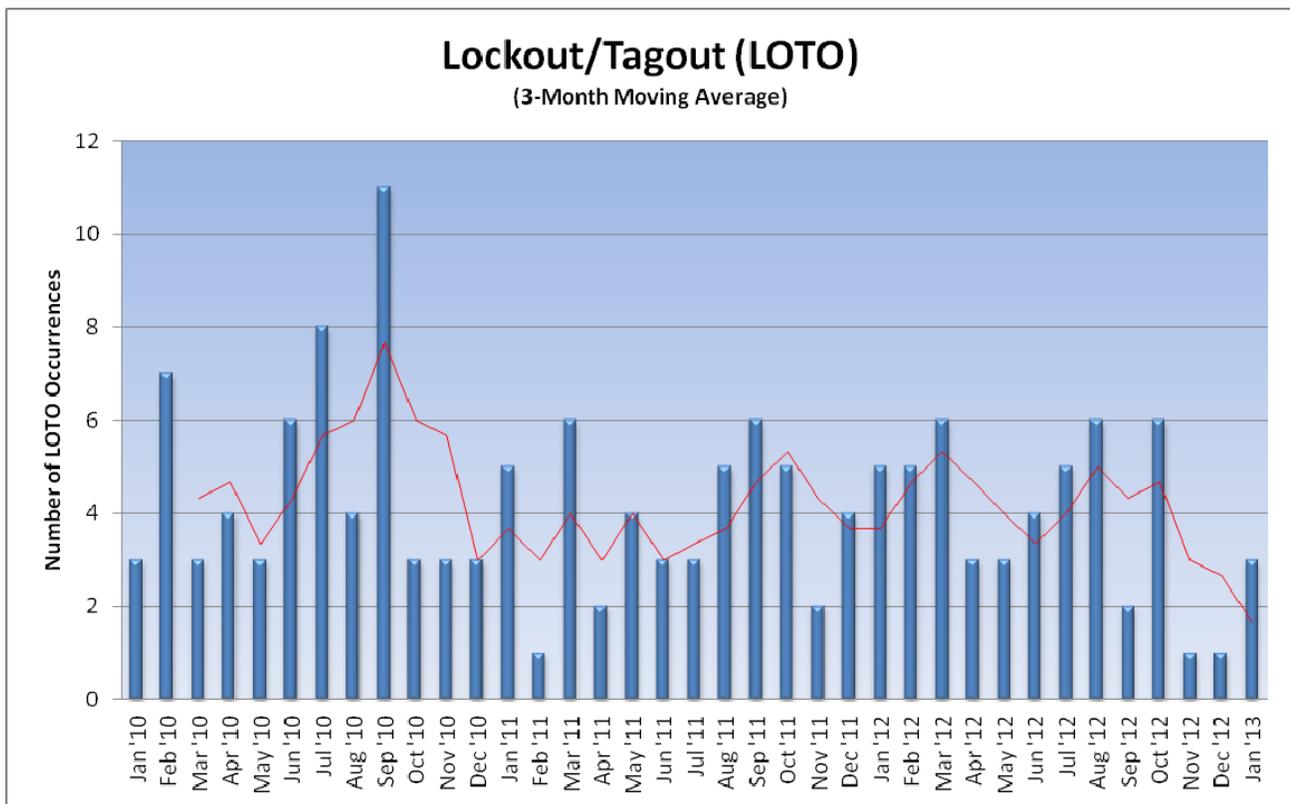
**Figure 5 – Three-Year Trend of Lockout/Tagout Occurrences**

Figure 5 shows a 3-year trend of LOTO occurrences for the DOE complex. The monthly average is 4.2 occurrences.

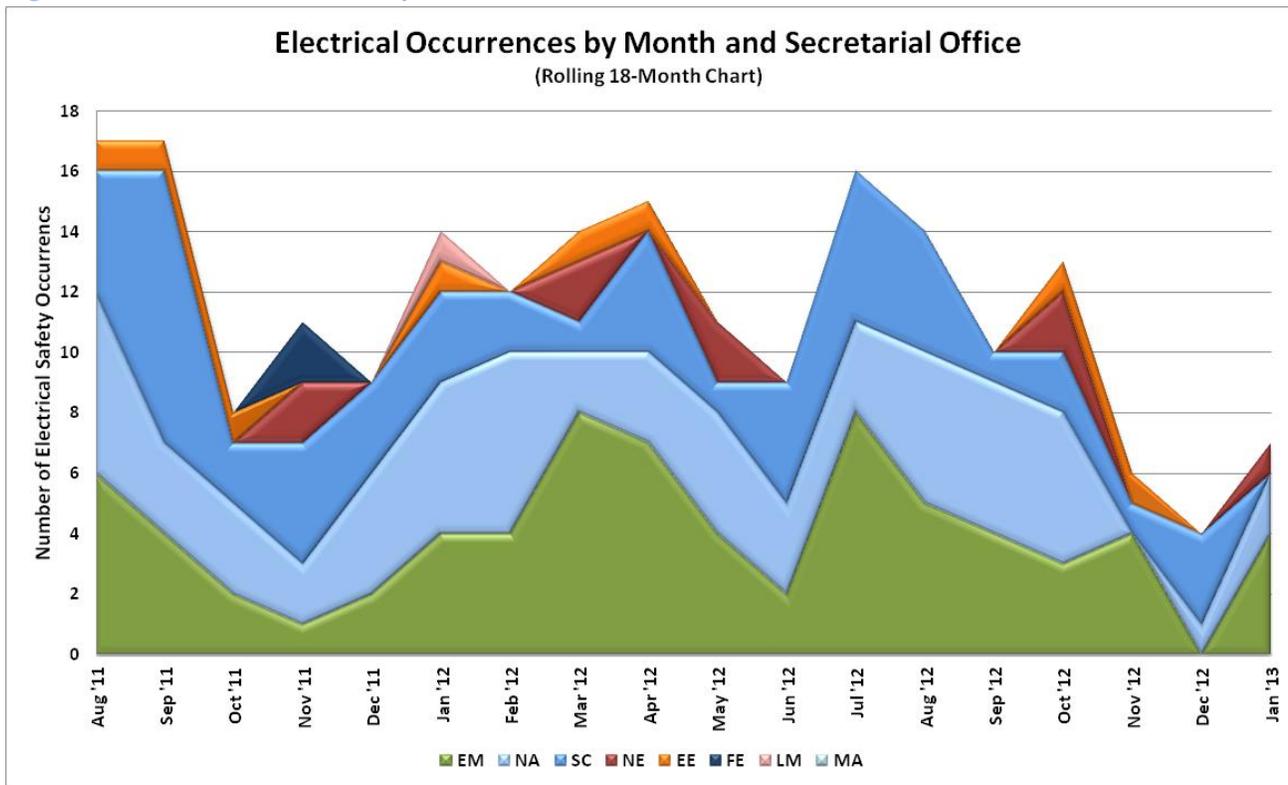
**Figure 6 - Electrical Occurrences by Month and Secretarial Office**

Figure 6 shows the distribution of electrical safety occurrences by Secretarial Office

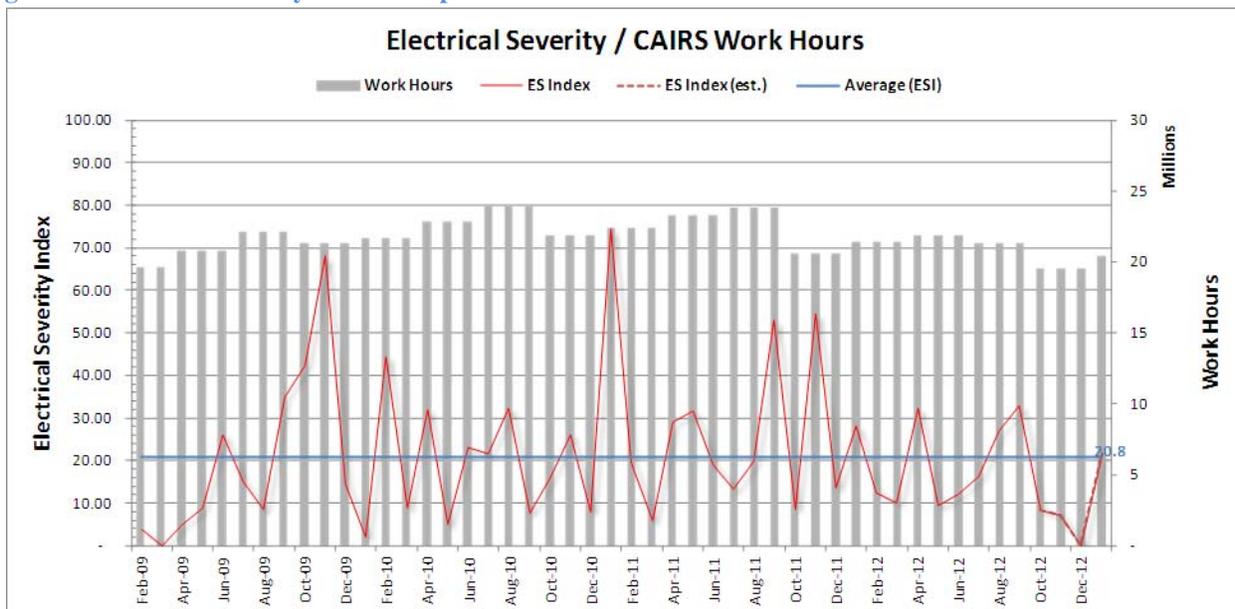
**Figure 7 - Electrical Severity Index Compared to Work Hours**

The Electrical Severity Index (ESI) is a performance metric that was developed to normalize events against organizational work hours. The ESI is calculated monthly and trended. Figure 7 shows a calculated ESI for the DOE complex and Table 4 shows the ESI and how it has changed from the previous month.

Note: An estimated ESI is calculated until accurate CAIRS man-hours are available. The chart is updated monthly.

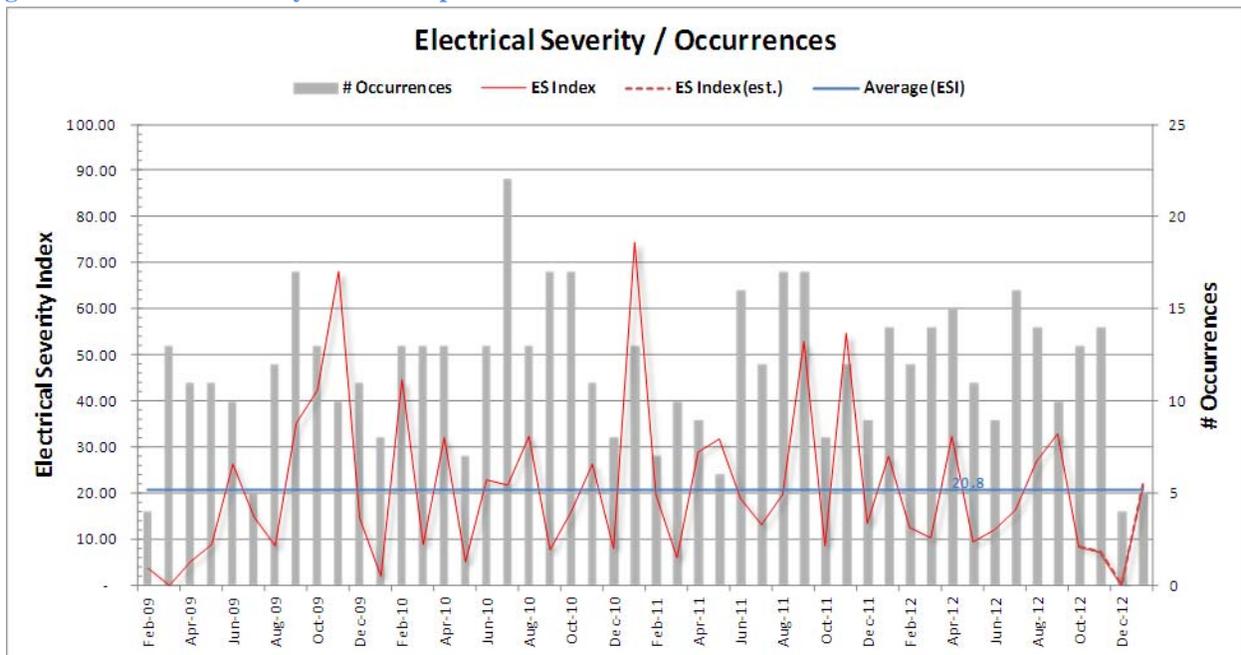
**Figure 8 - Electrical Severity Index Compared to Number of Occurrences**

Figure 8 shows the ESI with the number of Occurrences instead of Work Hours.

The average ESI (20.8) has decreased slightly for the last two months. The lowest average ESI was 19.2 in June 2010.

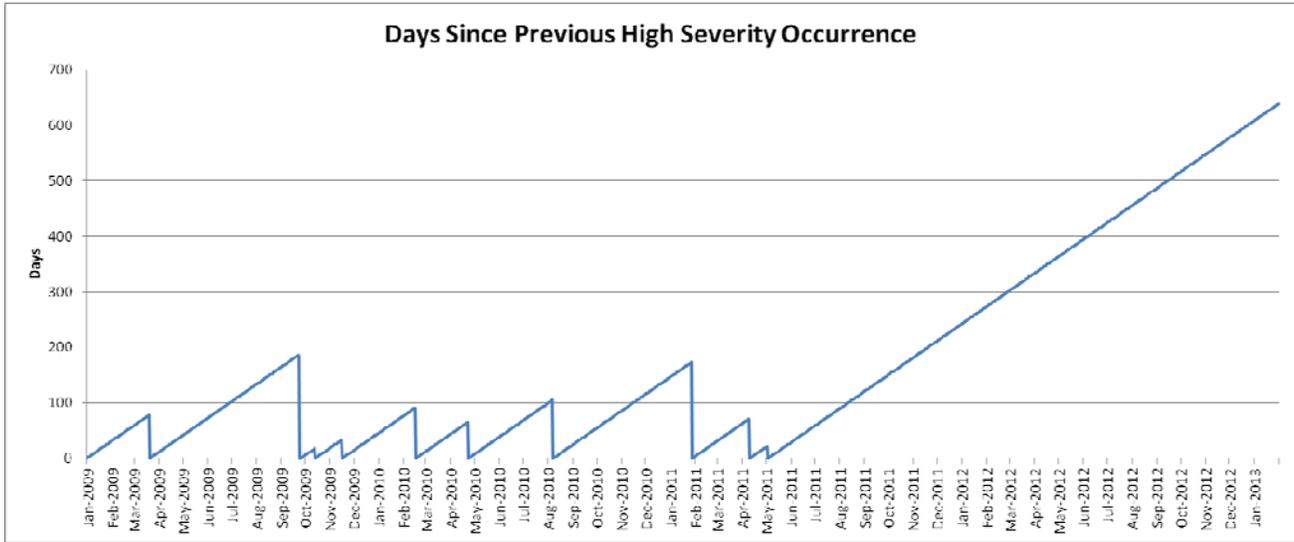
Figure 9 - Days since Previous High Severity Occurrence

Figure 9 shows the number of days since the previous high severity occurrence. The present interval is 639 days as of January 31. The previous longest interval was 181 days in 2009.

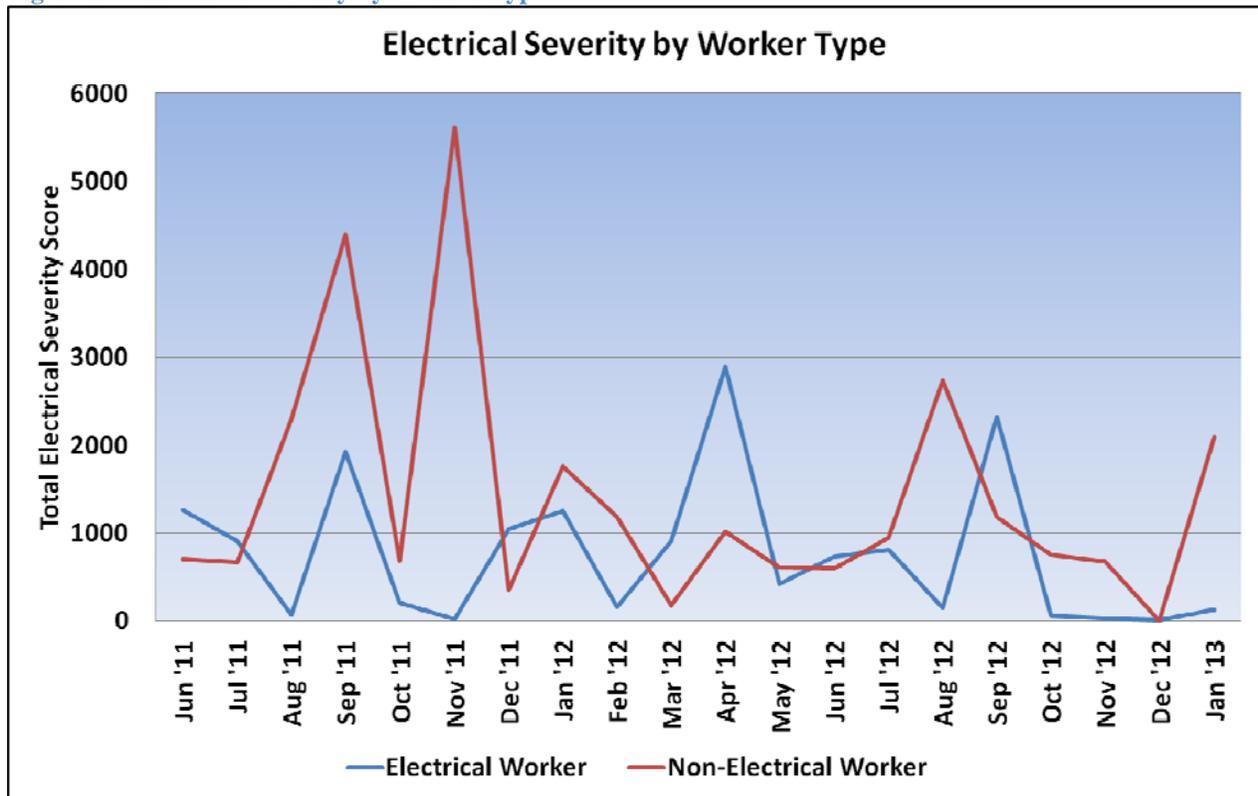
Figure 10 – Electrical Severity by Worker Type

Figure 10 shows the total electrical severity score by worker type for each month.

Electrical workers typically have the fewest number of occurrences. Following a spike of 2,320 in September 2012, the ES score for electrical workers is down to 130, while non-electrical workers ES scores have increased to 2,090. The average ES scores for the 18 month period are 1,060 for electrical workers and 1,380 for non-electrical workers.

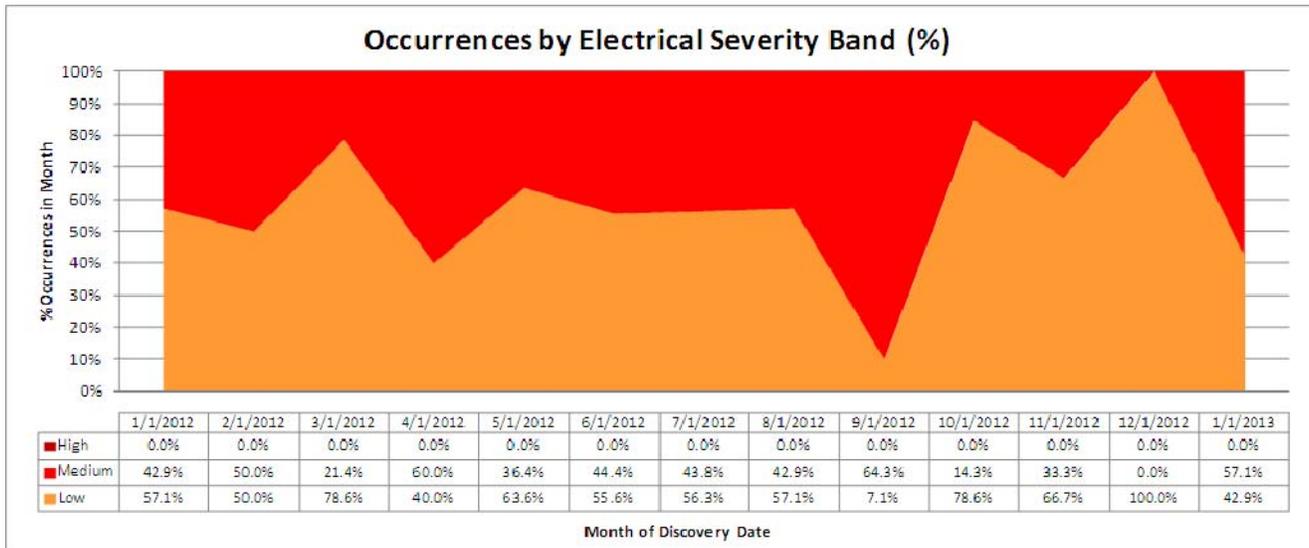
Figure 11 - Occurrences by Electrical Severity Band (Percentage)

For the interval January 2012 through January 2013 (current month and the past 12), Figures 11 and 12 summarize occurrences by severity band and month of discovery date by percentage of total occurrences in month and number of occurrences in month.

What can be seen from the previous two charts is that the number of occurrences with High electrical severity scores has remained at zero with the last event occurring back in May 2011. The number of occurrences with Medium increased while the number of Low and zero severity occurrences showed a slight decrease.

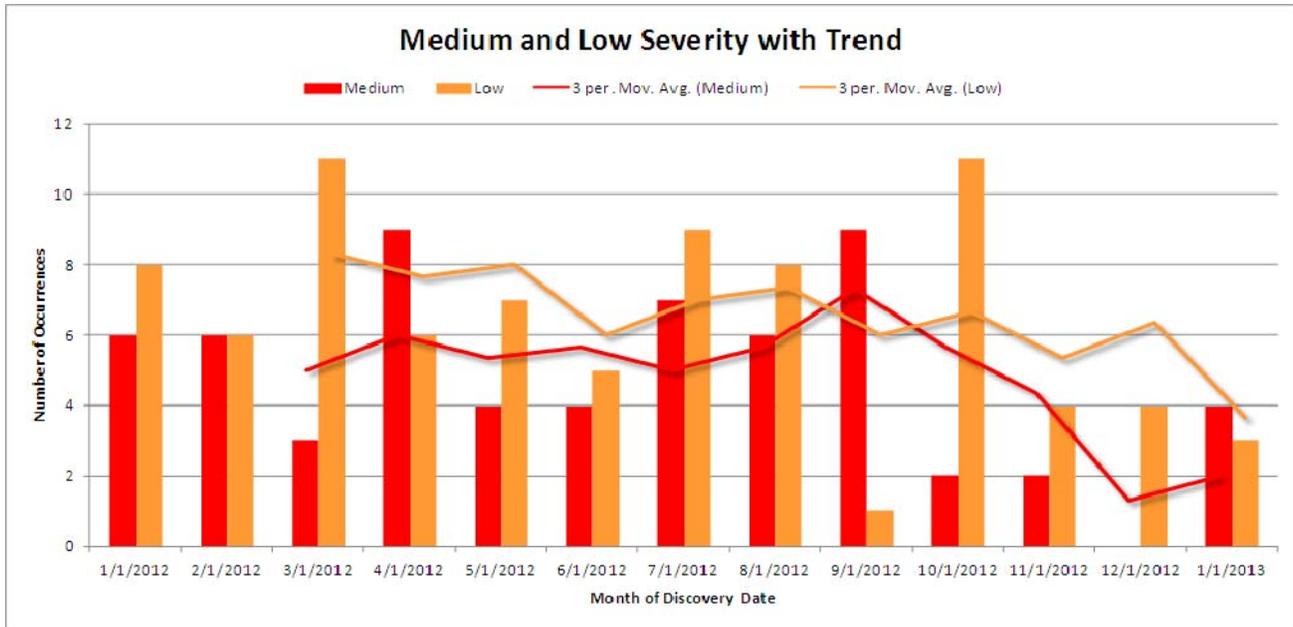
Figure 13 - Trend of Medium and Low Electrical Severity Occurrences

Figure 13 focuses on the Medium and Low severity data series for January 2012 through January 2013. Trend lines are included for each, using a 3-month moving average.

The 3-month moving average shows a slight increasing trend for Medium severity occurrences as Low severity occurrences decrease. A higher percentage of Low severity occurrences is preferred.
