Office of Health, Safety and Security

Monthly Analysis of Electrical Safety Occurrences

June 2012

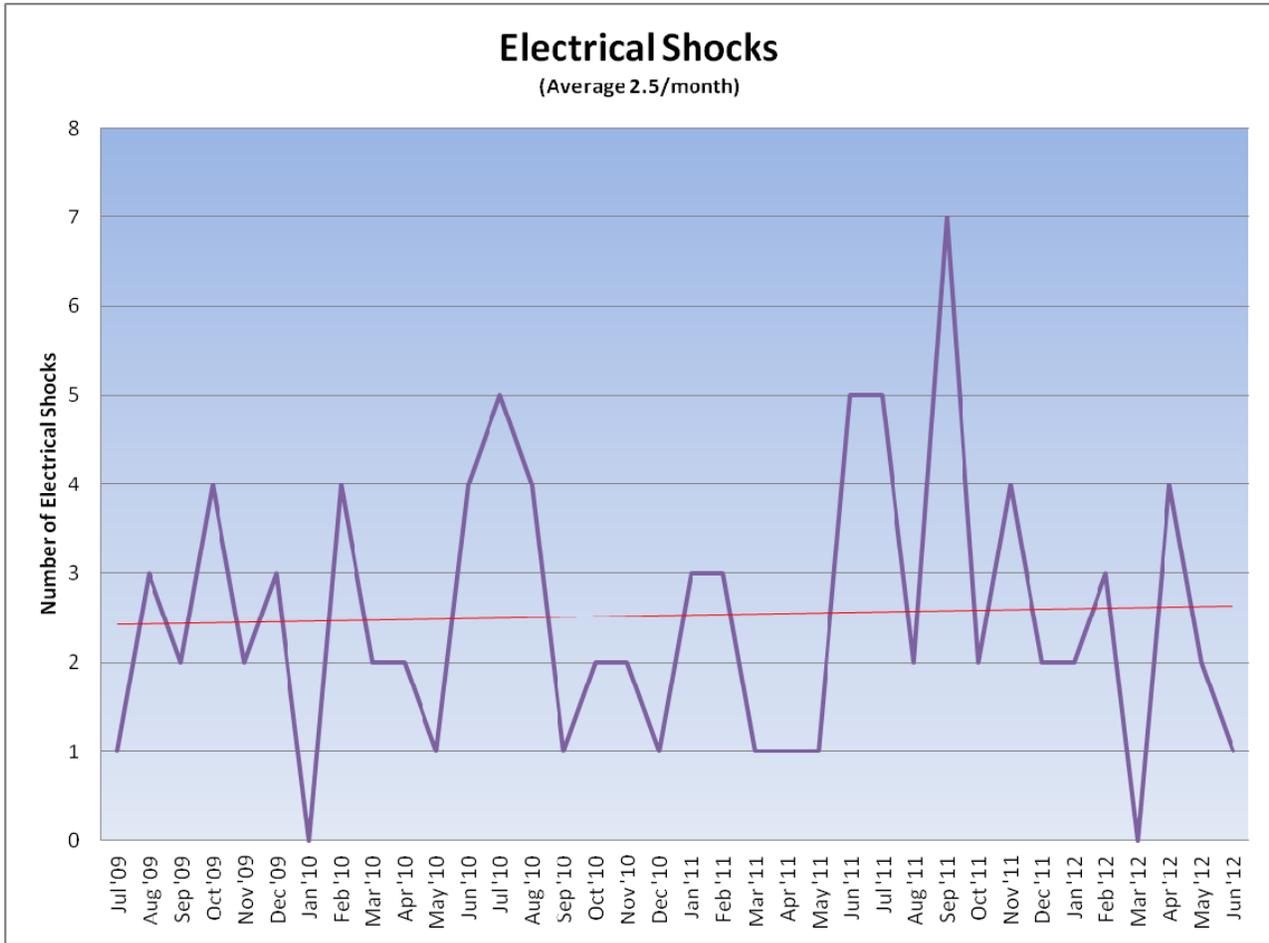
Figure 1 – Three-Year Trend of Electrical Shocks

Figure 1 shows a 3-year trend of electrical shocks for the DOE complex. During this period, the average number of electrical shocks has remained below three per month. The majority of shocks (about 75 percent) involve non-electrical workers.

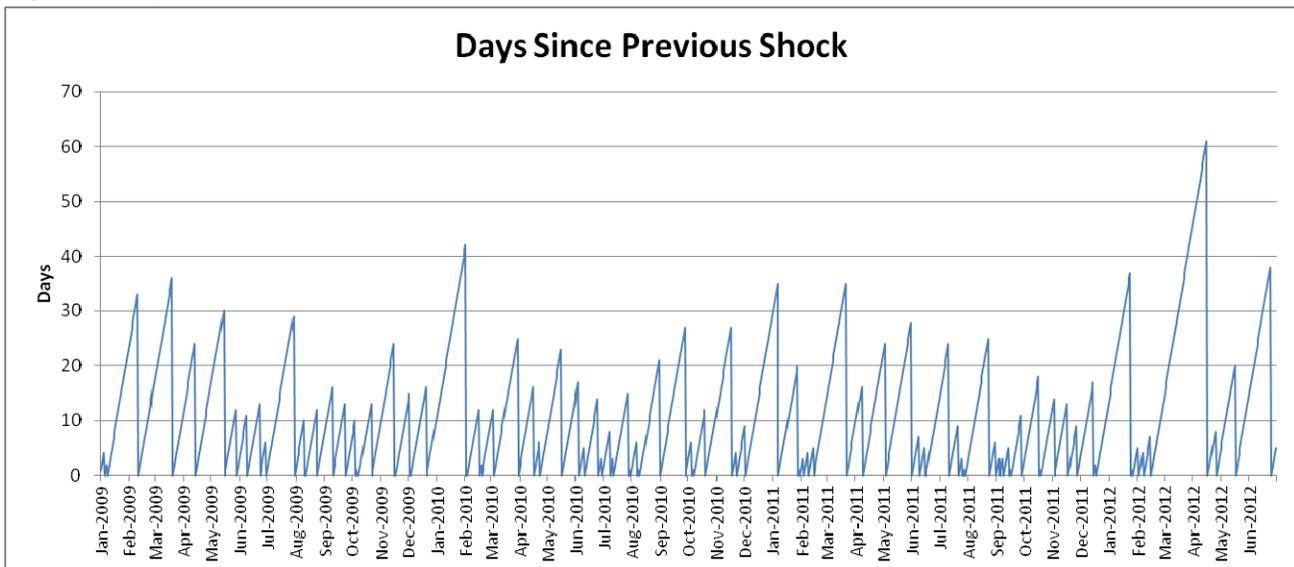
Figure 2 - Days since Previous Shock

Figure 2 shows the number of days since the previous electrical shock for the DOE complex. The longest interval was 61 days (April 16) and the present interval is 5 days as of June 30.

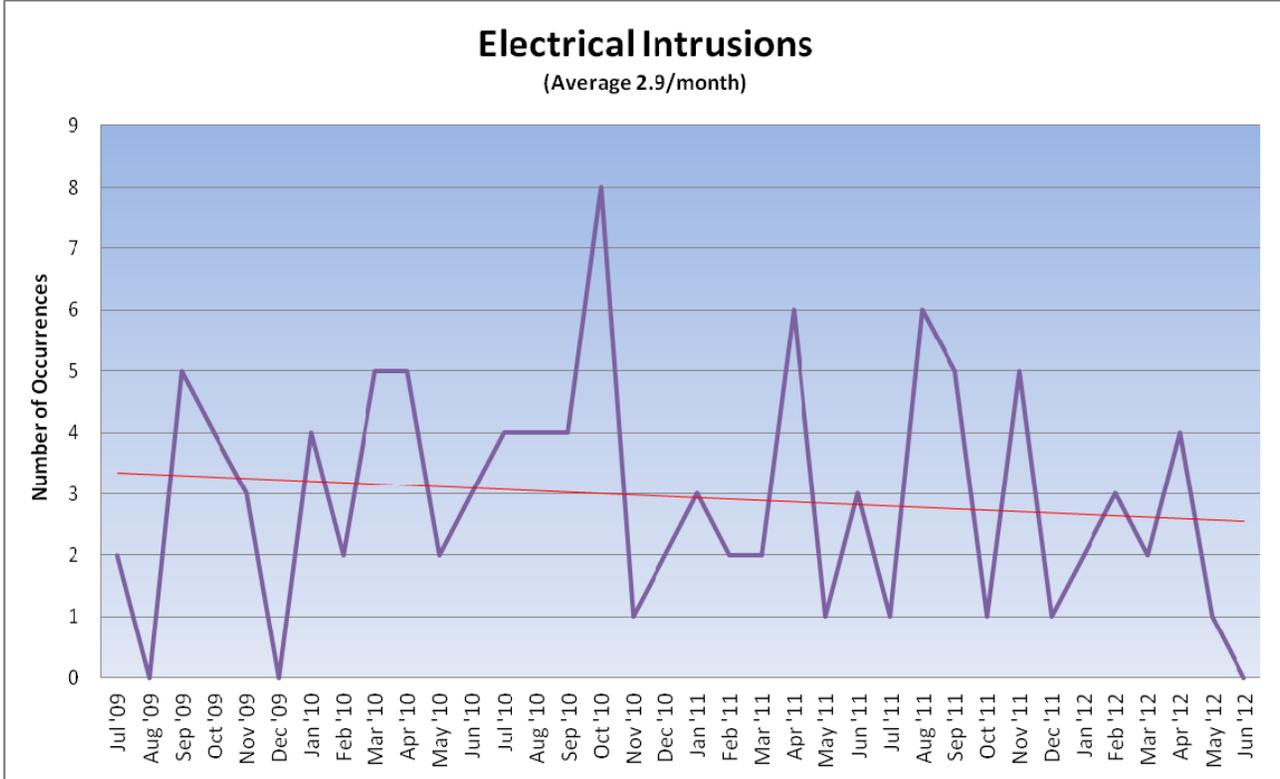
Figure 3 – Three-Year Trend of Electrical Intrusion Occurrences

In June, the number of electrical intrusion occurrences (i.e., cutting/penetrating, excavating, or vehicle contact of electrical conductors) decreased to zero from the single occurrence in May. Figure 3 shows a 3-year trend of electrical intrusion occurrences for the DOE complex. During this period we see a slight decrease in the overall trend. June is the first month since December 2009 in which no electrical intrusion occurrences were reported.

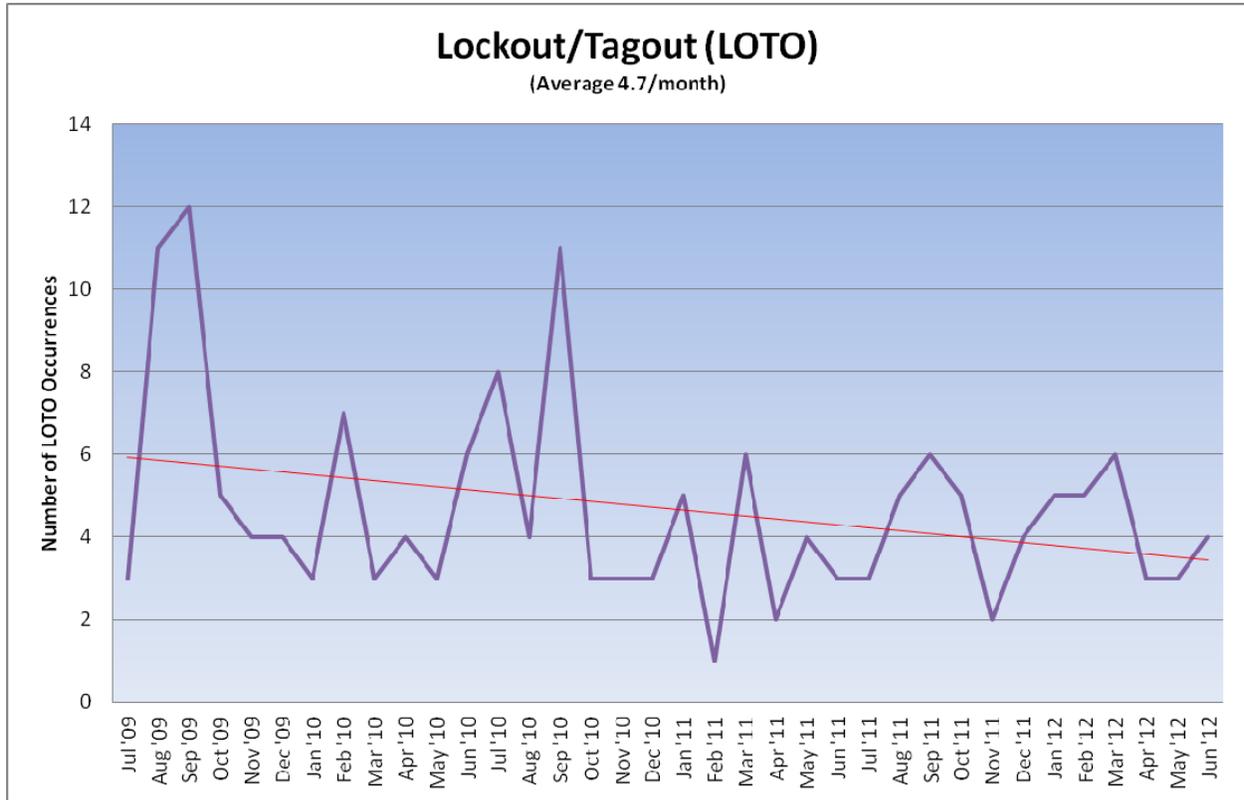
Figure 4 – Three-Year Trend of Lockout/Tagout Occurrences

Figure 4 shows a 3-year trend of LOTO occurrences for the DOE complex. Although there was a small increase from last month, we can see a general decrease in the number of occurrences involving the implementation of lockout/tagout for electrical work during this period.

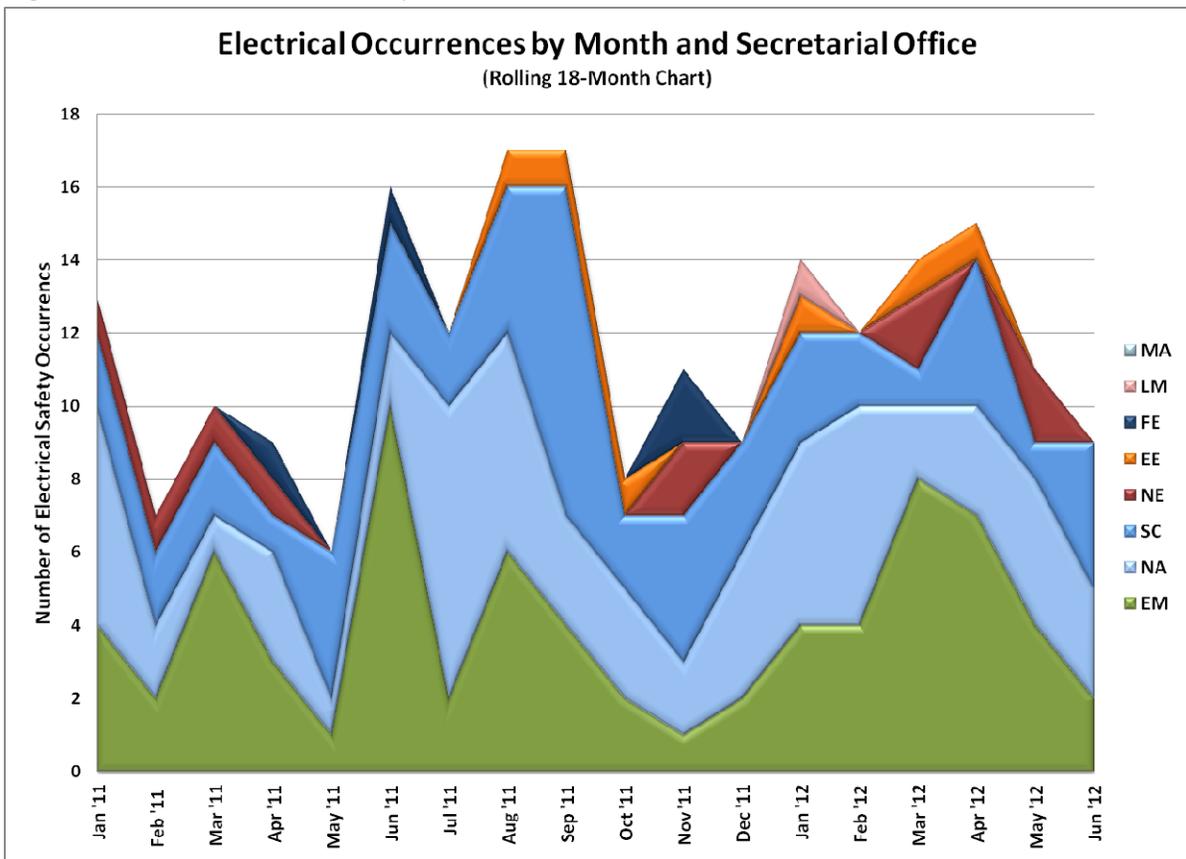
Figure 5 - Electrical Occurrences by Month and Secretarial Office

Figure 5 shows the distribution of electrical safety occurrences by Secretarial Office. The Office of Environmental Management (EM), the Office of Science (SC), and the National Nuclear Security Administration (NA) typically report the most occurrences of all the offices. Since March, EM has shown a continued decrease in the number of occurrences. Following slight increases during the same period, NA decreased in June, while SC increased from last month.

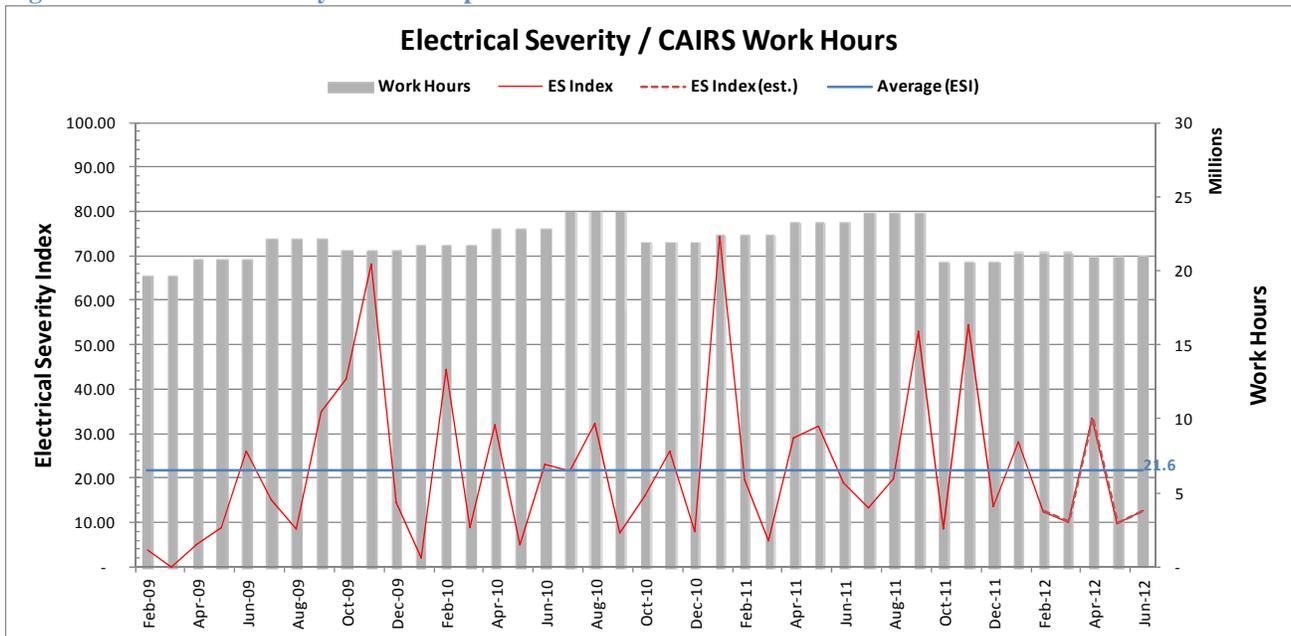
Figure 6 - Electrical Severity Index Compared to Work Hours

The Electrical Severity Index (ESI) is a performance metric that was developed to normalize events against organizational work hours. The ESI is calculated monthly and trended. Figure 6 shows a calculated ESI for the DOE complex and Table 4 shows the ESI and how it has changed from the previous month.

Note: An estimated ESI is calculated until accurate CAIRS man-hours are available. The chart is updated monthly.

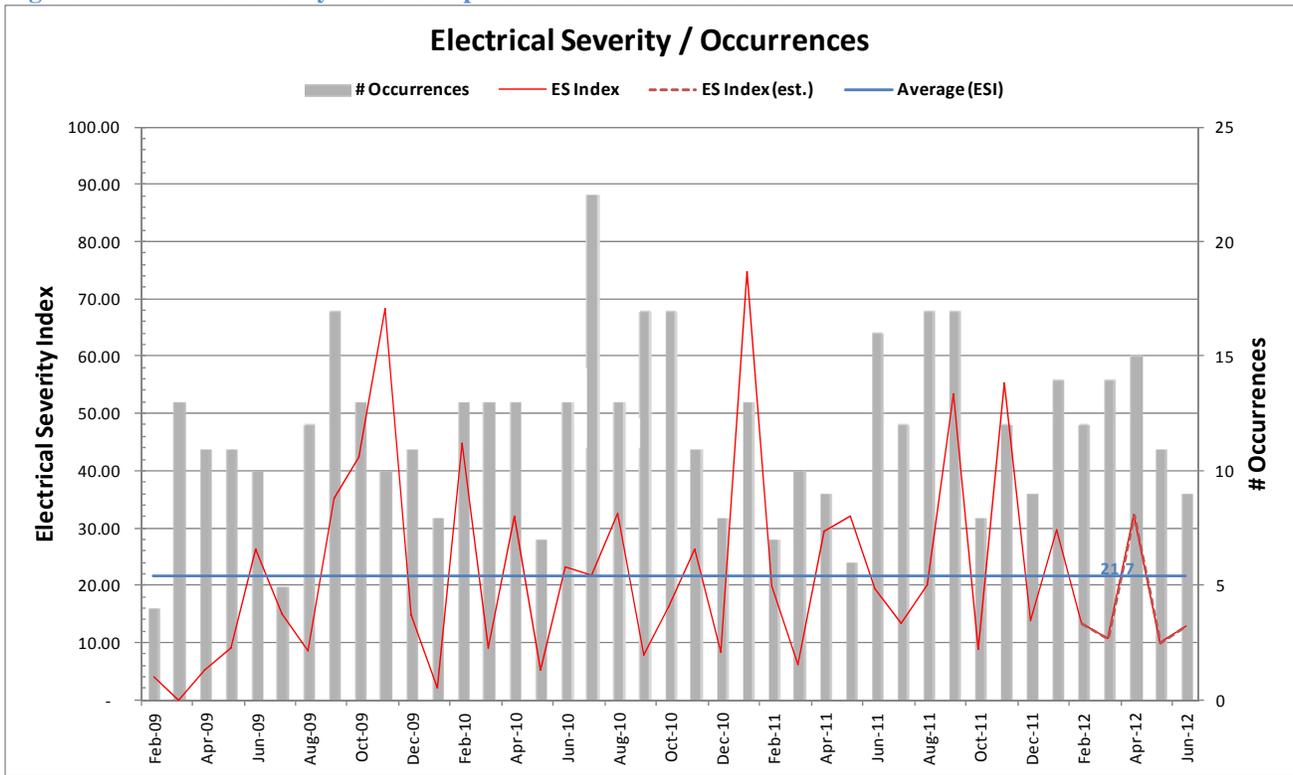
Figure 7 - Electrical Severity Index Compared to Number of Occurrences

Figure 7 shows the ESI with the number of Occurrences instead of Work Hours.

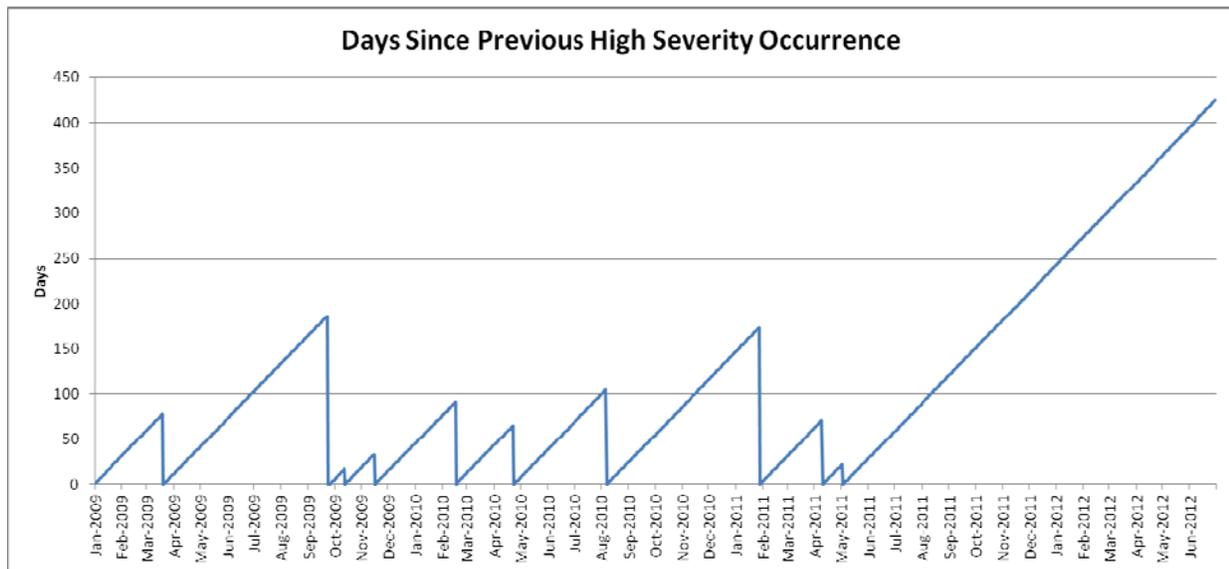
Figure 8 - Days since Previous High Severity Occurrence

The average ESI (21.6) has decreased for two consecutive months. The lowest average ESI was 19.2 in June 2010. Figure 8 shows the number of days since the previous high severity occurrence. The present interval is 425 days as of June 30. The previous longest interval was 181 days in 2009.

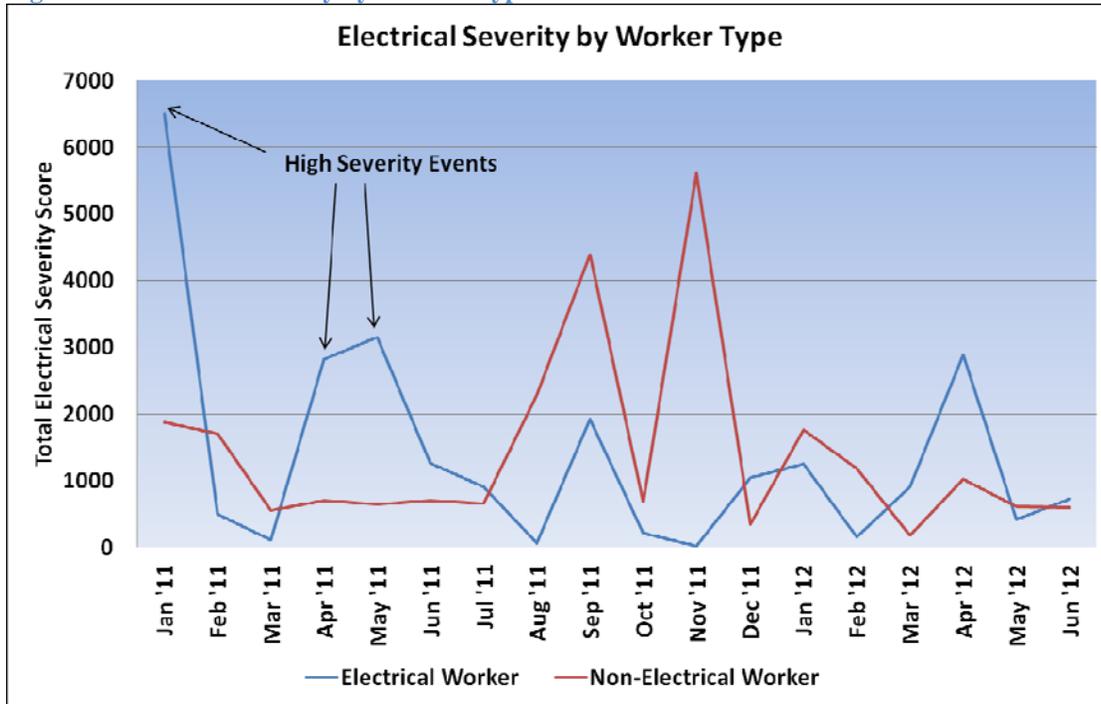
Figure 9 – Electrical Severity by Worker Type

Figure 9 shows the total electrical severity score by worker type for each month.

Electrical Workers typically have the fewest number of occurrences but they had three High-Severity events while Non-Electrical Workers have Low to Medium ES scores. The ES scores for June were close with Non-Electrical Workers at 600 and Electrical Workers at 731.

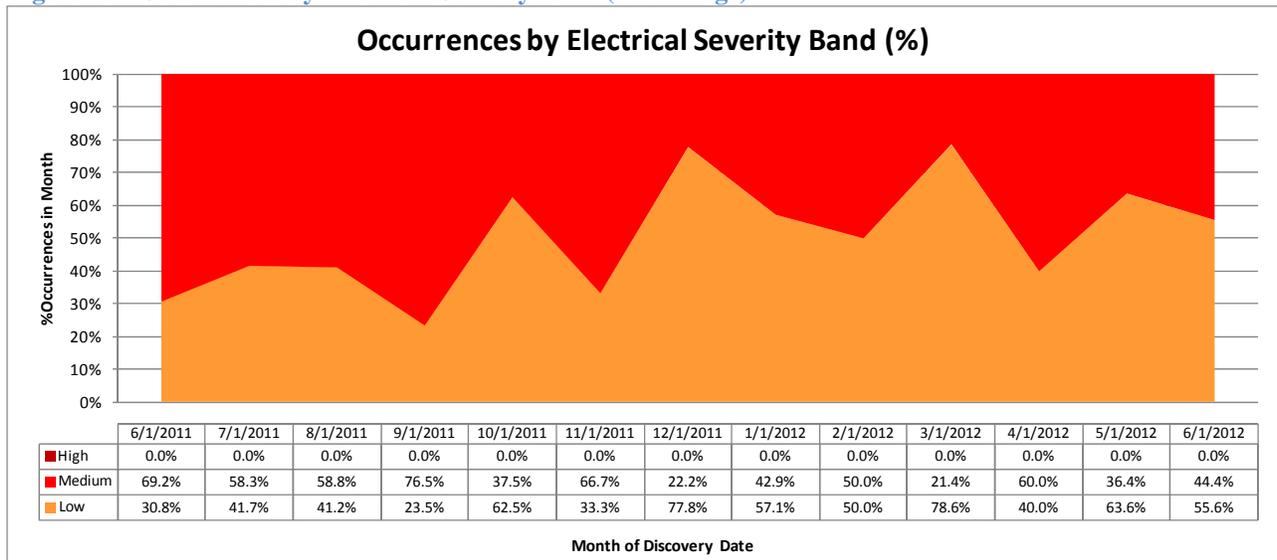
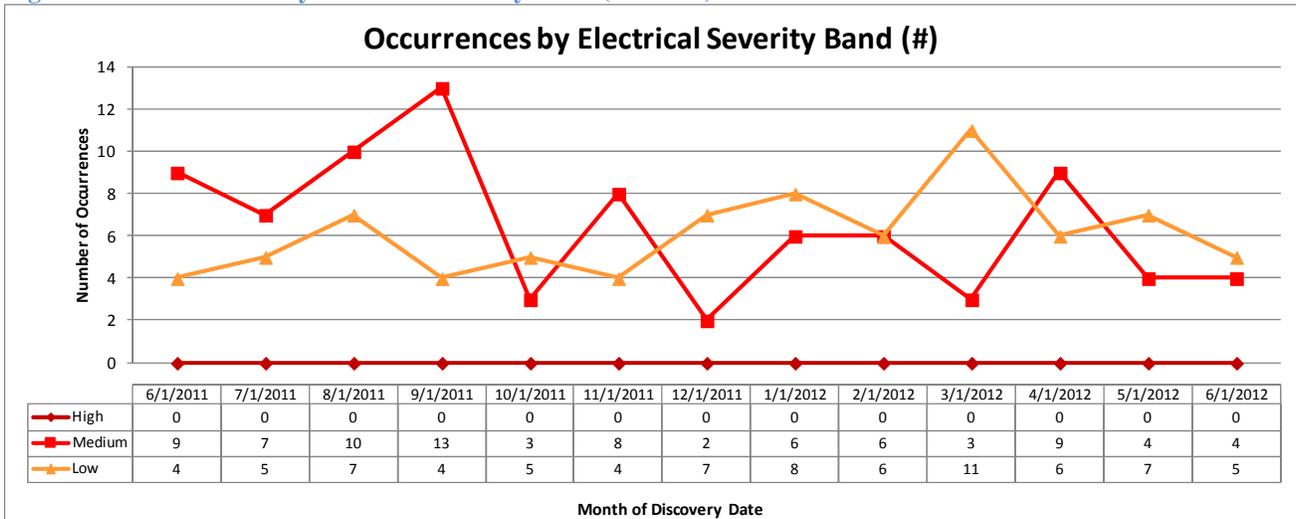
For the interval June 2011 through June 2012 (current month and the past 12), Figures 10 and 11 summarize occurrences by severity band and month of discovery date by percentage of total occurrences in month and number of occurrences in month.

Figure 10 - Occurrences by Electrical Severity Band (Percentage)

Figure 11 - Occurrences by Electrical Severity Band (Number)

What can be seen from the previous two charts is that the number of occurrences with High electrical severity scores has remained at zero for the past 12 months and that the number of occurrences with Medium scores has decreased below the number of Low severity occurrences.

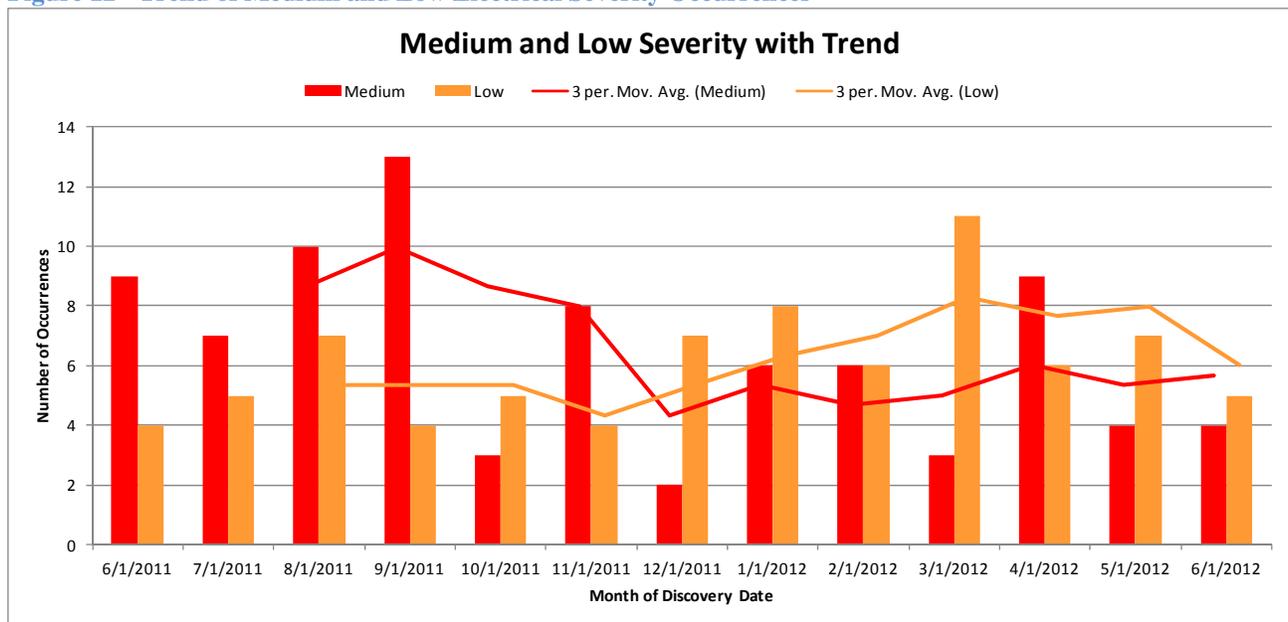
Figure 12 - Trend of Medium and Low Electrical Severity Occurrences

Figure 12 focuses on the Medium and Low severity data series for June 2011 through June 2012. Trend lines are included for each, using a 3-month moving average.

The 3-month moving average shows a decreasing trend for Low severity occurrences while Medium severity occurrences have remained relatively the same. A higher percentage of Low severity occurrences is preferred.
