Office of Health, Safety and Security

## Monthly Analysis of Electrical Safety Occurrences

November 2012

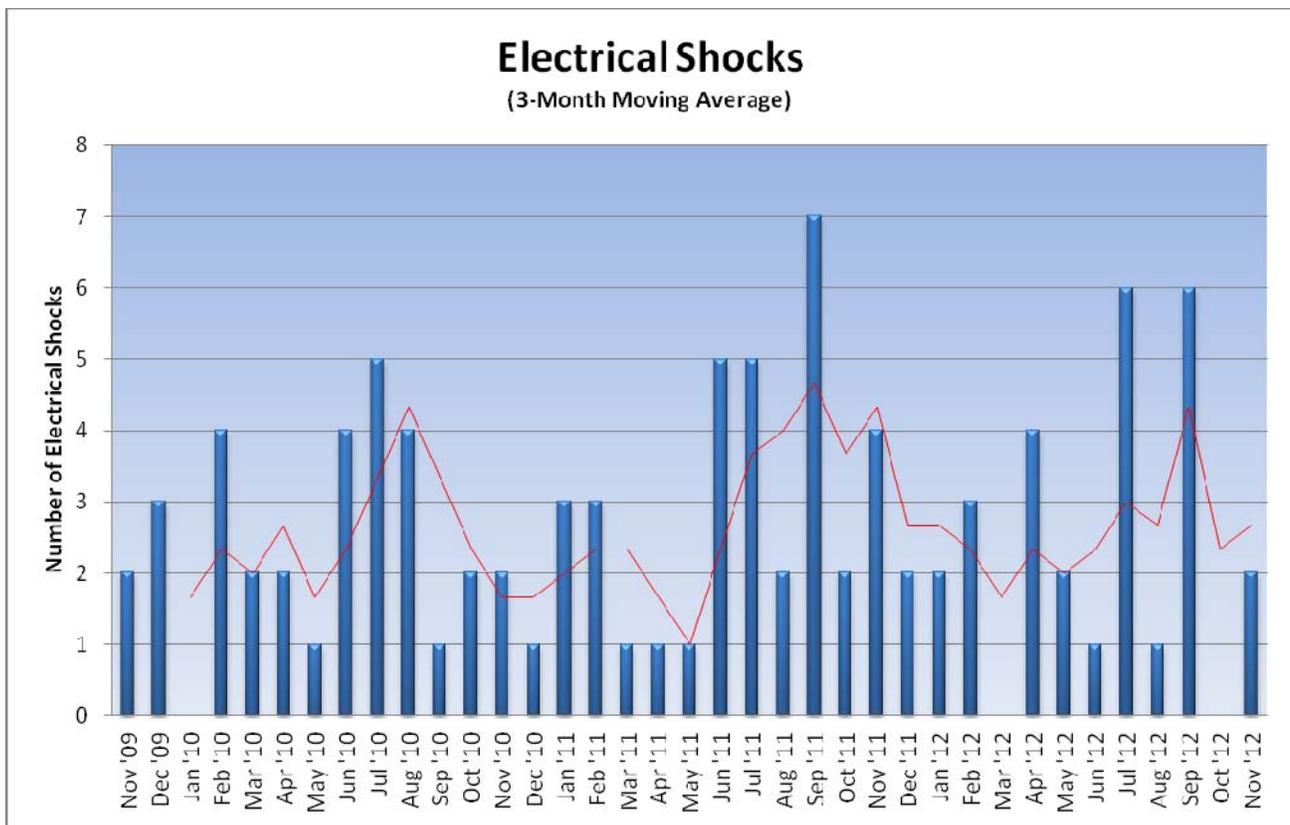
Figure 1 – Three-Year Trend of Electrical Shocks

Figure 1 shows a 3-year trend of electrical shocks for the DOE complex. During this period, the average number of electrical shocks has remained below three (2.6) shocks per month.

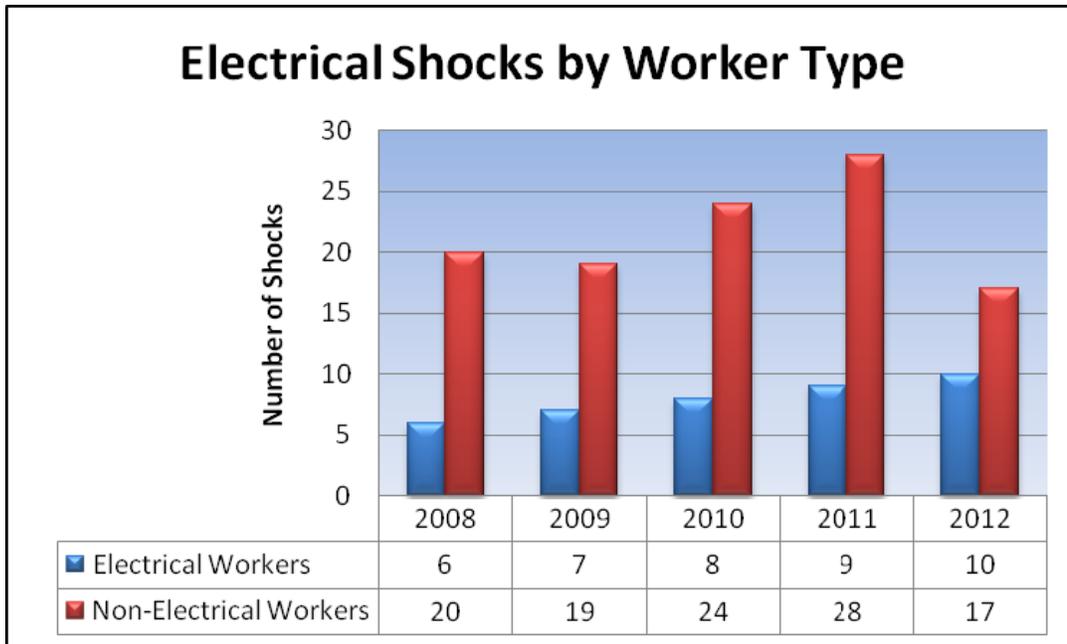
Figure 2 - Electrical Shock by Worker Type

Figure 2 shows electrical shocks by worker type. The number of shocks involving electrical workers has slowly increased, while those involving non-electrical workers decreased after 2011. Since 2008, the majority of shocks (about 73 percent) involve non-electrical workers.

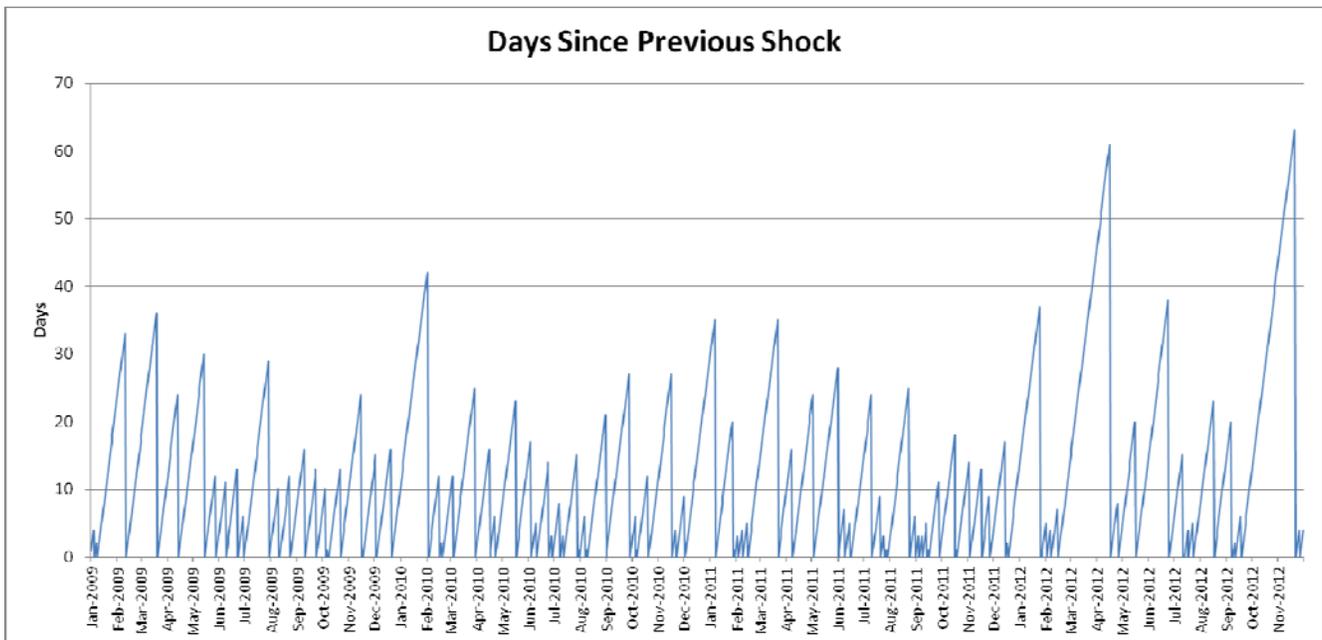
Figure 3 - Days since Previous Shock

Figure 3 shows the number of days since the previous electrical shock for the DOE complex. The longest interval was 63 days (November 20, 2012) and the present interval is 4 days as of November 30.

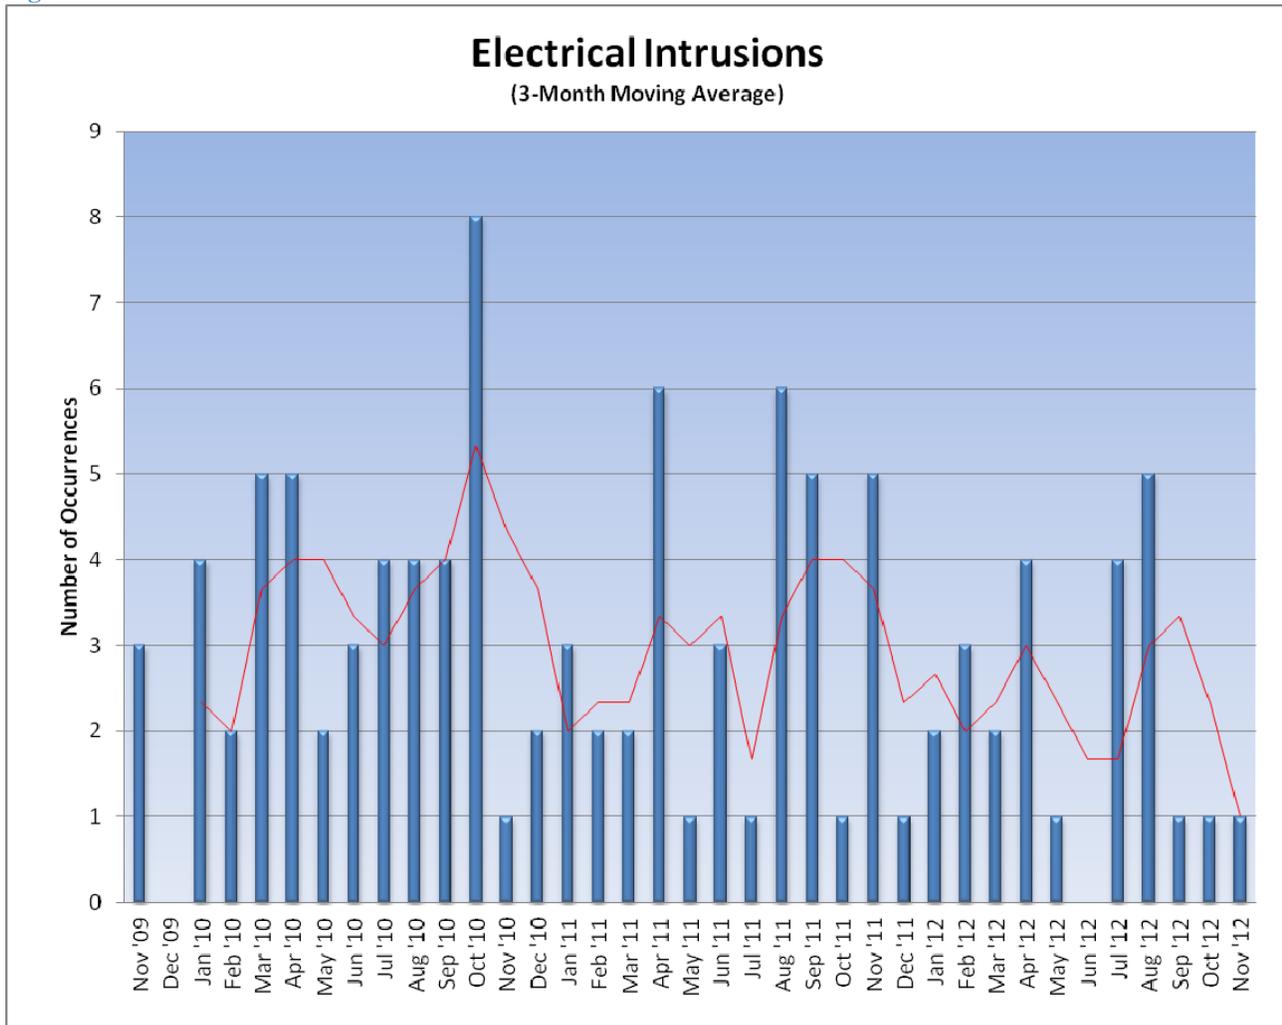
**Figure 4 – Three-Year Trend of Electrical Intrusion Occurrences**

Figure 4 shows a 3-year trend of electrical intrusion occurrences for the DOE complex. During this period we have seen an average of just under 3 occurrences per month (2.9).

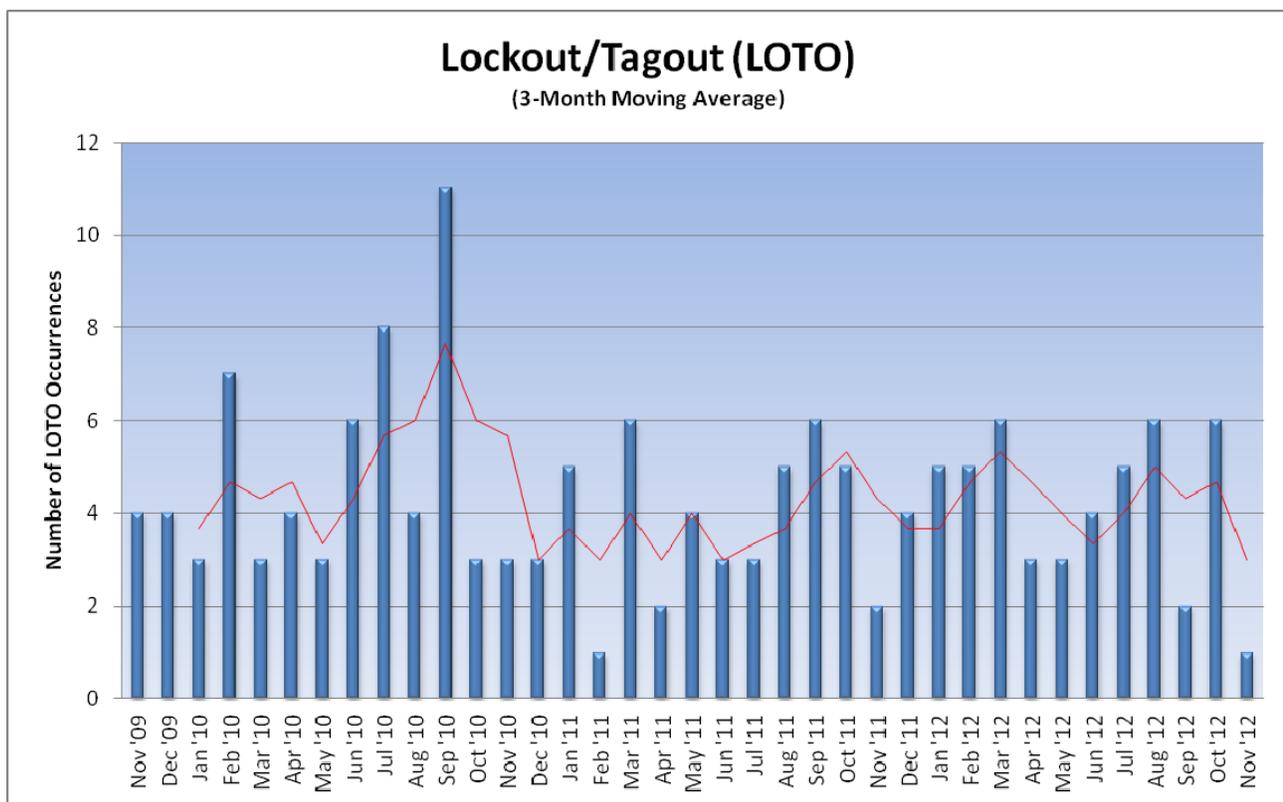
Figure 5 – Three-Year Trend of Lockout/Tagout Occurrences

Figure 5 shows a 3-year trend of LOTO occurrences for the DOE complex. The monthly average is 4.3 occurrences.

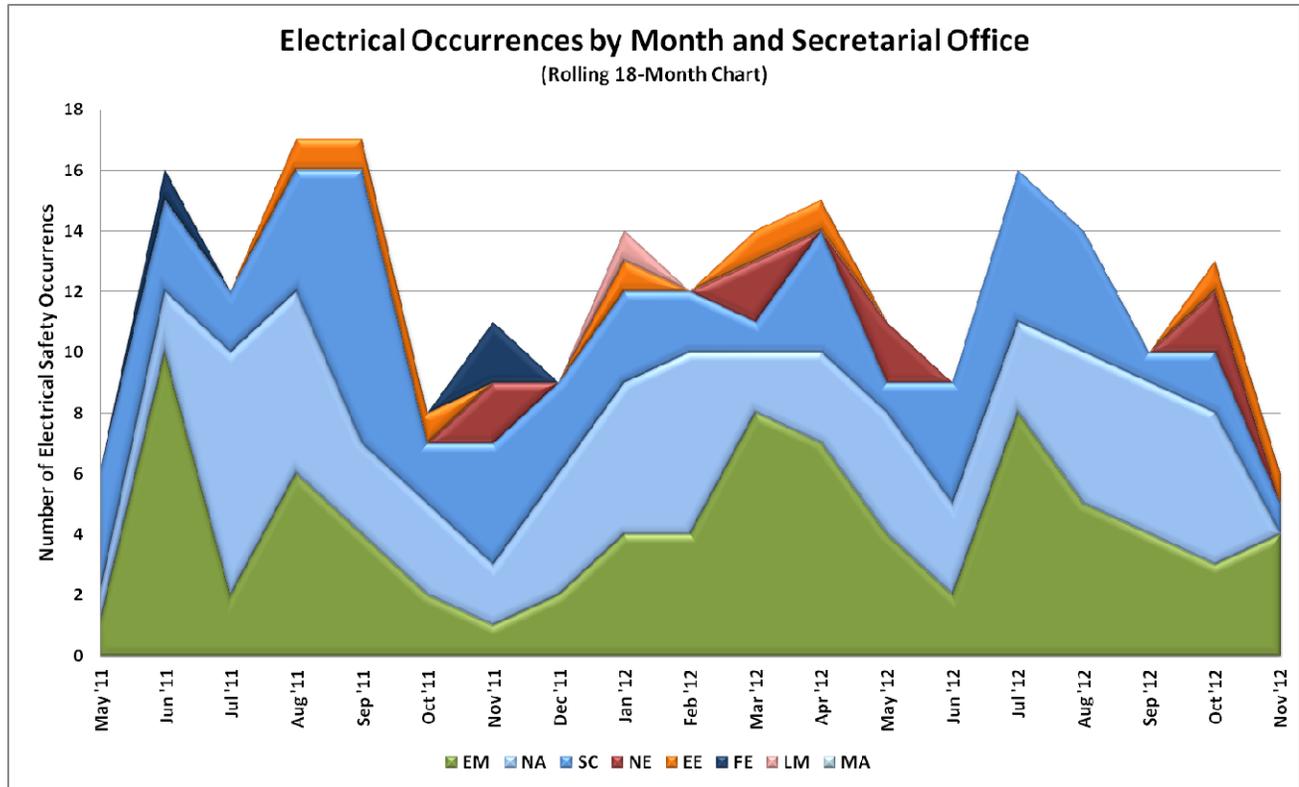
Figure 6 - Electrical Occurrences by Month and Secretarial Office

Figure 6 shows the distribution of electrical safety occurrences by Secretarial Office

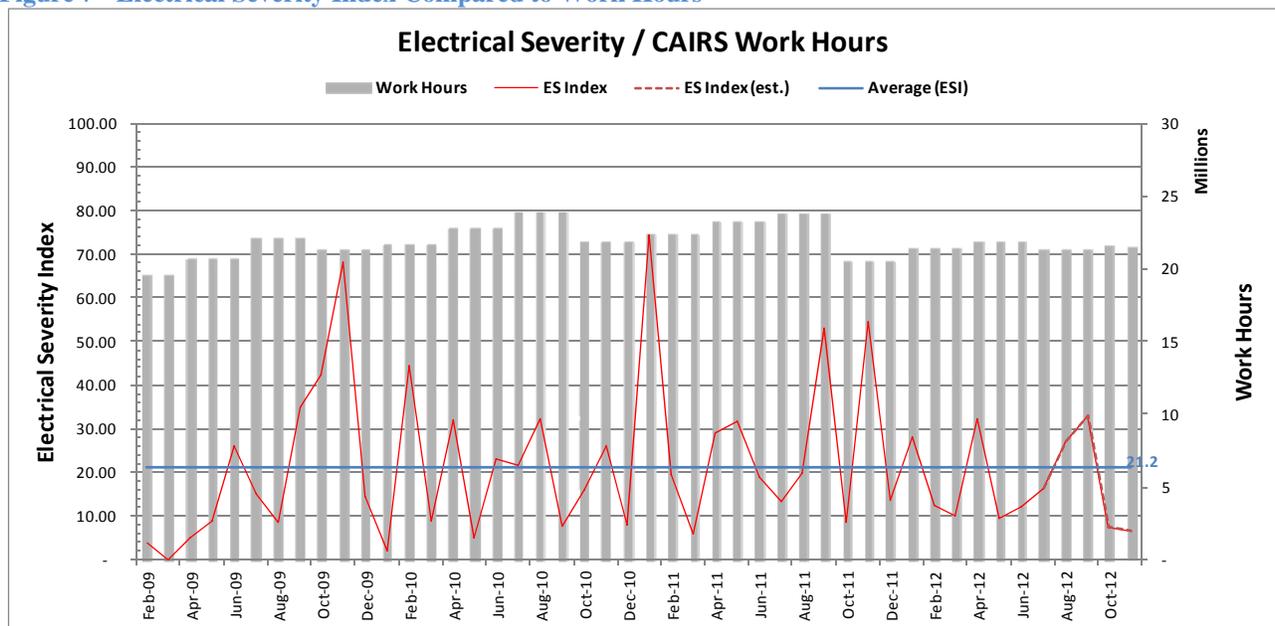
**Figure 7 - Electrical Severity Index Compared to Work Hours**

The Electrical Severity Index (ESI) is a performance metric that was developed to normalize events against organizational work hours. The ESI is calculated monthly and trended. Figure 7 shows a calculated ESI for the DOE complex and Table 4 shows the ESI and how it has changed from the previous month.

Note: An estimated ESI is calculated until accurate CAIRS man-hours are available. The chart is updated monthly.

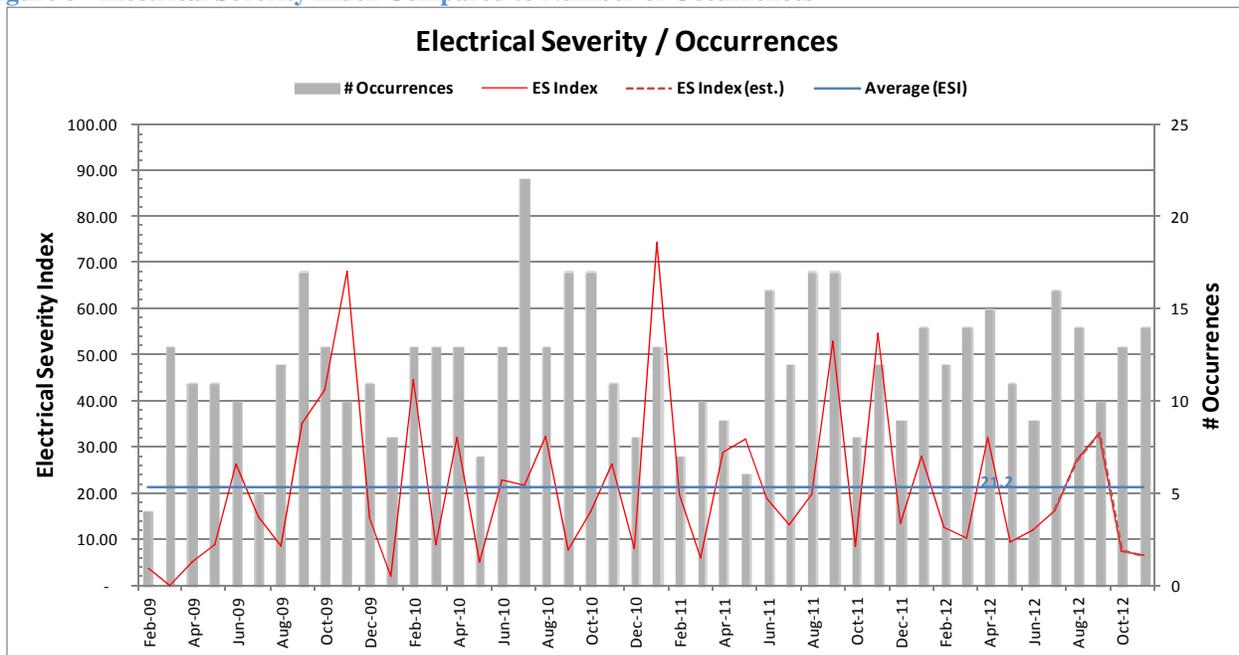
**Figure 8 - Electrical Severity Index Compared to Number of Occurrences**

Figure 8 shows the ESI with the number of Occurrences instead of Work Hours.

The average ESI (21.2) has decreased slightly for the last two months. The lowest average ESI was 19.2 in June 2010.

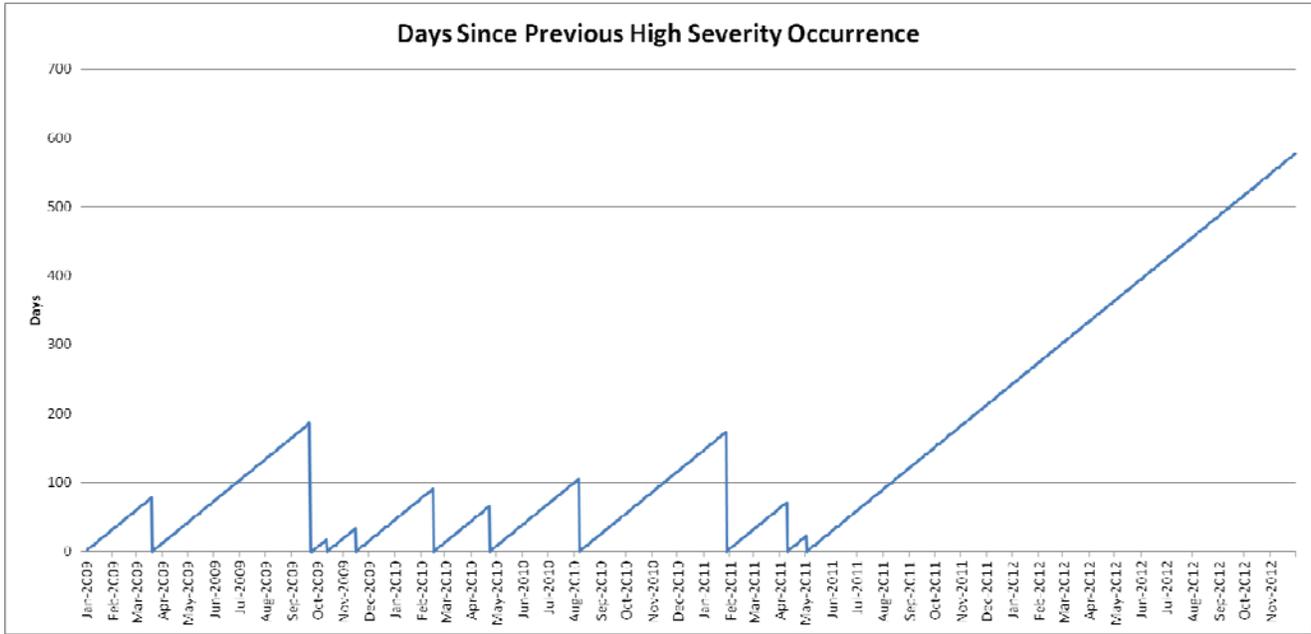
Figure 9 - Days since Previous High Severity Occurrence

Figure 9 shows the number of days since the previous high severity occurrence. The present interval is 577 days as of November 30. The previous longest interval was 181 days in 2009.

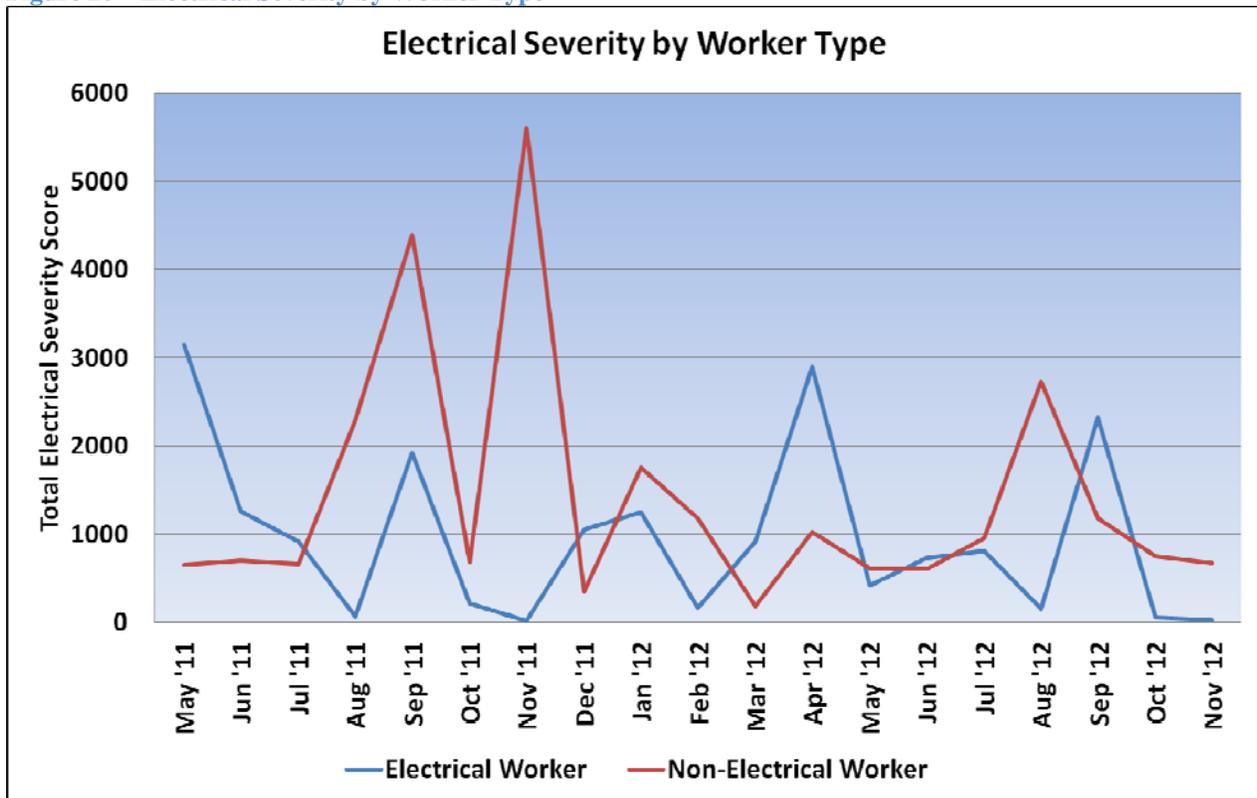
Figure 10 – Electrical Severity by Worker Type

Figure 10 shows the total electrical severity score by worker type for each month.

Electrical workers typically have the fewest number of occurrences. Following a spike of 2,320 in September 2012, the ES score for electrical workers has dropped to 30, while non-electrical workers ES scores decreased from 1,180 to 670. The average ES scores for the 18 month period are 1,137 for electrical workers and 1,406 for non-electrical workers.

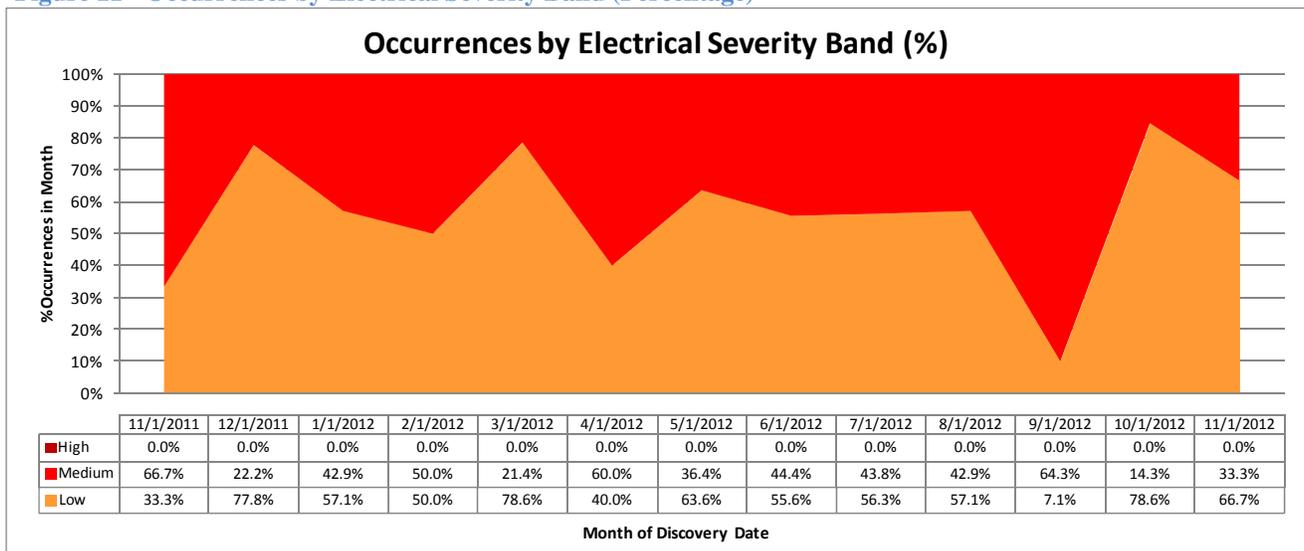
Figure 11 - Occurrences by Electrical Severity Band (Percentage)

For the interval November 2011 through November 2012 (current month and the past 12), Figures 11 and 12 summarize occurrences by severity band and month of discovery date by percentage of total occurrences in month and number of occurrences in month.

What can be seen from the previous two charts is that the number of occurrences with High electrical severity scores has remained at zero with the last event occurring back in May 2011.

The number of occurrences with Medium did not change while the number of Low and zero severity occurrences decreased.

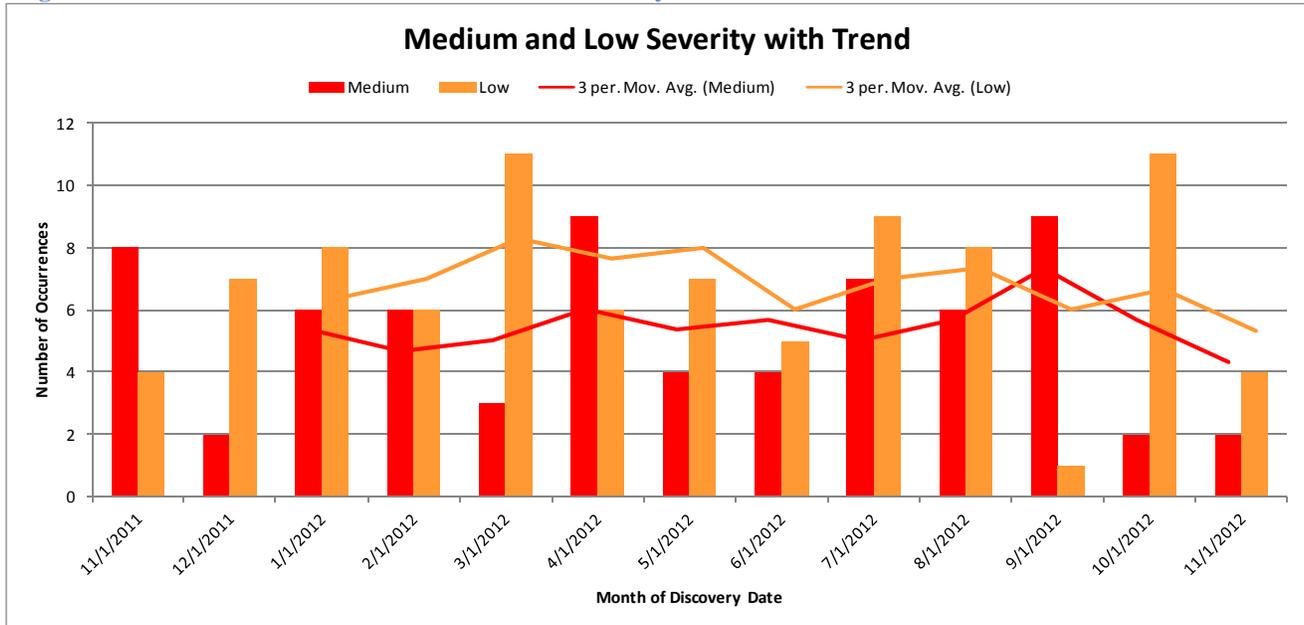
**Figure 13 - Trend of Medium and Low Electrical Severity Occurrences**

Figure 13 focuses on the Medium and Low severity data series for November 2011 through November 2012. Trend lines are included for each, using a 3-month moving average.

The 3-month moving average shows a decreasing trend for Medium severity occurrences and Low severity occurrences. A higher percentage of Low severity occurrences is preferred.
