Office of Health, Safety and Security

Monthly Analysis of Electrical Safety Occurrences

September 2013

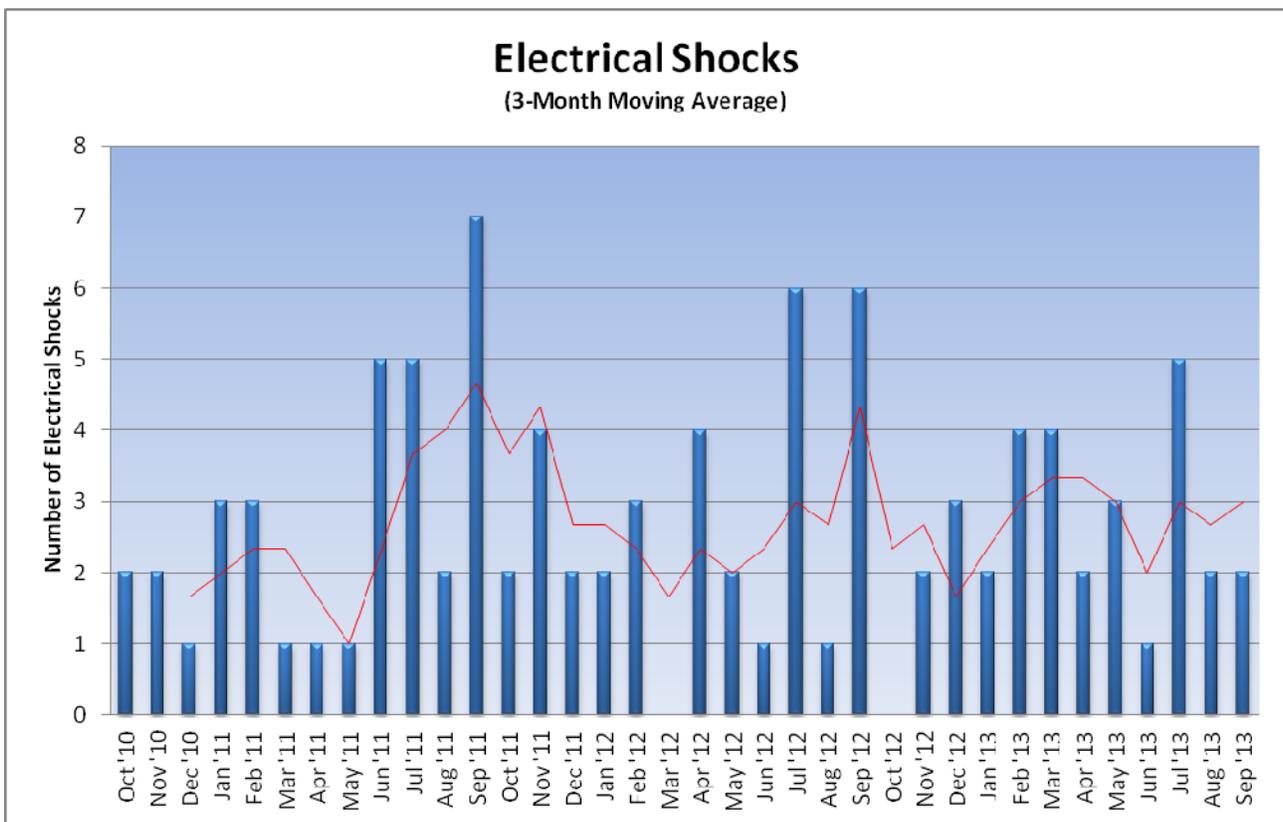
Figure 1 – Three-Year Trend of Electrical Shocks

Figure 1 shows a 3-year trend of electrical shocks for the DOE complex. During this period, the average number of electrical shocks has remained below three (2.7) shocks per month.

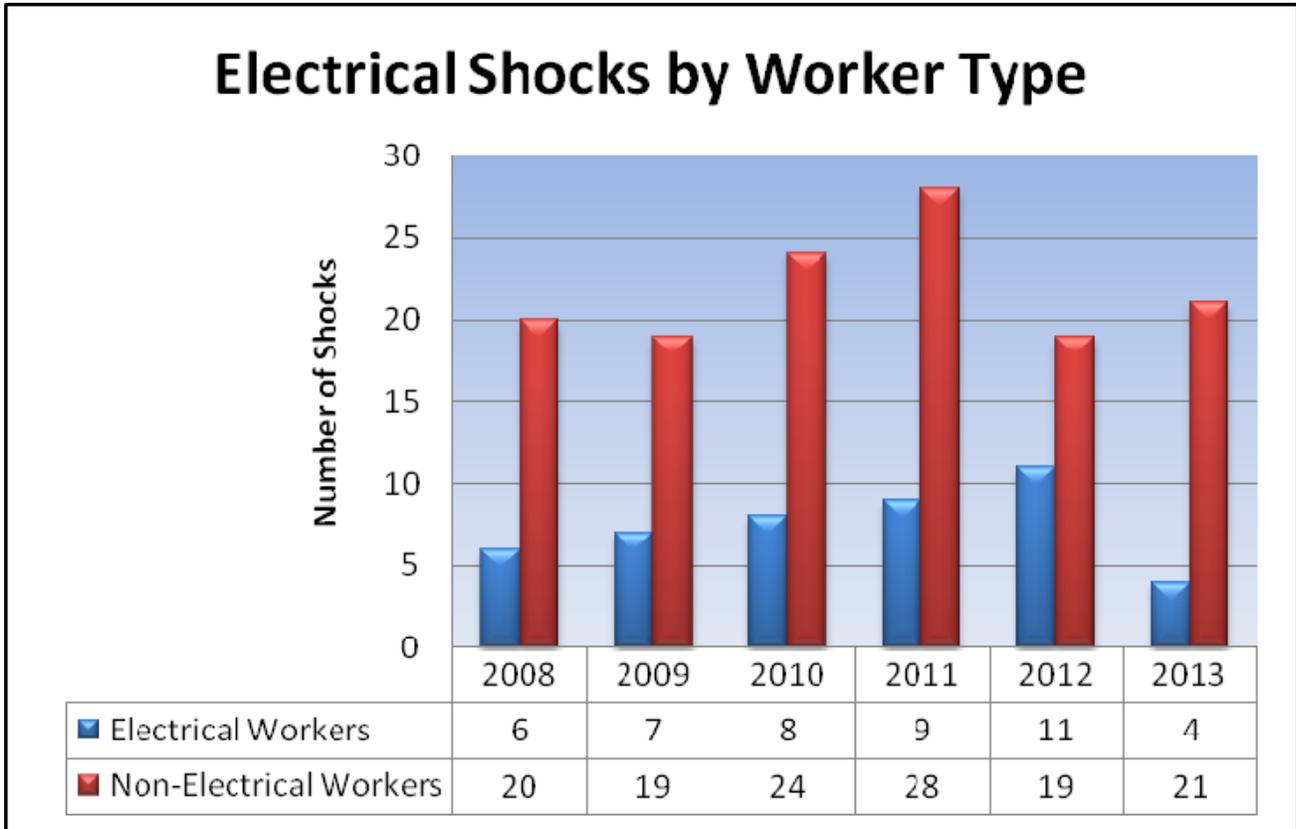
Figure 2 - Electrical Shock by Worker Type

Figure 2 shows electrical shocks by worker type through September 2013. The number of shocks involving electrical workers slowly increased through 2012 and then dropped in 2013. Presently, this is the lowest year since 2008. Shocks involving non-electrical workers decreased after 2011. Since 2008, the majority of shocks (about 74 percent) involve non-electrical workers. So far for in 2013, that percentage is 83.

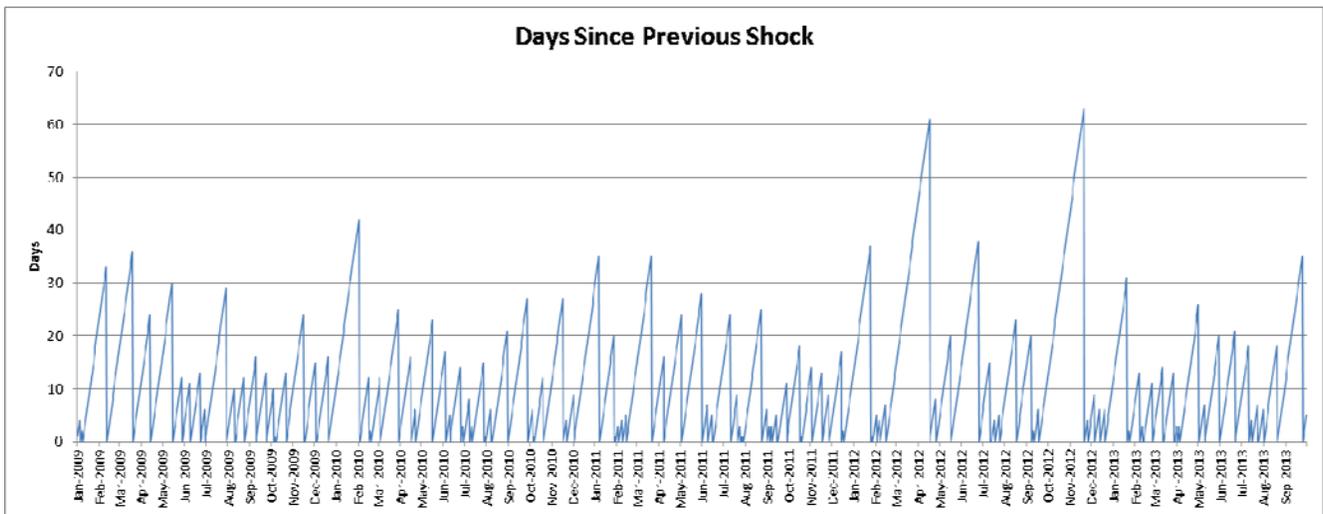
Figure 3 - Days since Previous Shock

Figure 3 shows the number of days since the previous electrical shock for the DOE complex. The longest interval was 63 days (November 20, 2012) and the present interval is 5 days as of September 30.

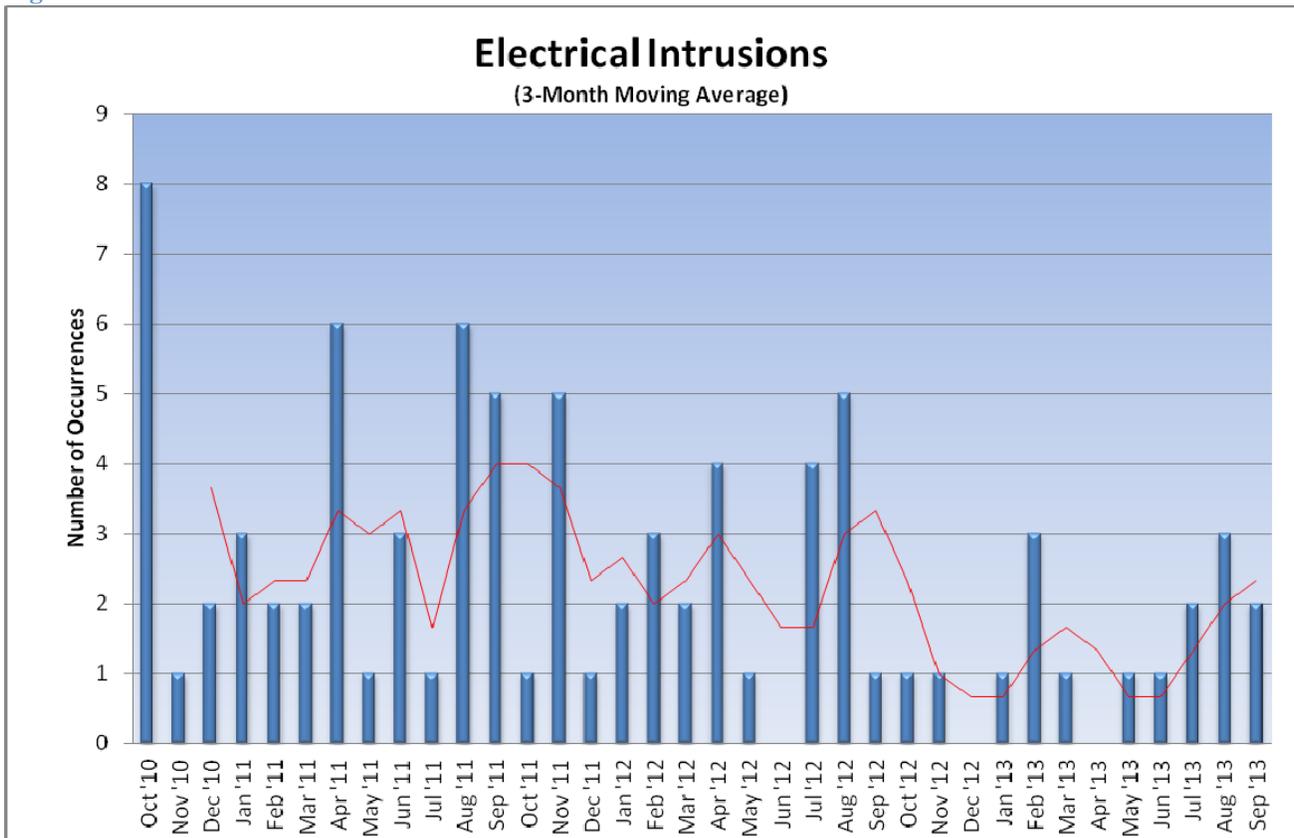
Figure 4 – Three-Year Trend of Electrical Intrusion Occurrences

Figure 4 shows a 3-year trend of electrical intrusion occurrences for the DOE complex. During this period we have seen an average of just under 3 occurrences per month (2.4).

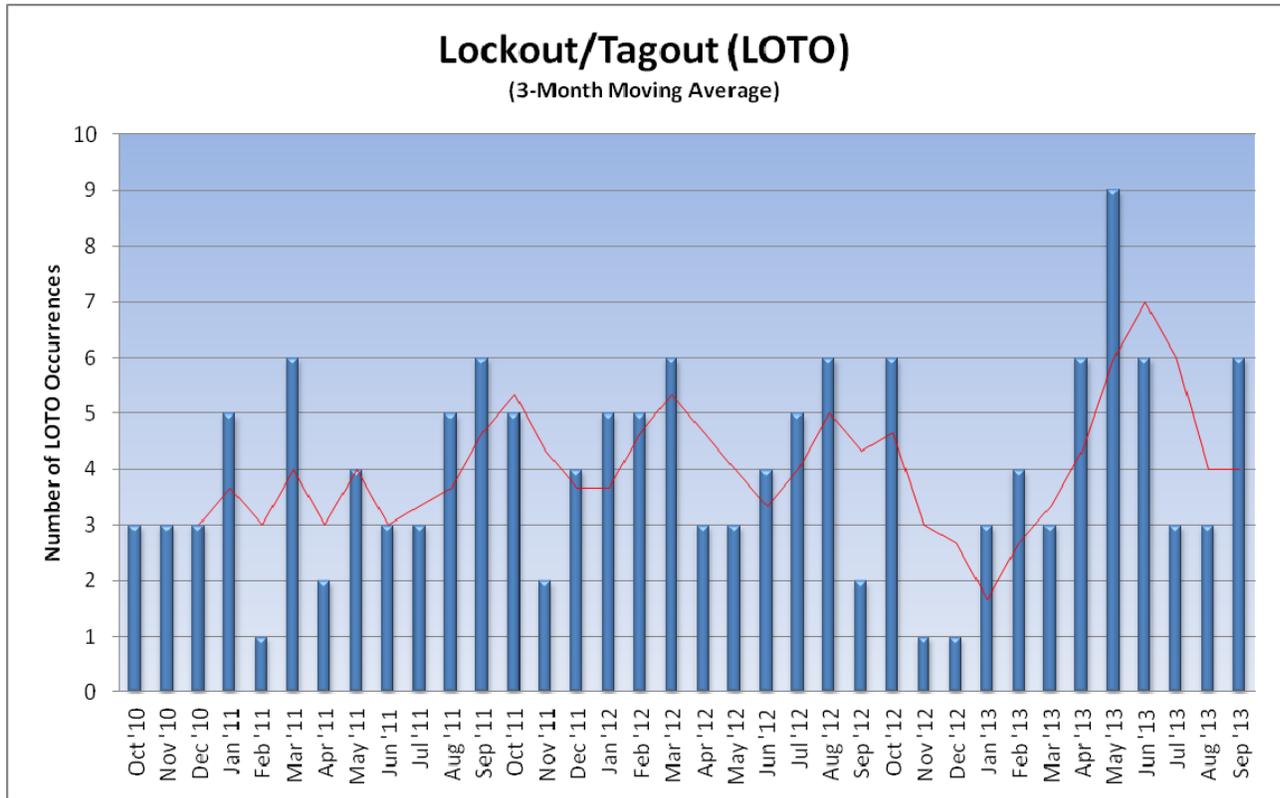
Figure 5 – Three-Year Trend of Lockout/Tagout Occurrences

Figure 5 shows a 3-year trend of LOTO occurrences for the DOE complex. The monthly average is 4.0 occurrences.

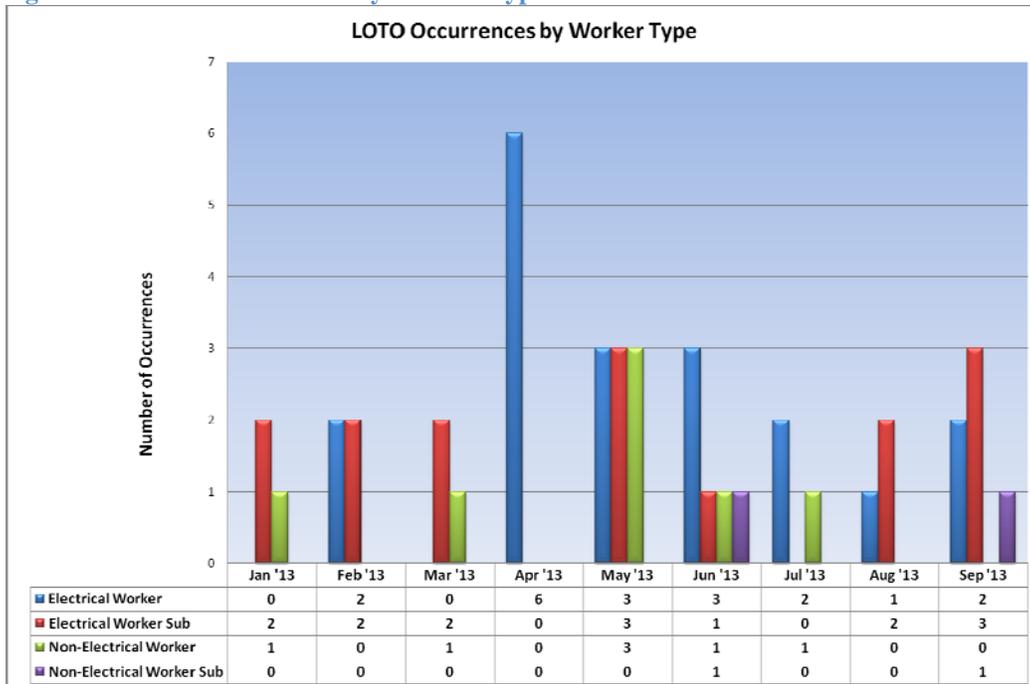
Figure 6 – LOTO Occurrences by Worker Type

Figure 6 shows LOTO occurrences by worker type. The distribution by percentage is 44% for electrical workers, 35% for electrical worker subcontractors, 16% for non-electrical workers, and 5% for non-electrical worker subcontractors.

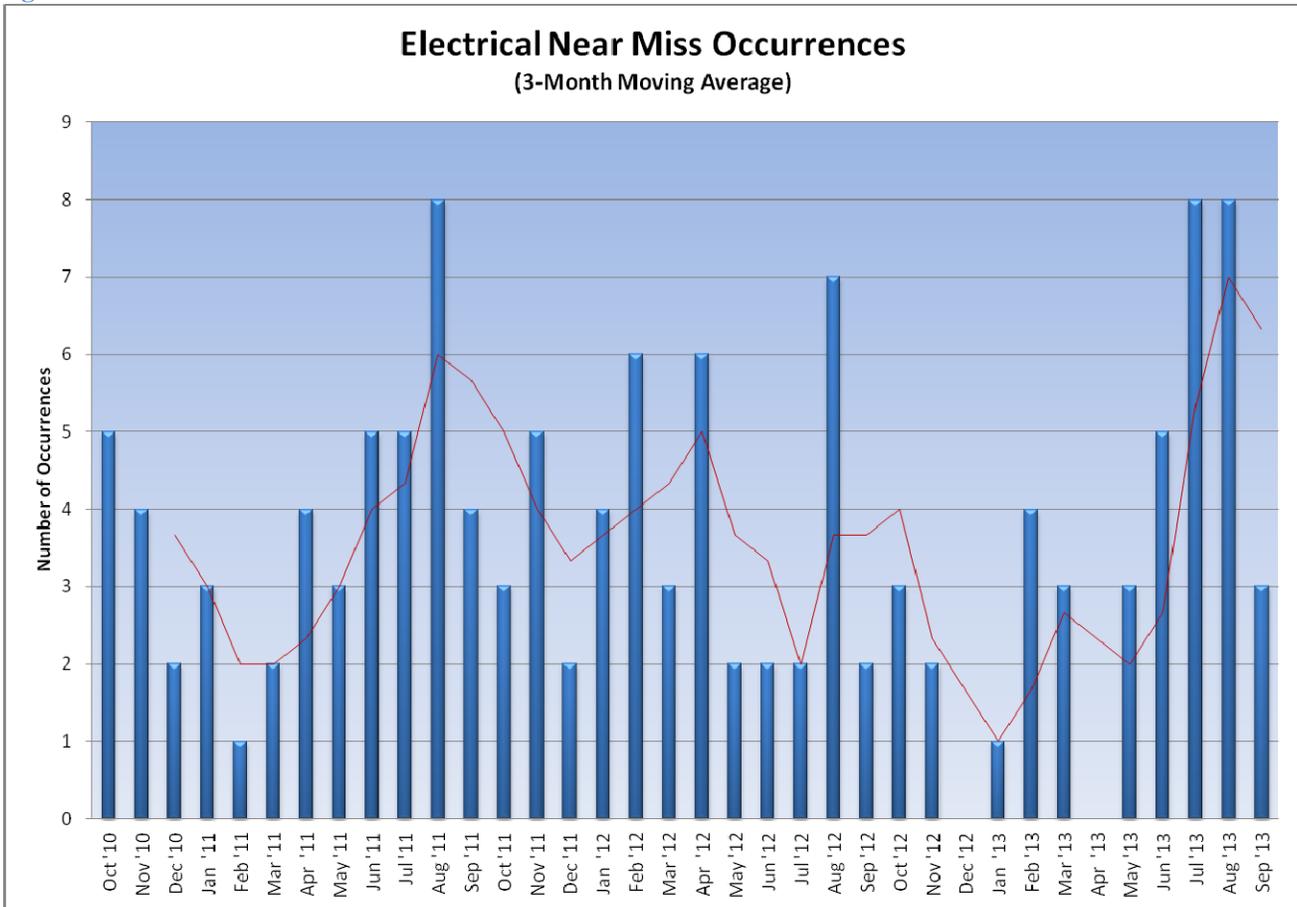
Figure 7 – Three-Year Trend of Electrical Near Miss Occurrences

Figure 7 shows a 3-year trend of near miss occurrences for the DOE complex. The monthly average is 3.6 occurrences.

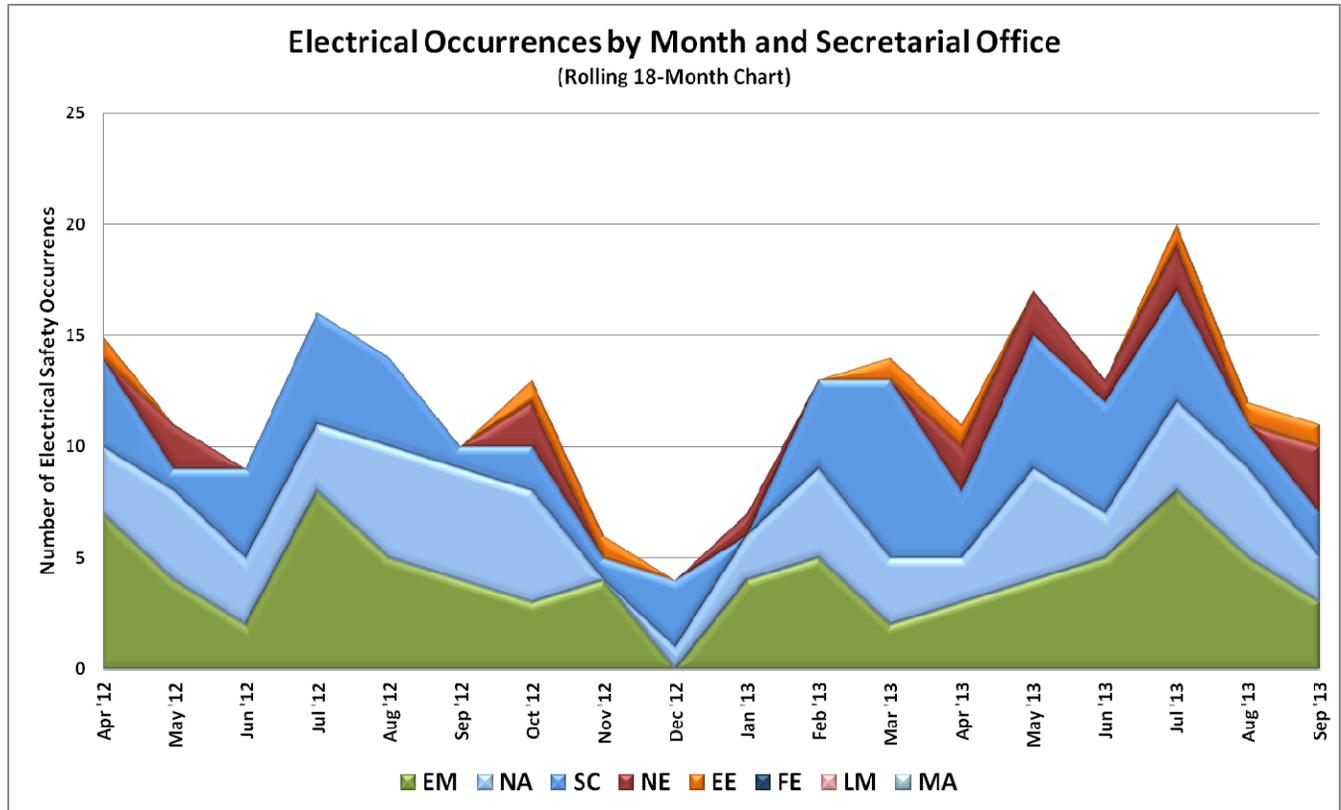
Figure 8 - Electrical Occurrences by Month and Secretarial Office

Figure 8 shows the distribution of electrical safety occurrences by Secretarial Office.

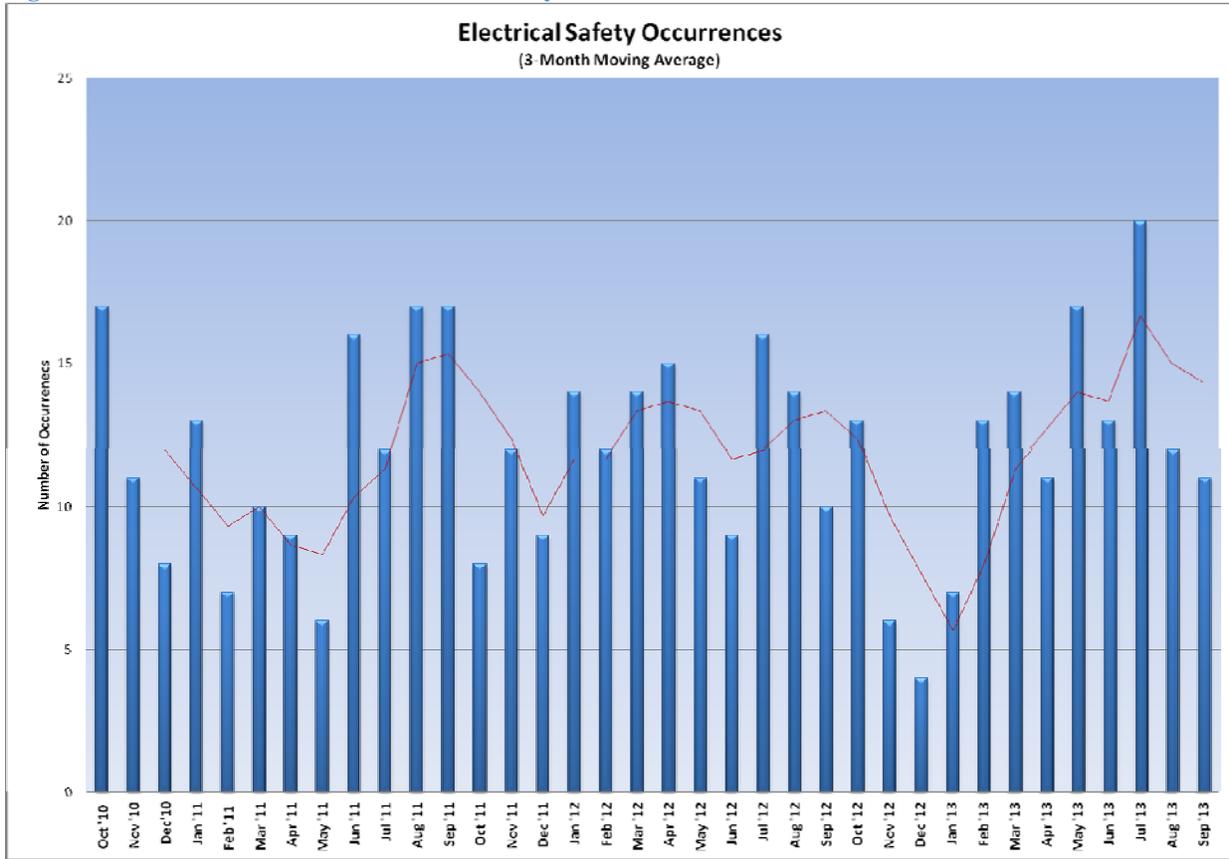
Figure 9 – Three-Year Trend of Electrical Safety Occurrences

Figure 9 shows 3-year trend of electrical safety occurrences for the DOE complex.

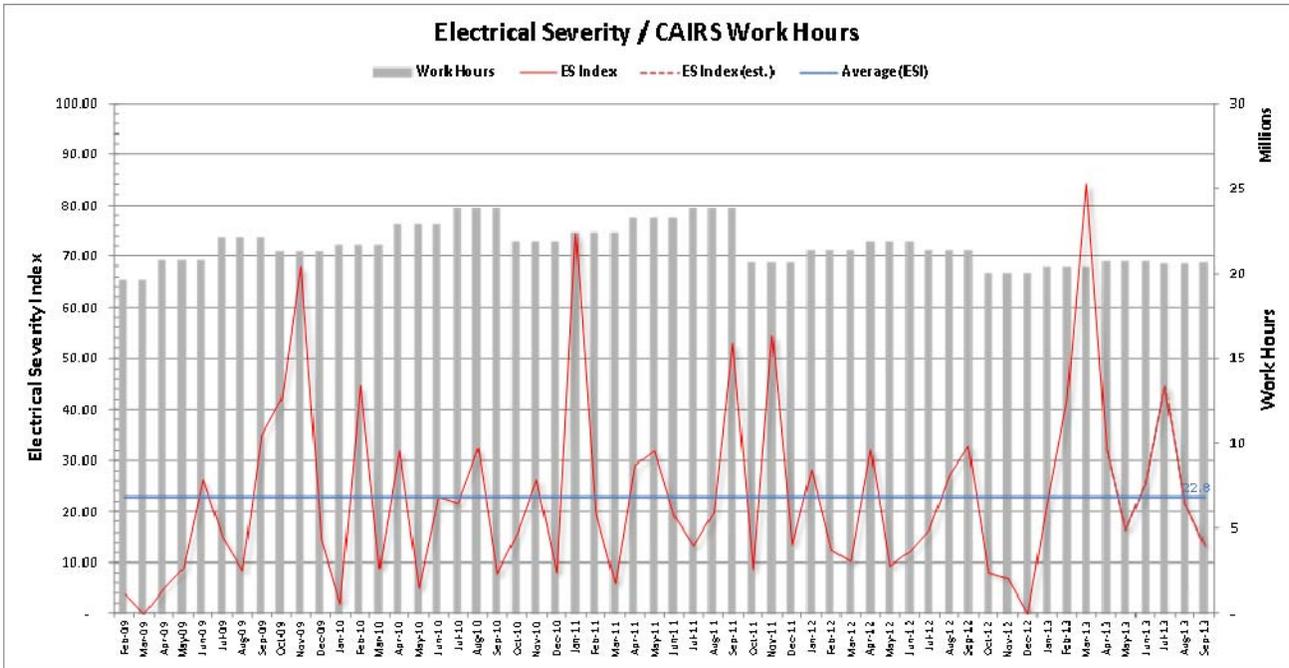
Figure 10 - Electrical Severity Index Compared to Work Hours

The Electrical Severity Index (ESI) is a performance metric that was developed to normalize events against organizational work hours. The ESI is calculated monthly and trended. Figure 10 shows a calculated ESI for the DOE complex and Table 4 shows the ESI.

Note: An estimated ESI is calculated until accurate CAIRS man-hours are available. The chart is updated monthly.

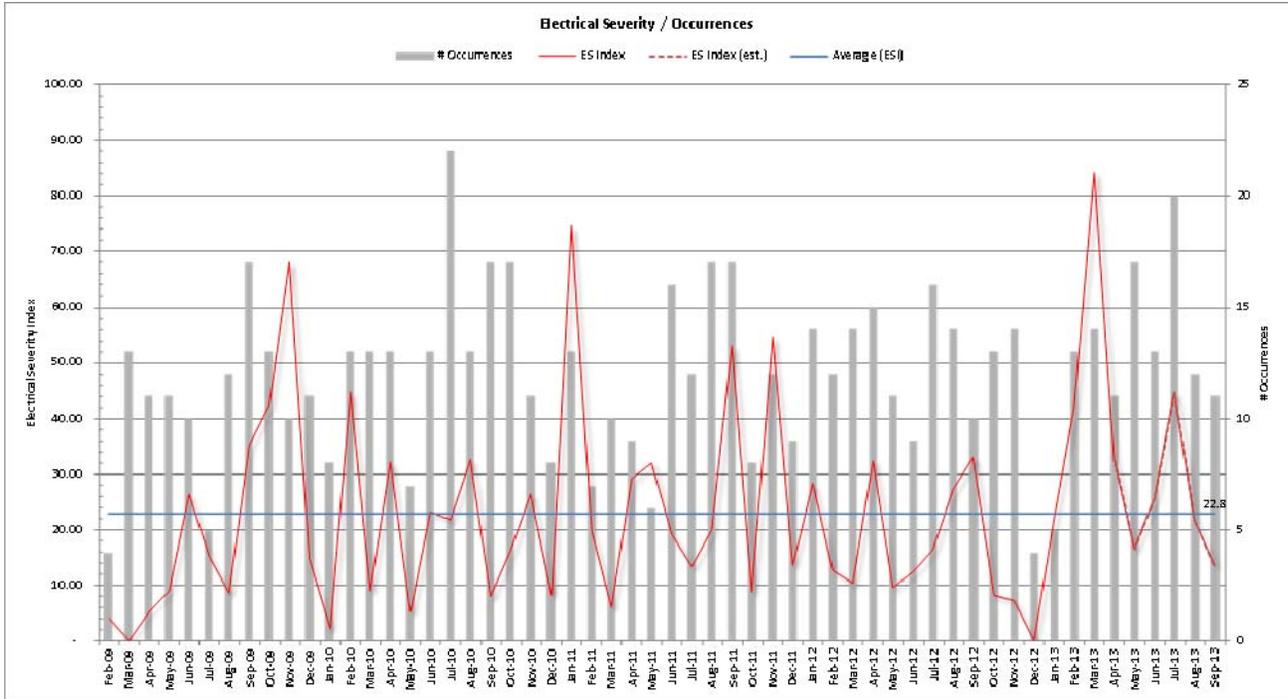
Figure 11 - Electrical Severity Index Compared to Number of Occurrences

Figure 11 shows the ESI with the number of Occurrences instead of Work Hours.

The average ESI (22.8) has remained fairly steady over the last three months following high severity occurrences in March and July. The lowest average ESI was 19.2 in June 2010.

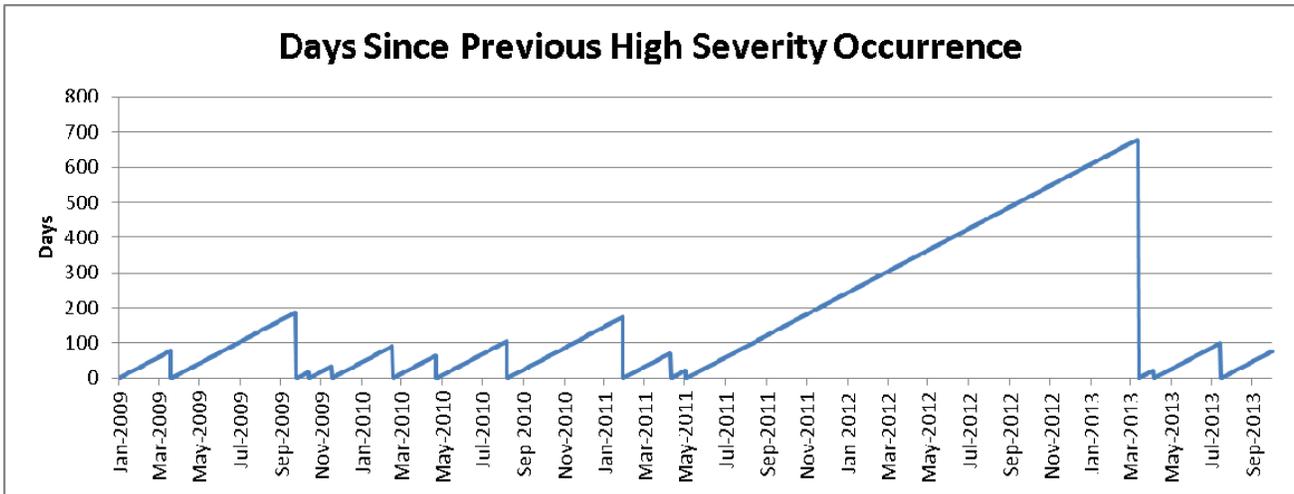
Figure 12 - Days since Previous High Severity Occurrence

Figure 12 shows the number of days since the previous high severity occurrence. The present interval is 77 days as of September 30. The previous longest interval was 679 days ending March 12, 2013.

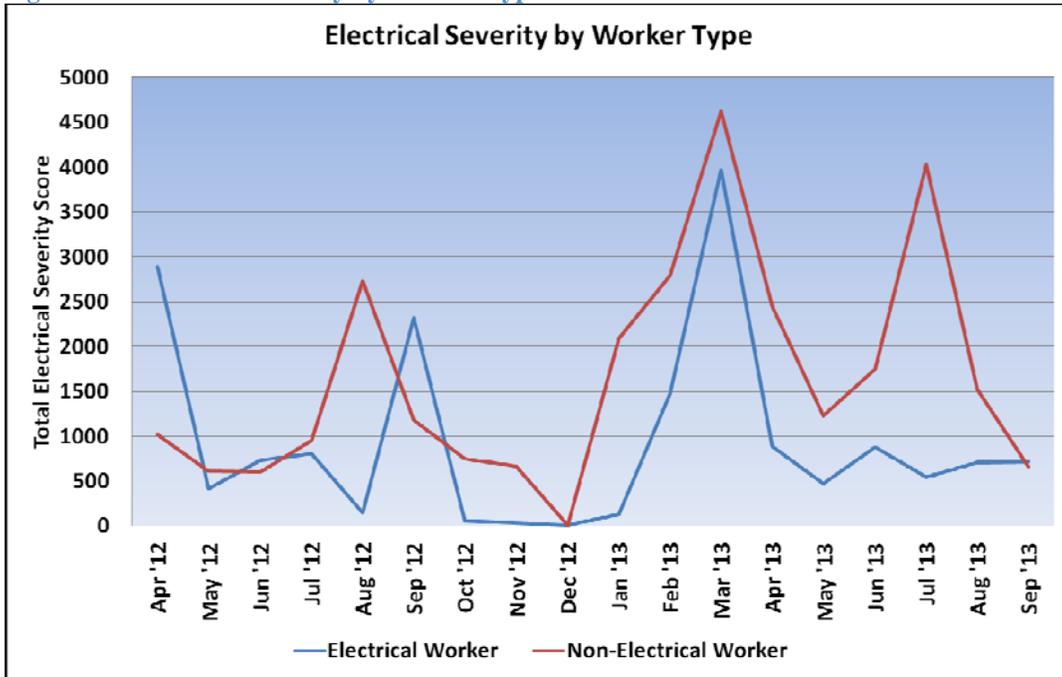
Figure 13 – Electrical Severity by Worker Type

Figure 13 shows the total electrical severity score by worker type for each month.

The present ES score for electrical workers is 720 and 660 for non-electrical workers.

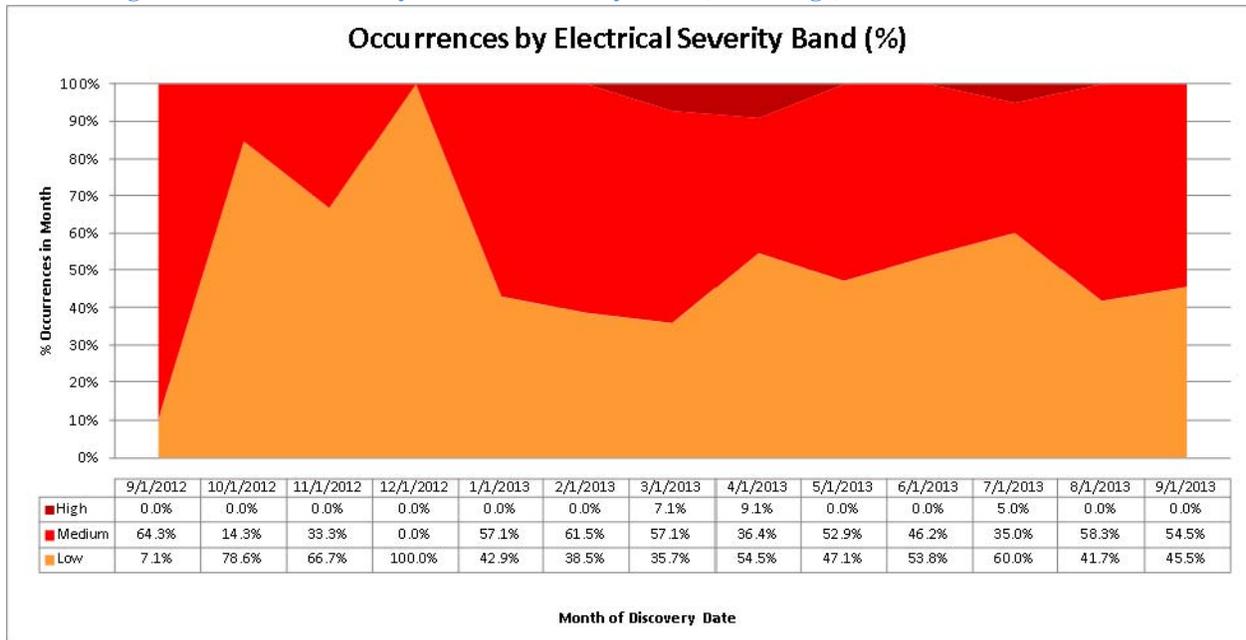
Figure 14 - Occurrences by Electrical Severity Band (Percentage)

For the interval September 2012 through September 2013 (current month and the past 12), Figures 14 and 15 summarize occurrences by severity band and month of discovery date by percentage of total occurrences in month and number of occurrences in month.

The previous two charts show that a high electrical severity event occurred in March, April and July ending a 679-day period since the last occurrence in May 2011. The number of occurrences with Medium severity scores decreased slightly while the Low severity scores remained the same.

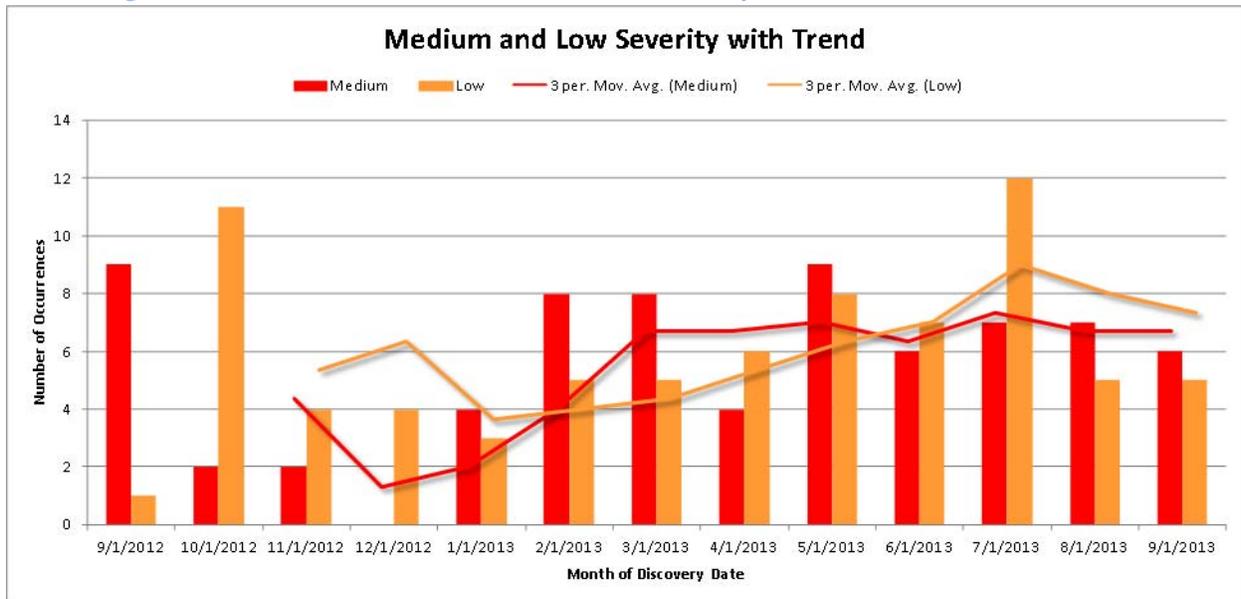
Figure 16 - Trend of Medium and Low Electrical Severity Occurrences

Figure 16 focuses on the Medium and Low severity data series for September 2012 through September 2013. Trend lines are included for each, using a 3-month moving average.

The 3-month moving average shows a slightly decreasing trend for Low and a flattening for Medium severity occurrences following an increase since the beginning of the year.
