**DOE ZERO ENERGY READY  
HOME™ CASE STUDY****Weiss Building &  
Development, LLC**Custom Home  
Downers Grove, IL

**BUILDER PROFILE****Weiss Building & Development LLC**Brandon Weiss, builder  
South Elgin, IL  
630-485-1818, Brandon@weissbd.com  
[www.weissbd.com](http://www.weissbd.com)**FEATURED HOME/DEVELOPMENT:****Project Data:**

- Name: Illinois First Zero Energy Ready Home
- Location: Downers Grove, IL
- Layout: 3 bedroom, 2.5 baths, 3 floors
- Conditioned Space: 3,600 ft<sup>2</sup>
- Completion: June 2013
- Climate Zone: 5A
- Category: Custom

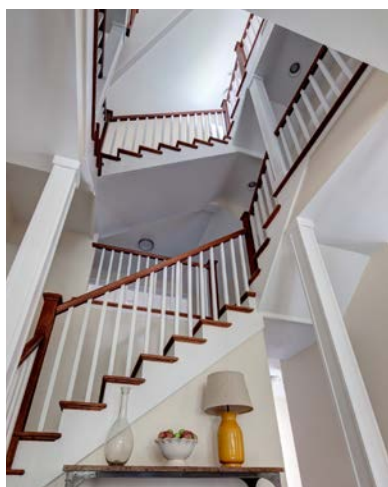
Weiss personally approved every material used in the construction—from the paints and drywall to the cabinets and flooring—to make sure every product met the criteria of the Underwriter Laboratories' GreenGuard Gold standard, ensuring that they are VOC- and formaldehyde-free and nontoxic.
