Siding & Window Retrofit Case Study

Long Island, NY: Vinyl over Stucco

Window Retrofit: Long Island, NY

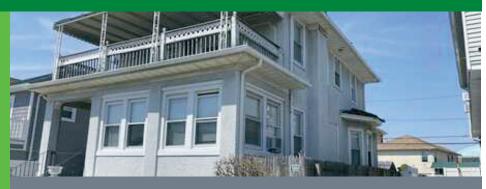
This stucco-covered Long Island home dates back to the 1920s. The retrofit project manager suspected lead paint outside and lack of insulation inside the exterior walls.

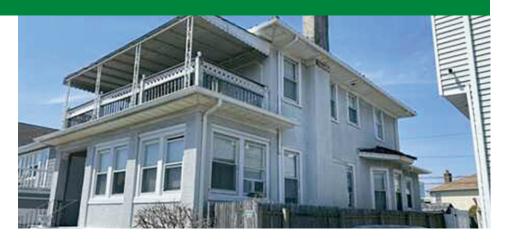
This 1920s stucco duplex home on Long Island is owned by a nonprofit agency and operated as transitional housing. When the home was assessed for upgrades to reduce utility bills, the builder/renovator decided to install rigid foam and vinyl siding over the existing stucco. Because the original single-pane windows had already been replaced with double-pane, vinyl-framed windows, the renovator decided to install low-emissivity storm windows rather than all new windows. The high-efficiency tight-fitting storm windows would provide both insulating and air sealing benefits at a reasonable cost of about \$350 per window for labor and materials. The renovator had not installed high-efficiency low-emissivity storm windows before and was eager to try this retrofit measure to determine if it would be a desirable retrofit to recommend for his affordable housing agency clients.

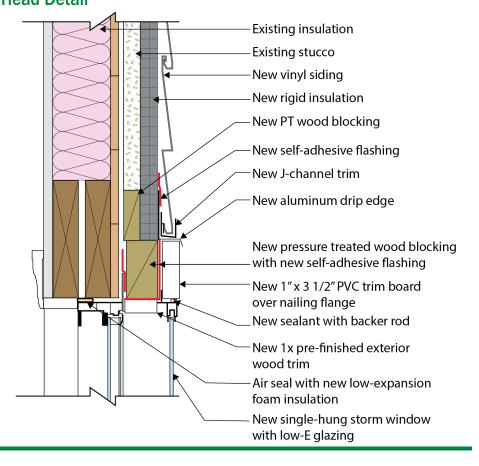
Head Detail

For the head and sill details, the view is from the side and the interior of the home is to the left of the wall. For the jamb detail, the view is from the top and the interior of the home is below the wall.

The deep frames of the existing windows would easily accommodate exterior low-e storm windows, which would help reduce both air leakage and heat transfer for lower energy bills and increased comfort along the exterior walls in the home. The low-emissivity coatings on the storm windows offer protection against both winter heat loss and summer heat gain for year-round benefits. Operable single-hung storm window models are available so the homeowner would not have to sacrifice the ability to open the windows once the storm windows were installed.
