### REVISED Addendum No. 3 to

Master Work Plan/Field Sampling and Analysis Plan, Co-Located Chemical Sampling at Area IV Santa Susana Field Laboratory, Ventura County, California

EPA Subarea 8N Soil Sampling

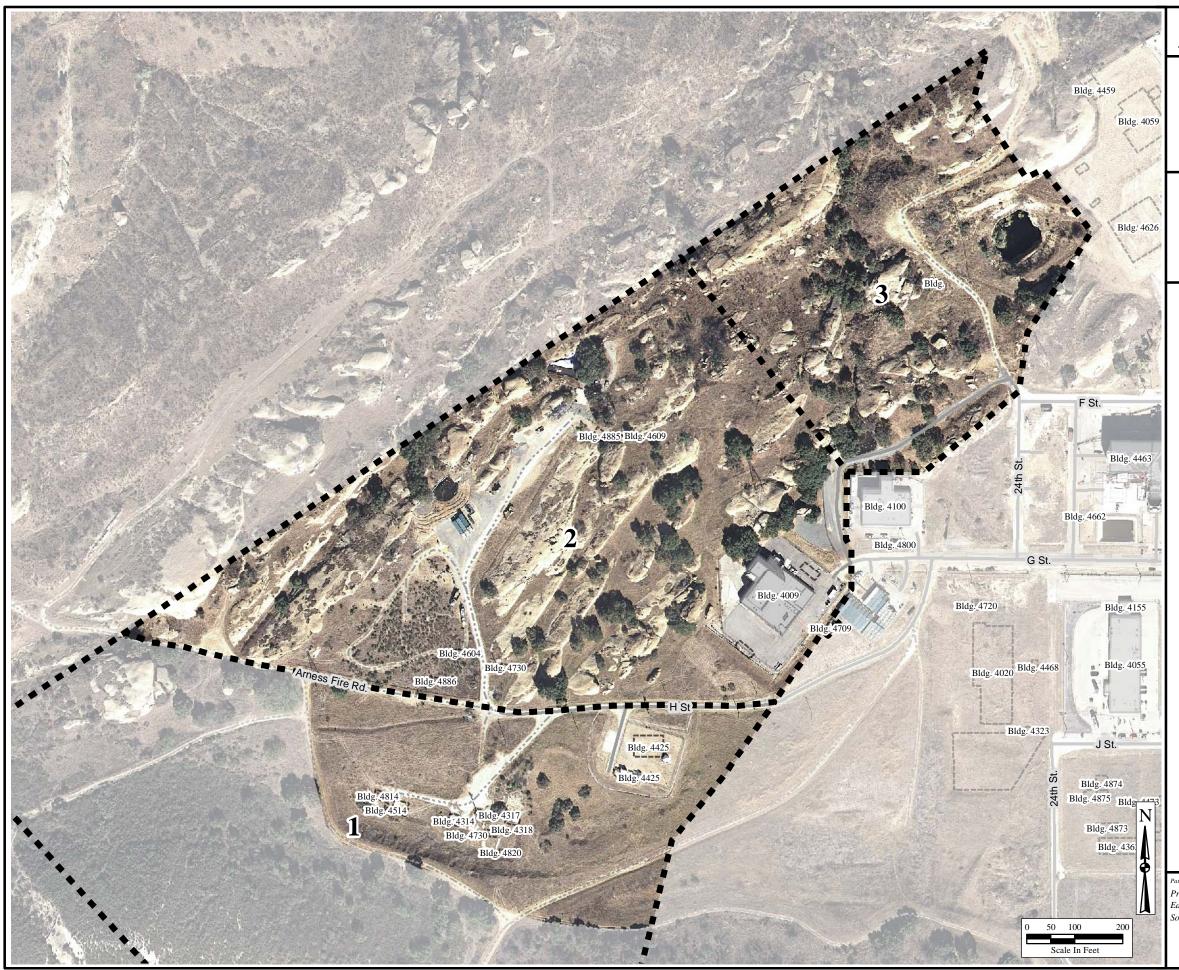
## Figure 1 Subarea 8N Base Map Santa Susana Field Laboratory

HGL—Subarea 8N Addendum to FSP for Soil Sampling for Area IV Radiological Study, SSFL—Ventura County, CA

Figure 1 is a layout of EPA's Subarea 8N. The proposed sample locations are shown on Figures 2 through 4, which were taken from EPA's FSP Addendum for Subarea 8N (HGL 2011). EPA's description and rationale for the soil sample locations in Subarea 8N are summarized in Table 1.

Chatsworth formation groundwater at the FSDF site in the vicinity of the former excavation has been observed at depths of approximately 155 feet below ground surface (bgs) or greater. Groundwater also occurs at shallow depths perched above the Chatsworth formation groundwater within the footprint of the former excavation. One near surface groundwater monitoring well, RS-54, is located within the former excavation footprint, and four near surface groundwater monitoring wells/peizometers (RS-18, PZ-099, PZ-100 and PZ-101) are located near the perimeter of the excavation footprints shown on Figure 1 and Figure 2.

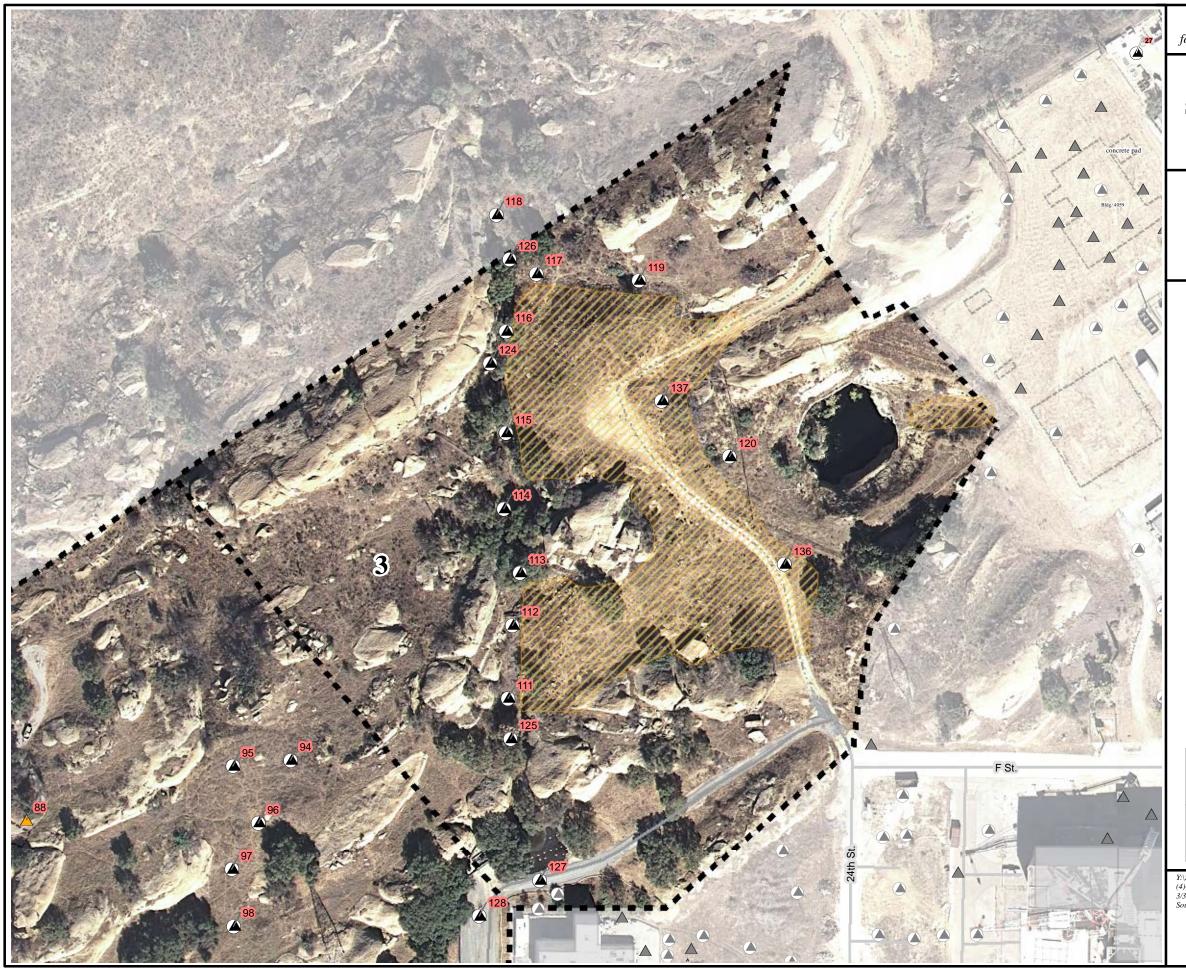
## Figure 4 **Subarea 8N Group 3 Sample Locations** Santa Susana Field Laboratory

HGL—Subarea 8N Addendum to FSP for Soil Sampling for Area IV Radiological Study, SSFL—Ventura County, CA
