Final Remedial Action Plan  
DOE-EM/GJ1547  
March 2024

### **Evapotranspiration Cover System Post-Construction Monitoring Plan**

Crescent Junction Disposal Site  
Evapotranspiration Cover System  
Post-Construction Monitoring Plan  
Stephen F Dwyer, PhD, PE

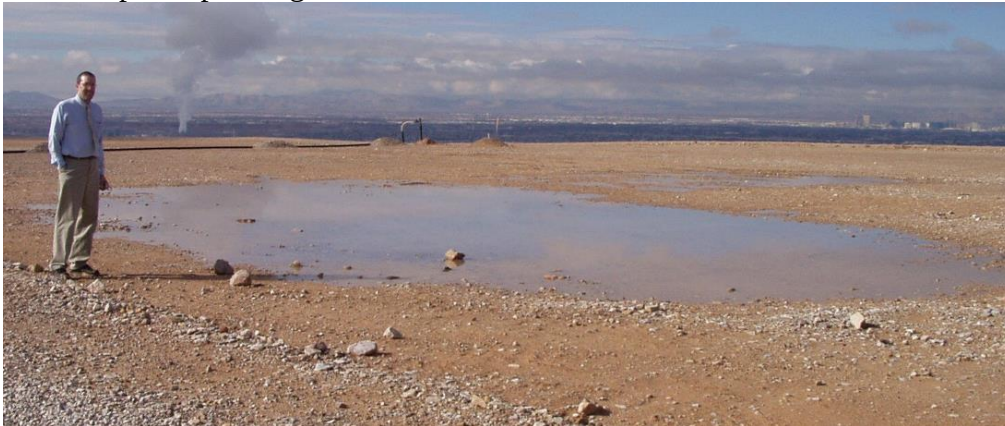
| Maintenance Issue | Monitoring Indications | Maintenance of Issue <sup>1</sup> |
|---|---|---|
| <b>SETTLEMENT</b> | Differential settlement can create ponding that in turn leads to increased infiltration, cover flux, and eventually contaminant transfer. | An example of ponding on a cover is seen below: |
| a. Ponding | Localized sediment deposits within the cover system, localized excessive vegetation, vegetation variance such as salt cedar or other plants that would appear only if there was excess moisture available. | <p>All ponded areas should be filled with a mixture of soil and rock meeting the specifications of the given cover surface admixture. These soils will be placed consistent with the original specifications for the given cover soils. After the area has been graded to the desired final grade with positive drainage, the area will be reseeded with a native seed mix matching that originally specified for the cover.</p> |

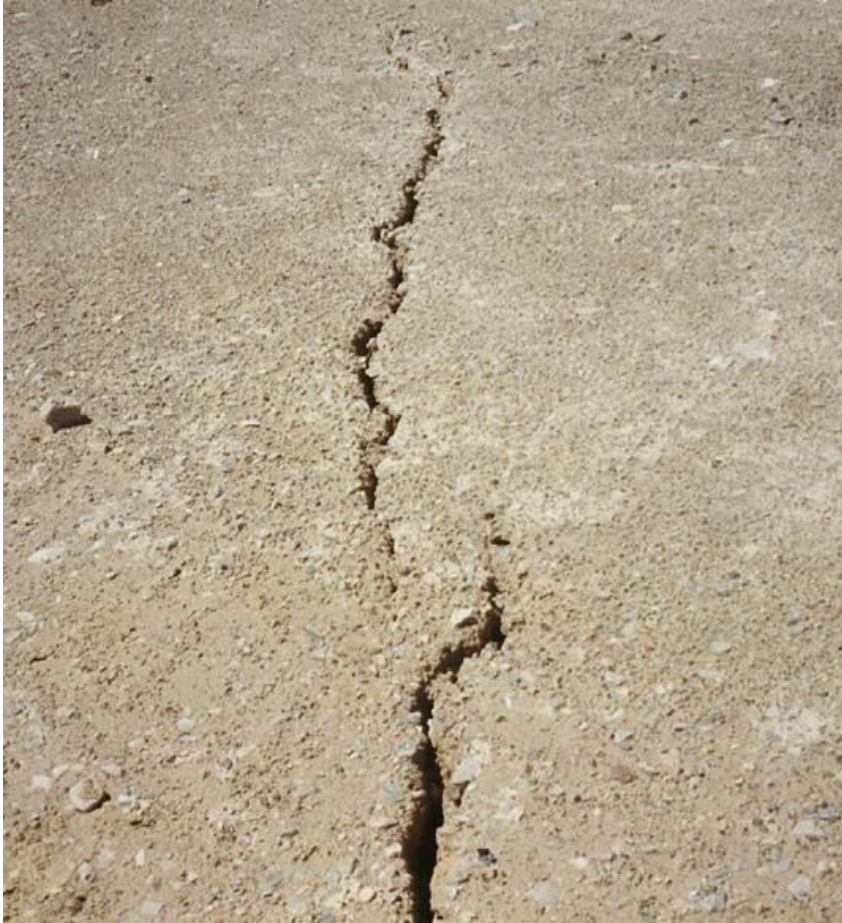
| Maintenance Issue | Monitoring Indications | Maintenance of Issue <sup>1</sup> |
|---|---|---|
| b. Surface Cracking | Surface tension cracks, particularly cracks perpendicular to surface water flow. | <p>Surface cracks that appear due to differential settlement can be exaggerated in arid climates where soils tend to form surface crusts. These cracks lead to localized saturated flow through the cover or preferential flow. These cracks will be excavated to just beyond their full depth. The soils will then be replaced in the area to match the original placement specifications for the cover soil. After the crack has been completely repaired physically and the area matches the adjacent grades, the disturbed area will be reseeded with a native seed mix to match that originally specified for the cover system.</p> |

| Maintenance Issue | Monitoring Indications | Maintenance of Issue <sup>1</sup> |
|---|---|---|
| | | <p>An example of a surface tension crack is seen below:</p> |

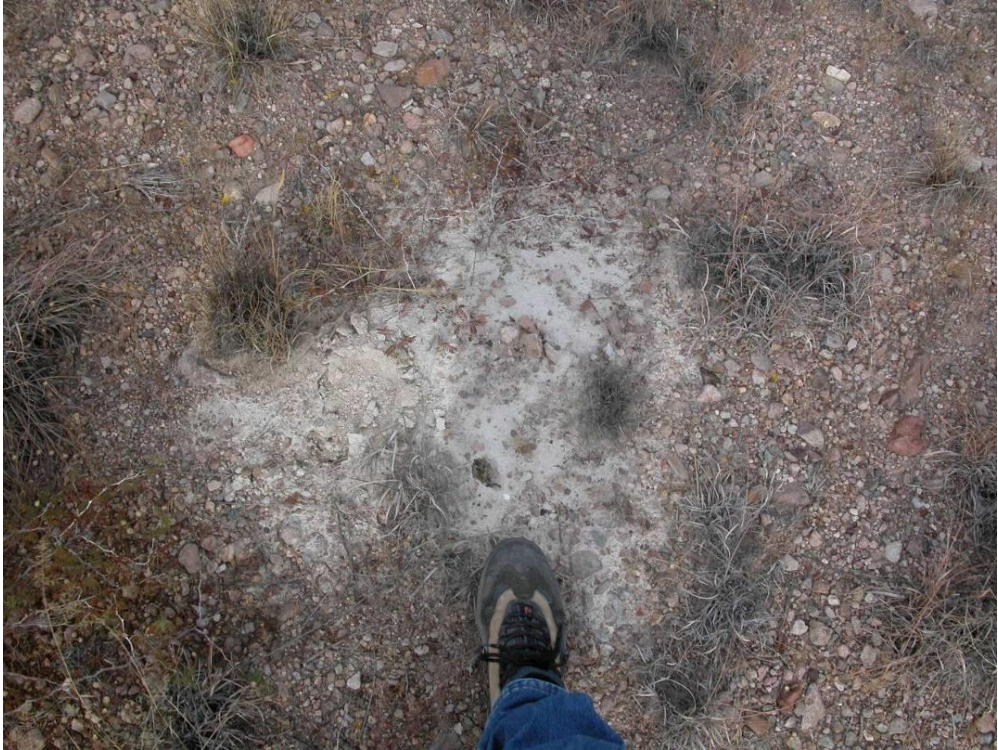
| Maintenance Issue | Monitoring Indications | Maintenance of Issue <sup>1</sup> |
|---|---|---|
| | | <p>An example of localized problems where source materials were brought to the surface from biointrusion is seen below.</p> <p>Excessive burrowing in a local area can create excessive preferential flow. This type of burrowing will be maintained by excavating the affected areas and replacing the soil to meet original cover soil placement specifications. The disturbed area will then be reseeded with native vegetation as originally specified for the given cover system. An example of excessive burrowing in a localized area is seen below:</p> |
