# Floodplain Assessment

## Pajarito Tank 4A 18-Inch Transmission Water Main Repair

Two Mile Canyon, Los Alamos National Laboratory  
Los Alamos County, New Mexico

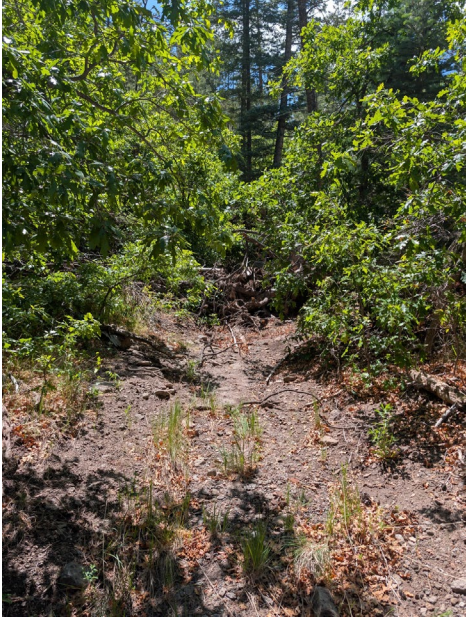
| <p>Photograph 1. View southwest along a narrow portion of the apparent former access route. May 27, 2026.</p> | <p>Photograph 2. View east-northeast showing exposed rock and dead or fallen woody material across the route. May 27, 2026.</p> |

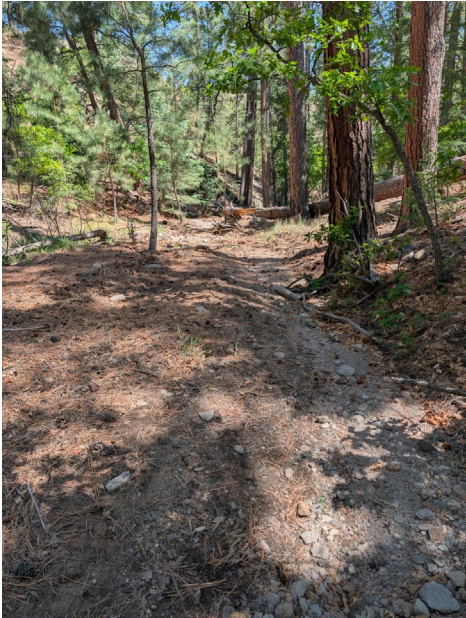
| <p>Photograph 3. View southeast along an existing earthen and rocky portion of the proposed access route. May 27, 2026.</p> | <p>Photograph 4. View southeast showing a large fallen tree and other dead woody material requiring removal for access. May 27, 2026.</p> |

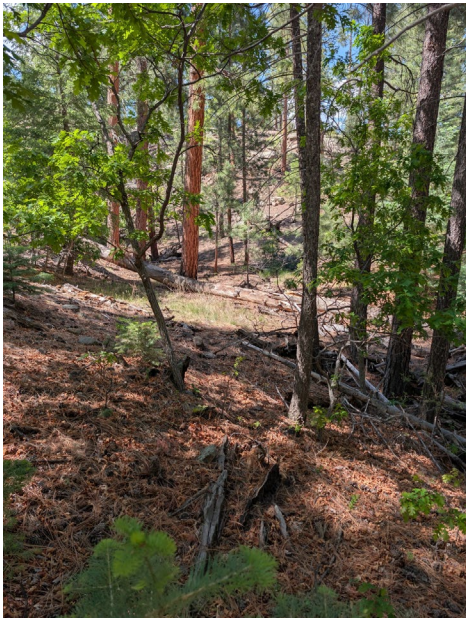
| <p>Photograph 5. View north-northwest across steep, forested terrain adjacent to the proposed route. May 27, 2026.</p> | <p>Photograph 6. View east across exposed rock, deadfall, and irregular ground near the canyon route. May 27, 2026.</p> |

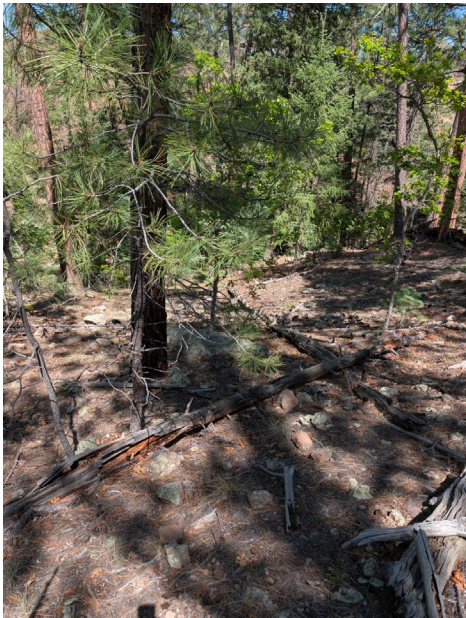
| <p>Photograph 7. View east-northeast along a rough segment of the proposed access alignment. May 27, 2026.</p> | <p>Photograph 8. View north-northwest down the steep, rocky canyon slope toward the repair area. May 27, 2026.</p> |

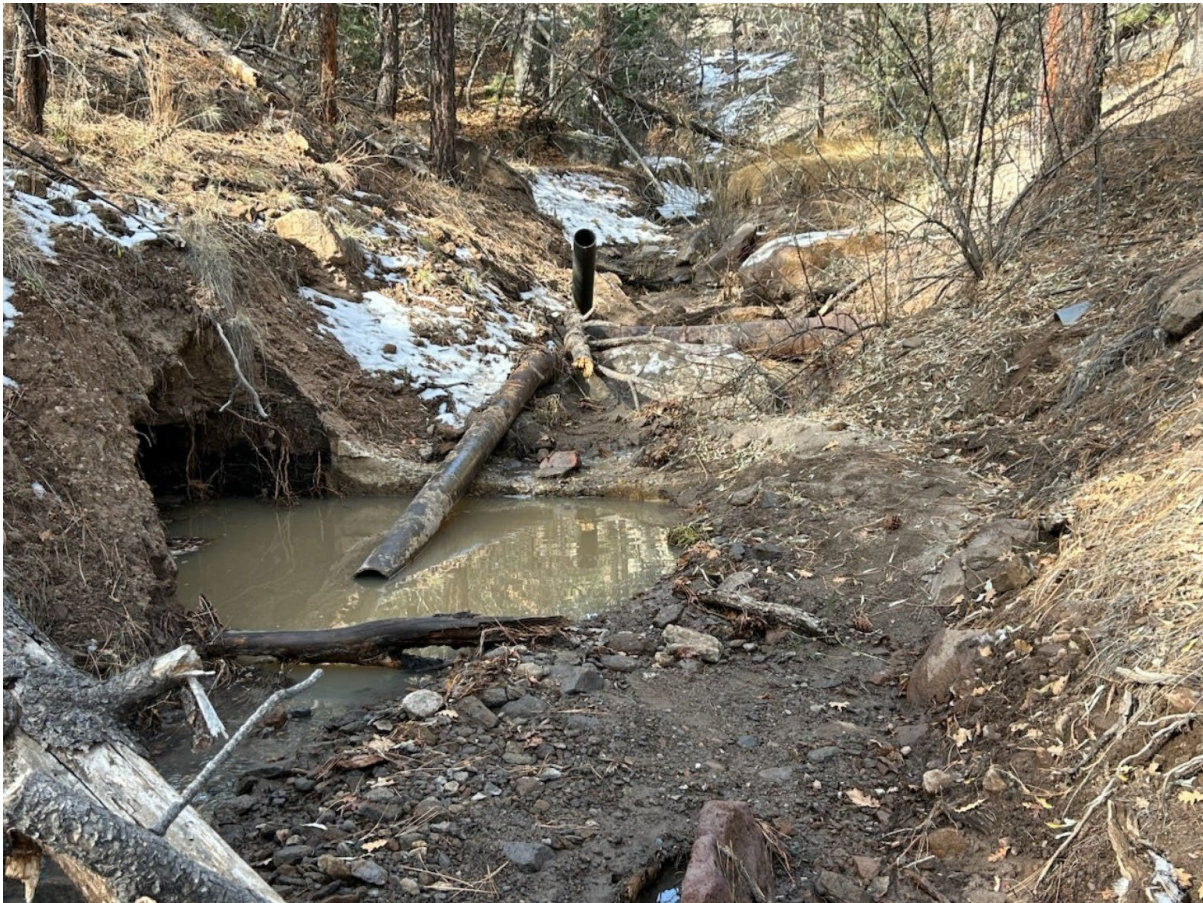
Photograph 9. View upstream at the canyon-bottom repair area and approximate location of the failed 18-inch transmission main. Late February 2026.  
Photograph 9 shows the constrained canyon-bottom work area and the approximate location of the failed transmission main.
