Office of Health, Safety and Security

Monthly Analysis of Electrical Safety Occurrences

April 2013

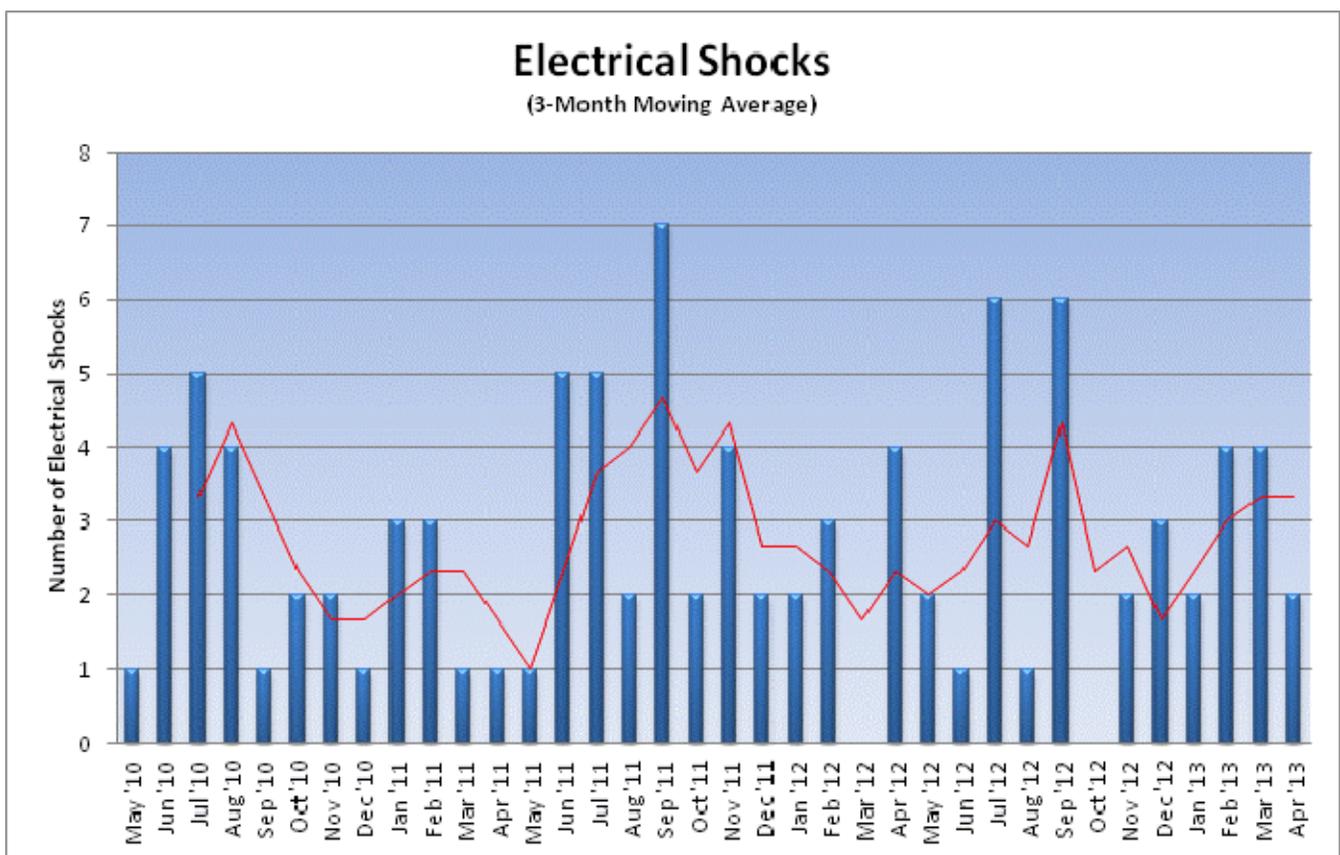
Figure 1 – Three-Year Trend of Electrical Shocks

Figure 1 shows a 3-year trend of electrical shocks for the DOE complex. During this period, the average number of electrical shocks has remained below three (2.7) shocks per month.

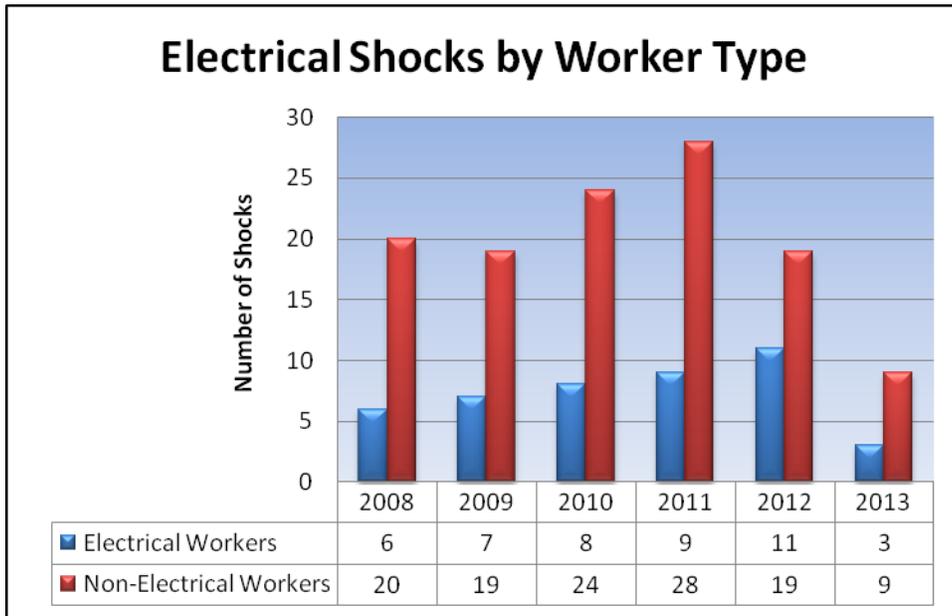
Figure 2 - Electrical Shock by Worker Type

Figure 2 shows electrical shocks by worker type through April 2013. The number of shocks involving electrical workers slowly increased through 2012 and then dropped in 2013, while

those involving non-electrical workers decreased after 2011. Since 2008, the majority of shocks (about 73 percent) involve non-electrical workers.

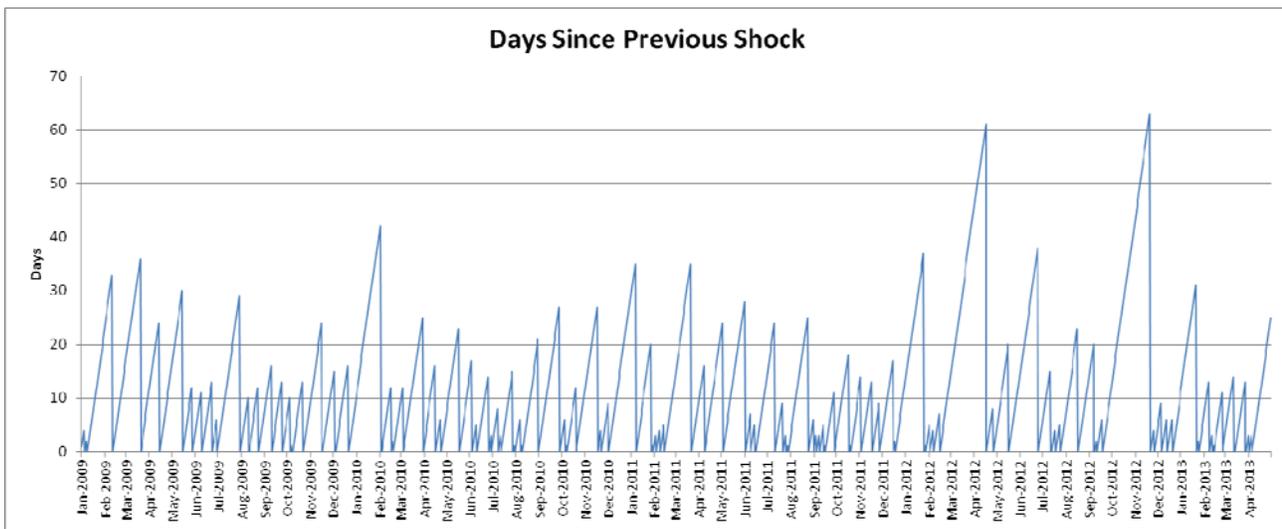
Figure 3 - Days since Previous Shock

Figure 3 shows the number of days since the previous electrical shock for the DOE complex. The longest interval was 63 days (November 20, 2012) and the present interval is 25 days as of April 30.

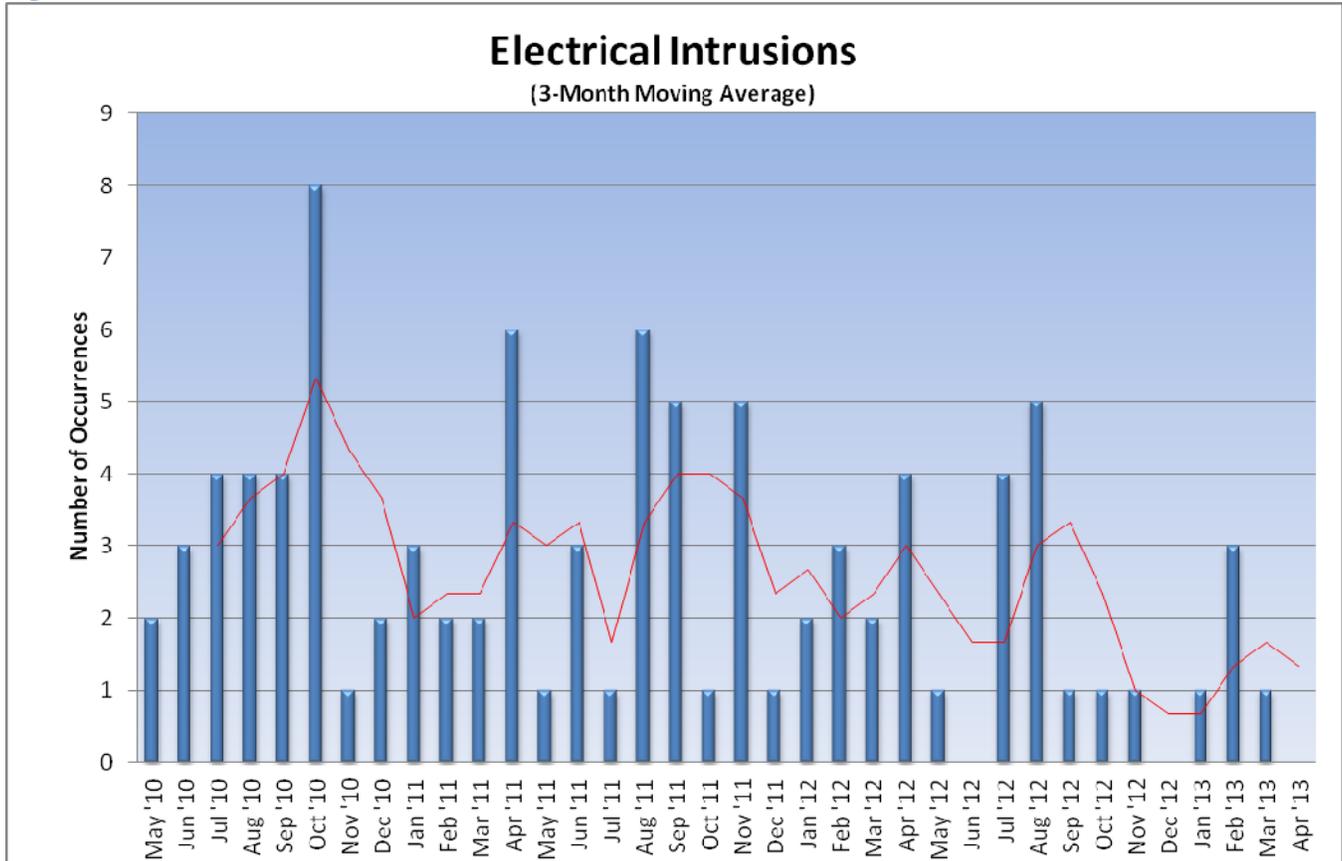
Figure 4 – Three-Year Trend of Electrical Intrusion Occurrences

Figure 4 shows a 3-year trend of electrical intrusion occurrences for the DOE complex. During this period we have seen an average of just under 3 occurrences per month (2.6). This is the third month during the period in which there were no electrical intrusion occurrences.

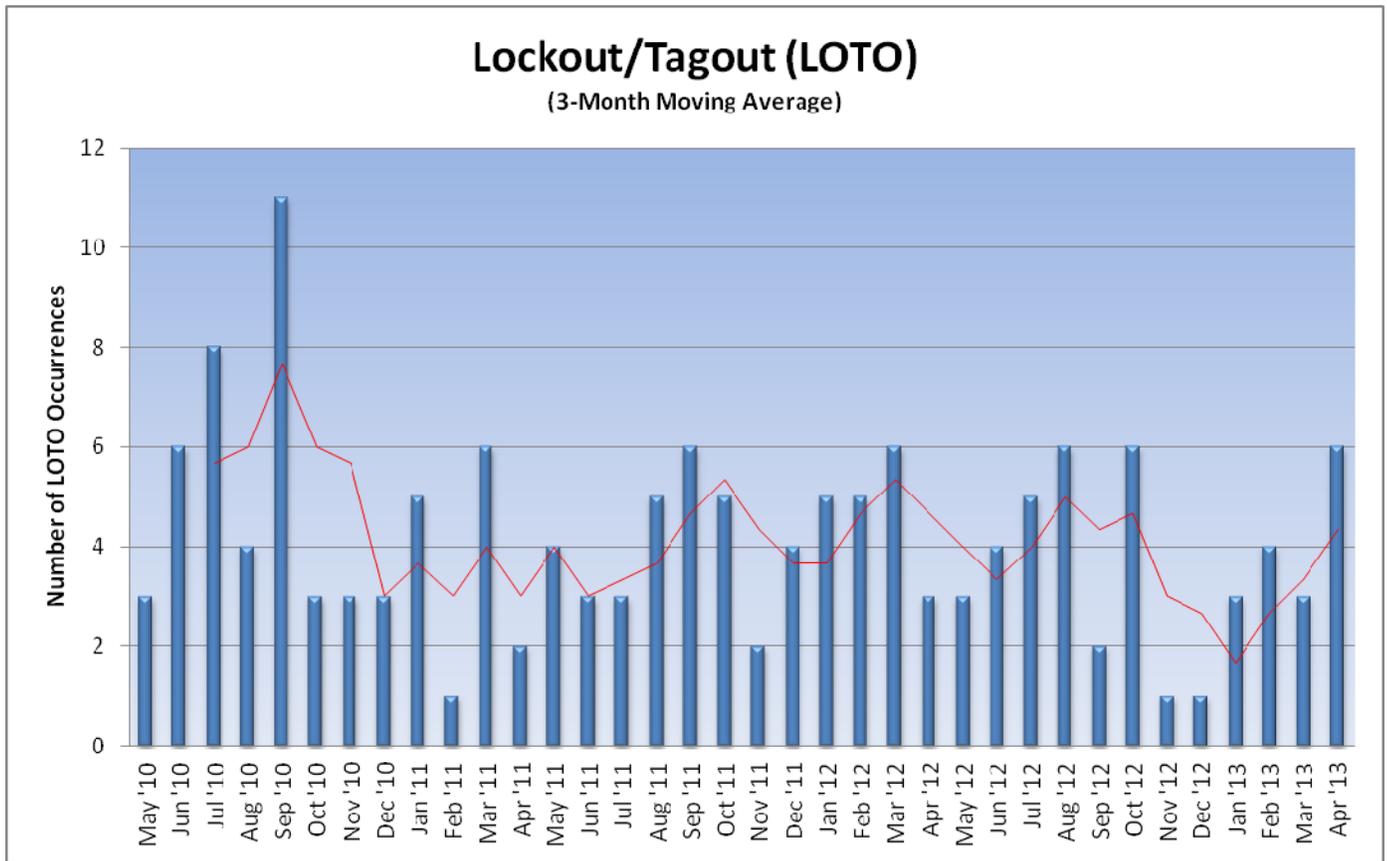
Figure 5 – Three-Year Trend of Lockout/Tagout Occurrences

Figure 5 shows a 3-year trend of LOTO occurrences for the DOE complex. The monthly average is 4.2 occurrences.

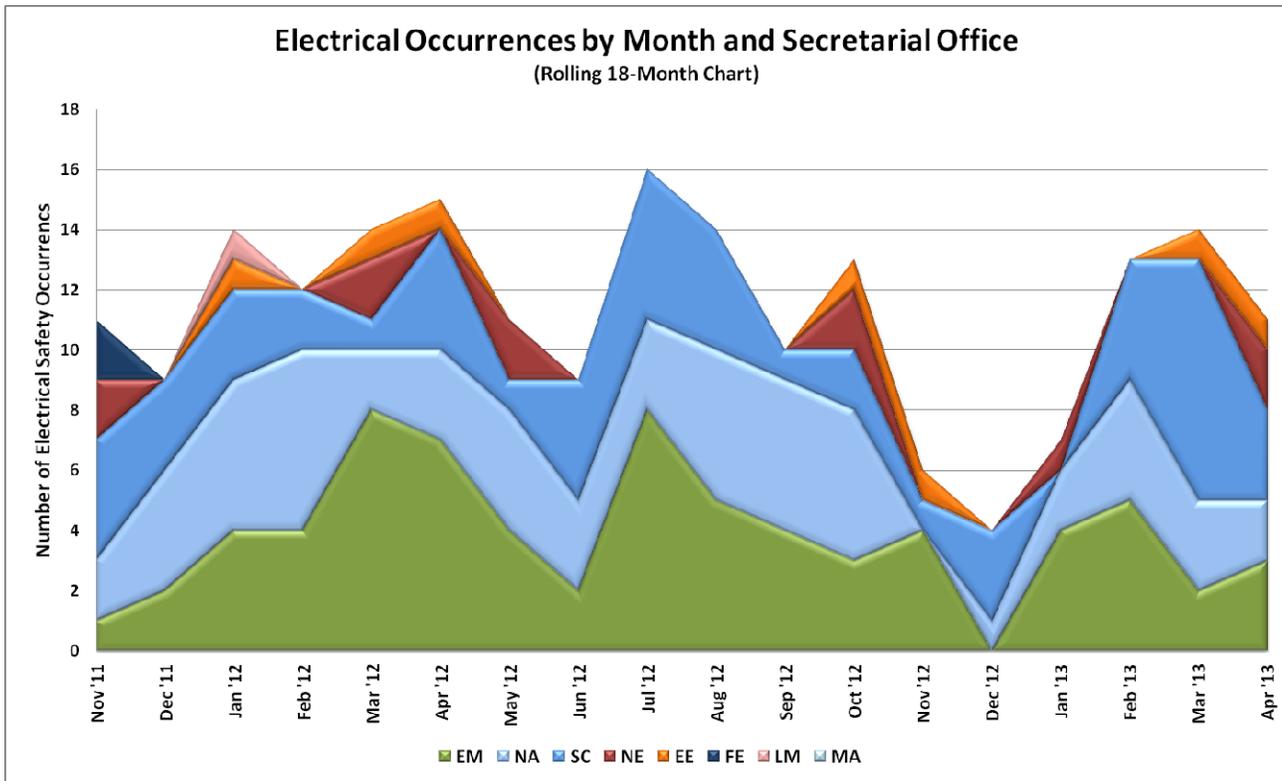
Figure 6 - Electrical Occurrences by Month and Secretarial Office

Figure 6 shows the distribution of electrical safety occurrences by Secretarial Office. The Office of Science has reported the most occurrences over the past three months.

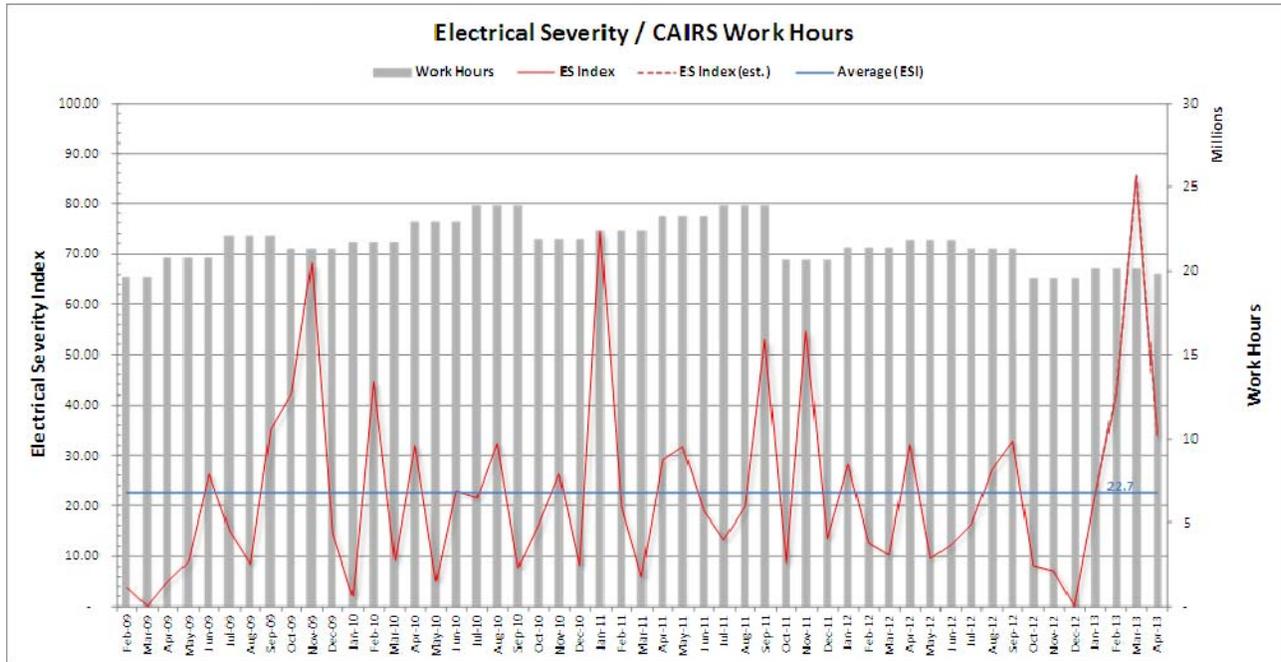
Figure 7 - Electrical Severity Index Compared to Work Hours

The Electrical Severity Index (ESI) is a performance metric that was developed to normalize events against organizational work hours. The ESI is calculated monthly and trended. Figure 7 shows a calculated ESI for the DOE complex and Table 4 shows the ESI and how it has changed from the previous month.

Note: An estimated ESI is calculated until accurate CAIRS man-hours are available. The chart is updated monthly.

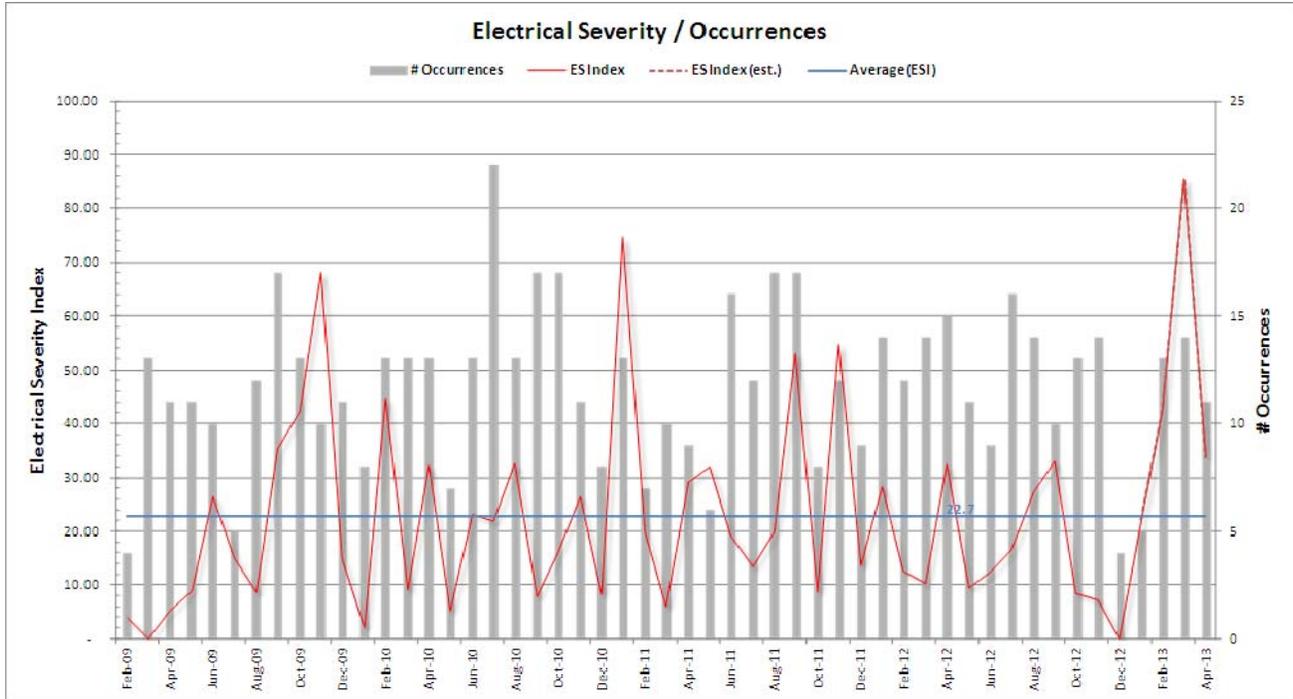
Figure 8 - Electrical Severity Index Compared to Number of Occurrences

Figure 8 shows the ESI with the number of Occurrences instead of Work Hours.

The average ESI (22.7) has increased for the last three months. The lowest average ESI was 19.2 in June 2010.

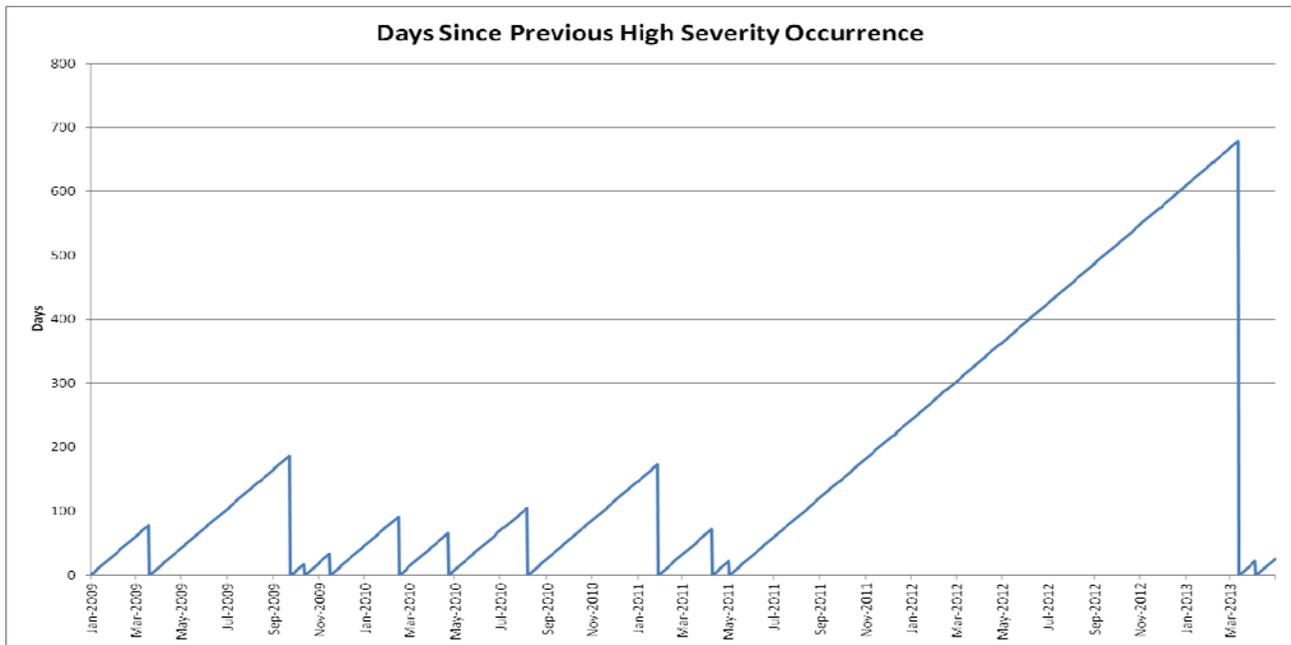
Figure 9 - Days since Previous High Severity Occurrence

Figure 9 shows the number of days since the previous high severity occurrence. The present interval is 25 days as of April 30. The previous longest interval was 679 days ending March 12, 2013.

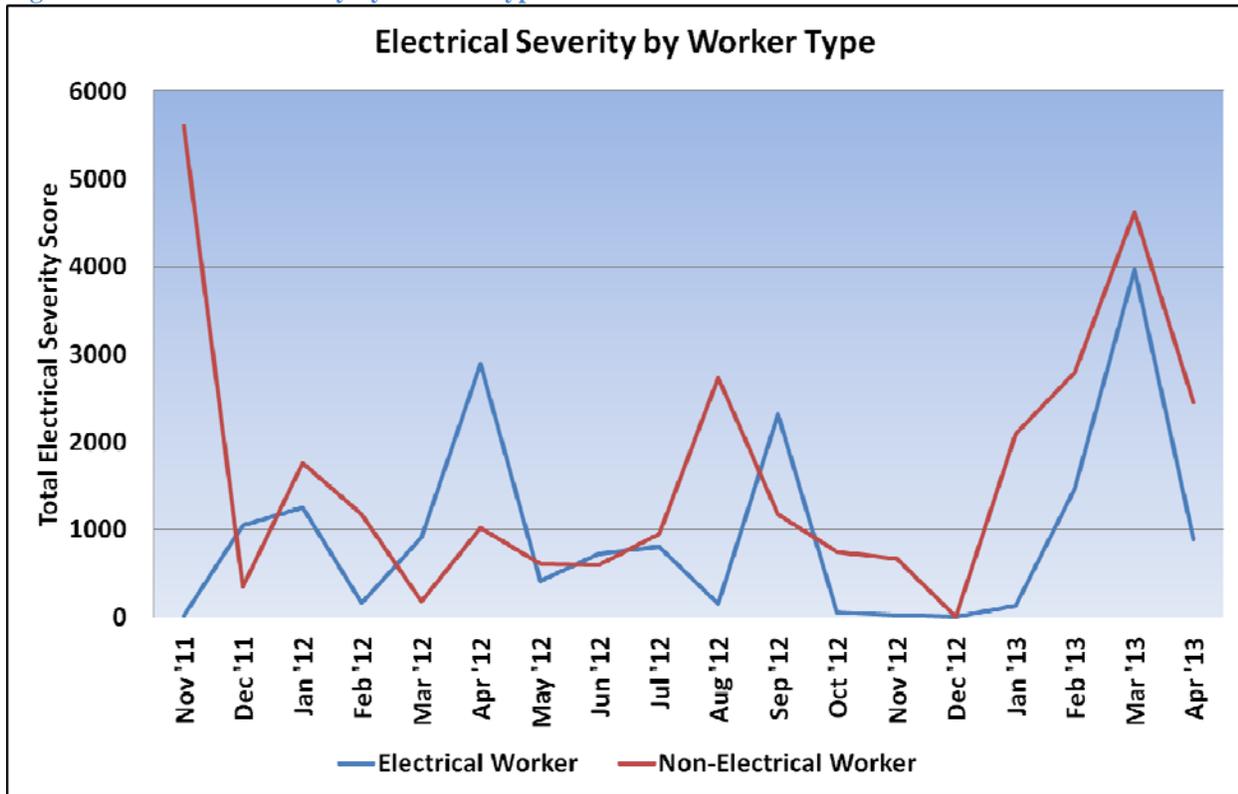
Figure 10 – Electrical Severity by Worker Type

Figure 10 shows the total electrical severity score by worker type for each month.

Following a peak in March 2013 for electrical workers and non-electrical workers, the ES score for both groups has started to drop. Electrical workers ES scores are at 891 and non-electrical workers ES scores are at 2,450. The average ES scores for the 18 month period are 960 for electrical workers and 1,641 for non-electrical workers.

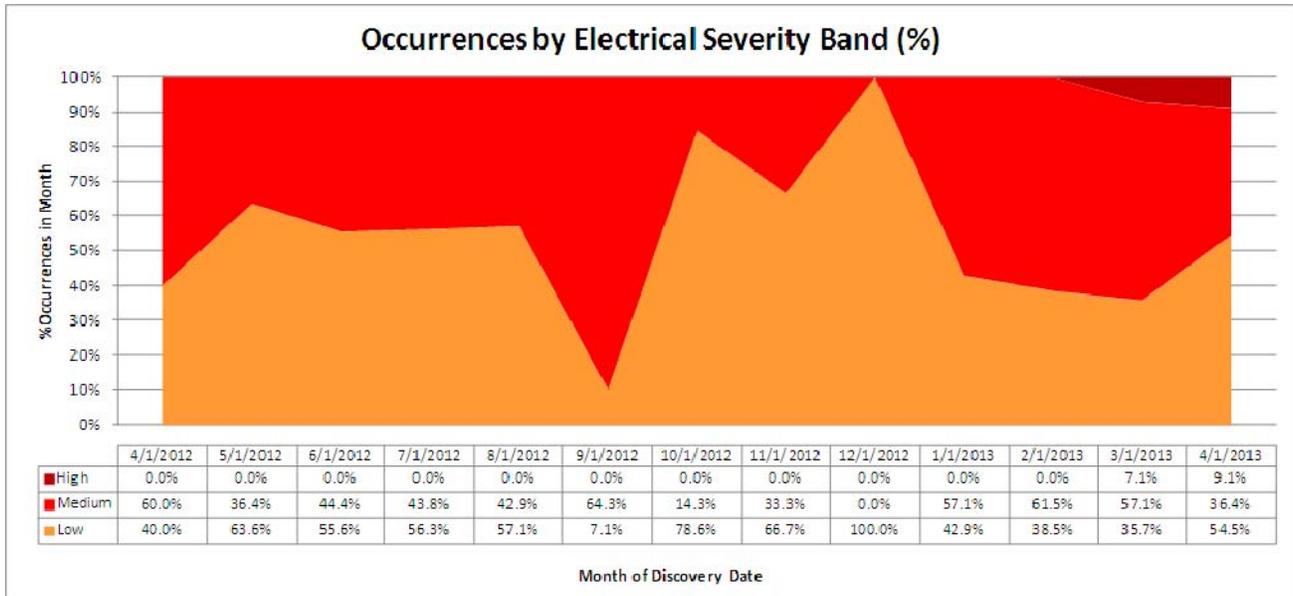
Figure 11 - Occurrences by Electrical Severity Band (Percentage)

For the interval April 2012 through April 2013 (current month and the past 12), Figures 11 and 12 summarize occurrences by severity band and month of discovery date by percentage of total occurrences in month and number of occurrences in month.

The previous two charts shows that a high electrical severity event occurred in March and in April, ending a 679-day period since the last occurrence in May 2011. The number of occurrences with Medium scores decreased and those with Low or zero severity scores increased from the previous month.

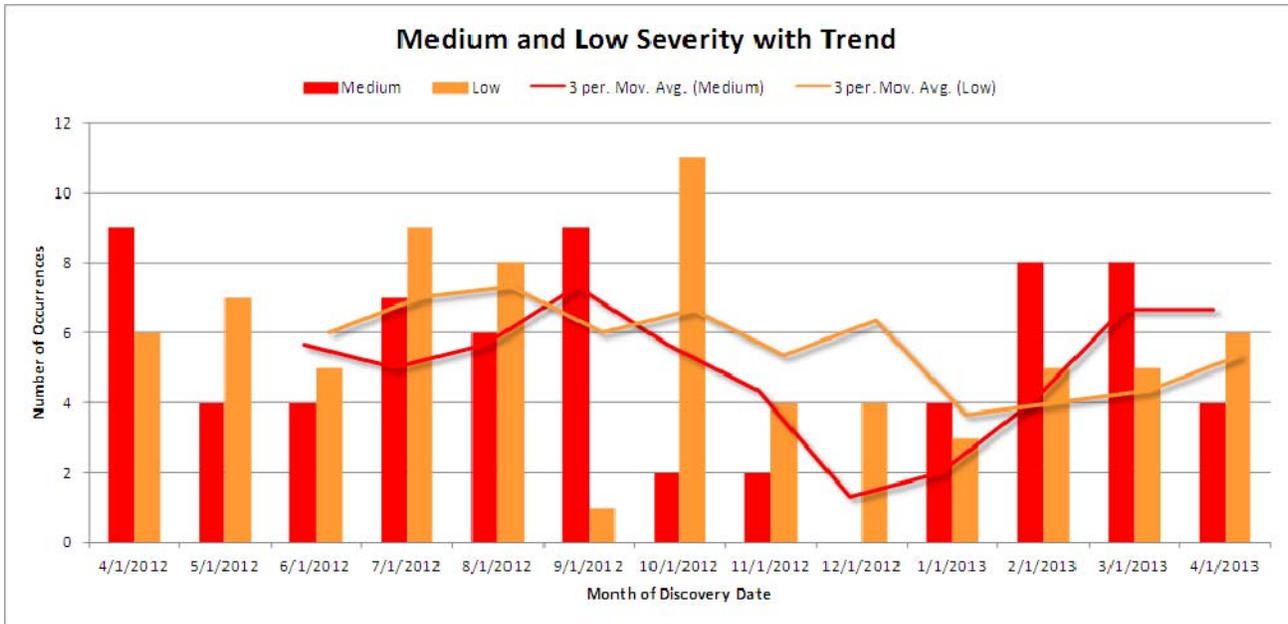
Figure 13 - Trend of Medium and Low Electrical Severity Occurrences

Figure 13 focuses on the Medium and Low severity data series for April 2012 through April 2013. Trend lines are included for each, using a 3-month moving average.

The 3-month moving average shows an slight increasing trend for Low severity occurrences and a leveling of Medium severity occurrences.
