Office of Health, Safety and Security

Monthly Analysis of Electrical Safety Occurrences

June 2013

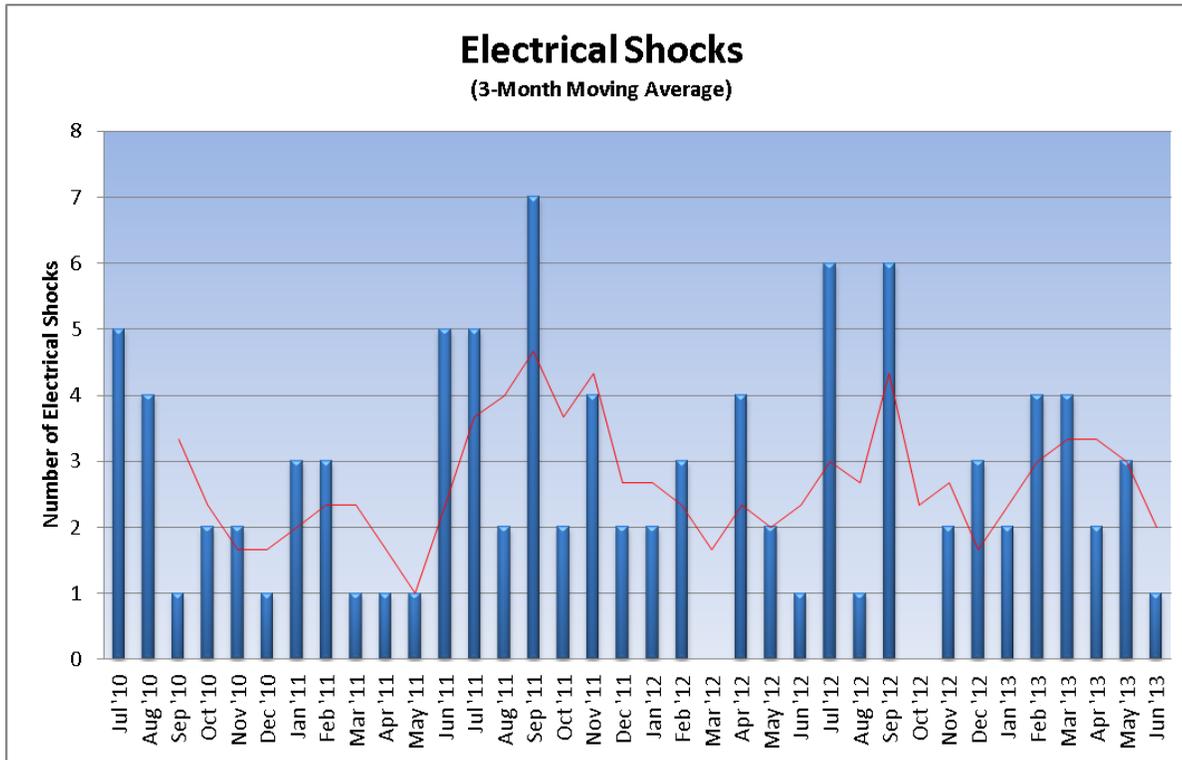
Figure 1 – Three-Year Trend of Electrical Shocks

Figure 1 shows a 3-year trend of electrical shocks for the DOE complex. During this period, the average number of electrical shocks has remained below three (2.7) shocks per month.

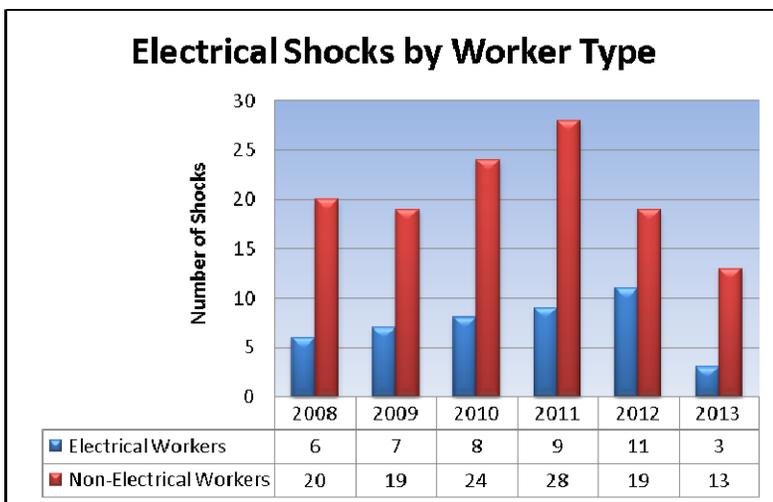
Figure 2 - Electrical Shock by Worker Type

Figure 2 shows electrical shocks by worker type through June 2013. The number of shocks involving electrical workers slowly increased through 2012 and then dropped in 2013, while those involving non-electrical workers decreased after 2011. Since 2008, the majority of shocks (about 74 percent) involve non-electrical workers.

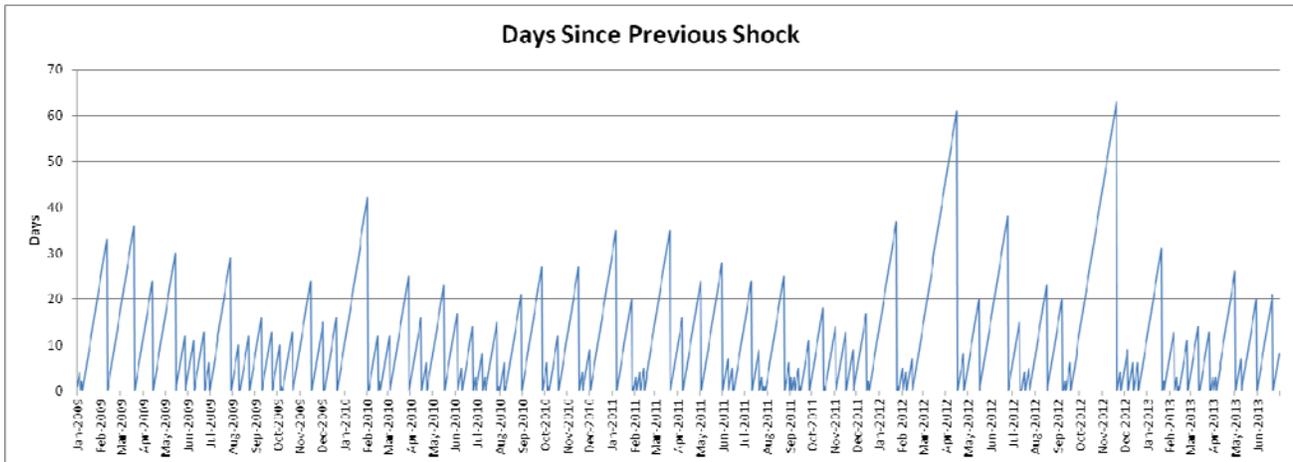
Figure 3 - Days since Previous Shock

Figure 3 shows the number of days since the previous electrical shock for the DOE complex. The longest interval was 63 days (November 20, 2012) and the present interval is 8 days as of June 30.

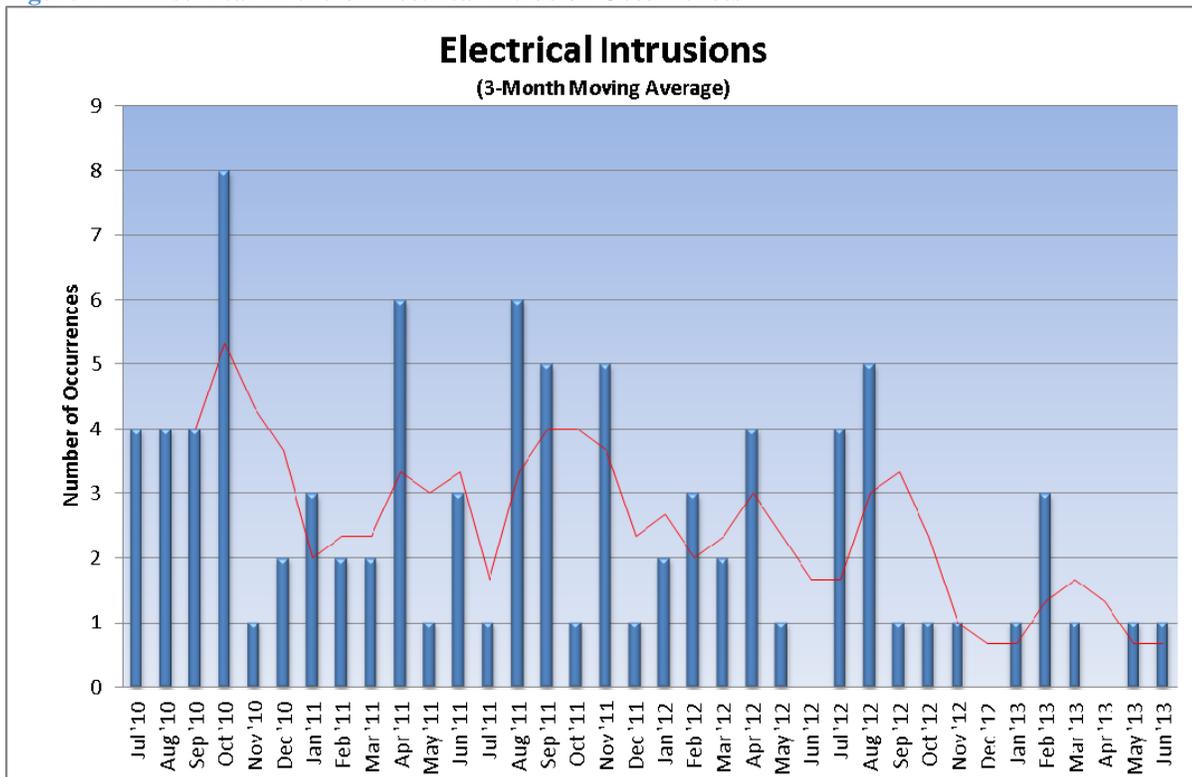
Figure 4 – Three-Year Trend of Electrical Intrusion Occurrences

Figure 4 shows a 3-year trend of electrical intrusion occurrences for the DOE complex. During this period we have seen an average of just under 3 occurrences per month (2.5).

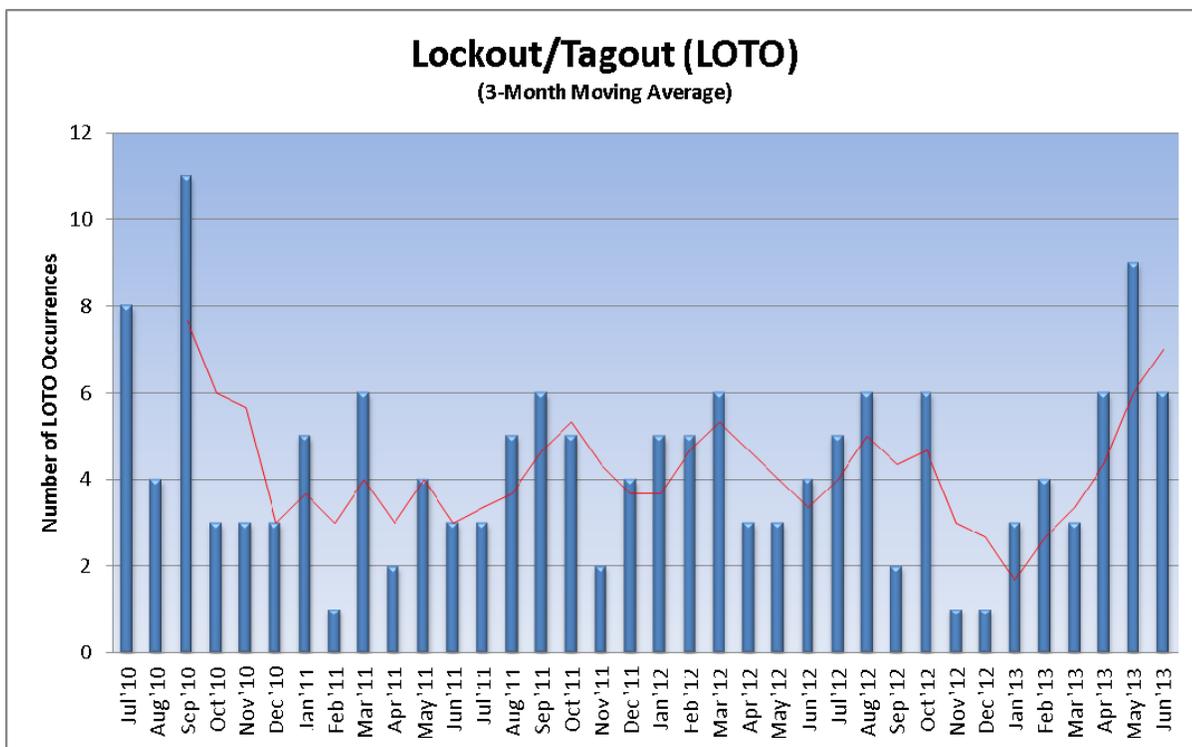
Figure 5 – Three-Year Trend of Lockout/Tagout Occurrences

Figure 5 shows a 3-year trend of LOTO occurrences for the DOE complex. The monthly average is 4.3 occurrences.

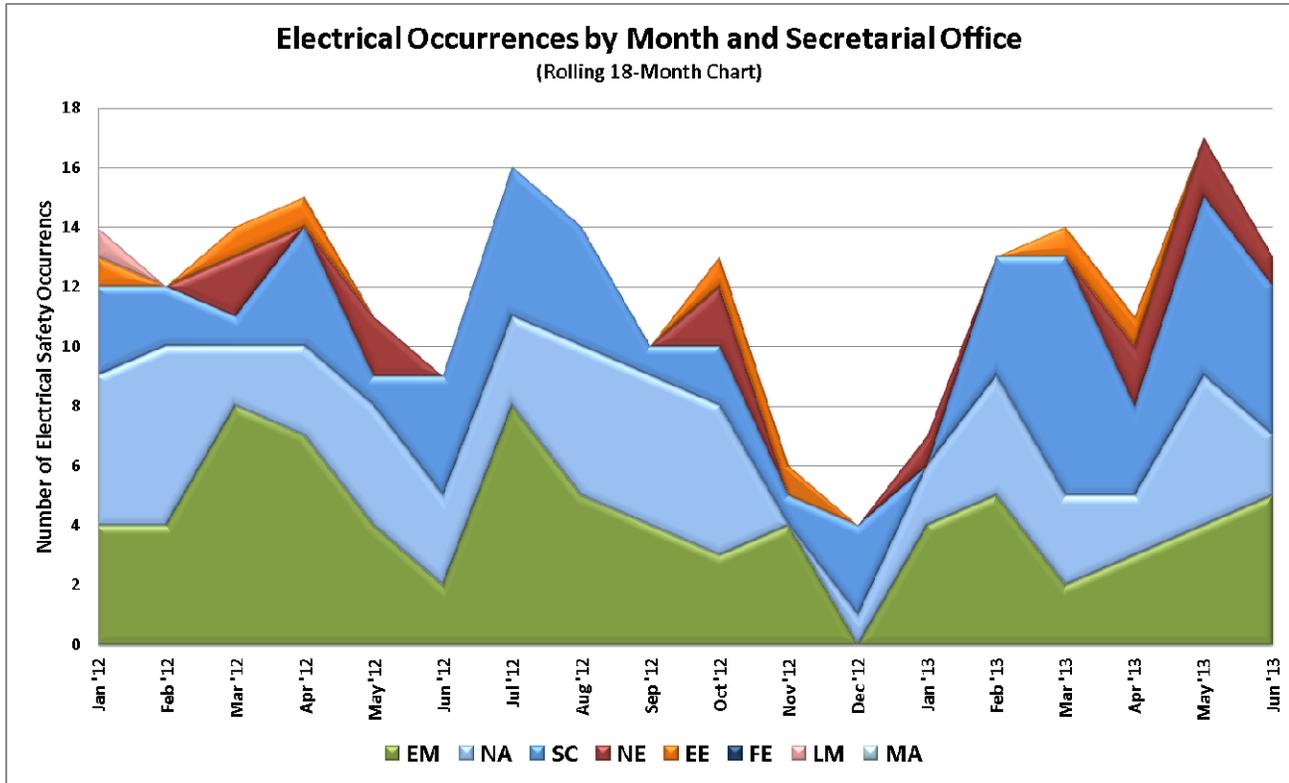
Figure 6 - Electrical Occurrences by Month and Secretarial Office

Figure 6 shows the distribution of electrical safety occurrences by Secretarial Office.

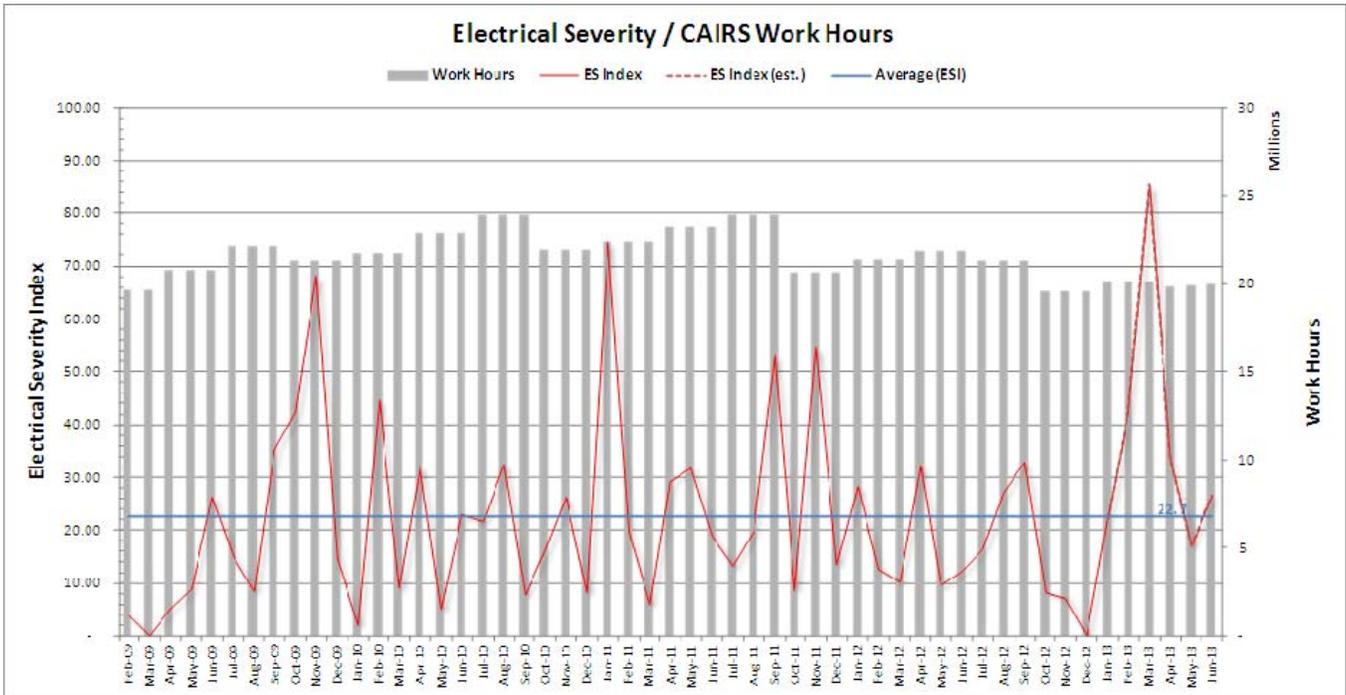
Figure 7 - Electrical Severity Index Compared to Work Hours

The Electrical Severity Index (ESI) is a performance metric that was developed to normalize events against organizational work hours. The ESI is calculated monthly and trended. Figure 7 shows a calculated ESI for the DOE complex and Table 4 shows the ESI.

Note: An estimated ESI is calculated until accurate CAIRS man-hours are available. The chart is updated monthly.

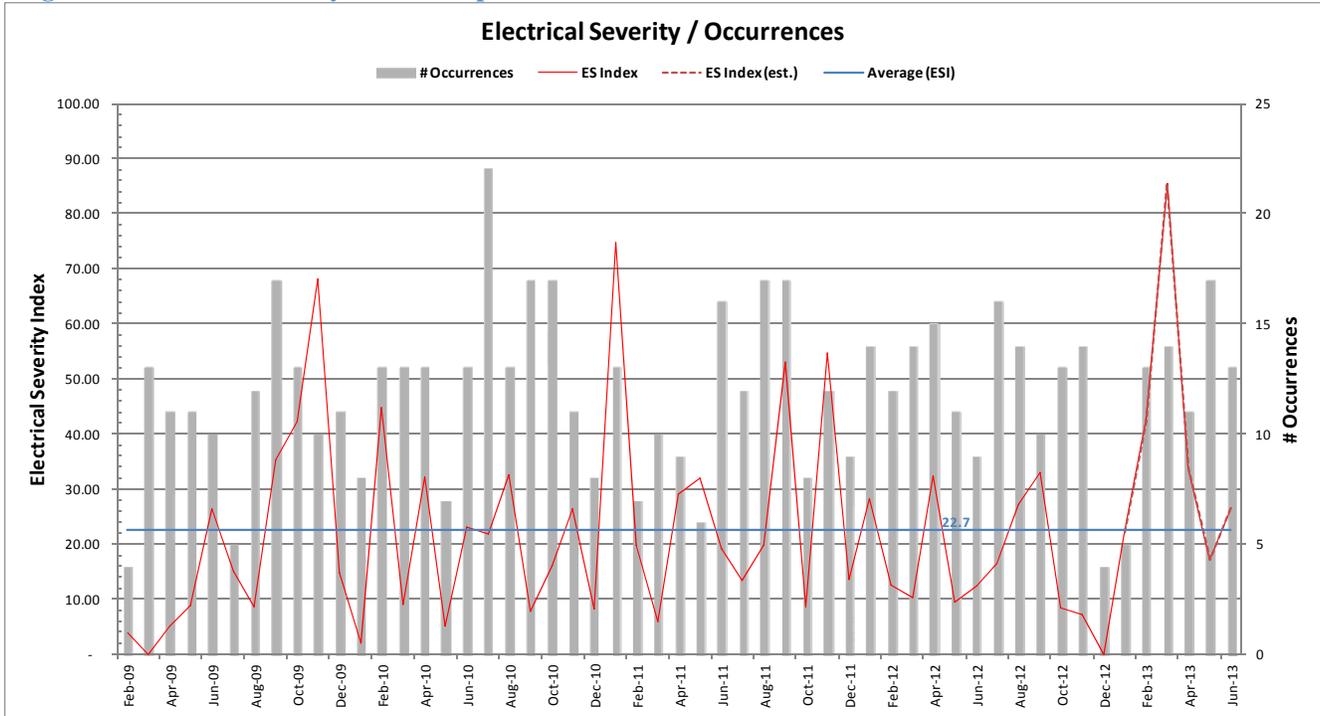
Figure 8 - Electrical Severity Index Compared to Number of Occurrences

Figure 8 shows the ESI with the number of Occurrences instead of Work Hours.

The average ESI (22.7) has remained fairly steady over the last three months. The lowest average ESI was 19.2 in June 2010.

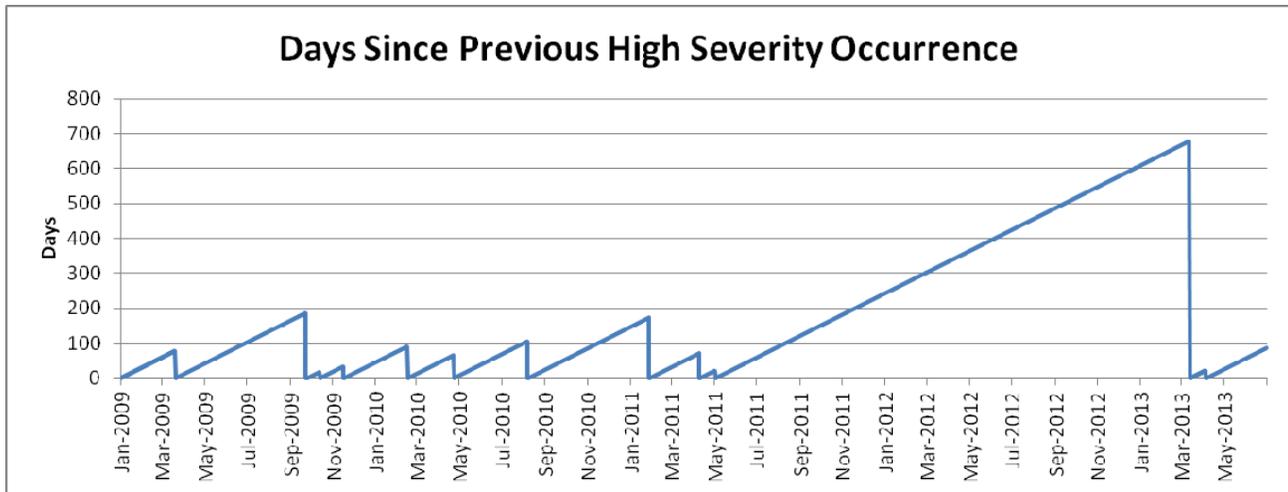
Figure 9 - Days since Previous High Severity Occurrence

Figure 9 shows the number of days since the previous high severity occurrence. The present interval is 86 days as of June 30. The previous longest interval was 679 days ending March 12, 2013.

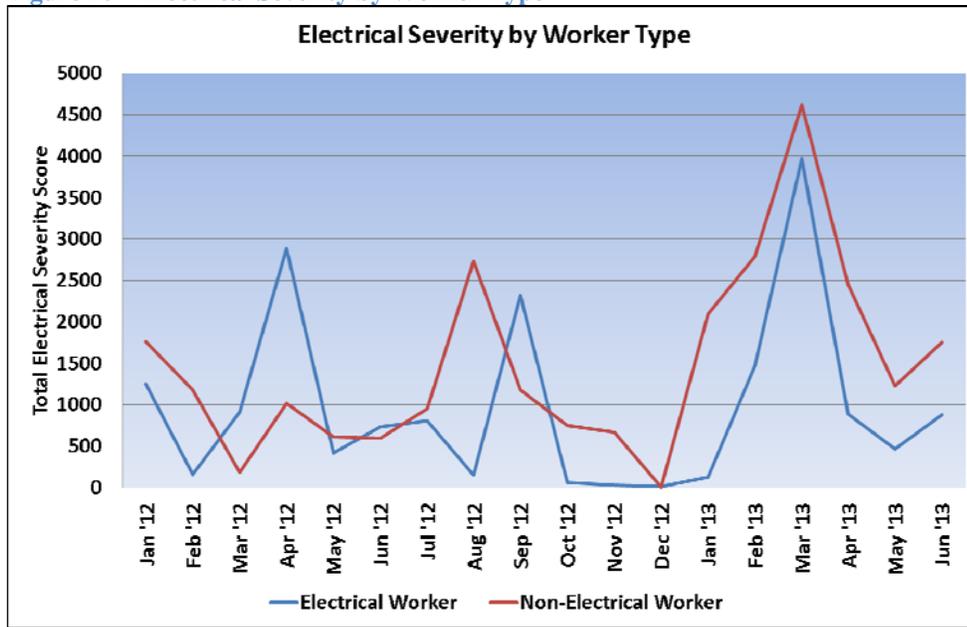
Figure 10 – Electrical Severity by Worker Type

Figure 10 shows the total electrical severity score by worker type for each month.

Following a peak in March 2013 for electrical workers and non-electrical workers, the total ES score for both groups decreased until June. The present ES score for electrical workers is 880 and 1,750 for non-electrical workers.

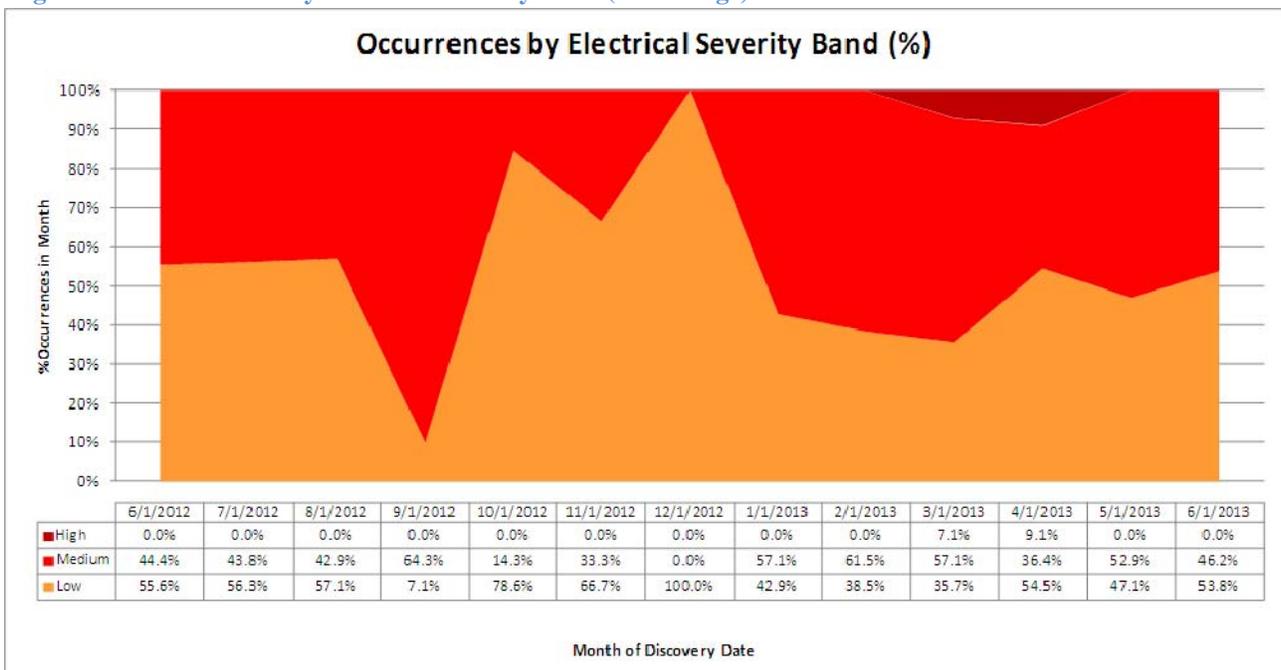
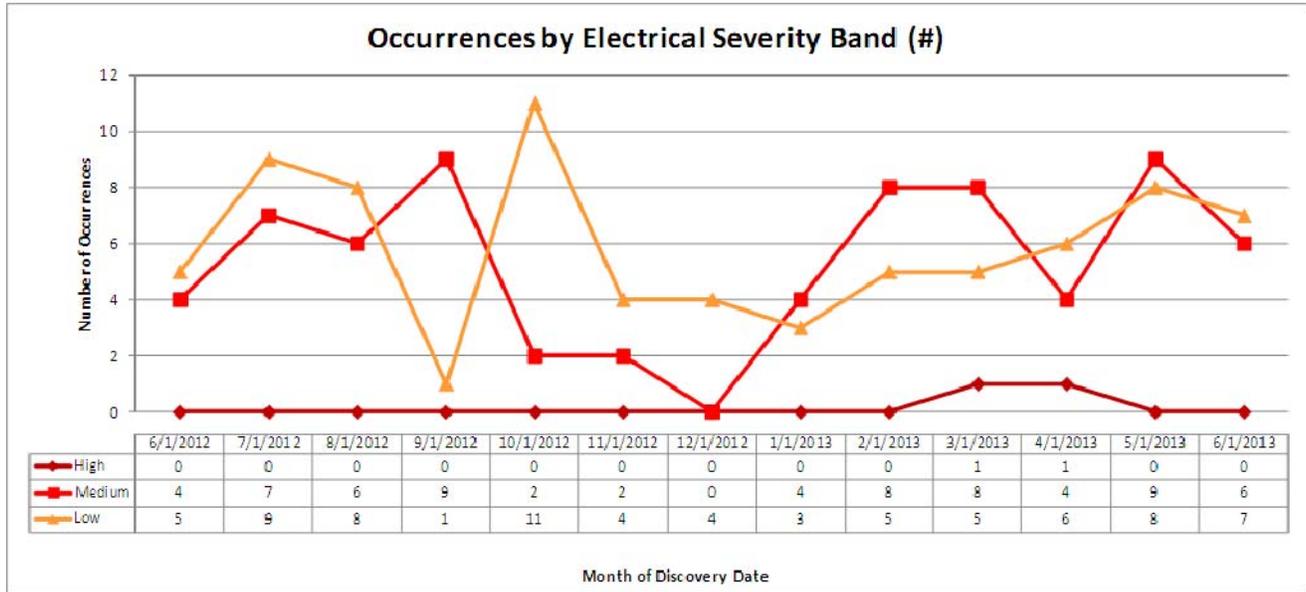
For the interval June 2012 through June 2013 (current month and the past 12), Figures 11 and 12 summarize occurrences by severity band and month of discovery date by percentage of total occurrences in month and number of occurrences in month.

The previous two charts shows that a high electrical severity event occurred in March and in April, ending a 679-day period since the last occurrence in May 2011. The number of occurrences with Medium and Low or zero severity scores decreased.

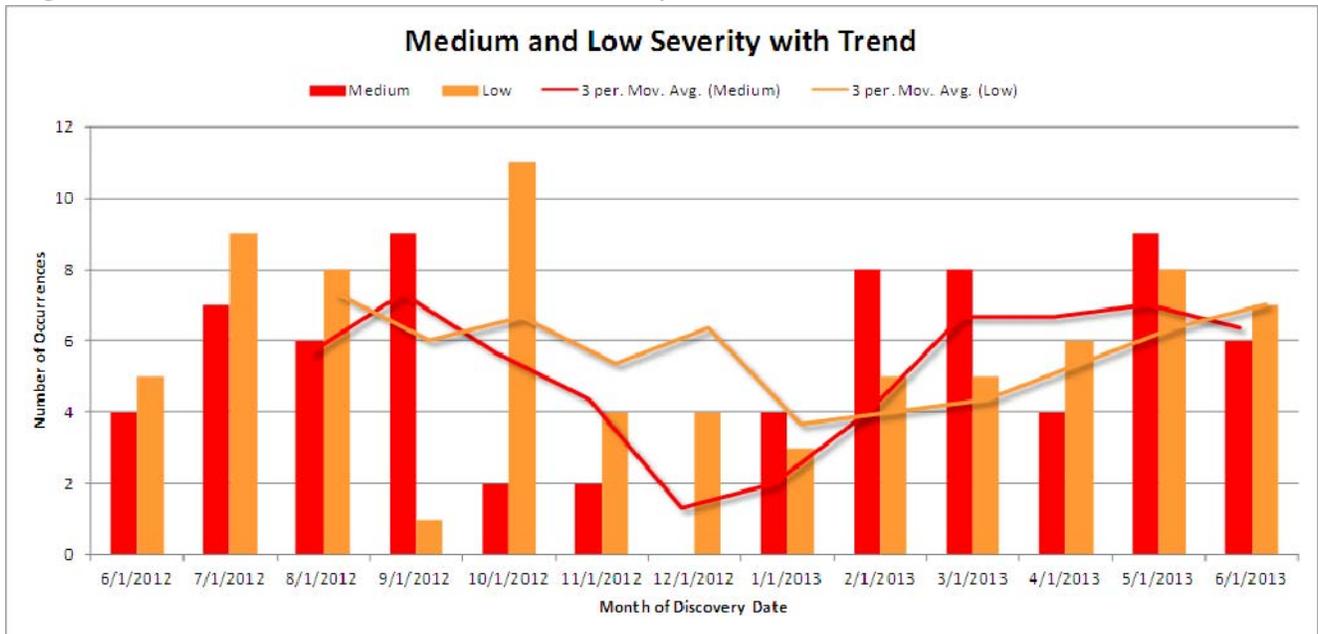
Figure 13 - Trend of Medium and Low Electrical Severity Occurrences

Figure 13 focuses on the Medium and Low severity data series for June 2012 through June 2013. Trend lines are included for each, using a 3-month moving average.

The 3-month moving average shows a slightly increasing trend for Low and Medium severity occurrences.
