Building America Case Study

Retrofit Measures for Embedded Wood Members in Insulated Mass Masonry Walls

Lawrence, Massachusetts

Project Name: The Bixby Building
(100 Parker Street)

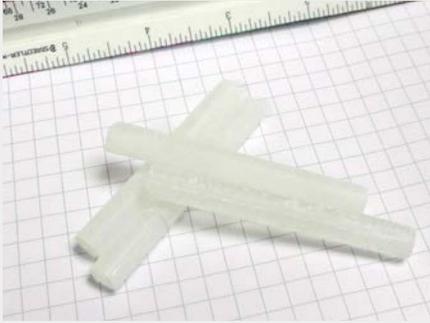
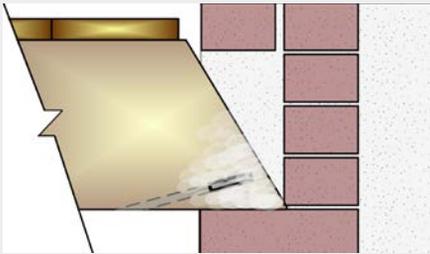
BORATE PRESERVATIVE

Joist ends can be protected from insect infestation and decay by using borate salts. They are commercially available as solid rods, which can be inserted into drilled holes in the embedded wood members.

When the joist ends are wetted, the borates will migrate to the areas of the highest MC, thus providing protection. When the wood is dry, diffusion will stop, but protection will remain in place. When MC rises again, the rods will resume diffusion.

If the joist end is extensively wetted (e.g., bulk rain leakage), the borate will be consumed over time. It is possible to replace the borate rods during the service life of the building, but this seems unlikely to occur in practice due to the intrusiveness of this retrofit in service.

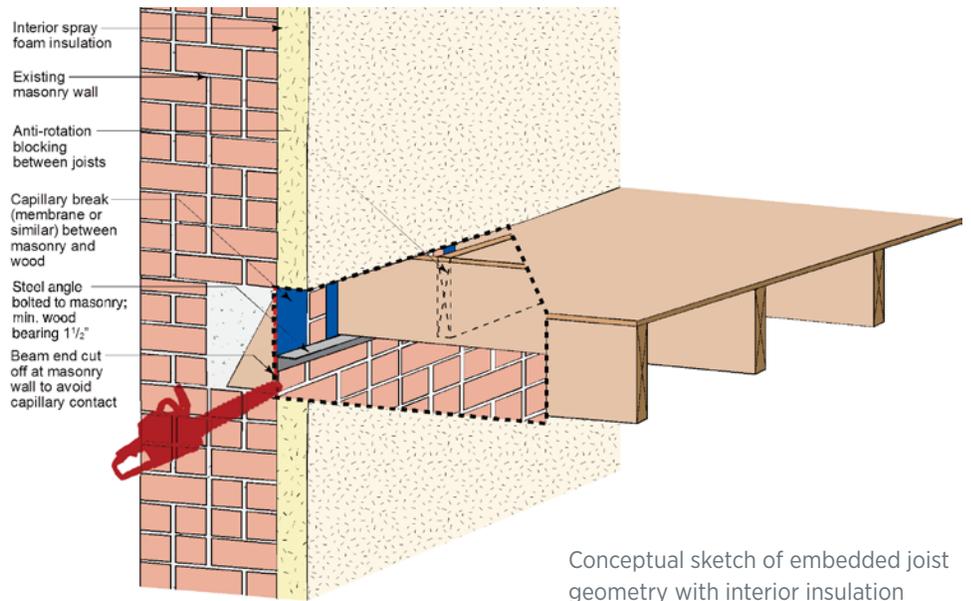
Conceptual sketch of embedded joist geometry with interior insulation

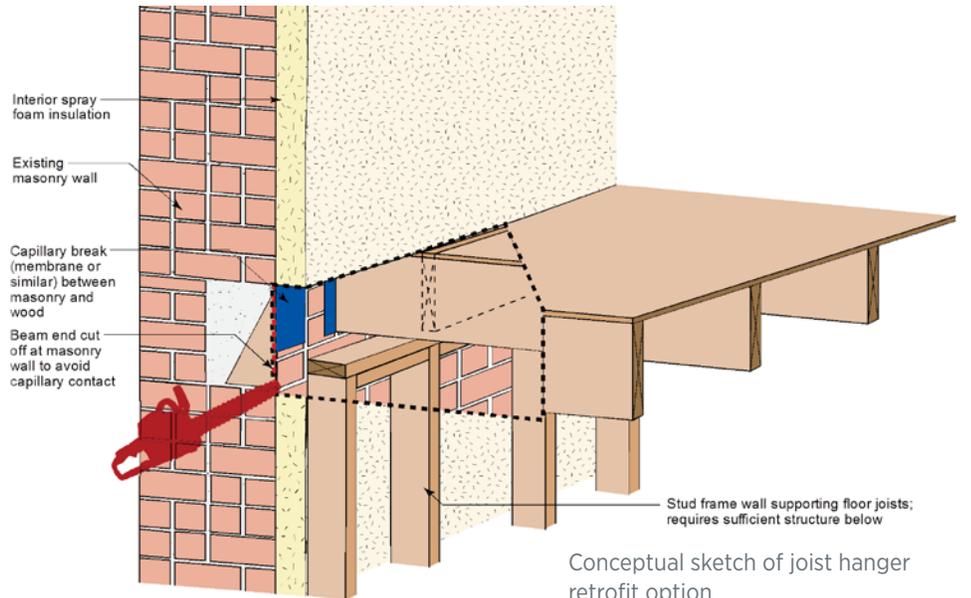
Conceptual sketch of joist hanger retrofit option

In high-risk situations, which include cases with significant water damage or decay to the beam ends or when a very conservative approach is warranted, the embedded wood member condition can be eliminated entirely. The most conservative approach is to cut off the embedded “tail” of the joist (eliminating capillary wicking) after safely supporting the floor structure from another point. Support options include joist hangers attached to the masonry (top figure), a continuous angle iron attached to the masonry, and a bearing wall below the joists (bottom figure). Building codes require that joist ends have a minimum of 1-1/2 in.-bearing on wood or metal supports. In addition, if joist hangers are not used, lateral restraint (full-depth solid anti-rotation blocking) is required.
