Development of the Mini Rover

Daniel Martin DOE Fellow, B.S. Electrical Engineering Applied Research Center Florida International University

• Small amounts of nuclear trace have been found in the anulus of the AY-102 waste tank located at the Hanford site. The objective is to develop a miniature inspection tool to inspect the integrity of the waste tanks.

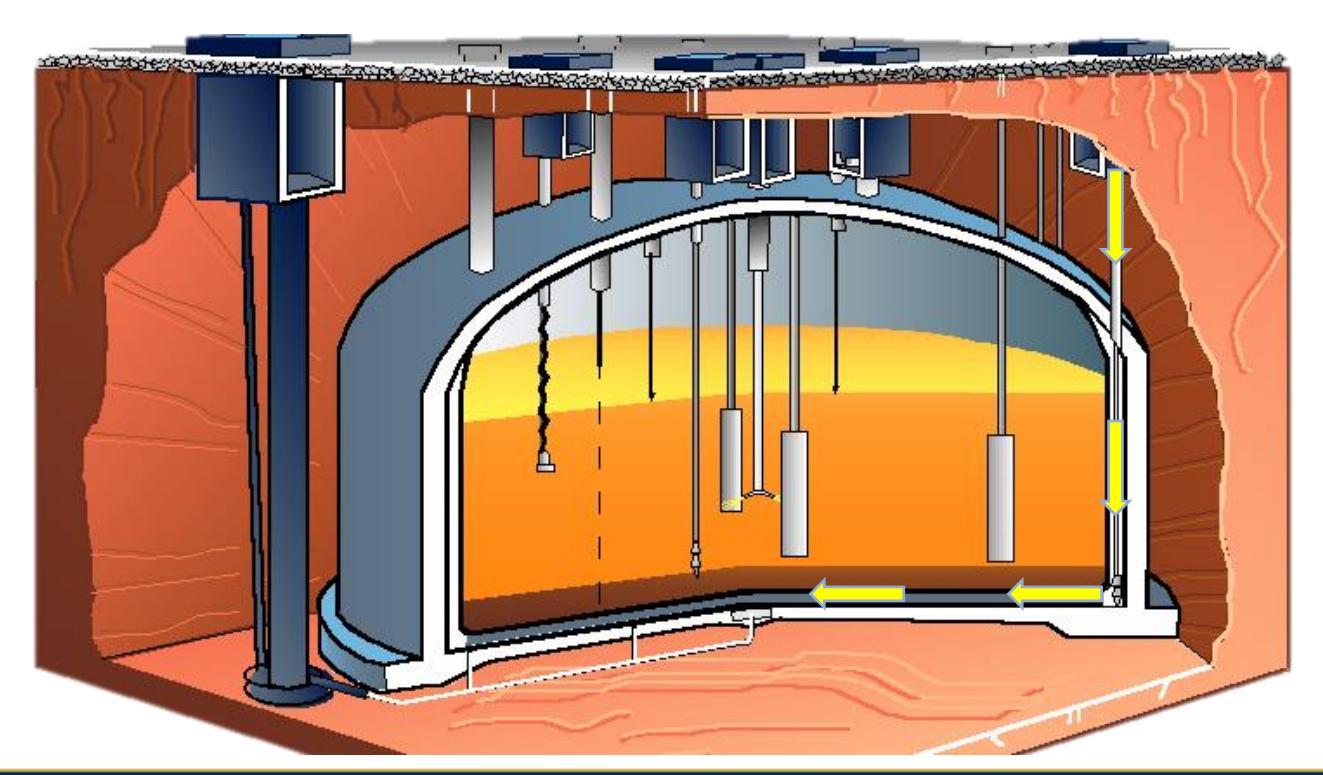
The yellow arrows shown in the diagram represent the path the mini rover will take.

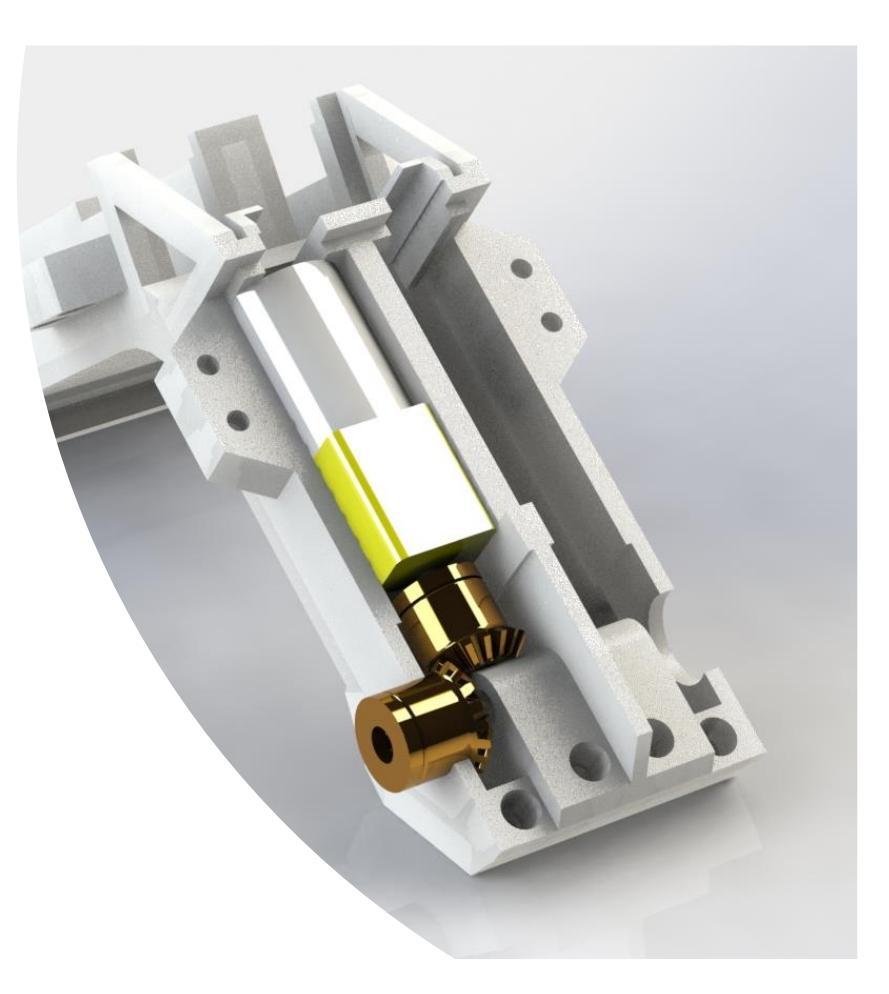
- In order to achieve the 90-degree angle, we utilized a bevel gear system to transfer the torque and power.
- The unit is designed into a V-shape body to aid in overcoming weld seams and uneven surfaces beyond 1" in forward and reverse direction.
- This unit has magnets strategically placed below the unit to provide sufficient attraction to the surface of the tank, but not actually touching the tank and hindering movement of the rover.

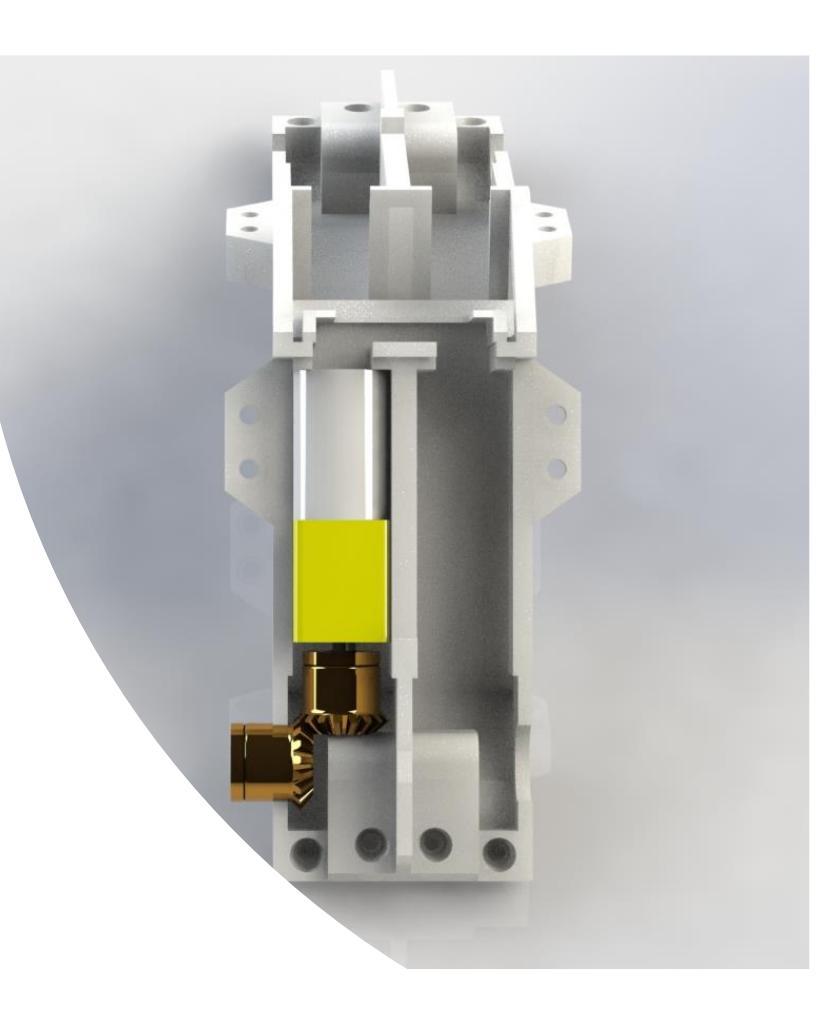
- Length= 4.1"
- Width = 1.6"
- Height= 1.8"

- 12 total N42
- 1mm gap from surface.

- Four motors on the unit which individually drives each wheel.
- Stall torque is rated at 140 oz-in.
- Each motor is geared to 1000:1 ratio for greater torque.
- All four motors turn at 35 RPM's.

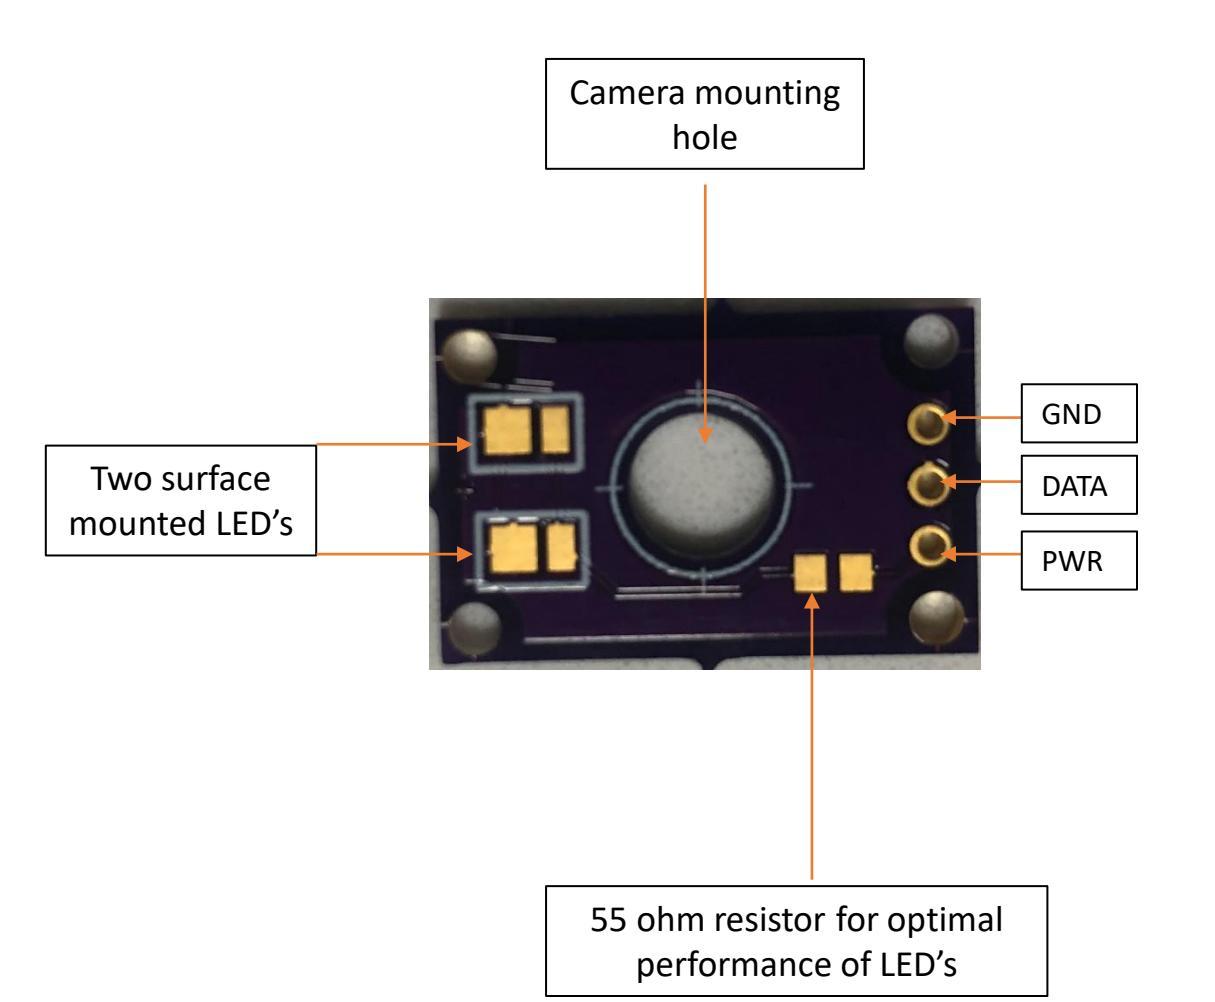
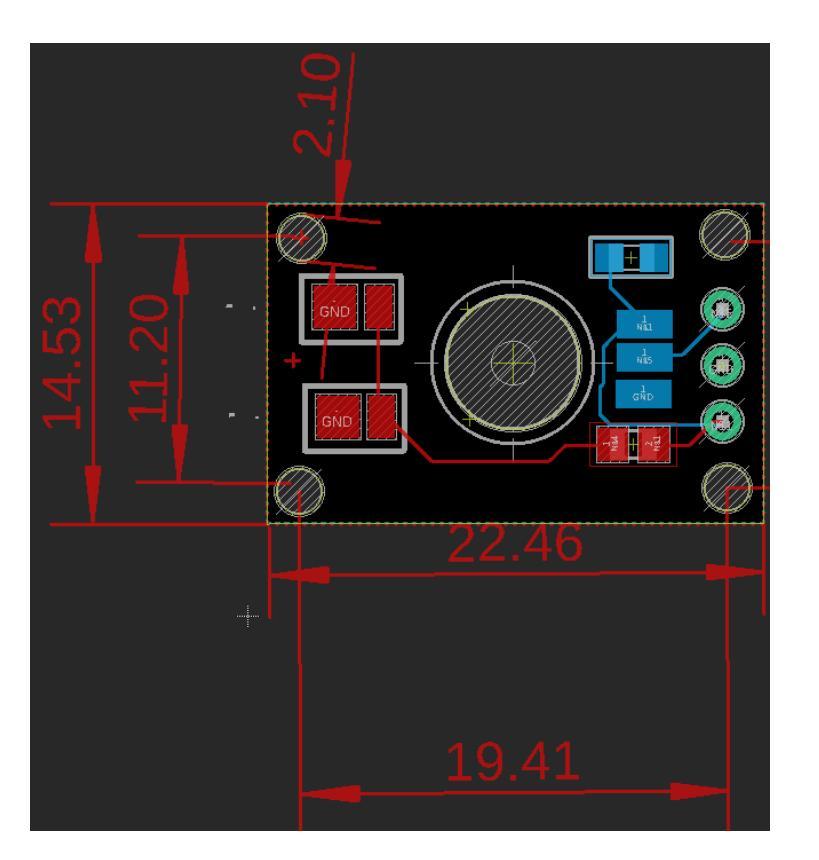
Camera and Light's PCB

Dimensions of the camera and light PCB shown above

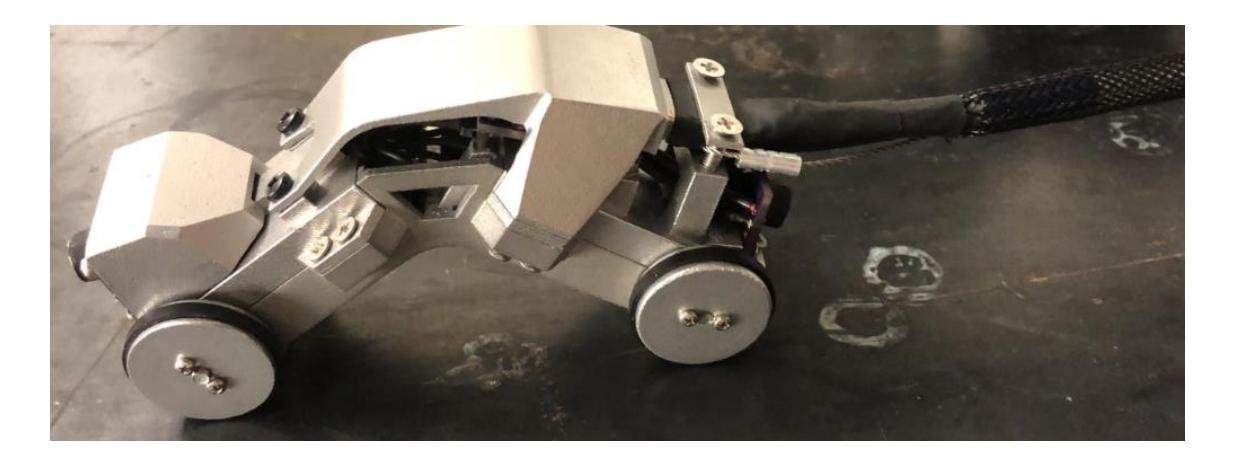
Final Rover Design

Final Mini Rover design printed in aluminum.

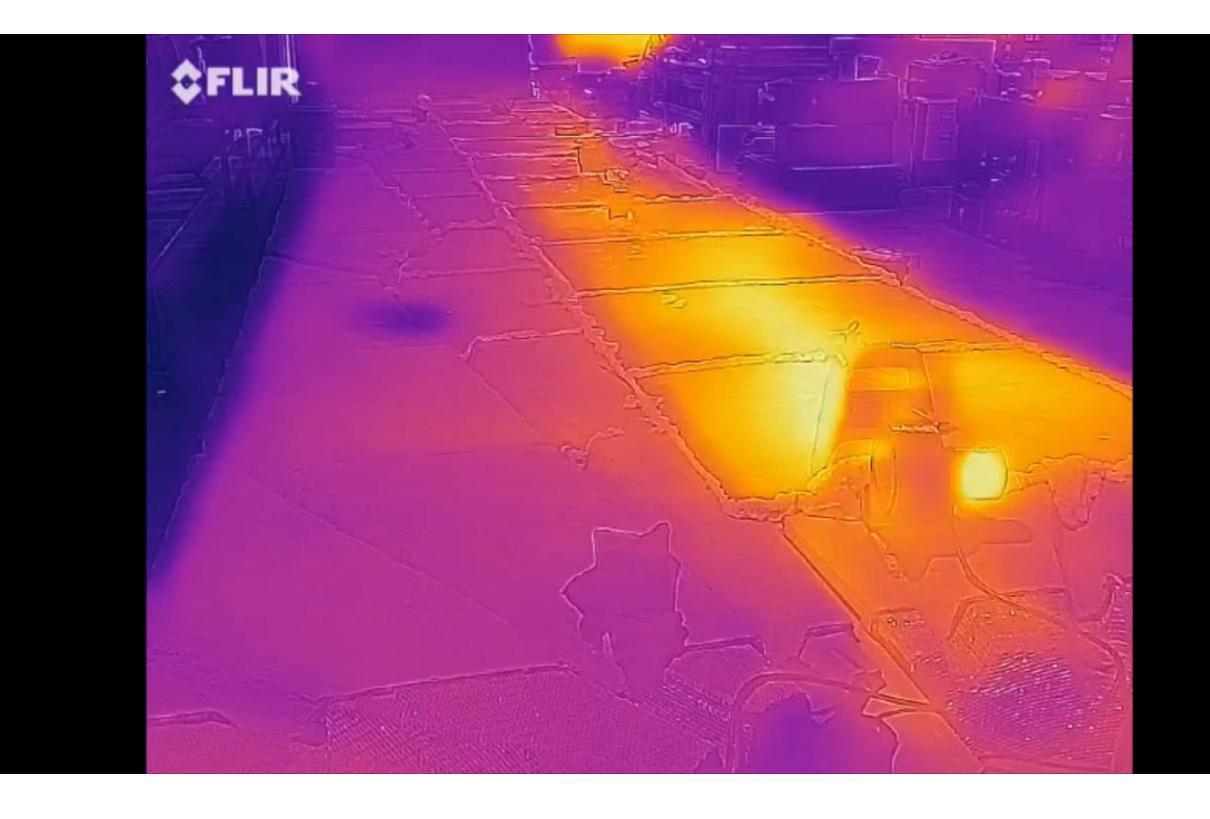
Weld Seam Test

<u>Trial</u>	<u>Pass / Fail</u>	Notes	MMR Integrity Observations	Date
1	Pass	Performed As Desired	Normal Conditions	12/ 14 / 20
2	Pass	Performed As Desired	Normal Conditions	12 / 14/ 20
3	Pass	Performed As Desired	Normal Conditions	12 / 14 / 20
4	Pass	Performed As Desired	Normal Conditions	12 / 14 / 20
5	Pass	Performed As Desired	Normal Conditions	12 / 14 / 20
6	Pass	Performed As Desired	Normal Conditions	12 / 14 / 20
7	Pass	Performed As Desired	Normal Conditions	12 / 15 / 20
8	Pass	Performed As Desired	Normal Conditions	12 / 15 / 20
9	Pass	Performed As Desired	Normal Conditions	12 / 15 / 20
10	Pass	Performed As Desired	Normal Conditions	12 / 15 / 20

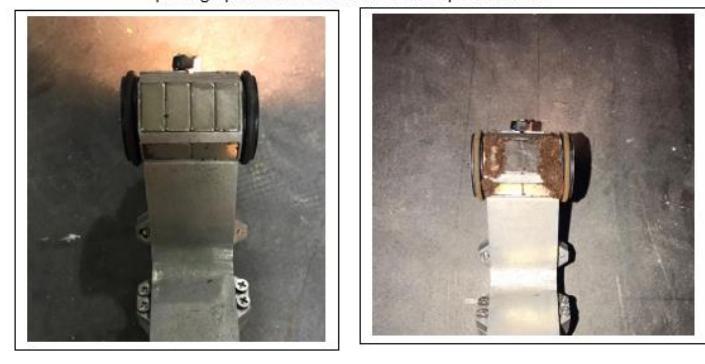
Rover Placed in Mock-up

After completing of the 108' of rusted surface test, ensure to photograph and document rust build up on the rover

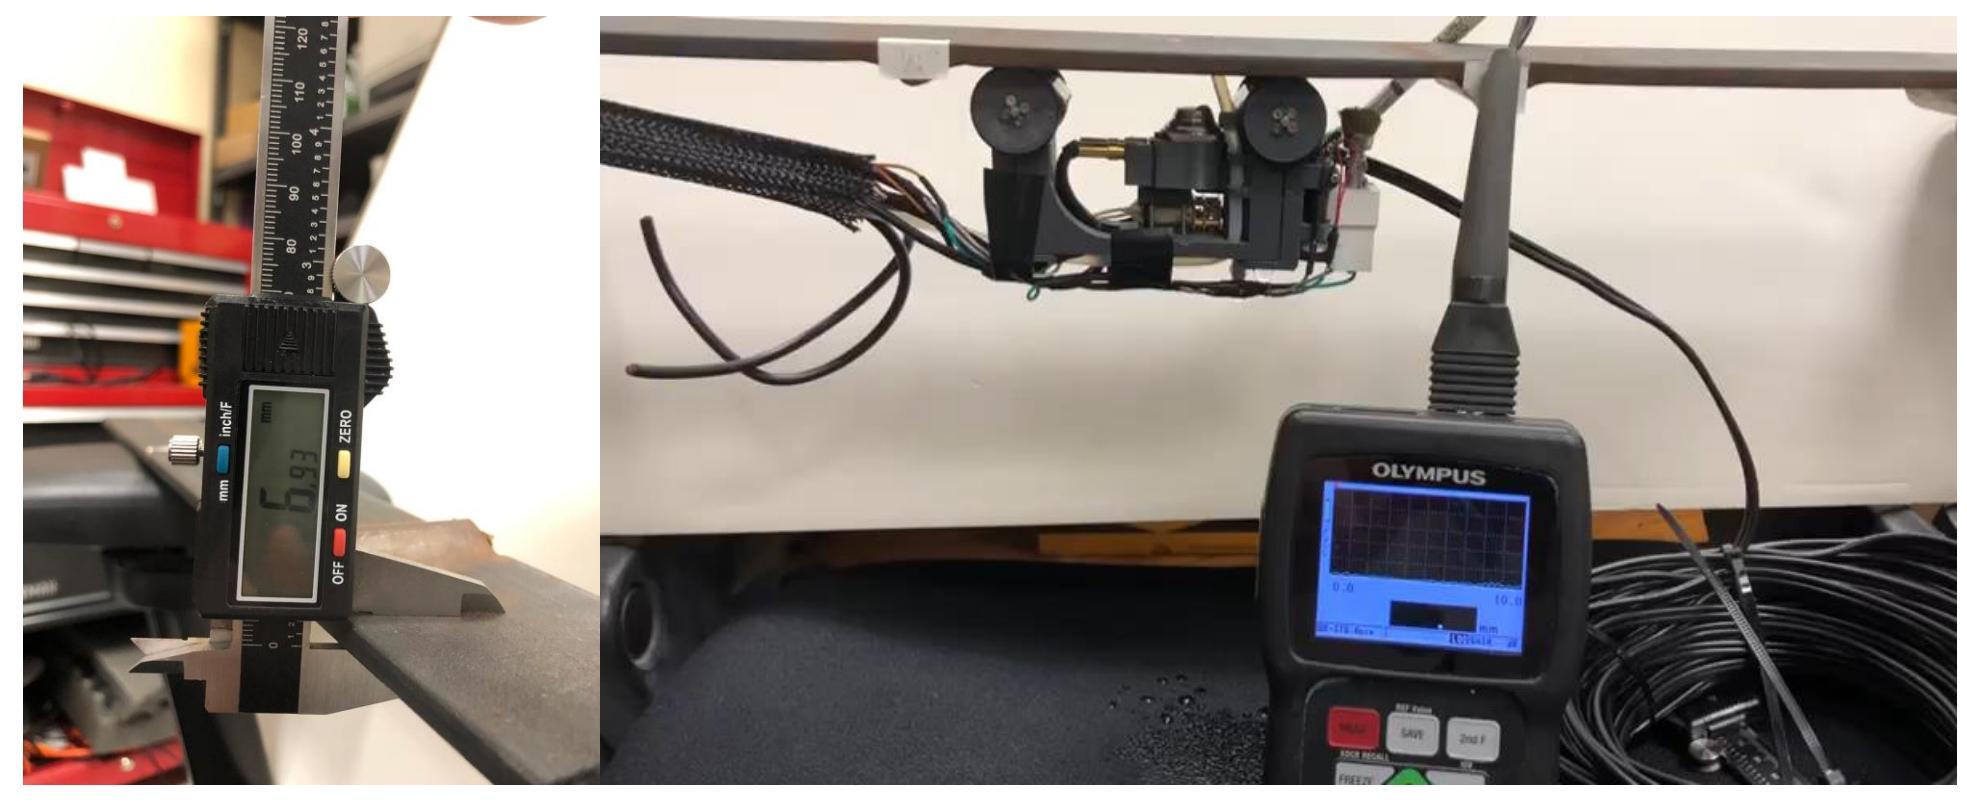
Incorporation of the Ultrasonic Sensor

After testing the UT Sensor rover, we are very pleased with the results. We have taken a base line measurement of 6.93mm with a caliper and the results we have received is the same shown in the video below.
