# CERTIFICATION TESTING OF UNITED STATES DEPARTMENT OF ENERGY ATLAS AND BUFFER RAILCARS-PHASE 4 REPORT

# for the United States Department of Energy

Certification Report P-22-012

January 18, 2023 Revised July 21, 2023

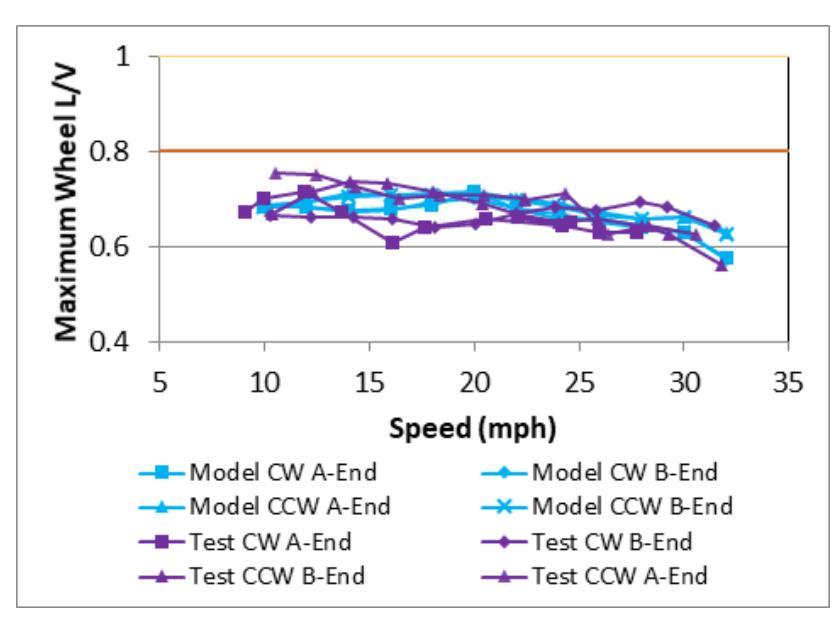
Figure 1. Simulation and test results on L/V ratios

Atlas railcar dynamic curving test results and simulation predictions are shown in Figure 1 The simulations and tests showed lateral/vertical (L/V) ratios below the Chapter 11 requirement of 1.0 and the more stringent S-2043 requirement of 0.8.

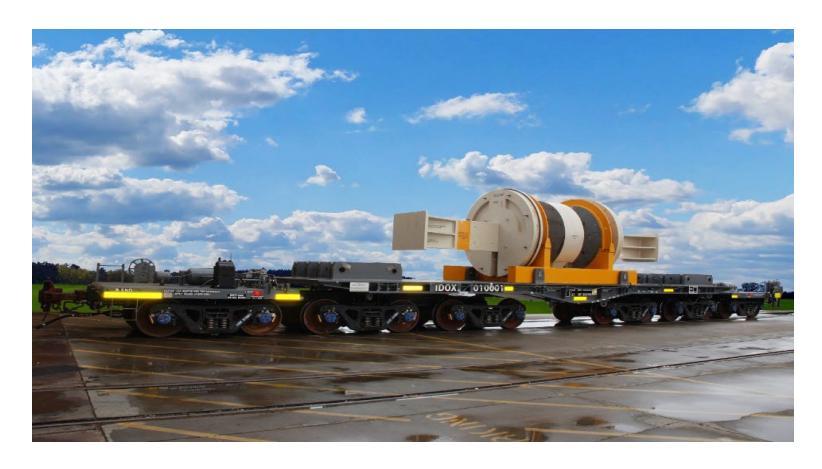
Figure 2. IDOX 010001 during testing with minimum test load

The Atlas railcar is a 12-axle span bolster railcar with fittings to accommodate cradles and end stops designed to allow the railcar to carry various casks used for the transportation of spent nuclear fuel and high-level radioactive waste. The railcar deck is supported on two span bolsters. Each span bolster rests on three two-axle trucks. Figure 2 shows the railcar with a test load installed. Table 2 lists the railcar dimensions.

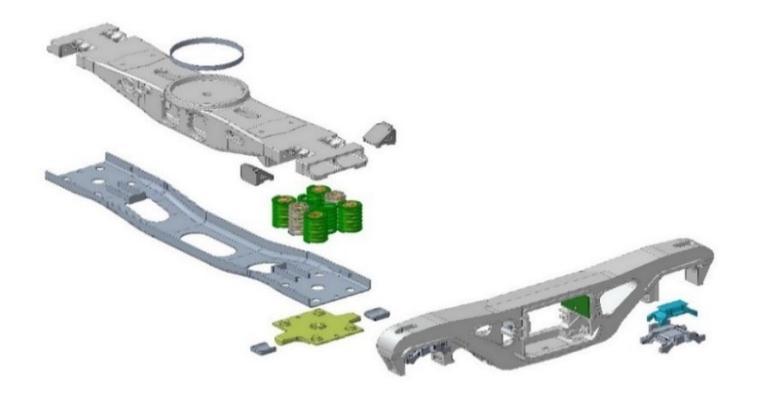
Figure 3. Exploded view of Swing Motion<sup>®</sup> truck

The railcar uses six Amsted Swing Motion<sup>®</sup> trucks (Figure 3). Each truck uses two wheelsets with AAR Class K-axles and AAR-1B narrow flange wheels. These wheels are specified for this railcar because the increased gage clearance allows more lateral movement for better performance. The trucks are designed to use a primary suspension polymer pad between the bearing adapter and the side frame. The suspension polymer pad gives the truck an improved passive steering capability. Figure 4 shows the primary suspension polymer pad (also called a bearing adapter pad).

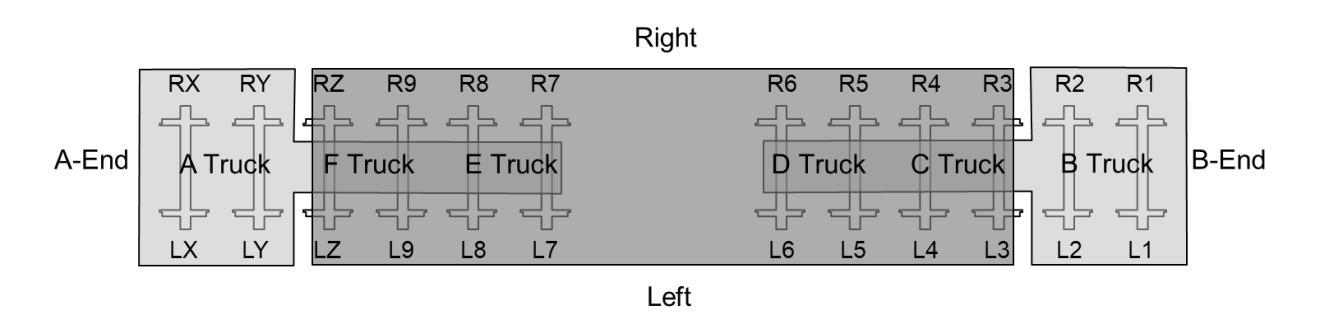
Figure 5. Axle and side naming convention

The convention for wheel and truck identification is shown in Figure 5. The B-end of a railroad freight car is normally the end with the handbrake, but because the Atlas railcar has two handbrakes, the railcar manufacturer designated and stenciled the B-end. The right and left sides of the railcar are designated from the perspective of standing at the B-end of the railcar and looking toward the A-end of the car. Axles are numbered starting from the B-end. For axle numbers greater than nine, the locations are stenciled with letters descending from Z.

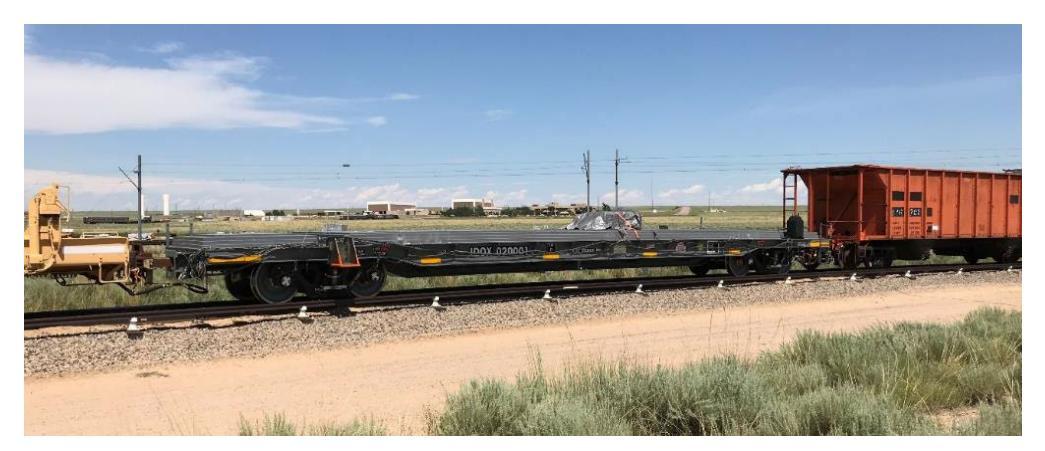
Figure 6. Buffer railcar IDOX 020001 during static testing

The Buffer railcar is a four-axle flatcar with a permanently attached ballast load (Figure 6). In 2018, Kasgro manufactured IDOX 020001 and IDOX 020002, two prototype Buffer cars that were delivered to the TTC. The tests described in this report were conducted on IDOX 020001. Figure 7 shows the general arrangement drawing of the car. Table 4 shows the railcar dimensions.

The steel plates were welded to the railcar during the manufacturing process, resulting in a railcar with a permanent gross rail load of 263,000 pounds. Because the railcar was not rated to carry any additional load, 263,000 pounds was the only load condition that was tested.

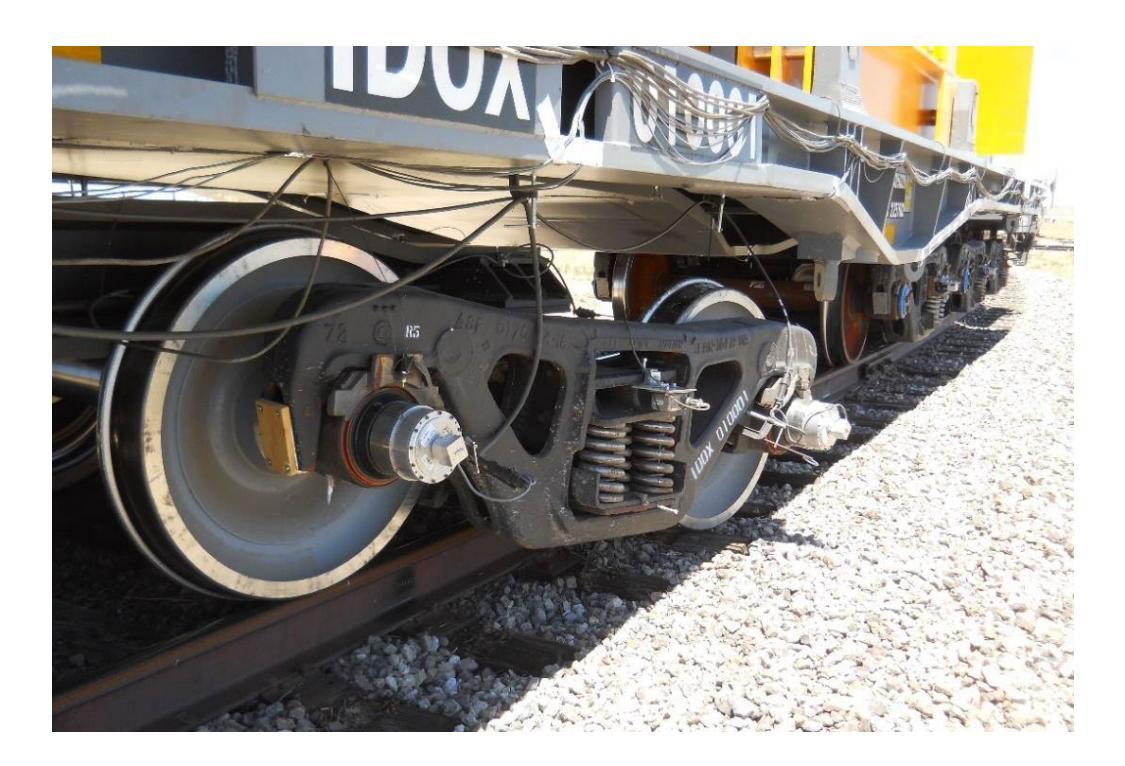
Figure 8. Derailed Axle 6 in final position outside of the curve

The point of derailment (POD) was in the body of a 12-degree left-hand (LH) curve with no superelevation. The POD was within the 2-inch-high rail dip of the CWSRP, resulting in a reverse cross level of 1.88 inches. At the POD, the gage was 56.72 inches, and the curvature was 12.5 degrees. The alignment deviation of a 62-foot chord from average curvature (155-foot average) was 3.7 inches at the POD. At the time of the derailment, the railcar was being shoved at 6 mph. The subject railcar was at the lead end of the movement with the instrumentation railcar and locomotive trailing.

At the time of the derailment, all six axles of the B-end (trailing) span bolster were instrumented wheelsets (IWS) that had been installed for testing. The railcar was tested with a simulated load (without any hazardous material).

MxV Rail noted damage to 1) two of the IWS, 2) the B-end span bolster, and 3) the leftside frame of the D-truck. The IWS were inspected, tested, and returned to service. The span bolster damage was repaired per the railcar builder's instructions, and the damaged left-side frame was replaced.

The primary cause of the derailment was a 3.7-inch variation in high rail alignment over a 47-foot test zone that resulted in a test zone that was more challenging than intended. A revision to AAR Standard S-2043 that will include additional requirements for curvature and alignment in the test zone is in progress.

MxV Rail proposed revisions to AAR Standard S-2043 that would add tolerances for curvature and alignment and adjust the track to meet the proposed requirements and retest with no modifications to the railcar other than the necessary repairs. The AAR EEC accepted the proposed revisions and agreed that the CWSRP test needed to be repeated. MxV Rail adjusted the test zone and repeated the test on August 26 and August 27, 2020. The results from the retest met AAR Standard S-2043 criteria.

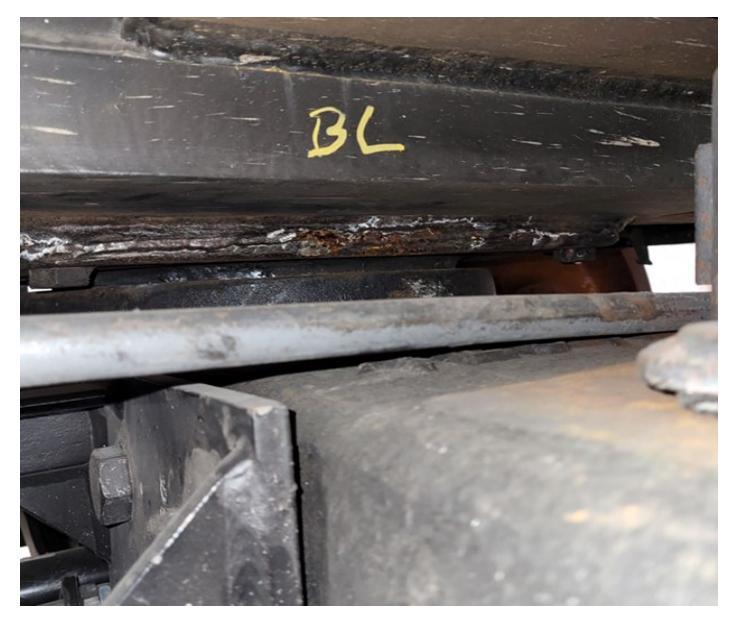
Figure 9. Atlas Railcar – Crack is on Left Side of Centerplate, B-Truck

In June 2022, MxV Rail's Rail Vehicle Maintenance (RVM) department inspected the Atlas railcar, the Buffer railcars, and the REV. One crack was found in the B-truck centerplate on left side of the Atlas railcar, parallel to the rail.

The crack was discussed with the DOE and Kasgro and was to be repaired in July while the consist was parked for installation of IWS. Figure 9 and Figure 10 show the crack defect.

Cracking Type 1 (B-end tri-span bolster, B-truck centerplate) – Reported to DOE in June 2022 – cracks parallel to the weld beads in Figure 9 and Figure 10 as shown above. • Cracking Type 2 (B-end tri-span bolster, C-truck centerplate) – Discovered Monday, July 25, 2022. Figure 11 shows vertical cracks that have the potential to migrate to the base tri-span bolster material. Kasgro determined that these cracks were in the centerplate.

The DOE, Kasgro, and MxV Rail agreed that both tri-span bolsters be shipped back to Kasgro for repairs or replacement. The tri-span bolsters were shipped by MxV Rail to Kasgro at the end of the first week of August 2022, and replacements were received back at the TTC on August 29, 2022. When received, MxV Rail installed the replacement tri-span bolsters to continue testing.

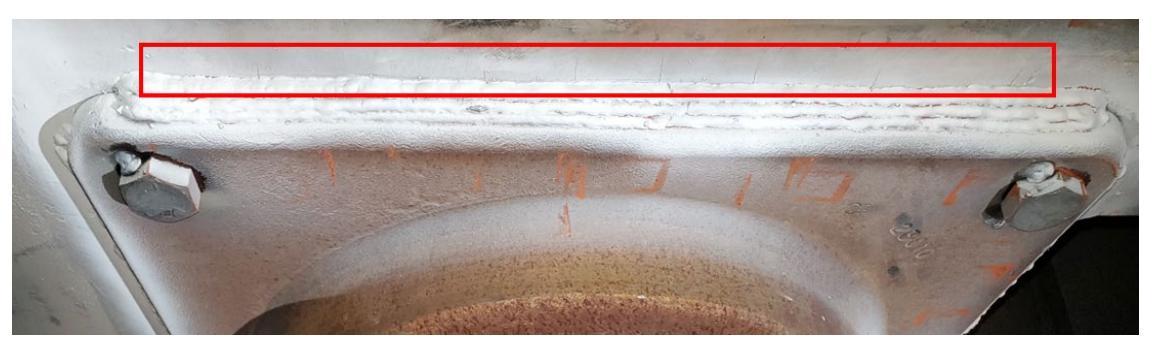
Figure 12. Cracking in tri-span bolster with new B truck centerplate

• Cracking Type 3 (B-span bolster, newly replaced B-truck centerplate). Cracks found after Kasgro's repair of Cracking Type 1, shown in Figure 12 and Figure 13. The cracks were in the tri-span bolster, above and perpendicular to the top weld bead. These cracks were significantly more concerning as they were in the tri-span bolster.

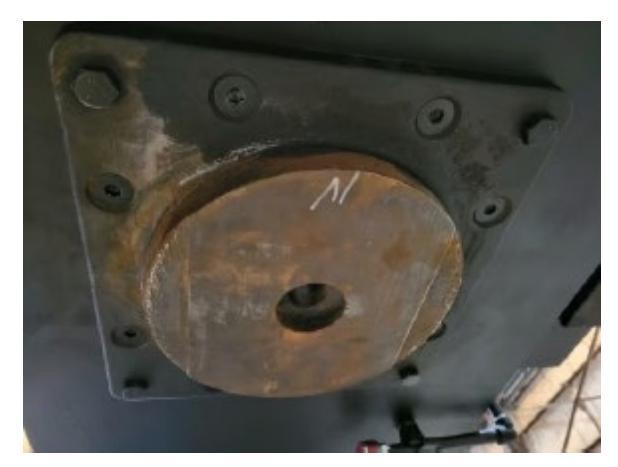
Figure 14. 12-bolt centerplate mounted to replacement Atlas tri-span bolster

The Atlas tri-span bolsters were delivered to the Kasgro Rail shop for repairs on August 11, 2022. All components and attachments to the original tri-span bolsters were removed, and Kasgro used two new tri-span bolsters to replace the original tri-span bolsters. In addition, the attachment design for center plates to tri-span bolster was changed from a bolt and welded design to a 12-bolt design center plate design (Figure 14).

Kasgro had the 12-bolt design center plates in stock. Because Kasgro could not confirm what was causing the weld cracks, the all-bolt design was chosen to avoid any additional weld cracking issues with the Atlas tri-span bolster center plates for the remainder of the S-2043 Atlas railcar testing. All AAR requirements for use of bolted center plates were followed.

To avoid future cracking issues, Kasgro changed the attachment method for the six centerplates to the two Atlas railcar tri-span bolsters. The former method, from the original build drawings, is to bolt and weld them in place.

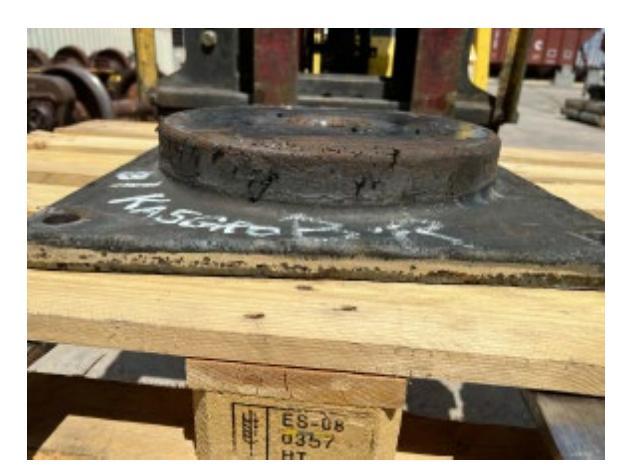
Figure 15. Atlas BL-end centerplate after removal

Kasgro sent the original center plate (Figure 15) removed from the B-end, left side of the Atlas railcar to an independent metallurgical test lab to determine if there were any issues with material properties of center plates. The metallurgical test lab concluded the center plate mechanical and chemical properties were in the acceptable range, and it was likely the cracks developed in the welds initially and then propagated into the center plate (see Kasgro Report 1).

Based on the results from the sample received from the investigation, both testing laboratories concluded there was no evidence that points out issues related to the material. The multiple cracks that were observed are probably related to welding practices used during the fabrication of the part.

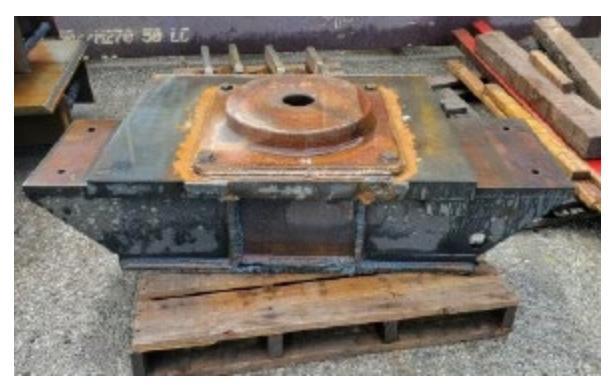
Figure 16. Tri-span section sent for NDE testing

Kasgro also sent a section of the original B-end tri-span bolster back to the steel mill that originally made the steel (Figure 16). The steel mill metallurgical lab investigated the surface indications located in the HAZ (Figure 12 and Figure 13) using a liquid dye penetrant NDE along the welds and determined that the originally noted surface indications were most probably

a result of the welding process and not material related. Kasgro's opinion is that the indications were most likely caused by the arc gouging removal of cracked welds and subsequent repair welding. The steel mill test lab did use NDE and ultrasonic testing to find two crack indications, that extended 5 inches and 6 inches in length but did not appear to encroach on the exterior edges of the test sample (see Kasgro Report 2).

The steel mill lab conclusions indicated both the chemical composition and mechanical tests results obtained from the sample received for investigation meet the ASTM A572-15 GR. 60 steel requirements. These results were consistent with MTR (Material Test Reports) of the possible plate serials, and they match the chemistry of the plates sent to Kasgro (see Kasgro Report 3).

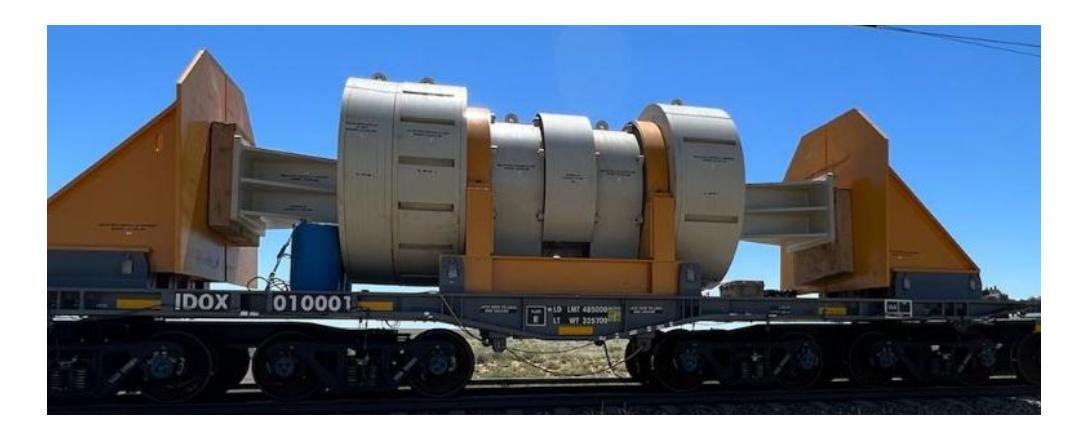
Figure 17. Dunnage problem: block on right side has slipped downward

Whenever the Atlas railcar is carrying a load that requires end stops, dunnage is required as padding between the load and the end stops. This dunnage is in the form of heavy wooden blocks. Movement of one of the dunnage blocks on the Atlas Cask railcar was exhibited during testing at the TTC (Figure 17). A design modification was required to prevent the heavy wooden blocks from wiggling free and falling off the side of the railcar.

The solution to this issue is welding pieces of angle iron to the Atlas railcar's end stops. This will prevent lateral movement of the dunnage blocks as the railcar experiences many miles of bumps and turns on the nation's rail lines. Orano, DOE's contractor for the cask securement system design and manufacture, approved MxV Rail's proposal to weld 2- to 4-inch, 72-inchlong angles to the end stops on each side of the dunnage blocks. The angles would be installed 1 to 2 inches outside the dunnage block. The angle flat edge will be on the block side. Slot welds will be used and ground smooth on the block side to eliminate the possibility of restricting block movement. The angle top edge will be welded to hinder water entry from above, while the bottom edge will not be welded to encourage moisture to drain.
