Report on the Visual Study and Groundwater Analysis of the Cactus Crater Containment Structure on Runit Island, Republic of the Marshall Islands

Report to Congress November 2022

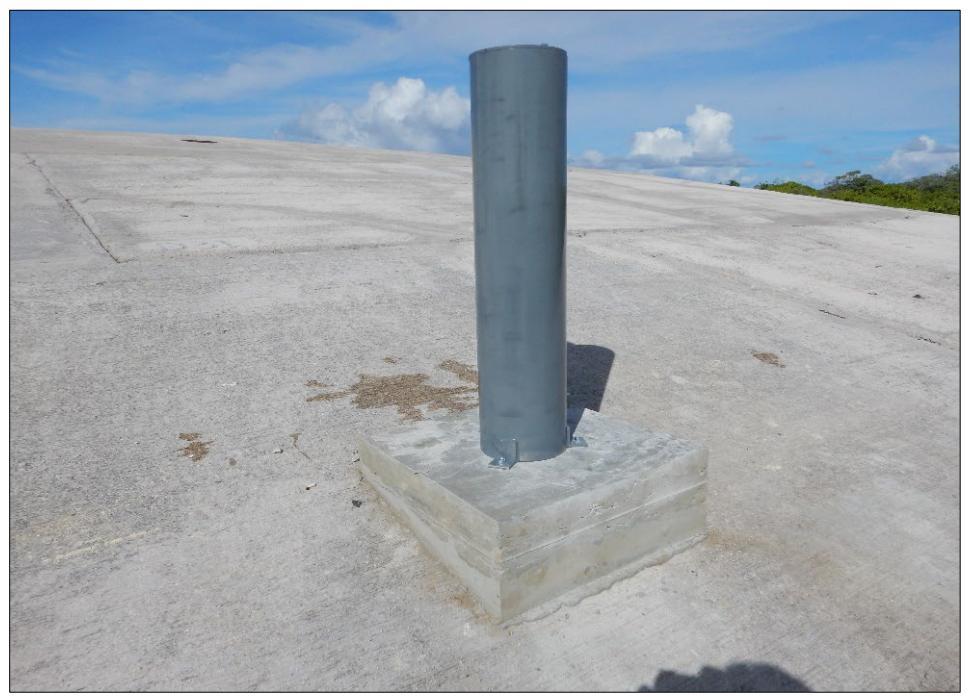
**Fig. 1.** Reconstituted CD-17 NAS Borehole on the Cactus Crater Containment Structure (after NAS, 1980)

At the onset of the Runit Island groundwater monitoring program, DOE identified three groundwater boreholes from previous scientific studies and reestablished the boreholes as groundwater sampling wells. These existing boreholes have been used to provide initial groundwater testing and analysis and to help assess the requirements and logistics needed to drill and install any additional groundwater sampling wells needed to improve sampling and monitoring capabilities.

This report contains results of analyses of groundwater collected from two reconstituted boreholes from a 1980 study conducted by the NAS, identified as CD-16 and CD-17, and a third borehole, identified as ARU-2, from Project EXPOE (see Figure 1, Section VIII). CD-16 is located approximately 45 feet away from the base of the structure on the lagoon side (Ristvet, 1980). CD-17 is a shallow water borehole located on the third ring from the base of the Cactus Crater Containment Structure cap (Hamilton, 2013). ARU-2 is located approximately 330 feet south-southeast of Cactus Crater Containment Structure.

CD-17 is a shallow well, depending on the influence of tidal fluctuations, the standing groundwater in CD-17 rarely exceeded a few feet. Therefore, contaminant levels observed in CD-17 may not be representative of the full range of contaminants that could be found in deeper layers or from other locations on or around the Cactus Crater Containment Structure. However, these data, together with analyses of lagoon and open ocean seawater samples, provided a scientific basis for identifying key radionuclides and/or isotopic signatures that might be used as tracers to study the release of Cactus Crater-derived contamination through the groundwater aquifer into the local marine environment.

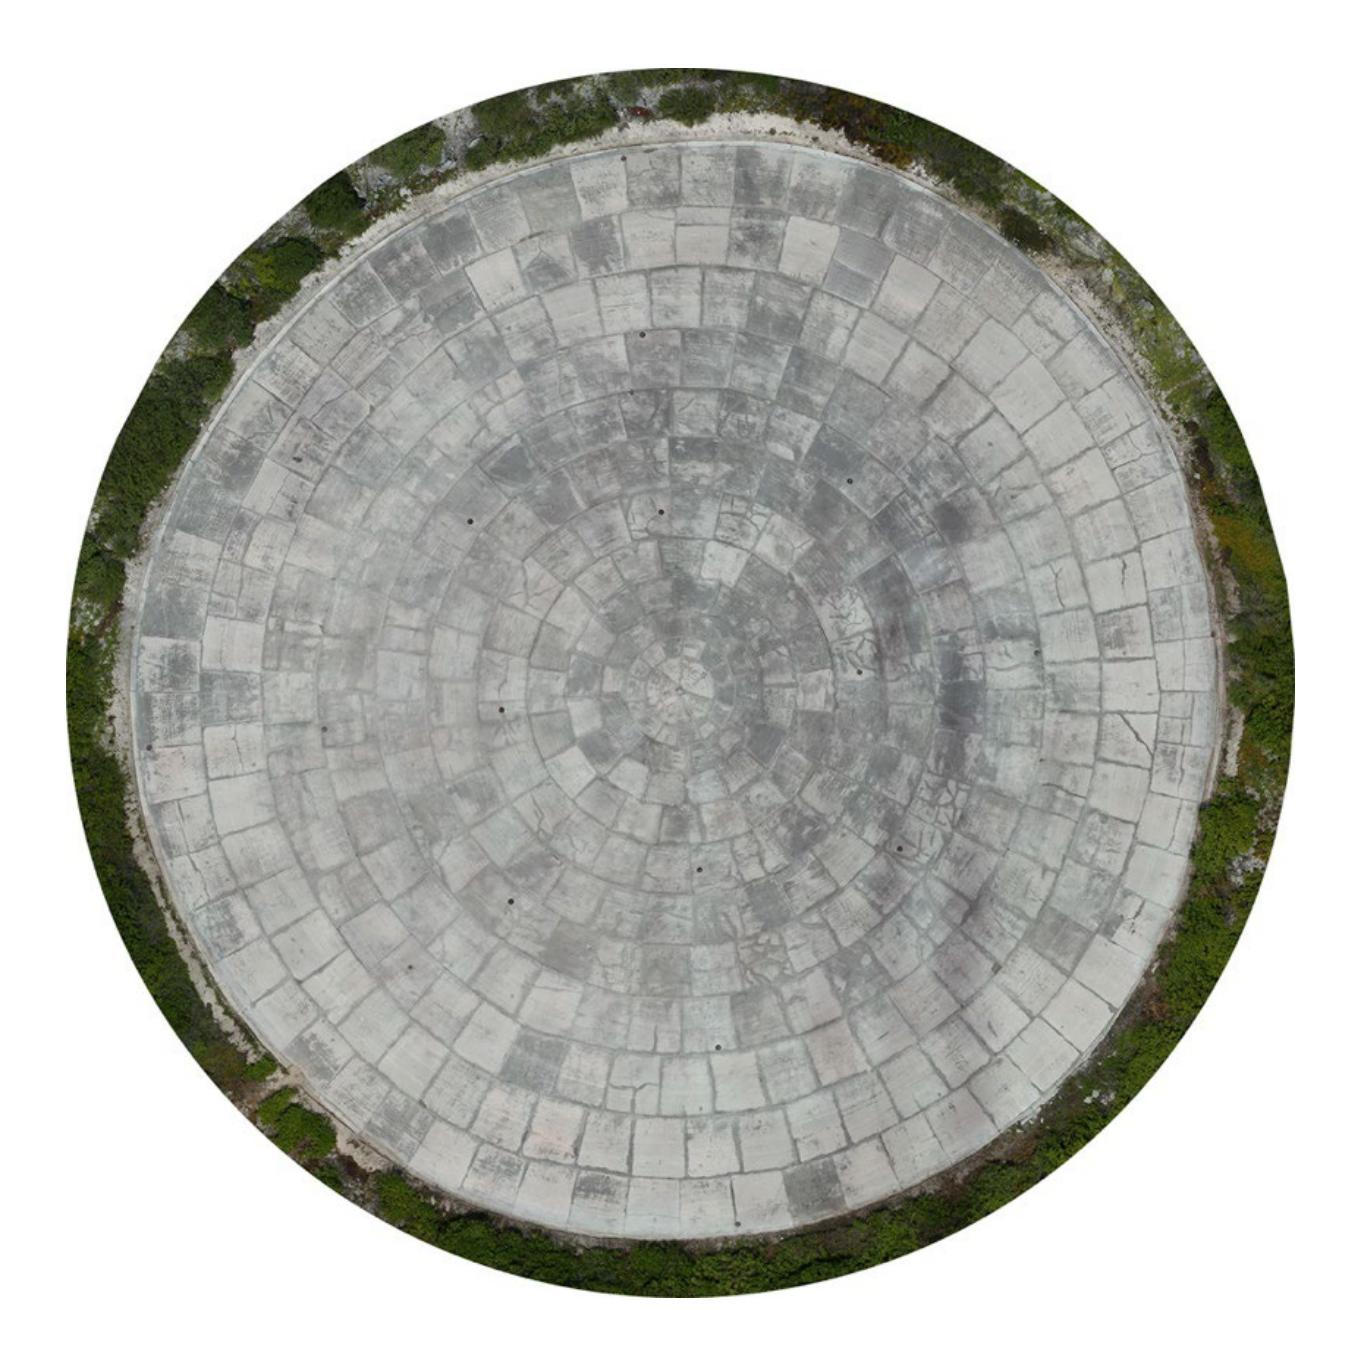
Fig. 2. <u>3D Model Output</u> from the UAS Survey of the Cactus Crater Containment Structure

(https://marshallislands.llnl.gov/runit\_visual\_survey.php; Hamilton and Nyholm, 2021; Hamilton et al., 2019a; Hamilton et al., 2018a; Hamilton et al., 2018b). More than 500 UAS photo images were taken and used to produce a viewable montage or photomosaic record of the structure (see Figure 2, Section VIII). High resolution UAS video was also taken to provide footage of the overall integrity of the containment structure cap and highlight the general condition of the key wall extending around the perimeter of the structure and of the riprap material placed along the ocean shoreline (Hamilton et al., 2019; Hamilton et al., 2018a; Hamilton et al., 2018b). The results of the two visual studies indicated that the cracks and spalling of concrete were not considered structural in nature or likely to present any additional hazard associated with the spread of radioactive contamination into the environment.

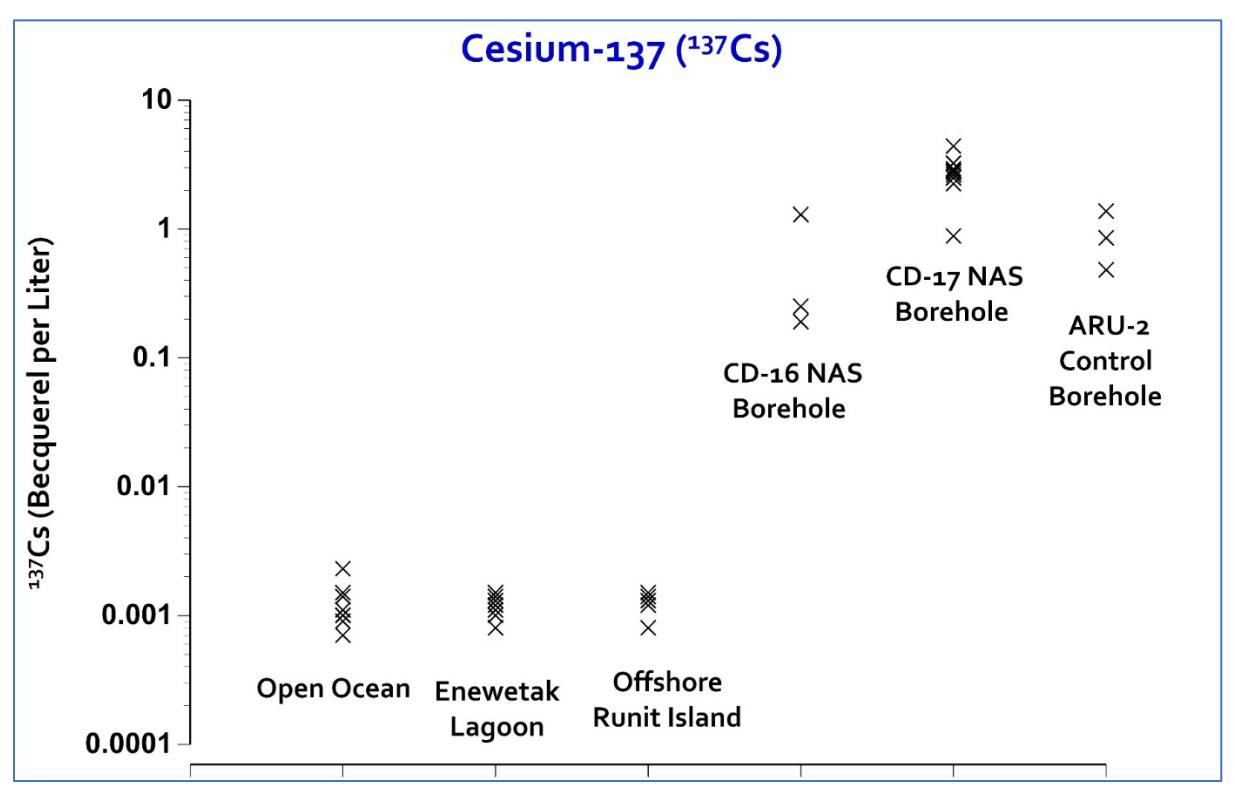
**Fig. 4.** Range of <sup>137</sup>Cs activity (Bq L<sup>-1</sup>) observed in groundwater from Runit Island compared with that observed in seawater samples collected from Enewetak Lagoon and the Open Ocean

The mean activity concentrations of <sup>239+240</sup>Pu and <sup>137</sup>Cs measured in groundwater samples from CD-16 and ARU-2 were about a third of that observed in groundwater from CD-17. The activity concentration of <sup>137</sup>Cs observed in surface waters of the lagoon was comparable with levels found in open ocean surface (see Figure 4, Section VIII). This observed level of <sup>137</sup>Cs activity concentration indicated that any release of <sup>137</sup>Cs from the Cactus Crater Containment Structure through the groundwater aquifer is having a negligible impact on radiological conditions in the wider marine environment on Enewetak Atoll.

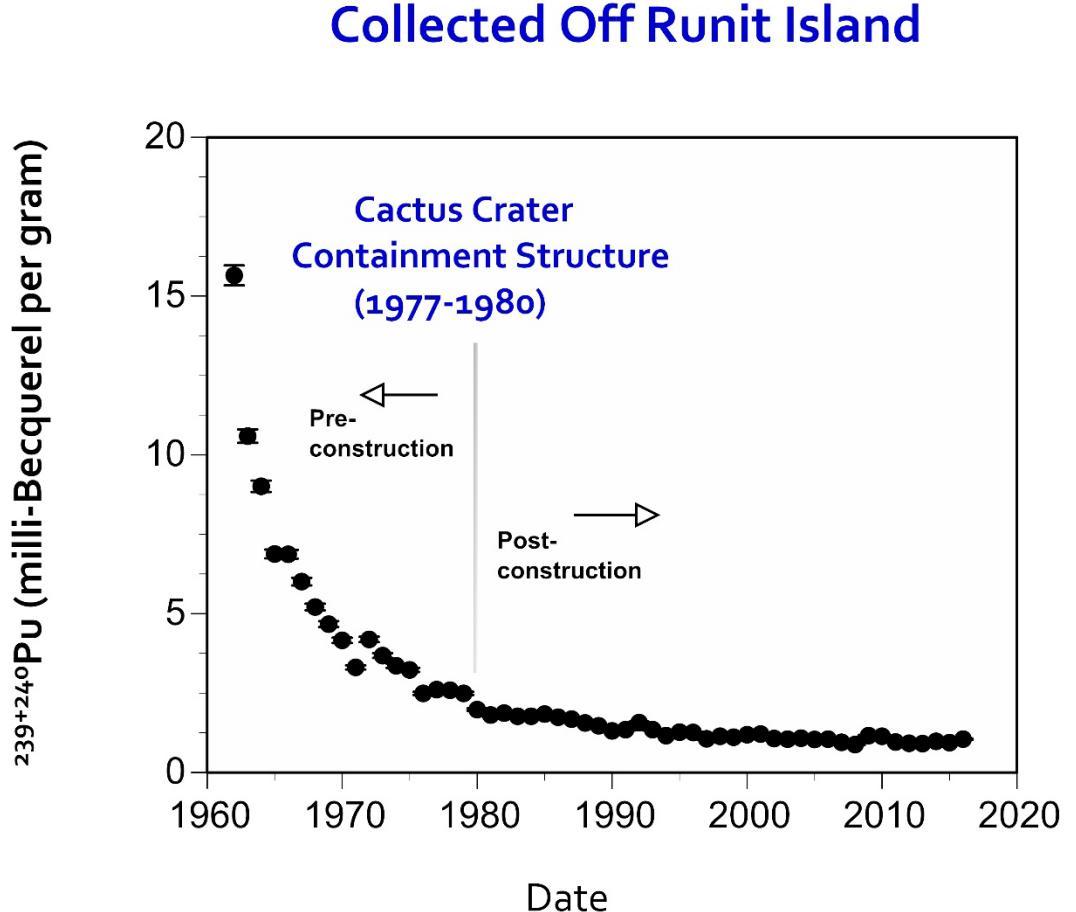
<sup>239+24</sup>°Pu in a Banded Coral Core Collected Off Runit Island

Fig. 5. Analysis of <sup>239+240</sup>Pu in a dated coral core collected off Runit Island (2016)

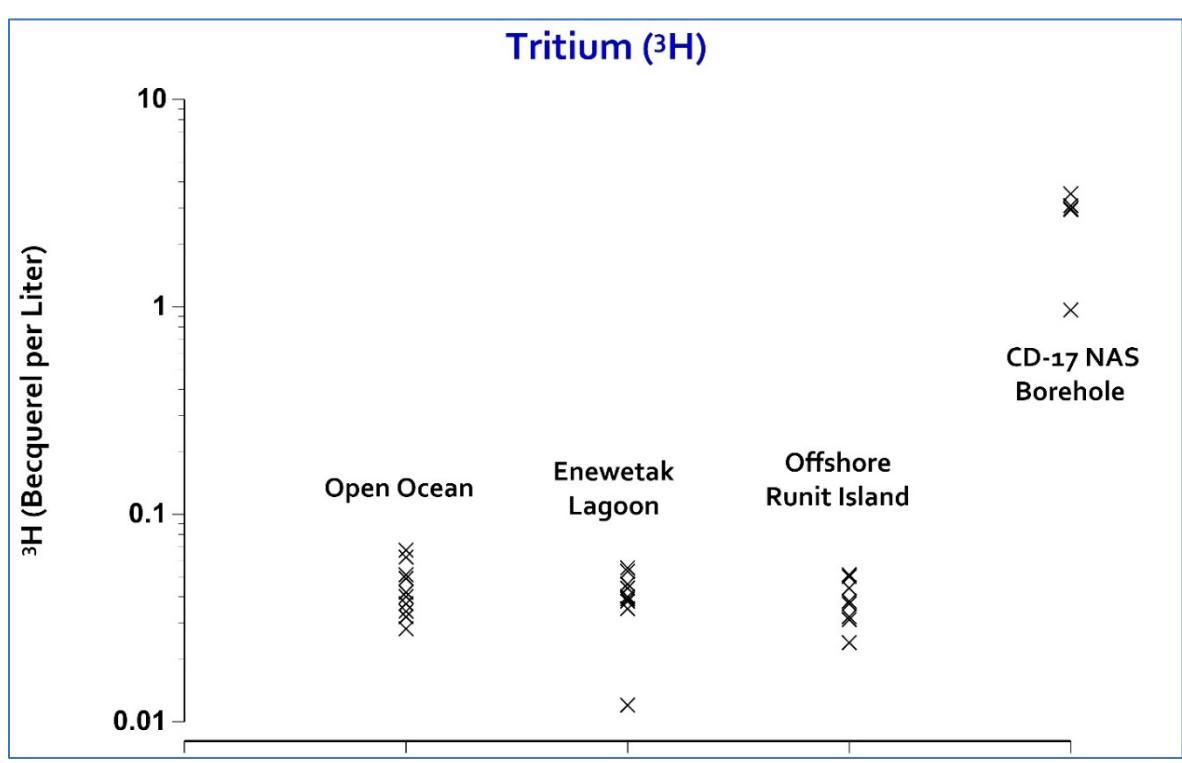
**Fig. 6.** Range of <sup>3</sup>H activity concentrations (Bq L<sup>-1</sup>) observed in groundwater from the CD-17 borehole on *Cactus Crater* versus that observed in seawater samples collected from Enewetak Lagoon and the Open Ocean

The activity concentration of <sup>3</sup>H and <sup>129</sup>I in groundwater from CD-17 was found to be higher than the concentration measured in lagoon water and the open ocean (see Figures 6 and 7, Section VIII). There was no statistically significant difference in the activity concentration of <sup>3</sup>H in lagoon water versus levels observed in the open ocean and <sup>129</sup>I was only marginally elevated in lagoon water relative to that measured in the open ocean. These data are consistent with previously measured levels for <sup>137</sup>Cs and indicate that any outflow of radioactive contaminants into the lagoon from the Cactus Crater Containment Structure groundwater aquifer is not distinguishable from the concentrations of fallout radionuclides in the wider marine environment and present a minimal added risk. The consistency of the <sup>129</sup>I data measured for the different water bodies indicates that this radionuclide is a good candidate for future monitoring of potential discharges of Cactus Crater-derived contaminants into the lagoon.

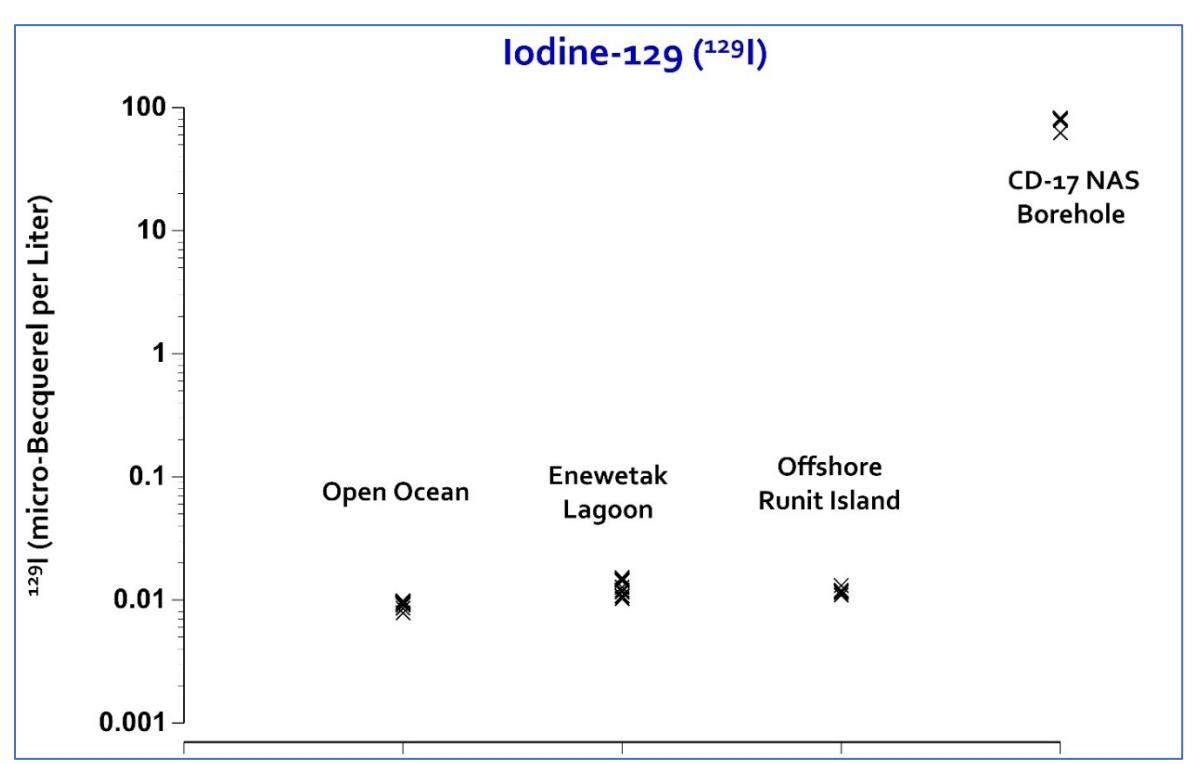
**Fig. 7.** Range of <sup>129</sup>I activity concentrations ( $\mu$ Bq L<sup>-1</sup>) observed in groundwater from the CD-17 borehole on *Cactus Crater* versus that observed in seawater samples collected from Enewetak Lagoon and the Open Ocean

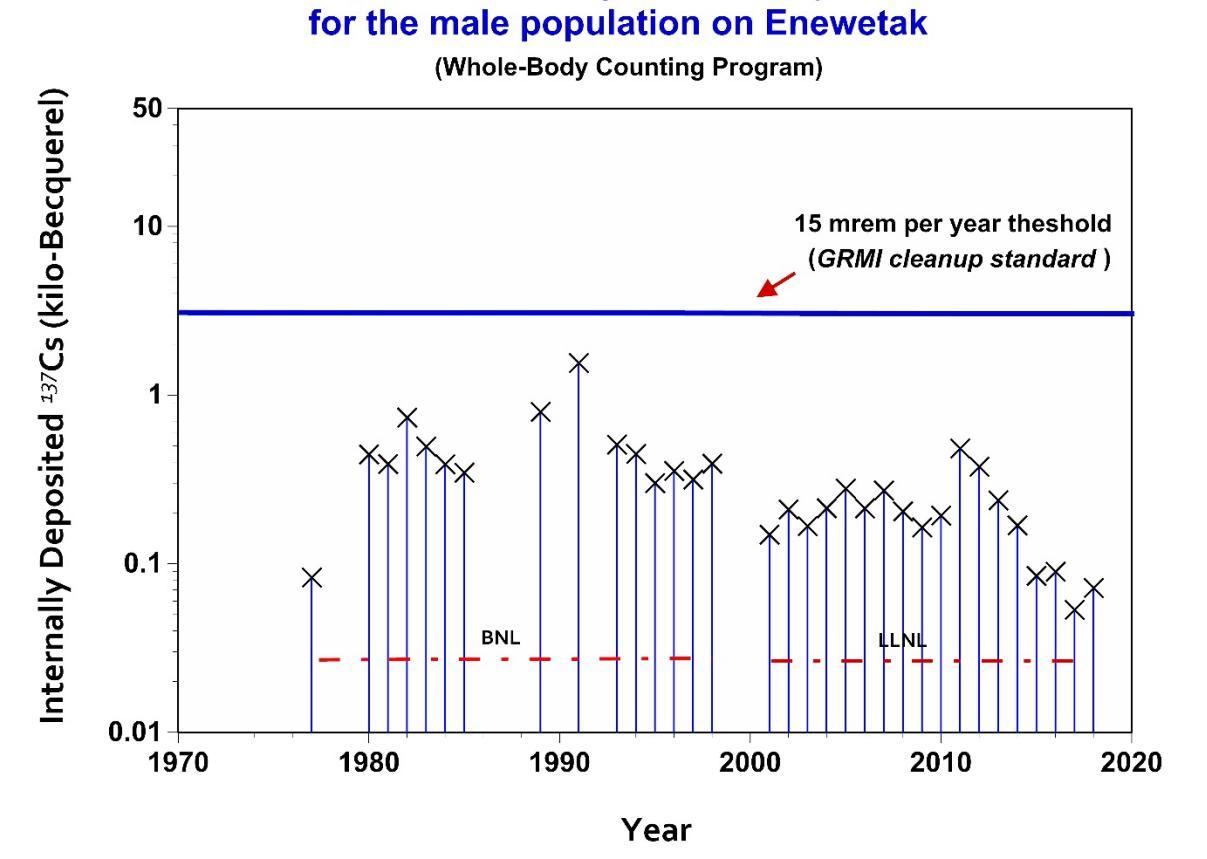
Population average <sup>137</sup>Cs body burden

**Fig. 8.** Average body burden of  $^{137}$ Cs (kBq) in the adult male population on Enewetak Atoll (1977-2018)

The cohort on Enewetak with the highest potential for uptake of dietary <sup>137</sup>Cs appears to be adult males, especially those individuals who visit the northern islands to fish or participate in recreational or resource development activities. The average level of internally deposited <sup>137</sup>Cs in the adult male population on Enewetak 1977-2018 has rarely exceeded 1 kBq. This amount of <sup>137</sup>Cs for an adult male equates to an annual effective dose of around 5 millirem per year, which is below the RMI government cleanup standard of 15 mrem per year for the public (see Figure 8, Section VIII).

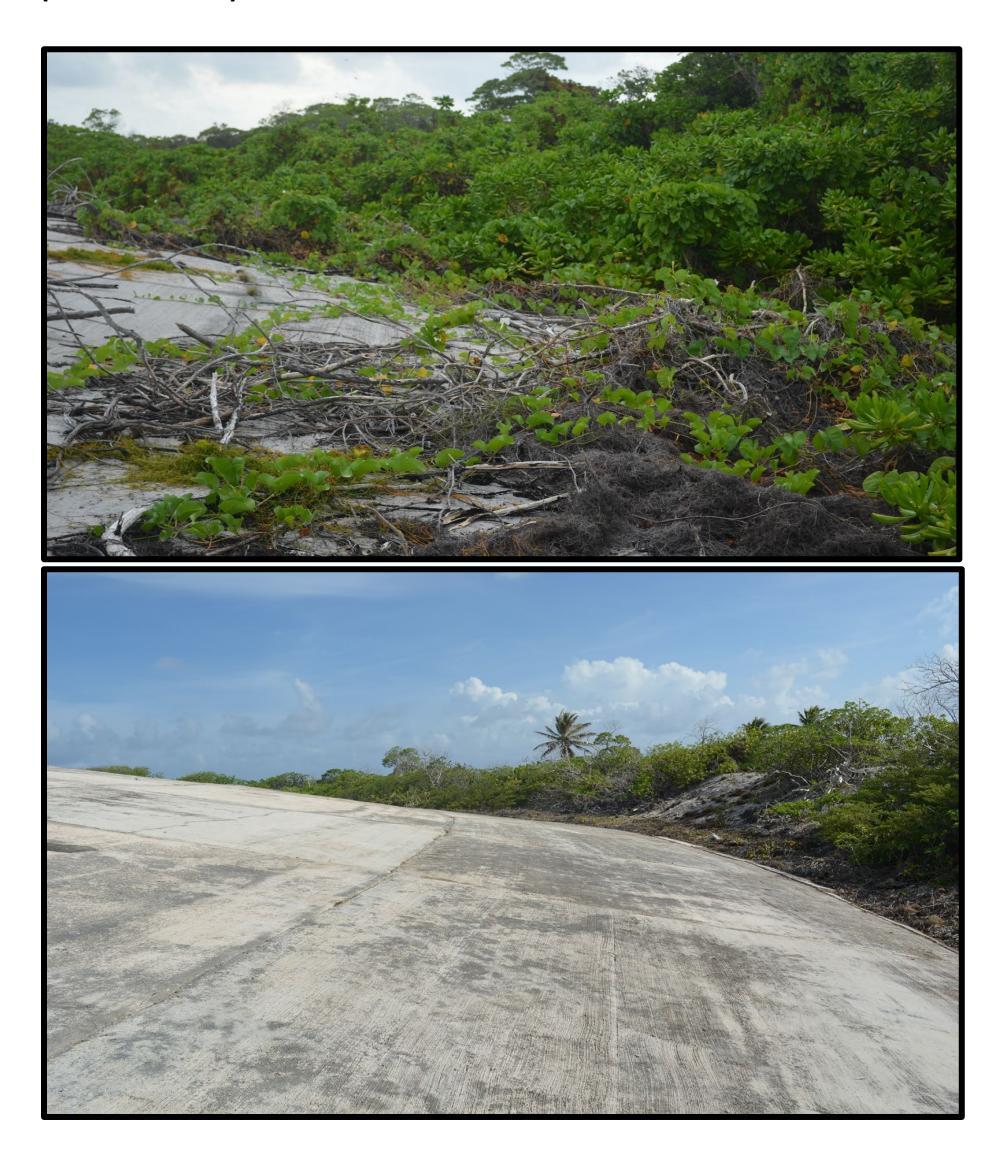
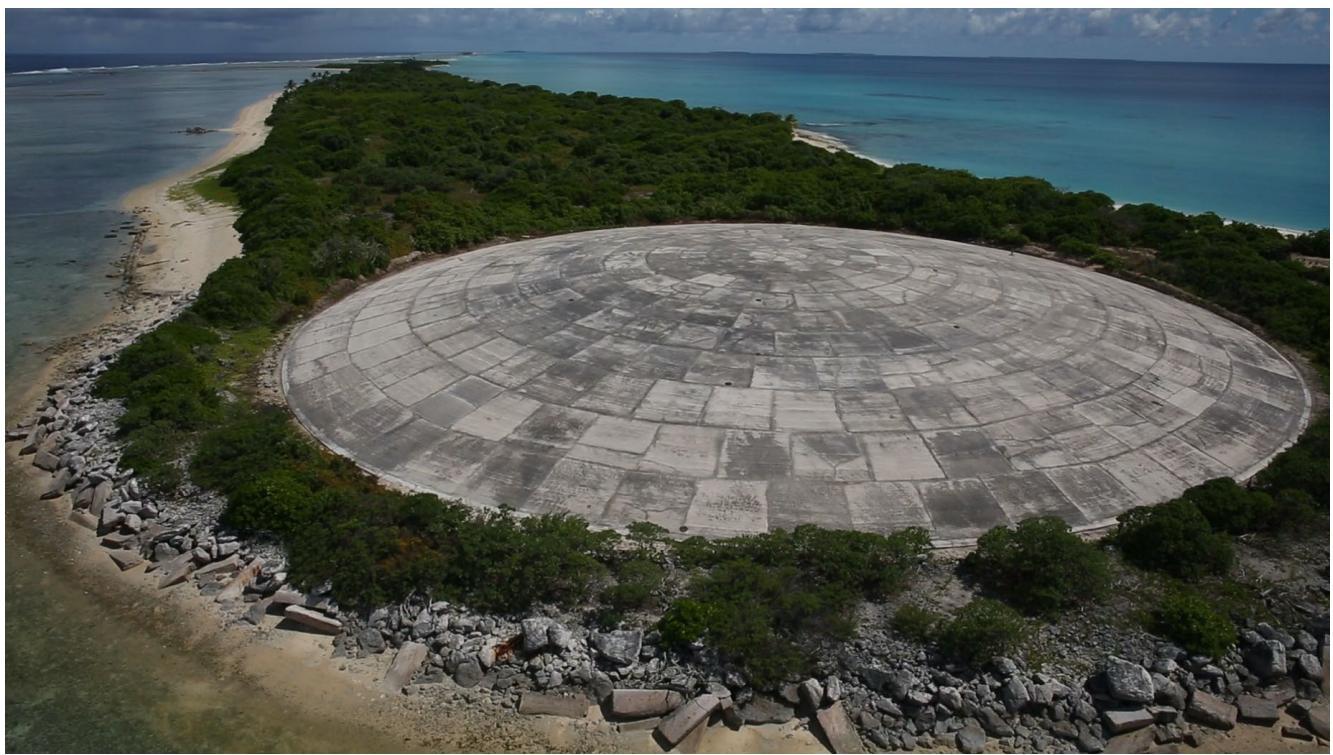
#### Fig. 9. Cleanup of Cactus Crater Containment Structure Before and After (October 2018)

UAS Photo of the Cactus Crater Containment Structure (October 2018)

Since 2018, DOE has regularly conducted general maintenance activities on the Cactus Crater Containment Structure and has employed and trained local workers to remove vegetation growing on the structure, take photographs, and report any significant changes in the overall integrity of the structure every 3 to 6 months (see Figure 9, Section VIII).
