Sweetland Wind Hand County, South Dakota

**Appendix C. Photographs of Grassland Tracts Evaluated During the Grassland Assessment at the Sweetland Wind Energy Project in 2018**

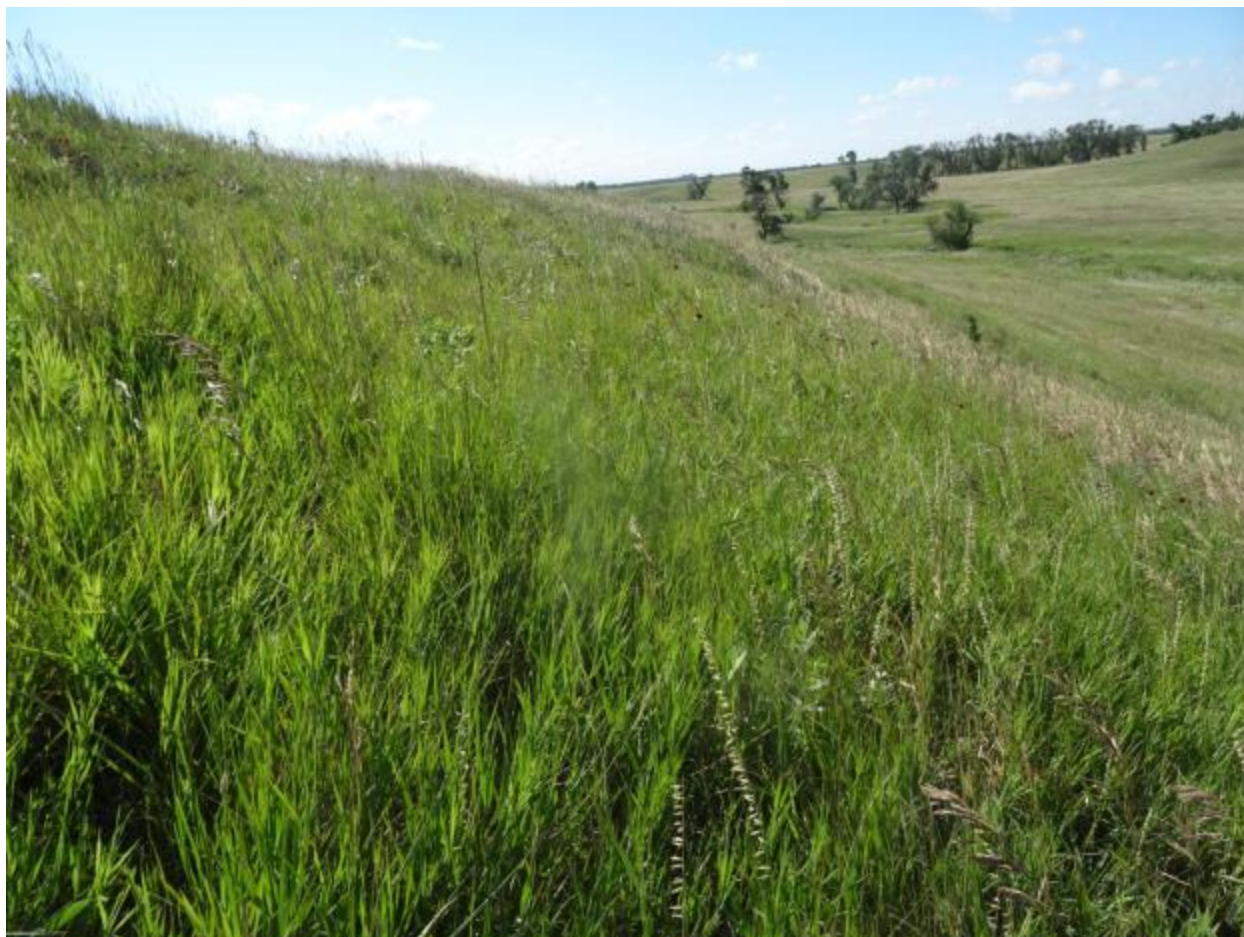
**Figure 4. Slopes in Project area rated as Above Average due to prevalence of native grasses and forbs. Sideoats grama is prevalent here, but note that smooth brome is still a common component of these sites.**
