## Gnome-Coach, New Mexico

### A WEAPONS RELATED AND VELA UNIFORM SITE

This fact sheet provides information about the **Gnome-Coach site**. Long-term stewardship responsibilities for this site are managed by the **U.S. Department of Energy Office of Legacy Management** under the **Plowshare/Vela Uniform/Weapons Related Program**.

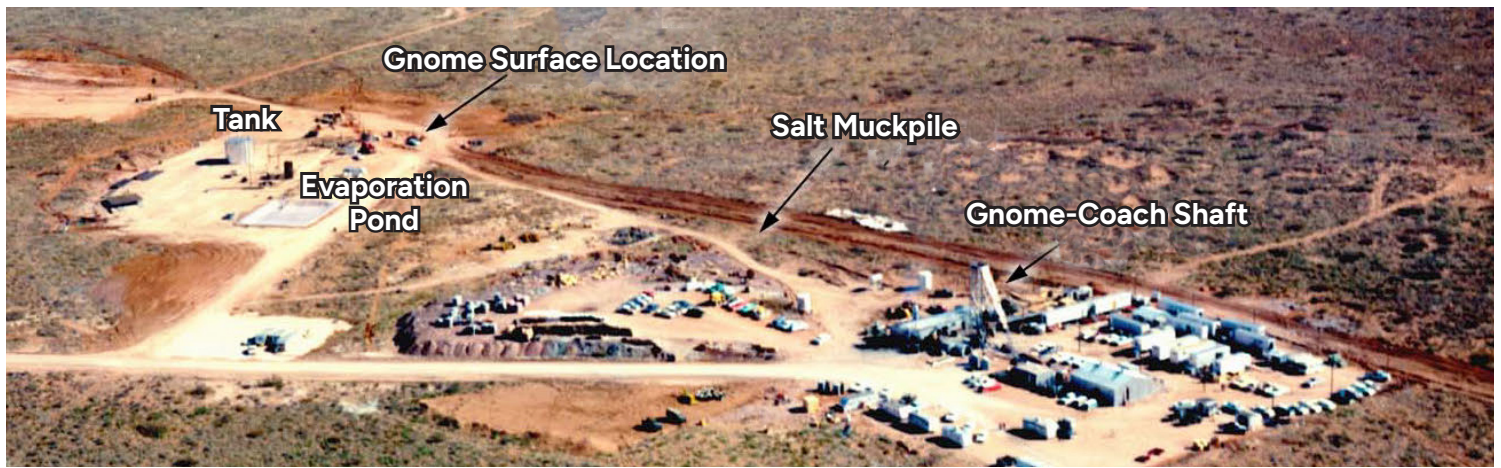
Top: View of Gnome-Coach, New Mexico, Site in 1961; Bottom: View in 2014.
