FINAL
RADIOLOGICAL CHARACTERIZATION OF SOILS
AREA IV AND THE NORTHERN BUFFER ZONE

AREA IV RADIOLOGICAL STUDY
SANTA SUSANA FIELD LABORATORY
VENTURA COUNTY, CALIFORNIA

HydroGeoLogic, Inc.
5023 North Parkway Calabasas
Calabasas, California 91302

December 21, 2012

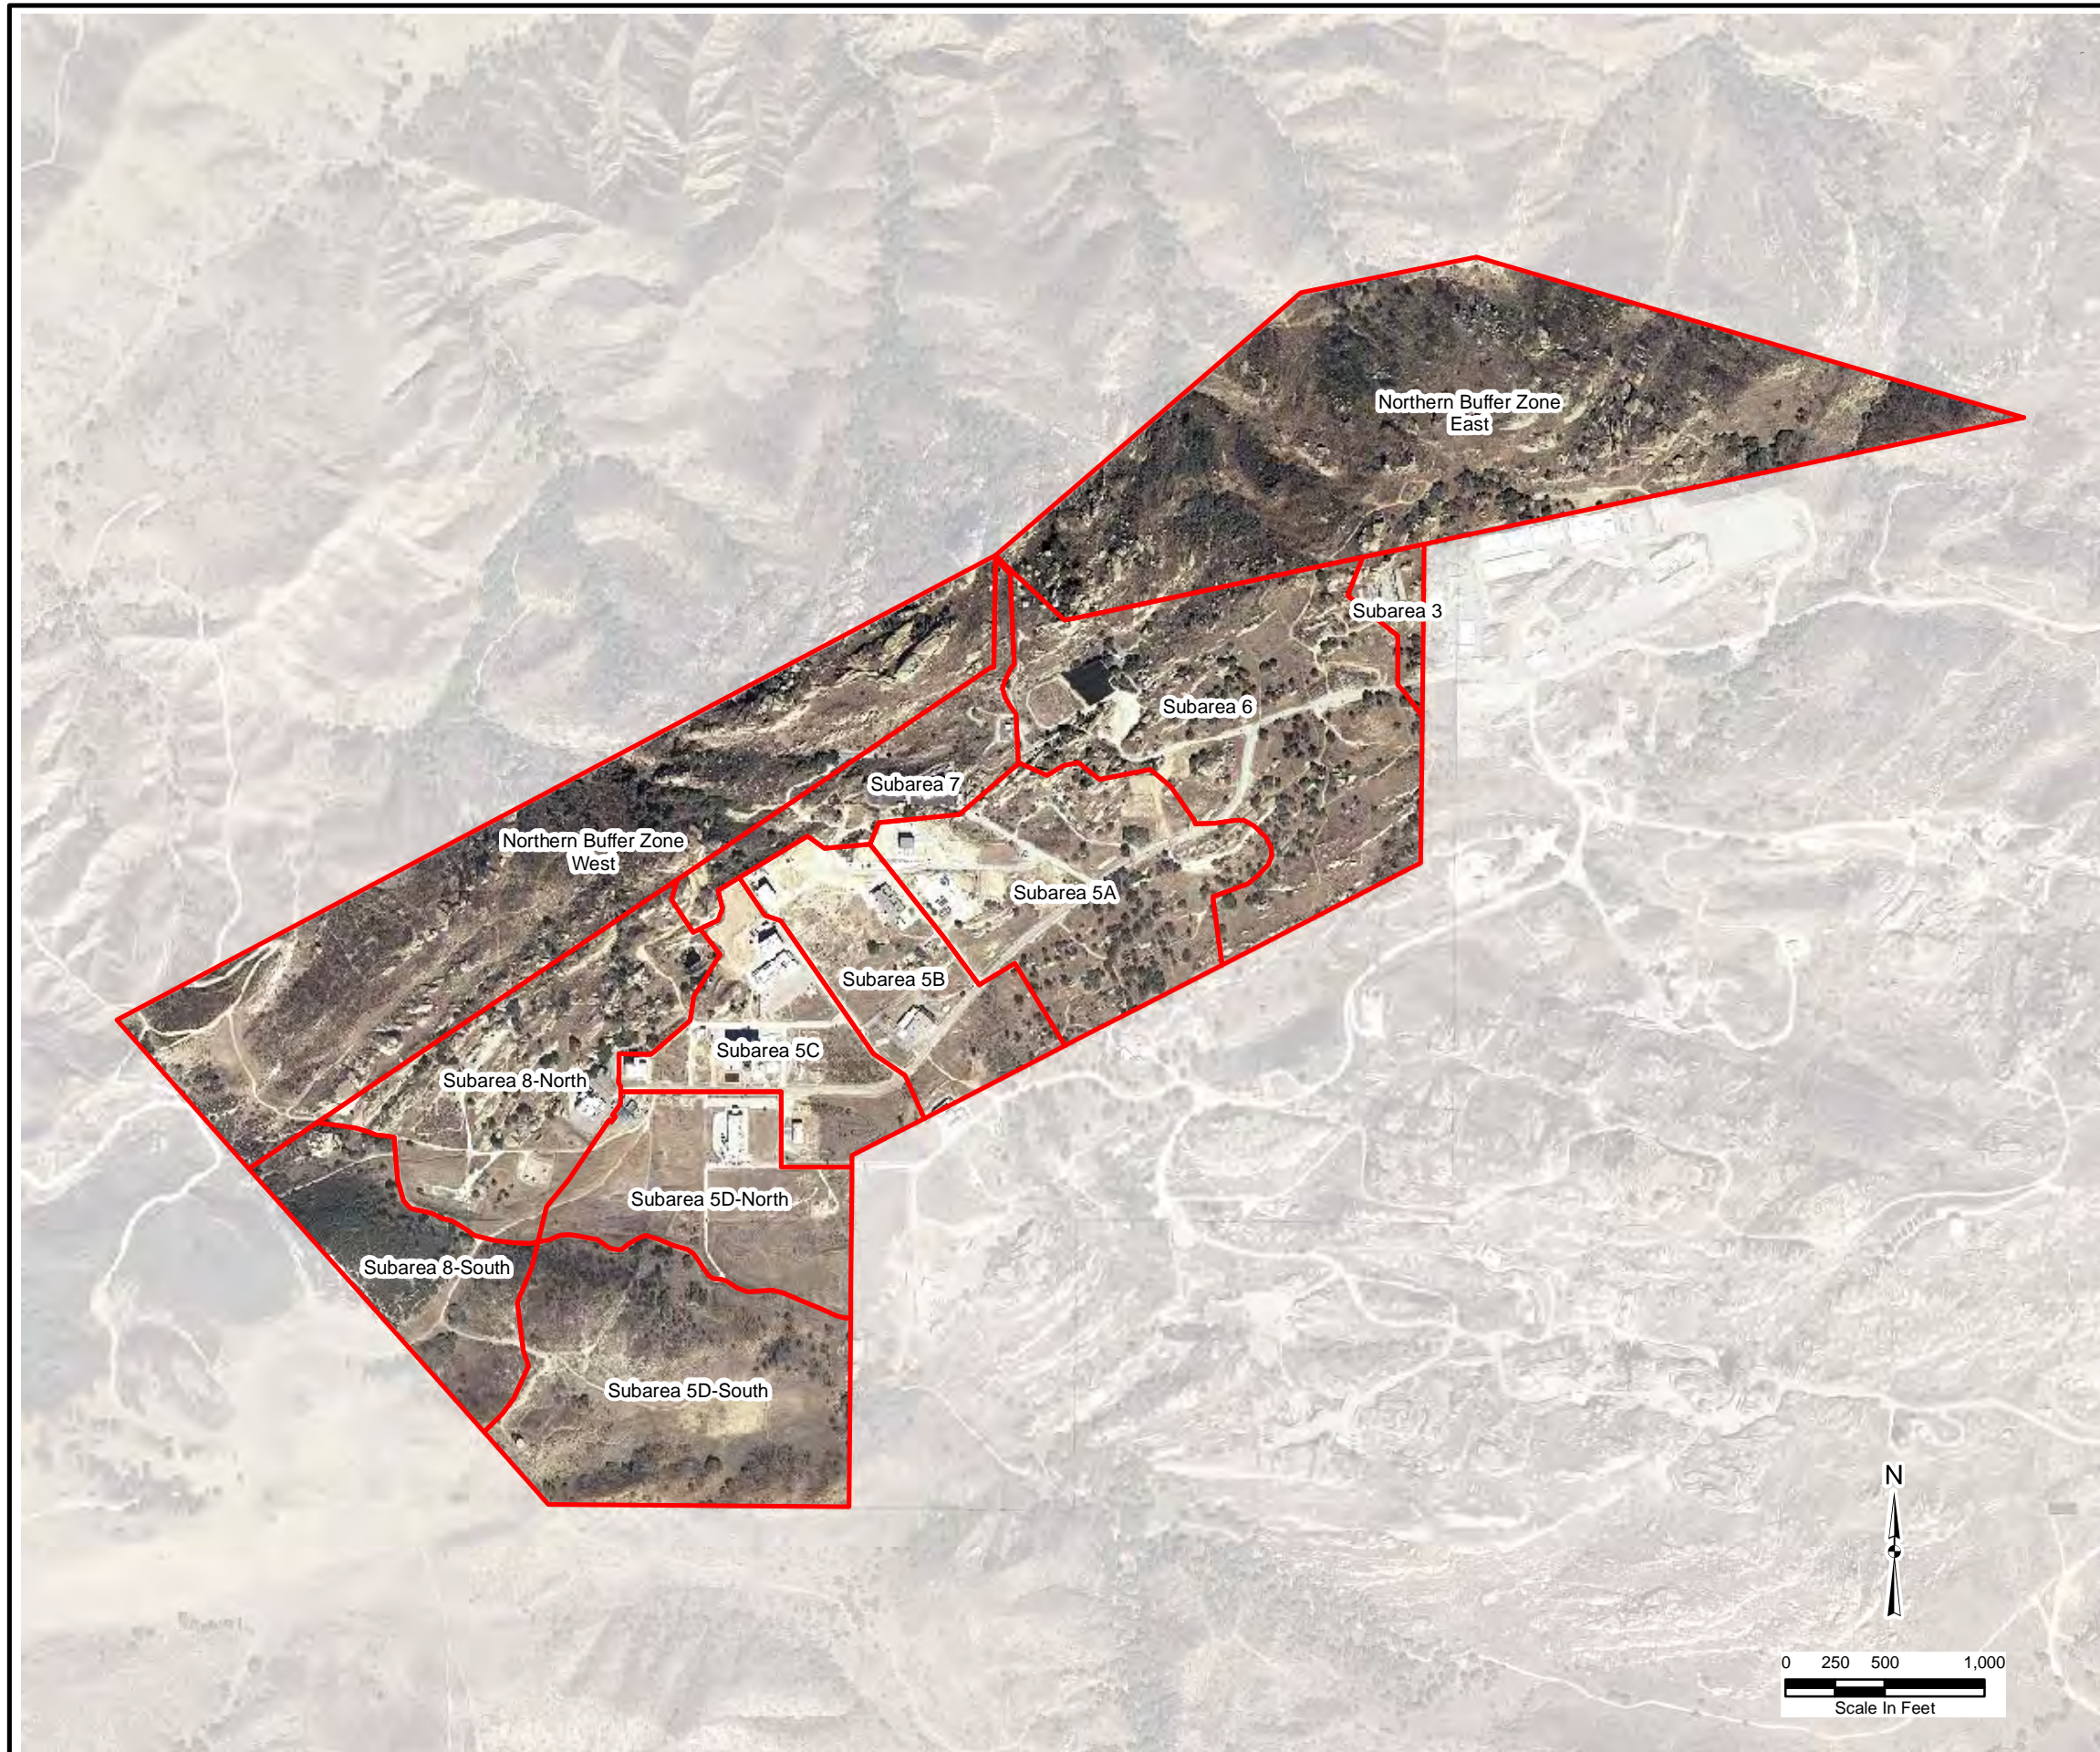
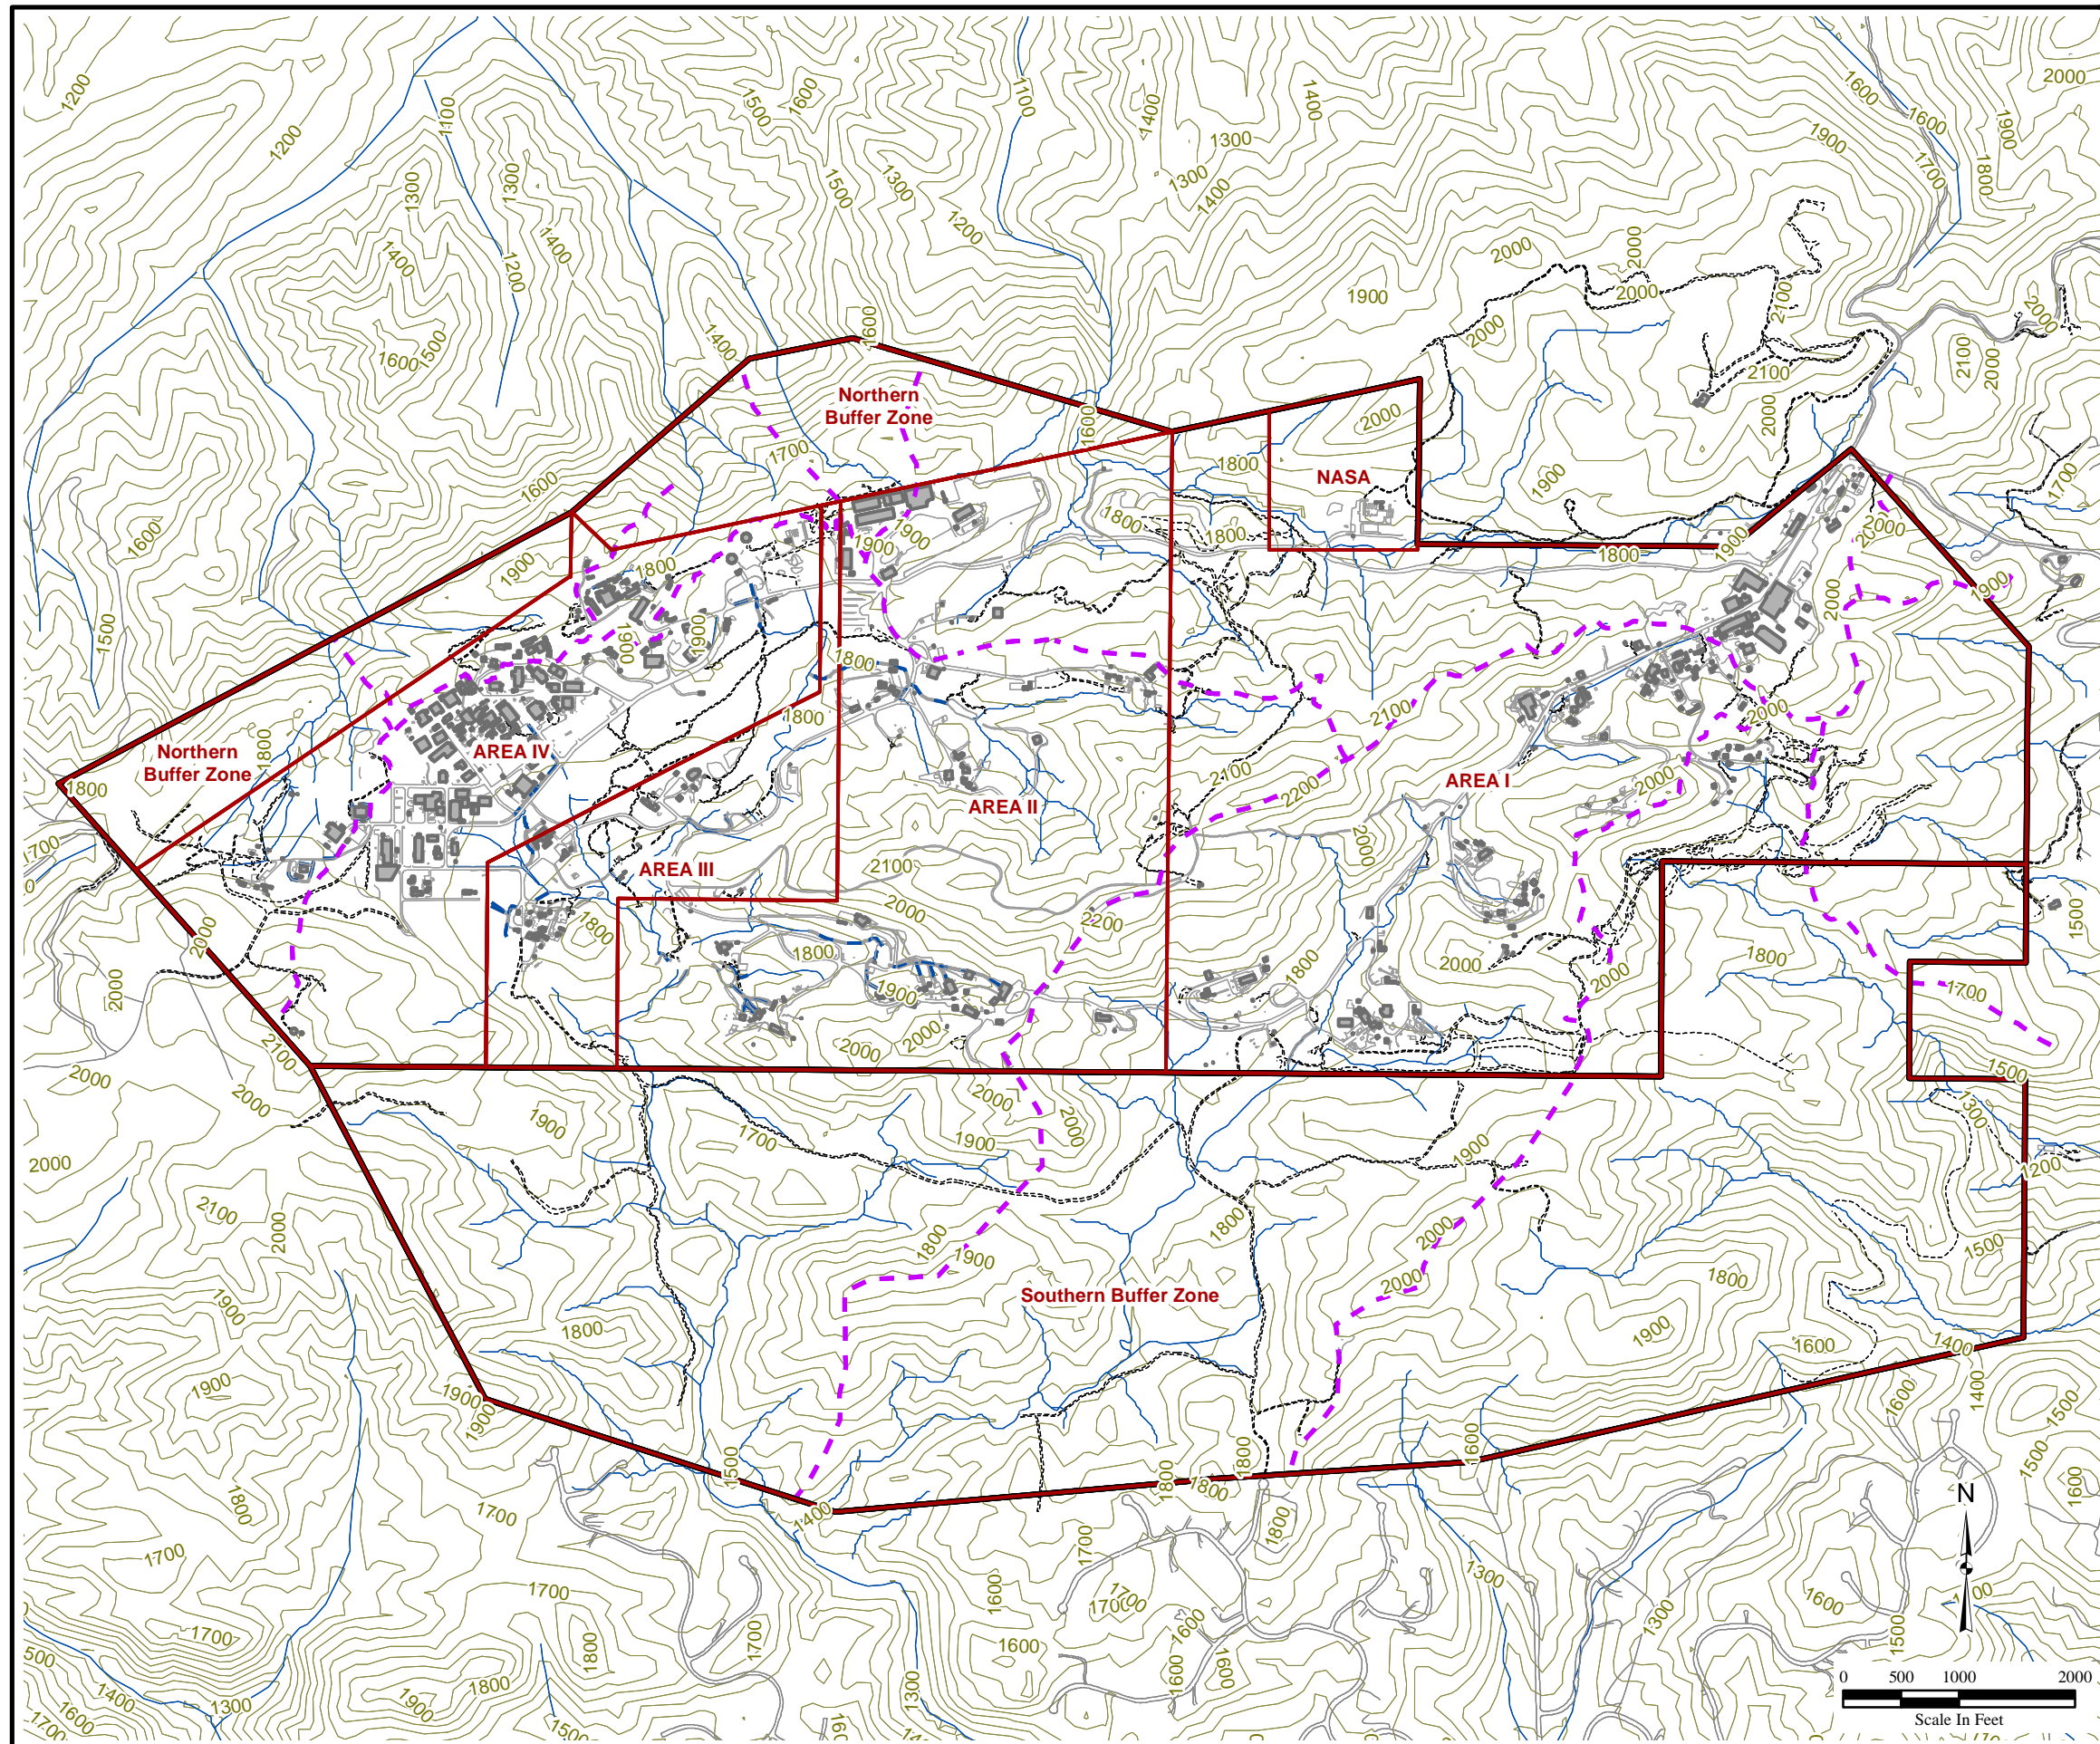
Figure 2.3 Topographic Map Santa Susana Field Laboratory

- Property Boundary
- Administrative Boundaries
- Drainage Divide
- Buildings
- Lined Channel
- Unlined Channel
- 50 ft Contours

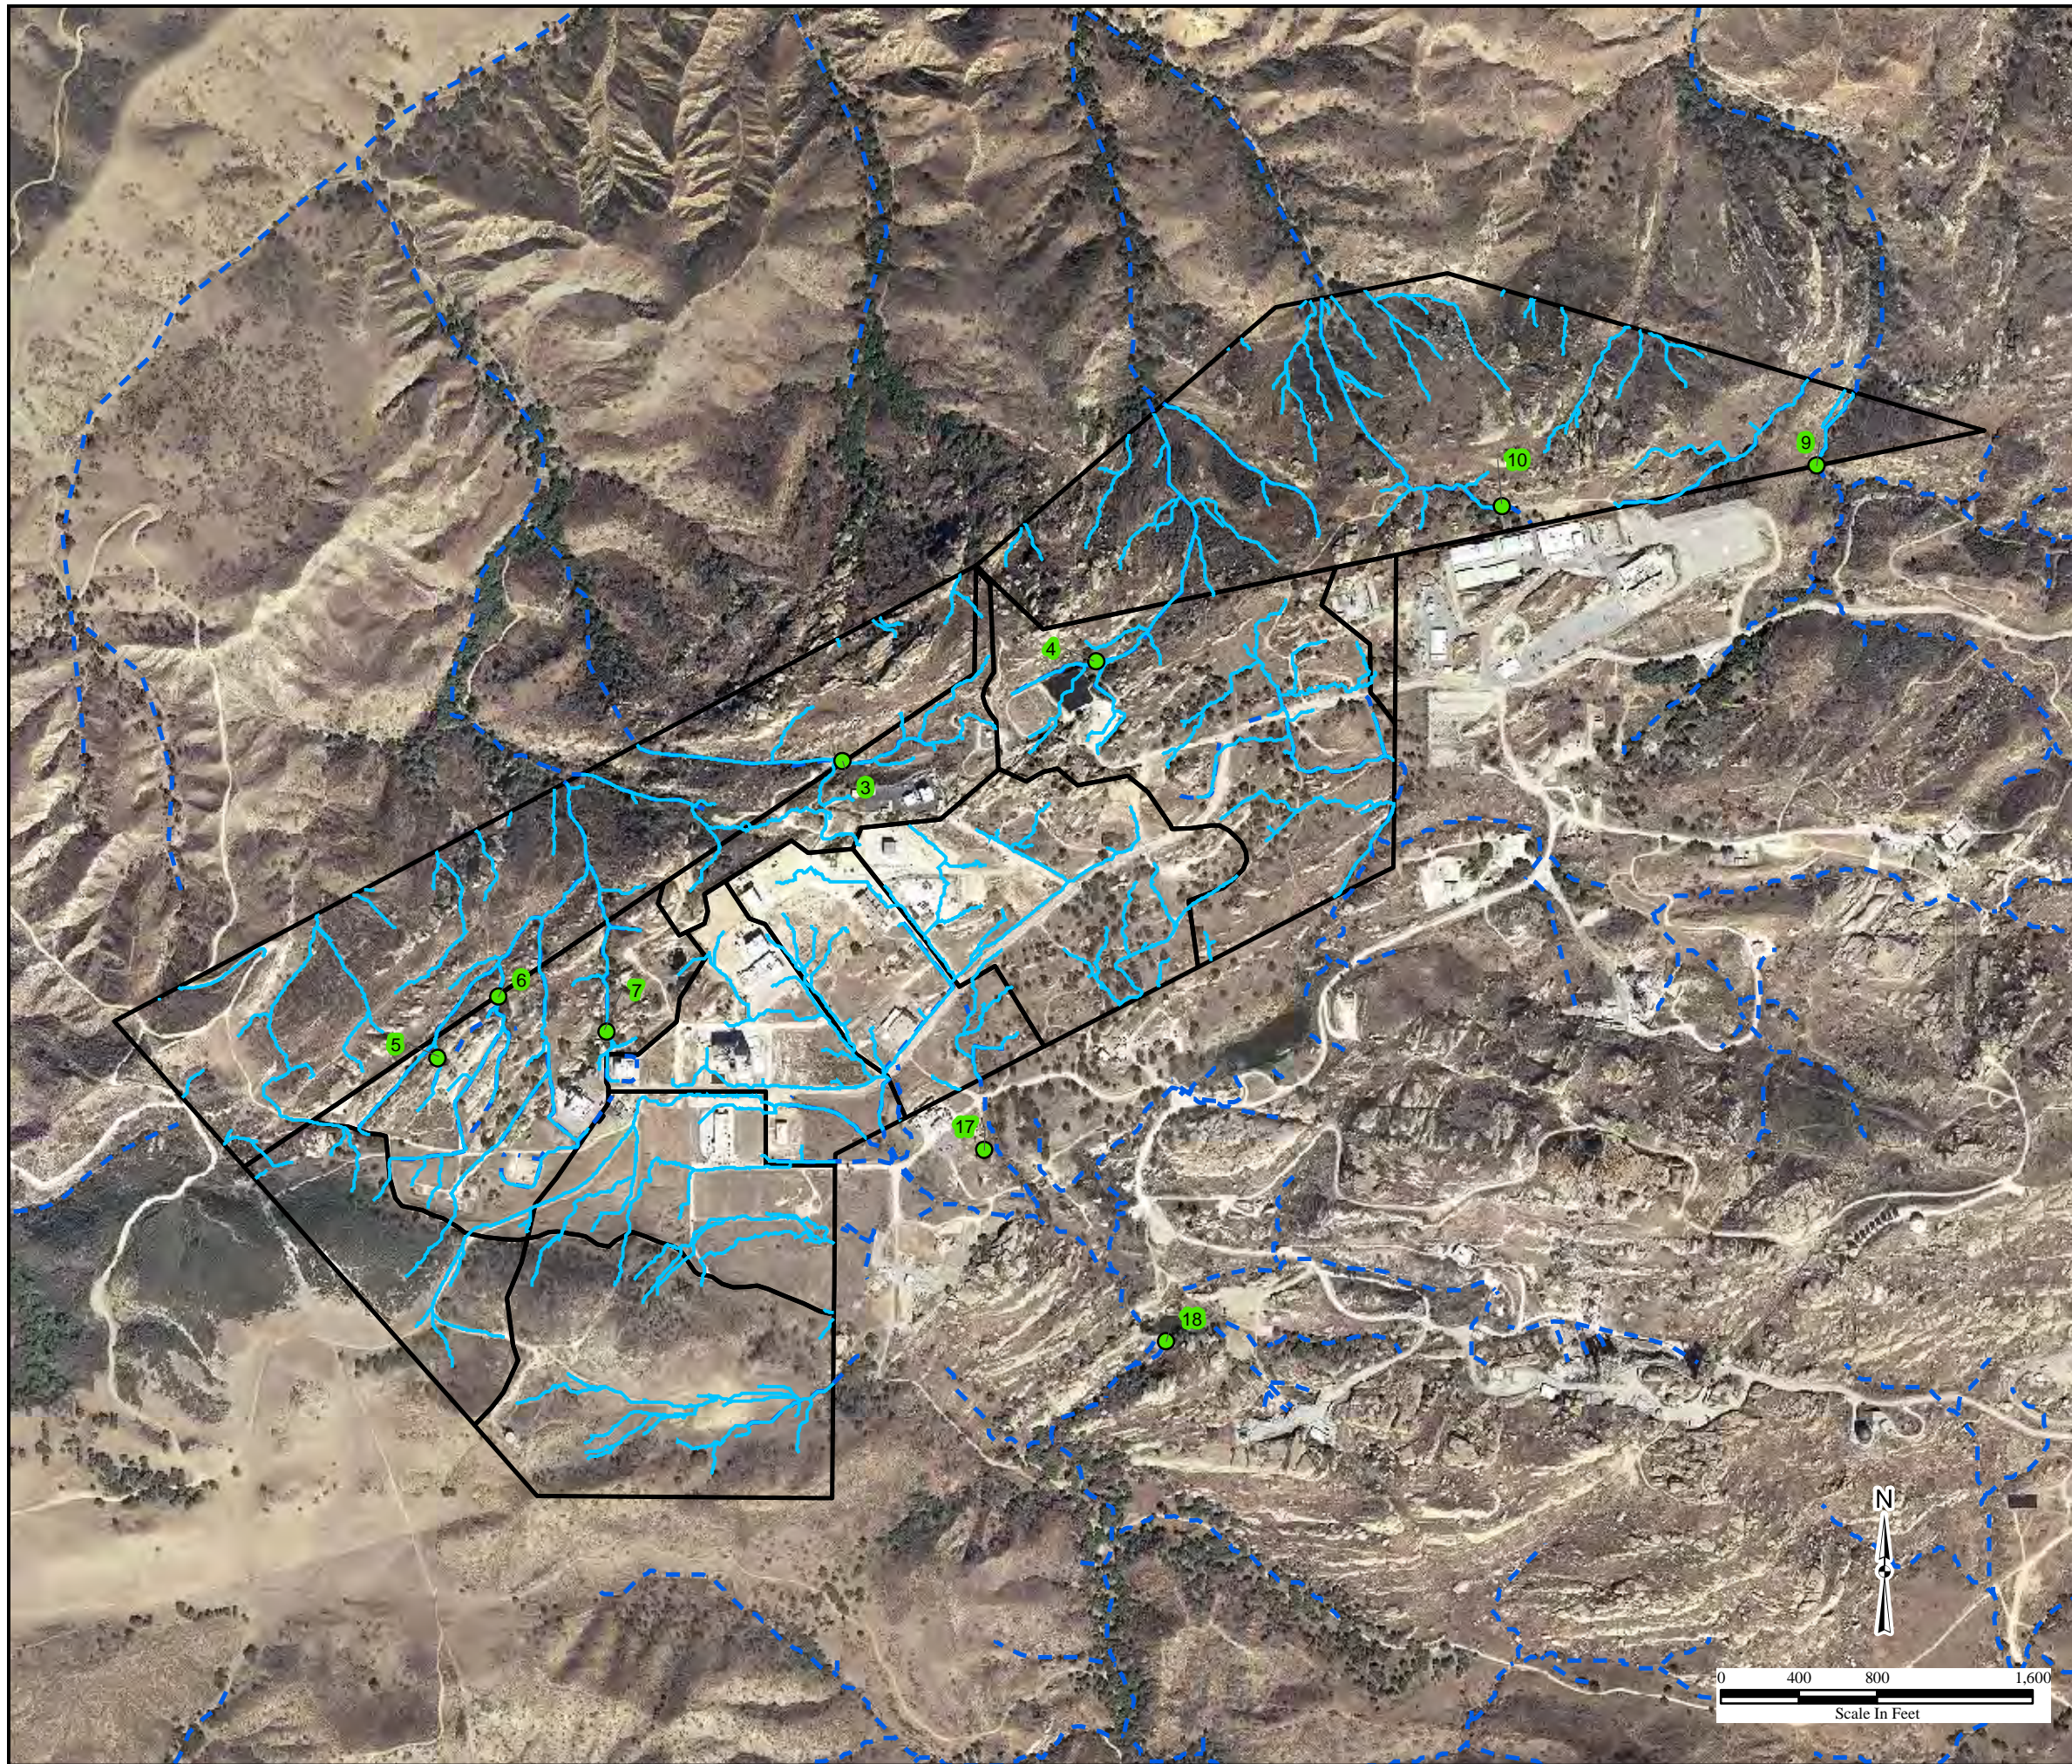
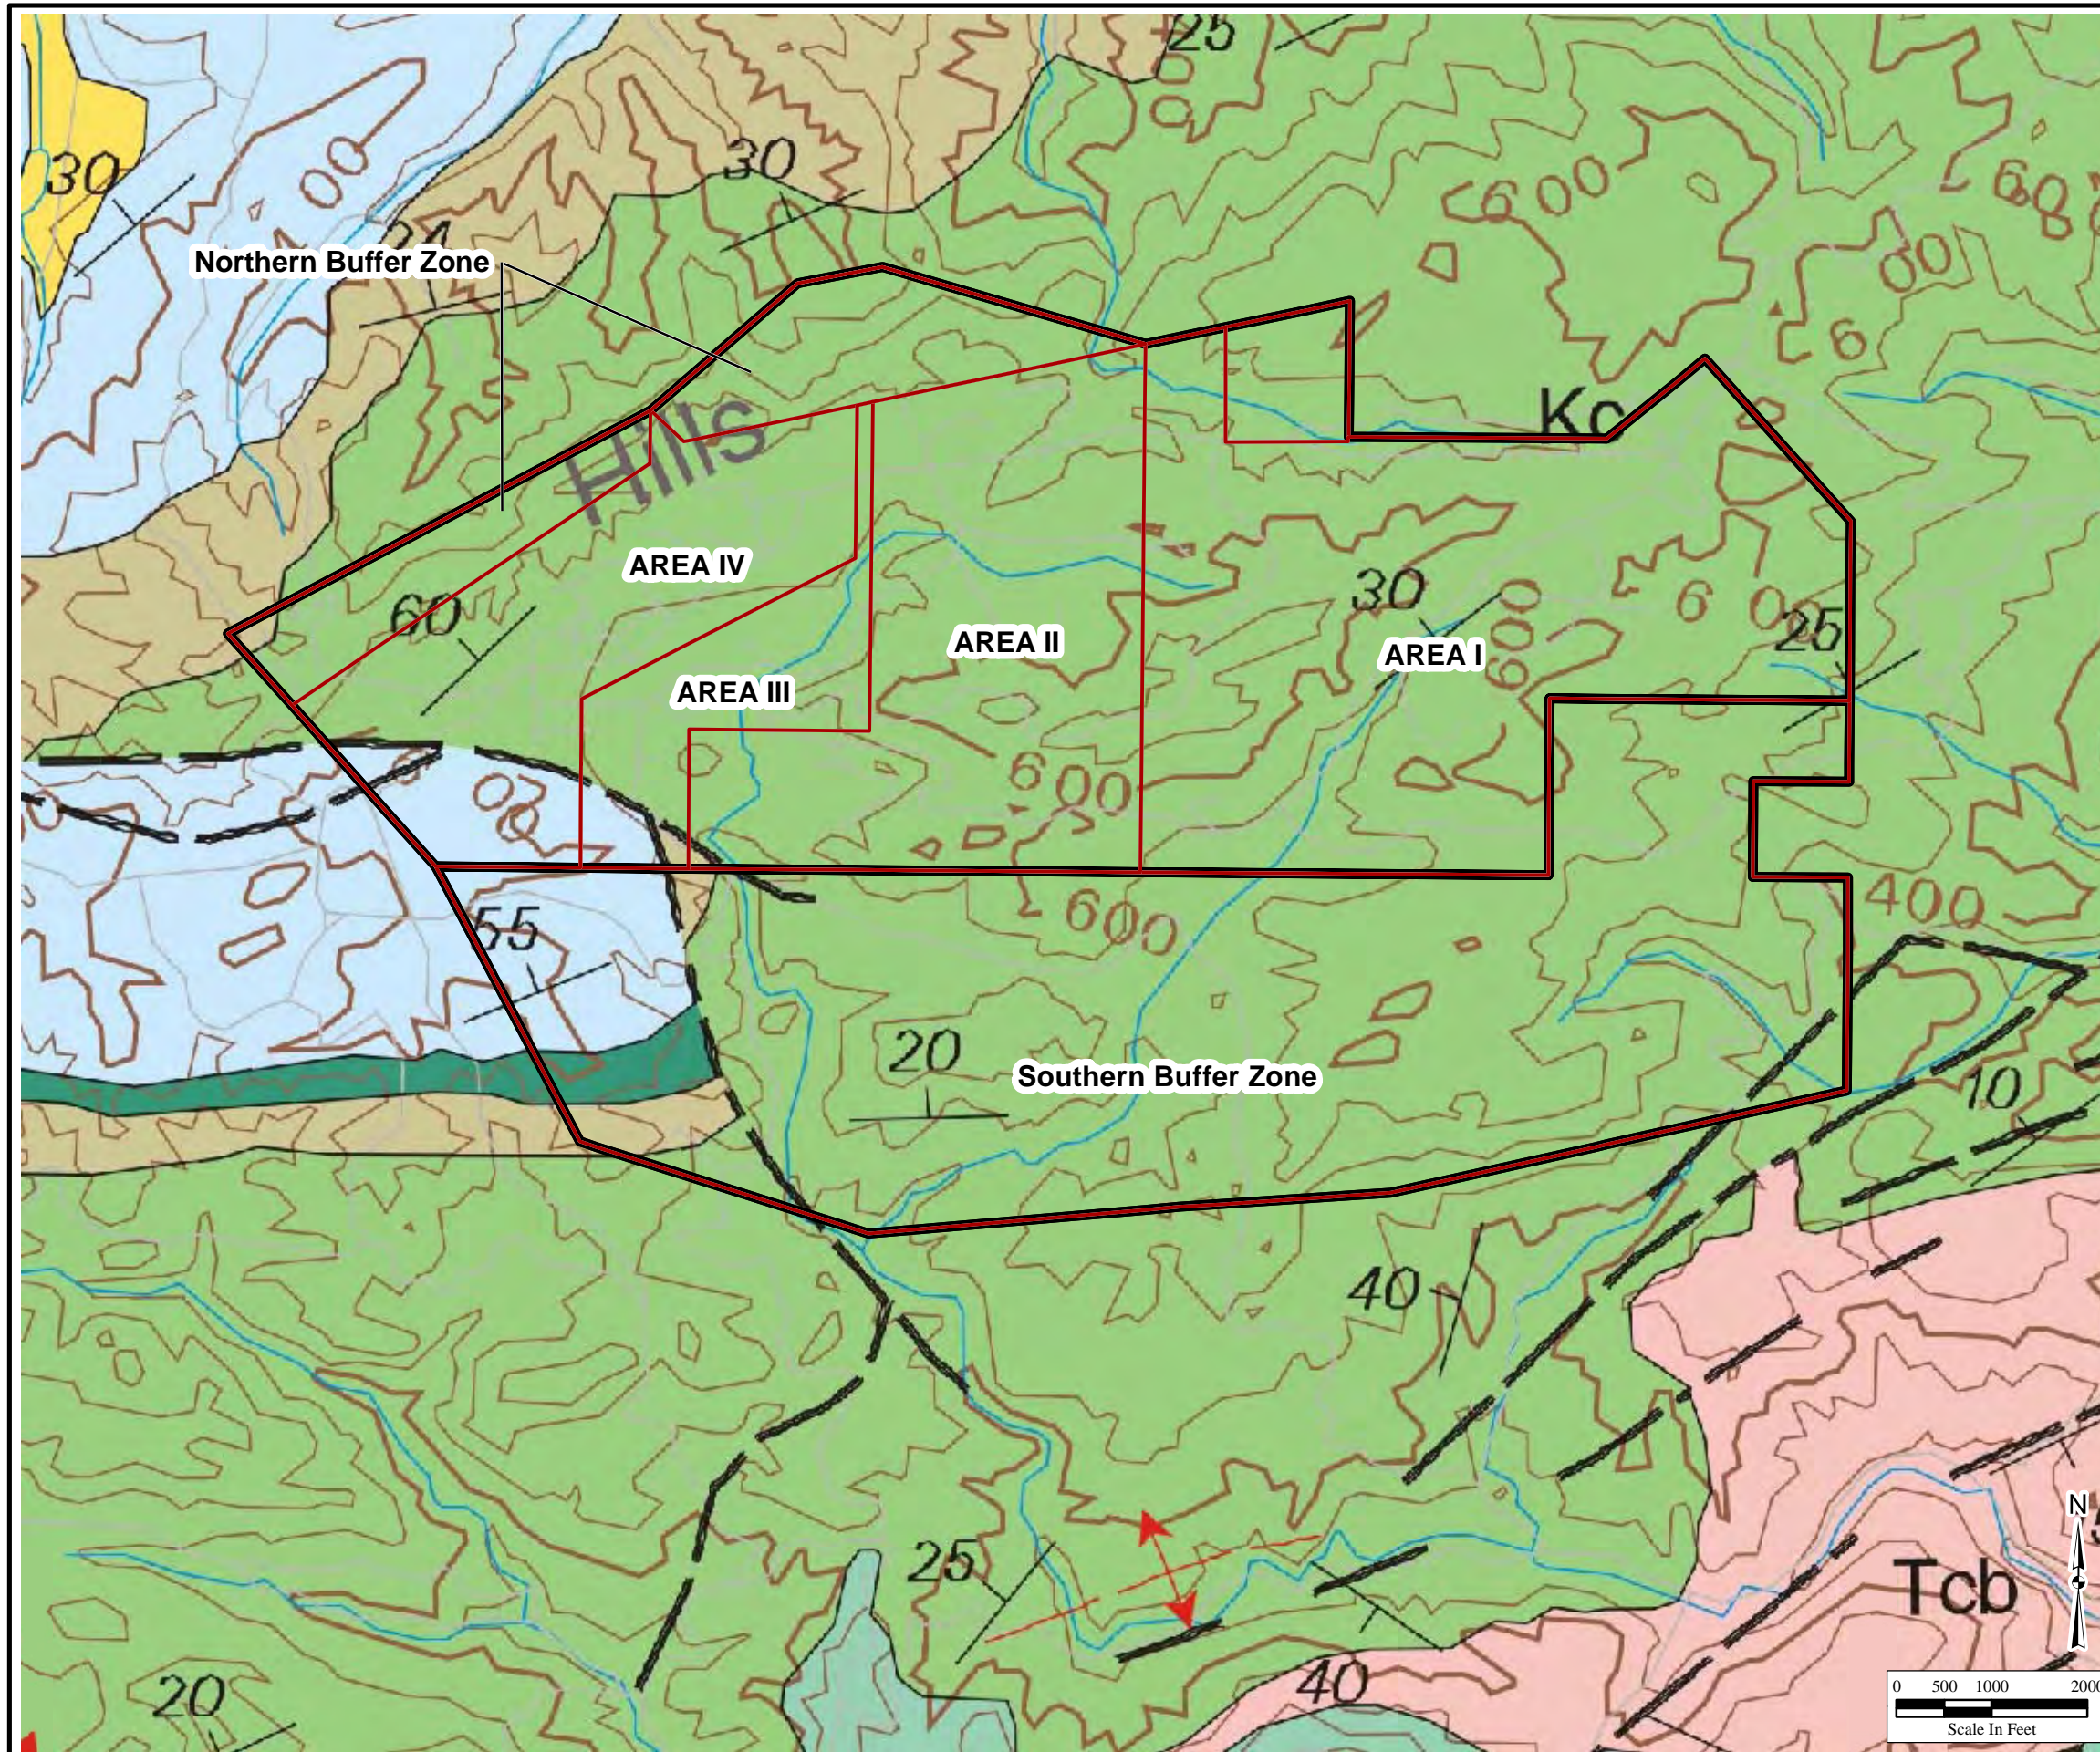
**Figure 2.5
Geologic Map
Santa Susana Field Laboratory**

- Administrative Boundaries at the Santa Susana Field Laboratory
- Santa Susana Field Laboratory Property Boundary
- Geologic Formation**
- Qof Old alluvial-fan deposits, Undivided (late to middle Pleistocene)
- Tm Modelo Formation Undivided (late Miocene)
- Tcb Calabasas Formation, Undivided (early late Miocene and late middle Miocene)
- Tsi Simi Conglomerate, Undivided (Paleocene)
- Tlv Las Virgenes Formation (Paleocene)
- Tss Santa Susana Formation (early Eocene to late Paleocene)
- Kc Chatsworth Formation (late Cretaceous)
- Anticline
- Strike and Dip of Bedding
- Fault (approximate location)

The Chatsworth Formation consists of three unnamed members. The members were deposited by turbidity currents in a deep ocean at depths ranging from 4,000 to 5,000 feet. Turbidity currents cause massive submarine landslides from the continental shelf into submarine canyons which are generally more than a half-mile wide and greater than ten miles in length. During periods without turbidity currents, silt and clay particles from runoff filtered to the ocean floor and formed the siltstone strata found in the formation.

Deposited in the late Cretaceous, the Chatsworth Formation is in excess of 6,000 feet thick. The uppermost member is a thick strata of light gray to brown sandstone, which is hard, coherent, arkosic, micaceous, primarily medium grained separated by thin partings of siltstone. The middle member is a gray conglomerate of cobbles of rounded, polished clasts of quartzite, porphyry and granitic rocks in hard rock matrix. The lower member is gray clay shale, crumbly with ellipsoidal fracture where weathered, and may include sandstone strata.

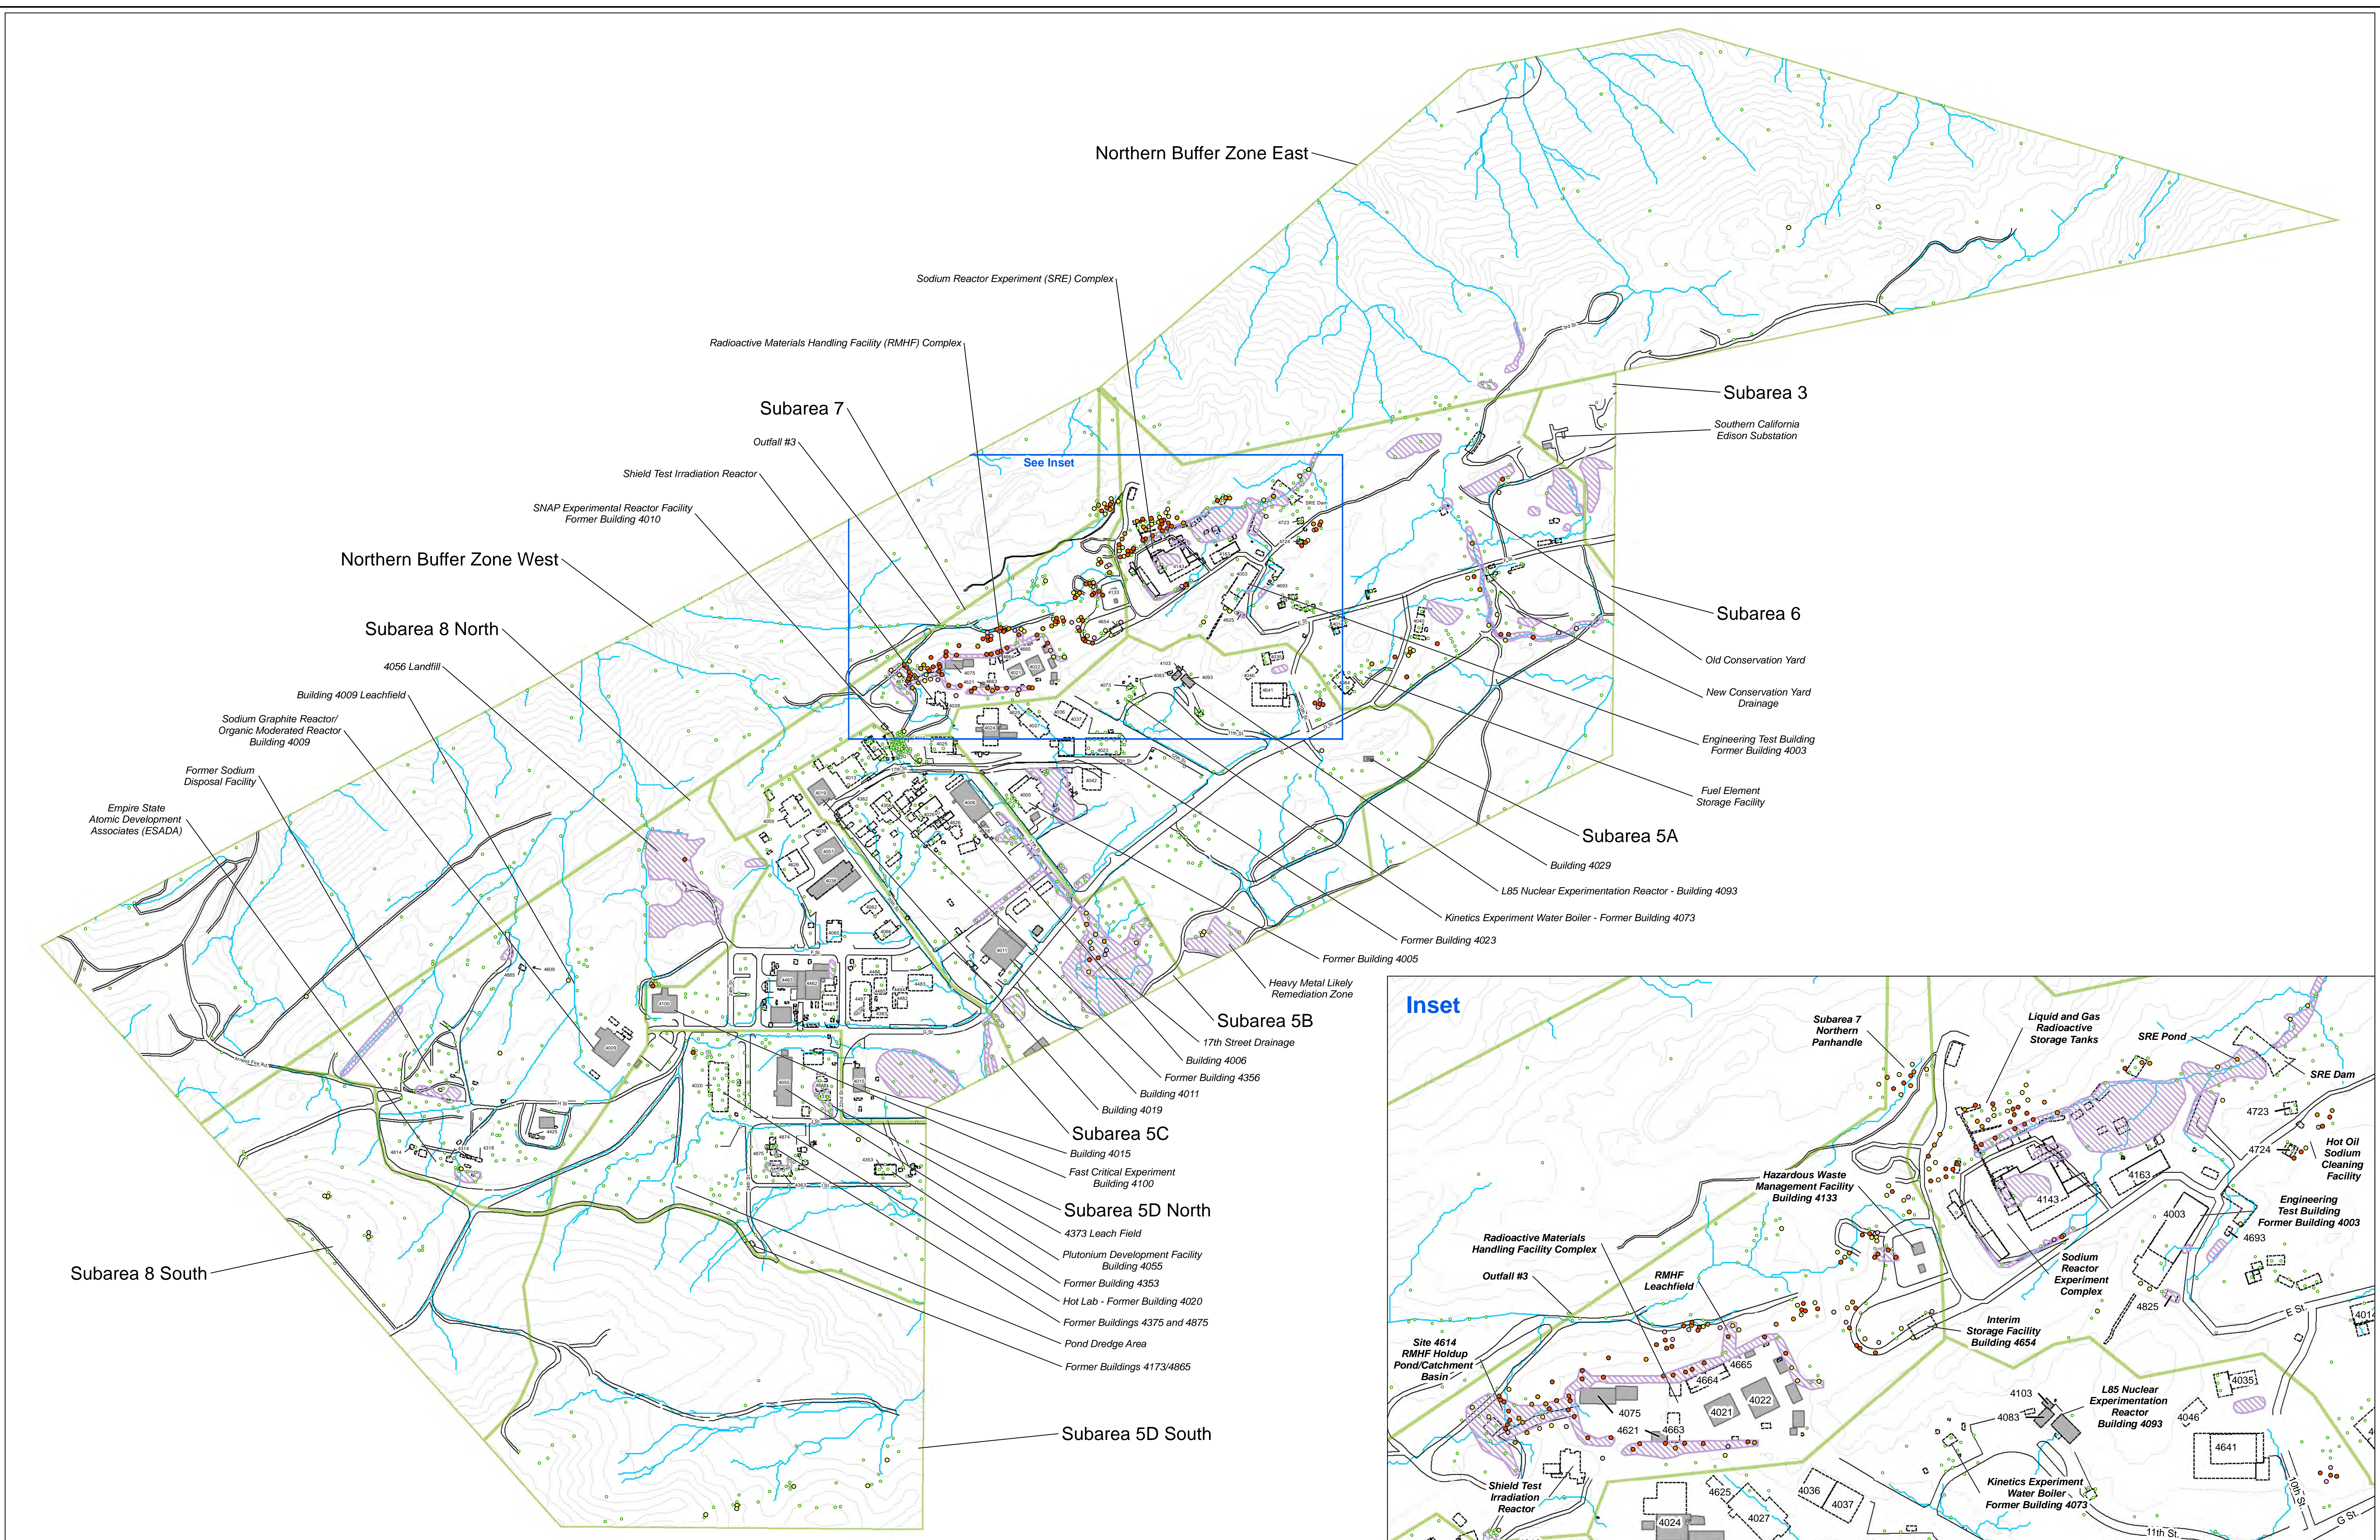
Cesium-137 (FAL = 0.193)

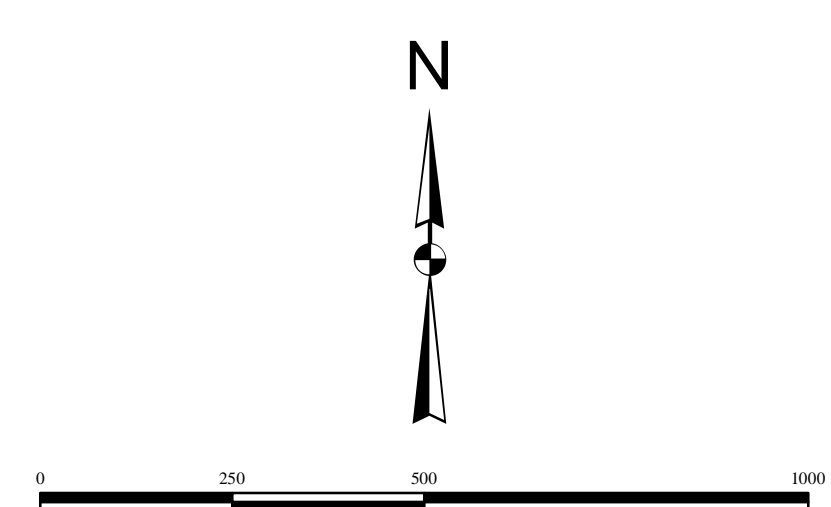
Figure 4.1
Cesium-137
Round 1 and 2 Surface Soil
and Sediment Results
Santa Susana Field Laboratory
Area IV and NBZ Radiological Study

With the exception of Subarea 3, Cs-137 was detected in every subarea and the NBZ. These concentrations are presented by subarea (surface and subsurface) in Tables 4.2 and 4.3 and are illustrated on Figures 4.1 and 4.2. Details pertaining to each subarea regarding the distribution of Cs-137 are provided in the following subsections.
